APPLIED PROBLEMS
OF STRENGTH AND PLASTICITY

Corrosion-Mechanical Failure of the Fittings of Pipeline Systems in Deposits with a High CO₂ Content

Abstract—The results of field (bypass) tests of fittings made of 13KhFA steel in oilfield media with a high content of CO₂, H₂S, and Cl[−] are presented. The corrosion resistance of the branches made of 13KhFA steel is shown to be two to three times higher than that of traditionally used 09G2S steel. Intense development of bacterial corrosion in steeply curved bends is detected.

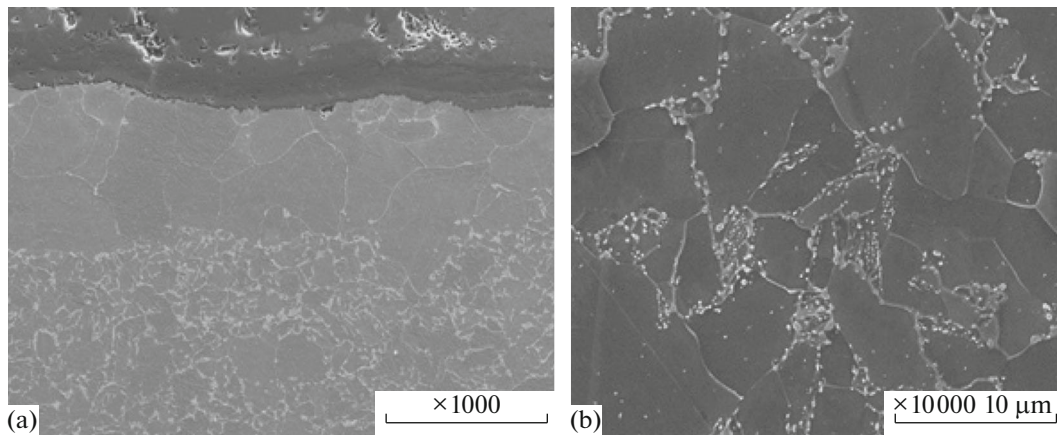
Fig. 1. Microstructure of 13KhFA steel (branch 219 mm in diameter with 6-mm-thick wall): (a) surface layer and (b) base metal.

quenching (above temperature A_{c3}), this scheme provides higher plasticity, impact strength, and uniformity of properties across the pipe wall thickness. The branches were made by pulling pipe billets along a horn-shaped core using the technology including heating to $\approx 960^\circ\text{C}$, bending deformation by 90 deg, air cooling, subsequent double quenching (at 930 and 770°C), and high tempering at 580°C. Heating for deformation and heat treatment led to the formation of a 200- μm -thick dense scale layer and to significant decarburization of the surface to a depth of $\approx 100 \mu\text{m}$. The surface layer of the branches in the initial state was represented by ferrite grains (Fig. 1a), and the base metal, by granular pearlite with ferrite crystals (Fig. 1b).

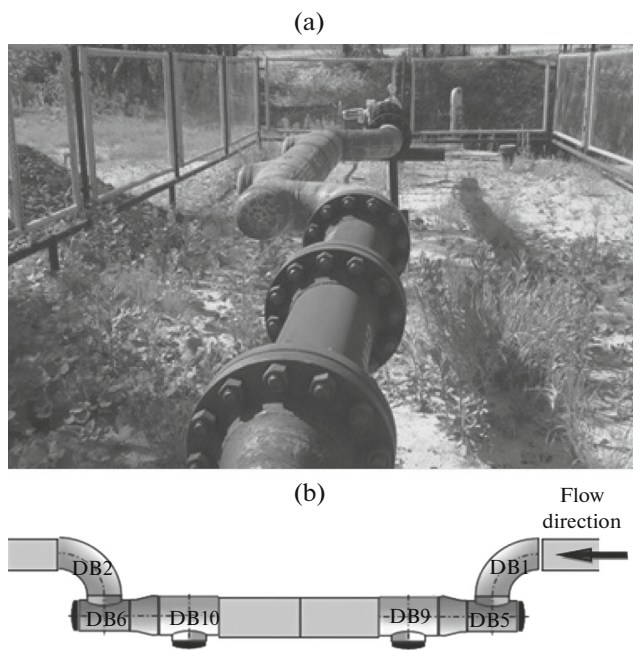
Fig. 2. (a) General view and (b) scheme of the test section (tested DB1 and FDB2 branches).

The bypass tests (Fig. 2) were carried out for 19 and 42 months under the conditions of the test bench created at the site of the oil-gathering reservoir of the Mamontovsk deposit of OOO RN-Yuganskneftegaz, the oilfield media of which are characterized by a high CO_2 content and are additionally saturated with H_2S and chlorine ions (Table 2). After PFT, the line was dismantled and the branches were cut and cleaned from oil products. The type, the intensity, and the character of damage to the inner surface and the composition, the structure, and the formation kinetics of corrosion products were evaluated.
