# Correlation between the cracking pattern of historical structure and soil properties: the case of the church in Kozuchów

Krzysztof Raszczuk<sup>1</sup> and Anna Karolak<sup>1\*</sup>

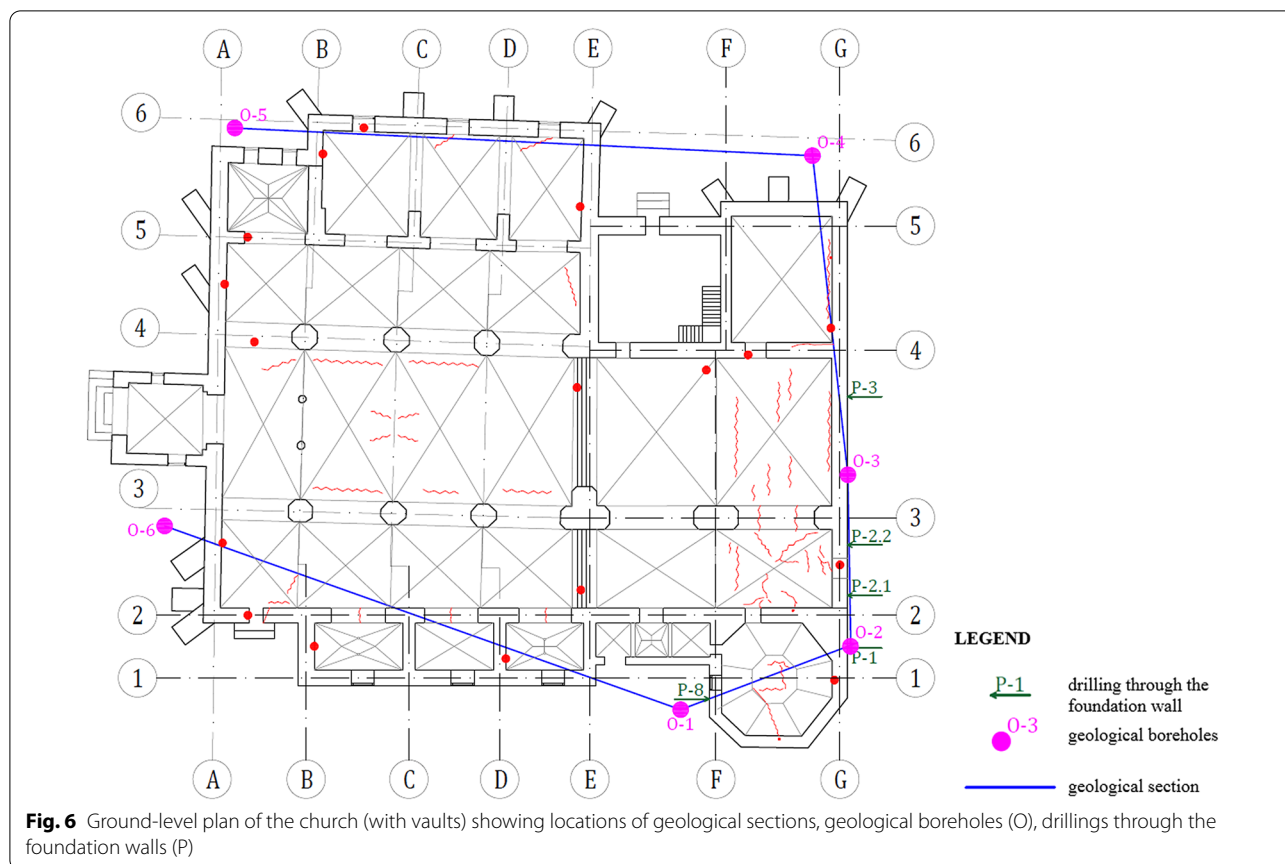
the foundation walls [61]. Six geological boreholes were drilled to a depth of about 4 to 12 m below ground level (total depth of approx. 50 running metres) and 5 core samples were taken from the foundation wall in the east, where damage was greatest. The locations of the boreholes and core samples from the foundation wall are presented in Fig. 6.
