# Engineering geological characteristics and failure mechanics of Jure rock avalanche, Nepal

**Study area** The present work is aimed at assessing the failure mechanism of the disastrous 2014 Jure rock avalanche along Araniko Highway, Northern Nepal. The event had blocked the Sunkoshi River and blocked an economically significant route to China.

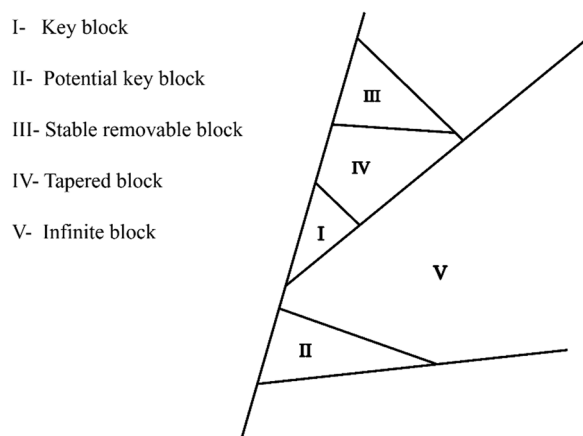
**Fig. 9** Key block theory classification of rock blocks (Kulatilake et al. 2011)

of the rock above the key block is balanced by the friction and shear resistance of the key block against the rock below it (Fig. 9). If the weight of the rock above the key block exceeds the resistance of the key block, the slope becomes unstable and may fail.

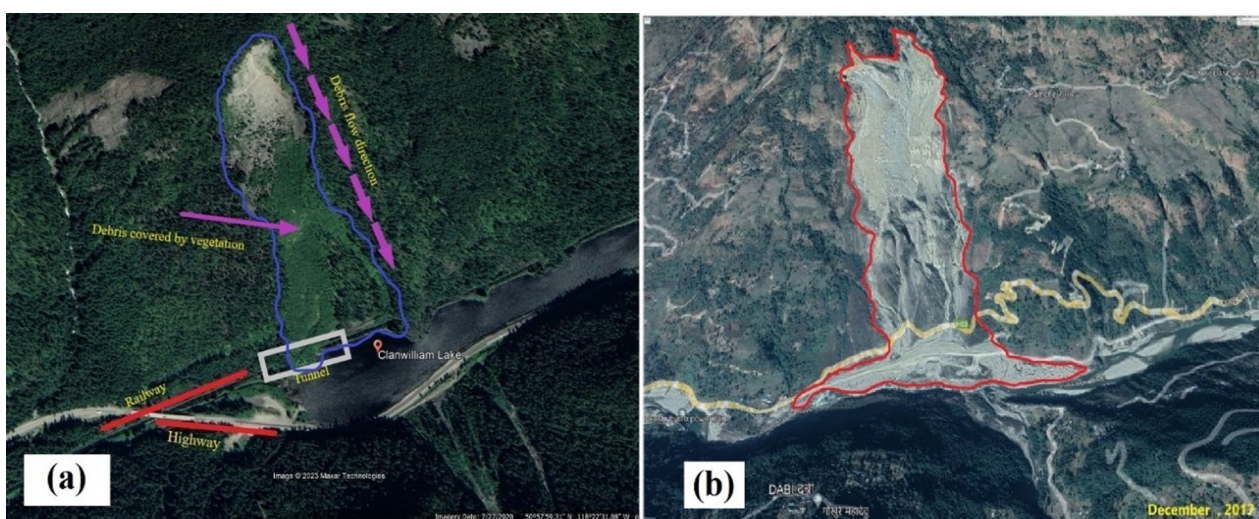
**Fig. 16** Overview of the Clanwilliam landslide and Jure rock avalanches, **a** Clanwilliam landslide, **b** Jure rock avalanche (Google Earth)

On April 2 1999, Clanwilliam landslide occurred on a south facing slope above Clanwilliam Lake, approximately 13 km west of Revelstoke, B.C. The failed mass is composed of gneissic material, that in the case of Jure is meta-sandstones and Pelitic schist. The published data examination shows that no earthquake events were recorded prior to the Clanwilliam failure. The climatic record showed that pronounced freeze–thaw cycles occurred the day before and on the day of the failure. Only a significant amount of precipitation (20–25 mm/day) was recorded eleven days before the failure. On the other hand, a heavy rainfall was recorded two days before the Jure landslide. The Clanwilliam landslide area exhibits classical morphology with steep rock walls and a valley bottom (Fig. 16a). The Jure area exhibits similar topography and morphology (Fig. 16b), with steep rock slopes and narrow valley bottom formed by river erosion.
