Crack Initiation and Propagation Analyses of Hydrogen-Related Fracture Surfaces of Tempered Martensitic Steel

Abstract Hydrogen-related crack initiation and propagation in tempered martensitic steel were investigated by fracture surface topography analysis (FRASTA) and crystallographic orientation analysis. Hydrogen-related fracture morphologies of tempered martensitic steel were characterized by intergranular and quasi-cleavage transgranular fractures. FRASTA results suggested that hydrogen-related crack initiation sites were inclusions and cracks propagated from quasi-cleavage fracture to intergranular fracture near the crack initiation site. Crystallographic orientation analysis results suggested that intergranular fracture propagated on prior austenite grain boundaries, whereas quasi-cleavage fracture propagated along $\{011\}$ planes near the crack initiation site. However, quasi-cleavage fracture consisted of not only $\{011\}$ planes but also various other planes. In a previous study, hydrogen-related fracture morphologies of tempered martensitic steel tended to change from quasi-cleavage to intergranular with an increase in strength or an increase in hydrogen content, and

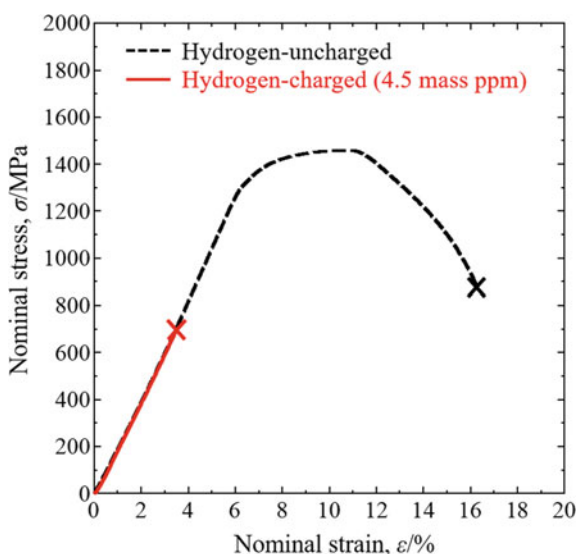
Fig. 2 Nominal stress-strain curves of hydrogen-uncharged (black line) and hydrogen-charged (red line) specimens

Figure 2 shows nominal stress-strain curves of the hydrogen-uncharged specimen (black line) and the hydrogen-charged specimen (red line). The hydrogen-uncharged

specimen fractured within the plastic region and its elongation was approximately 12.5%. In contrast, the hydrogen-charged specimen fractured within the elastic region. This result indicates that the elongation of the specimen reduced due to hydrogen charging.

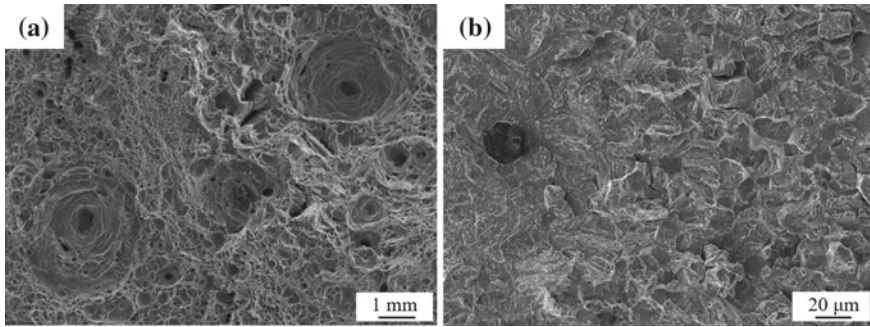
Fig. 3 SEM images of **a** hydrogen-uncharged specimen and **b** hydrogen-charged specimen

SEM images of the fracture surfaces of the hydrogen-uncharged and hydrogen-charged specimens are shown in Fig. 3. The Fracture surface of the hydrogen-uncharged specimen was covered with dimple fracture (Fig. 3a). The fracture surface exhibited typical ductile fracture. In contrast, the hydrogen-charged specimen displayed quasi-cleavage and intergranular fracture surfaces. The quasi-cleavage fracture surface was observed near the inclusion and the intergranular was found a bit far away from the inclusion (Fig. 3b).

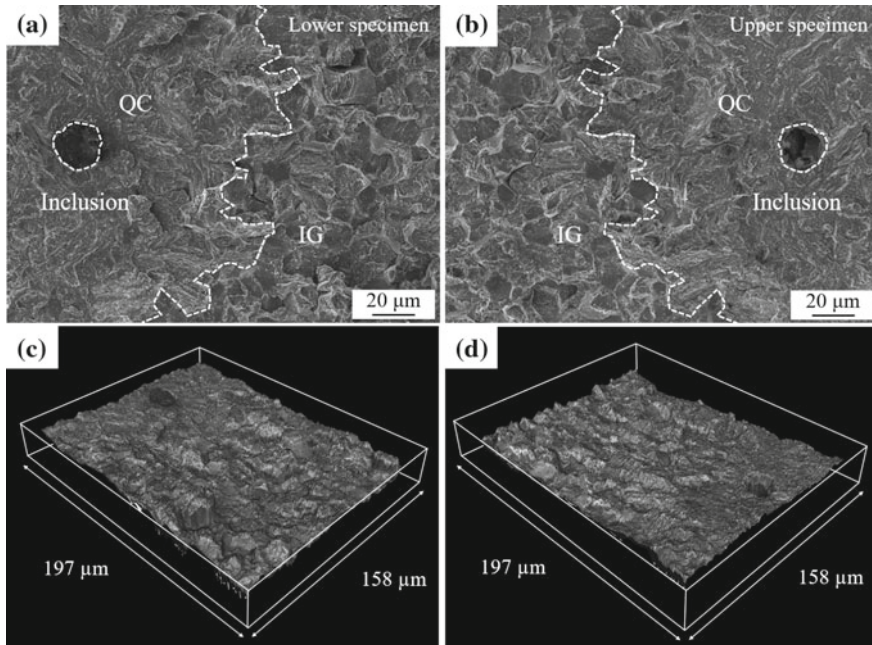
Fig. 4 SEM images of conjugate fracture surfaces of **a** lower and **b** upper specimens, and three-dimensional images of conjugate fracture surfaces of **c** lower and **d** upper specimens, respectively

Three-dimensional images of the hydrogen-charged fracture surface were obtained from three stereoscopic SEM images in Fig. 4a, b, which were taken by tilting the specimen by 0° and $\pm 5^\circ$. Mex 6.1 software was used to reconstruct three-dimensional fracture surface images. The reconstructed three-dimensional images of the conjugate fracture surfaces are presented in Fig. 4c, d. After reconstructing three-dimensional fracture surface images, the reconstructed three-dimensional image of the conjugate fracture surface was overlaid computationally until there was no gap between the two conjugate topography maps, by gradually increasing the relative distance between them. The results are shown in Fig. 5. The number (L) in the upper right corner of each figure indicates the distance between the two maps. L is defined as 0 when all areas of the two topographic maps completely overlap each other.

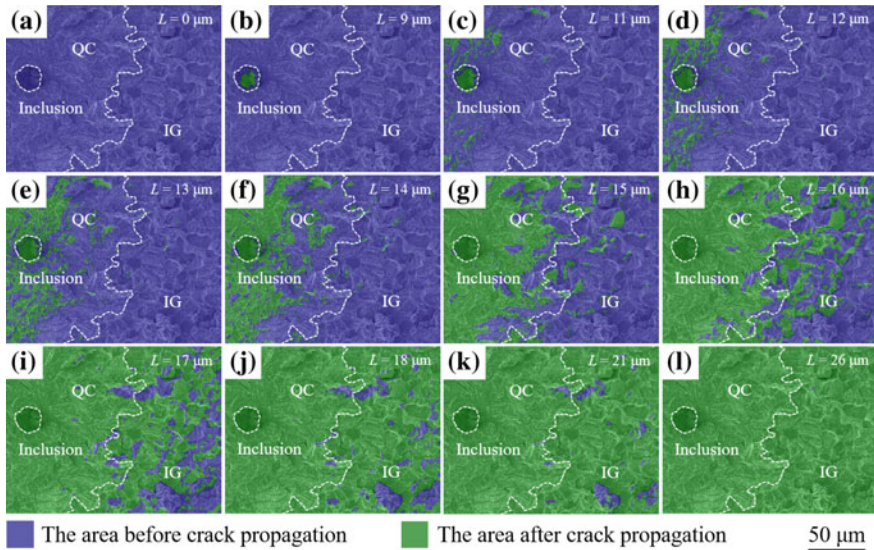
Fig. 5 Hydrogen-related fracture process reconstructed by FRASTA. Numbers (L) at the upper right corner of each figure are the distances between the two topographic maps. The fracture areas that appeared by increasing the distance between the two topographic maps are represented on the fracture surface SEM image by blue and green colors, which correspond to the areas before and after crack propagation, respectively

In Fig. 5, fractured areas that appeared by increasing the distance between two topographic maps are represented by blue and green colors, which correspond to areas before and after crack propagation, respectively. As shown in Fig. 5a, b, it was found that the debonding of an inclusion from the surrounding matrix occurred in the early stages of hydrogen-related fracture. In the following stages of the fracture, quasi-cleavage fracture gradually propagated inside prior austenite grains. In the final stages of the fracture, intergranular fracture occurred at prior austenite grain boundaries and propagated abruptly.

Results shown in Fig. 5 indicate that hydrogen-related fracture in the martensitic steel was initiated by the inclusion. Previous studies have reported that in high carbon chromium bearing steels, the debonding of an inclusion from the surrounding matrix was promoted by hydrogen [7]. Accordingly, it is inferred that hydrogen-induced the debonding of the inclusion from the surrounding matrix. On the other hand, crack propagation occurred from quasi-cleavage fracture to intergranular fracture near the crack initiation site. In a previous study, the hydrogen-related fracture morphologies of tempered martensitic steel shifted from quasi-cleavage to intergranular with an increase in strength or hydrogen content. However, the results in Fig. 5 show that the crack propagated from quasi-cleavage fracture to intergranular fracture near the crack initiation site. Therefore, it is postulated that the fracture propagation path varied from quasi-cleavage to intergranular fracture due to the influence of the inclusion.
