An Experimental Procedure to Estimate Surface Crack Density Using Thermography and Acoustic Emissions

Abstract. The current study discusses two aspects of an infrared thermography-based local SHM system for monitoring damage evolution during fatigue of composites materials, namely, pre-macrocrack damage (Stage I) followed by subsequent crack growth (Stage II).

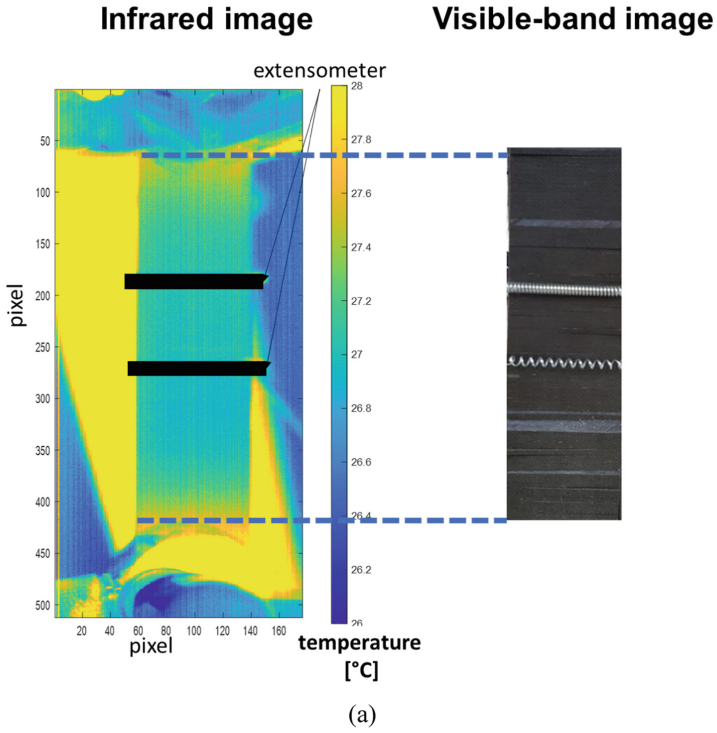
Fig. 2. (a) temperature map acquired halfway through the test duration and visible-band image acquired close to failure of sample 1, (b) binarized maps where transverse cracks (white bands crossing the sample) are detected.

In Fig. 2a, the temperature map of sample 1 is represented together with the sample in the visible-band where the transverse cracks are visible. The two images of Fig. 2a correspond to two different time instants (halfway of the test duration for temperature map and close to failure for the one in the visible-band).

The infrared thermal map presents not only an increase of temperature in proximity of the upper fixture that was imposing the monotonically increasing deformation, but also in lower part caused by hot oil from loading machine fixture and friction between AE sensor and sample. This leads to some issues in evaluating the cracks occurring in the matrix as the total gradient through the sample is basically higher than the temperature variation associated to a crack.

In this way, as described in [2], a Matlab® code was developed to operate on temperature tridimensional matrixes (each pixel value represented the temperature value at specific time instant) in order to subtract from each matrix at a specific time instant the data matrix from previous time instant (dynamic frame subtraction). According to the work [2] the cracks were assessed, Fig. 2b.

The maps in Fig. 2b, in particular, report the detected transverse cracks during static tensile test between 110th and 120th second of the thermal sequence. The maps are the output of a binarization process of converting a pixel image to a binary image after a threshold gets applied [2].

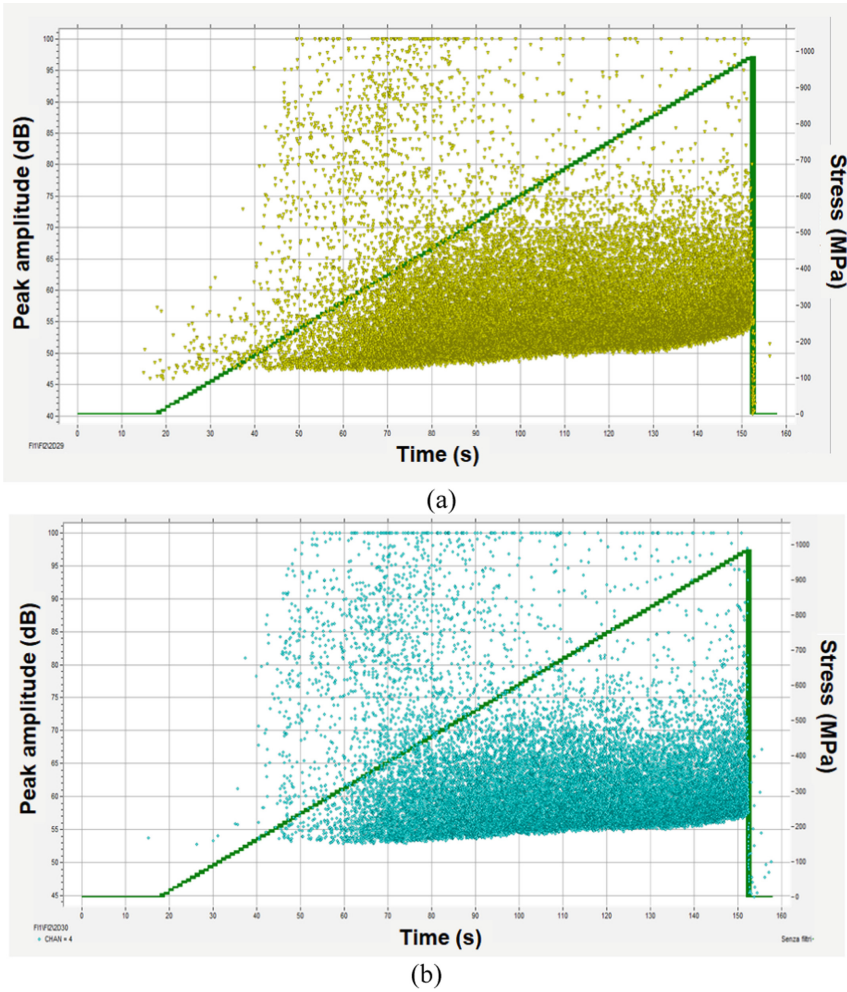
Fig. 3. Peak amplitude and stress versus time for (a) sensor 1, (b) sensor 2.

As for the acoustic emissions Fig. 3 shows the peaks and stress evolution measured by sensor 1 (S1) and sensor 2 (S2).

As a general consideration, it is possible to highlight that the peak events start immediately few instants after the test started, as the stress increase, specifically peaks starts after 20 s in the upper region (S1) and after 40 s in the lower region (S2), as expected. In effect, for composites the damage starts as the stress is imposed in a continuous damage progression. In the same Fig. 3, it is possible to observe that it is necessary a post processing analysis to filter out the signal from damage (transverse cracks) and noise. Moreover, another interesting observation is such that the damage events seems to start before on upper region than in lower region, this can be explained by considering that upper region, where S1 is positioned, is near moving fixture, and then the motion of the fixture can allow a more intense activity.
