Reactor Accidents in the Early Days of Nuclear Power

Abstract This chapter covers reactor accidents from the beginning of nuclear power until the 1980s. The accidents at Windscale (Great Britain), Vandellós (Spain), Vinča (Yugoslavia), SL-1 (USA), Santa Susana (USA), K-19 (USSR), Lagoon Beach (USA), Chapelcross (England), Grenoble (France), Lucens (Switzerland), Saint-Laurent-des-Eaux (France), Leningrad (Russia), Bohunice (Slovakia), and Constituyentes (Argentina) are analyzed in detail. Other less spectacular accidents are mentioned. The whole is abundantly illustrated with photos and diagrams.

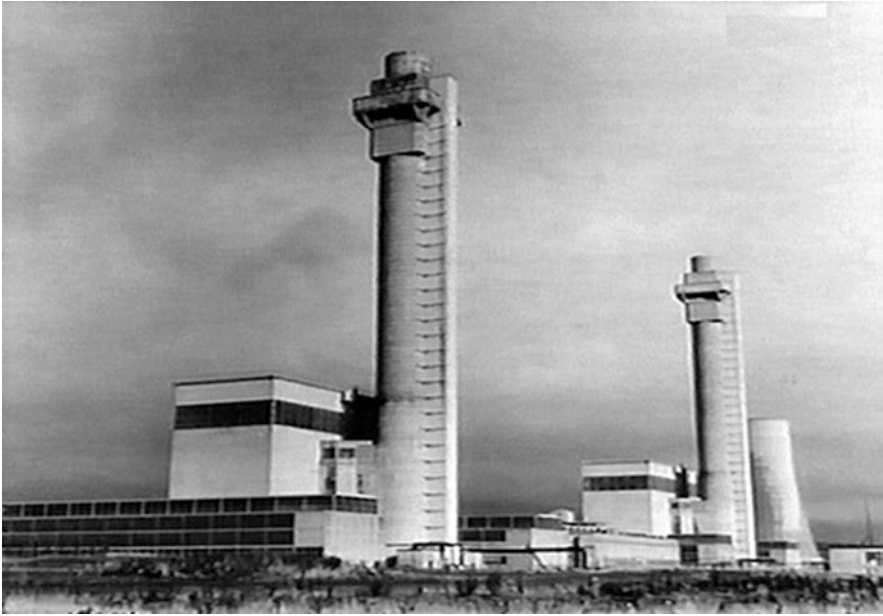
Photo 2.1 An ominous-looking photo (cloudy sky? low angle shot?) of the two military reactors at Windscale. One notices the filters placed abnormally at the top of the chimneys

The first major reactor accident occurred in 1957 on the first British military reactor at Windscale (Photo 2.1). Beginning in 1947, the British built a set of two graphite-moderated, air-cooled piles to produce weapons-grade plutonium. Windscale was located in the county of Cumberland, in the northwest of England, on the coast of the Irish Sea. This region was rather poor and sparsely populated, with barely 70 inhabitants per square kilometer at the time. Population therefore welcomed the arrival of an industrial complex that

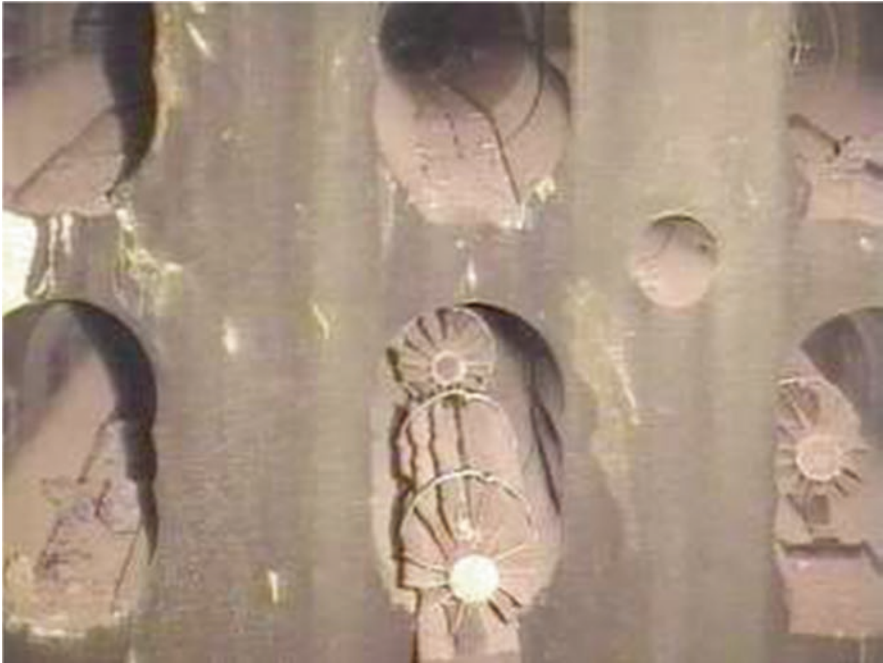
Photo 2.2 Fuel cartridges in the channels in the graphite. The fuel elements were loaded from the front of the piles, then during unloading, they were pushed towards the exit, from the back, where they fell into a compartment full of water. The sole purpose (not electricity production) of this reactor being to produce plutonium 239, the fuel elements were recovered after a short burn-up (so that the plutonium would be as rich as possible in plutonium 239), and then sent to a separation plant located on the Windscale site in order to limit the transport of dangerous materials. Within this plant, they were stored in a large pool to reduce their activity and their temperature because of the residual power

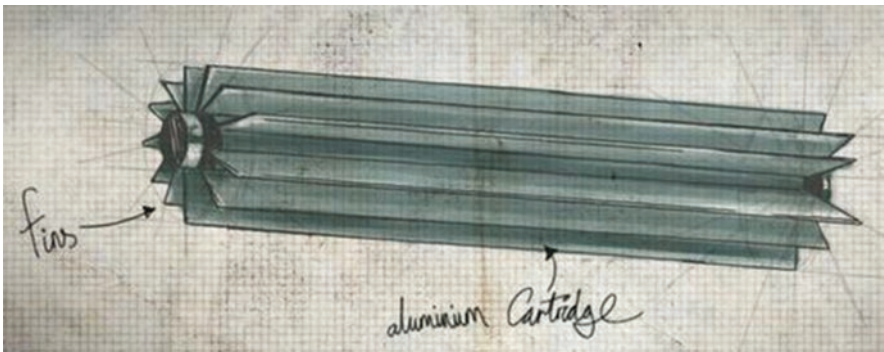
Photo 2.3 Drawing of a fuel cartridge with a uranium rod clad in aluminum and cooled by blades. Heated aluminum ignites easily in air, as does magnesium

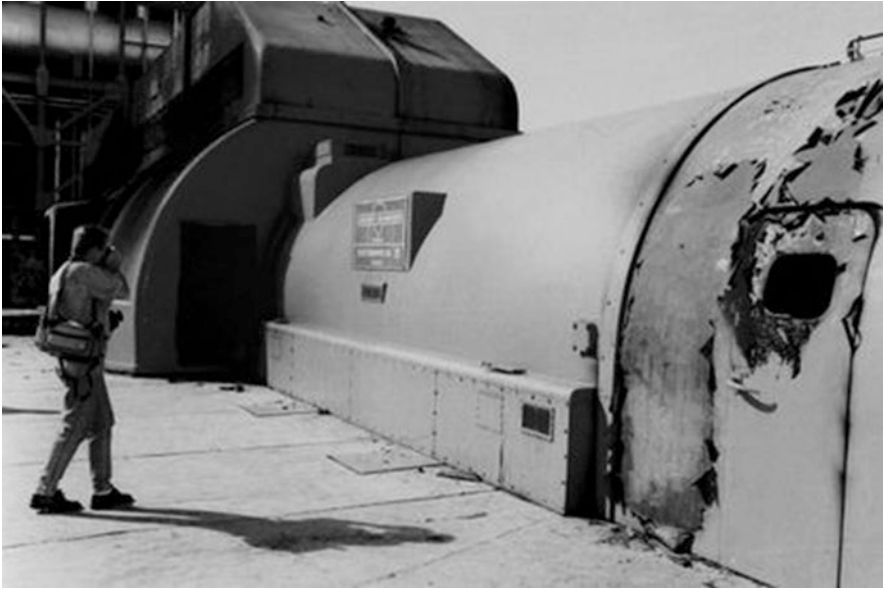
Photo 2.8 Photo taken outside (shadow of the photographer) probably showing a fan motor cowling damaged by the fire (photo J.L. Sellart)

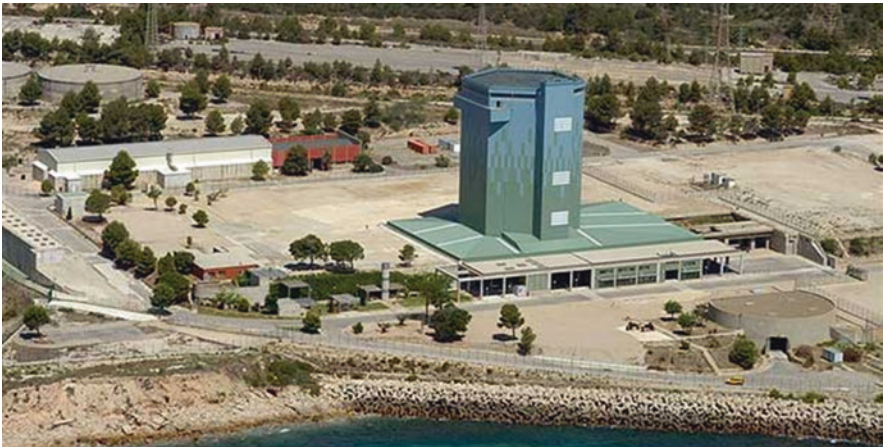
Photo 2.11 Hexagonal sarcophagus from Vandellos-1 in 2014

With difficulty, the operators finally managed to cool the reactor with the secondary cooling circuit, to prevent a general flashover of the graphite block, the situation that had occurred at Windscale. The accident will be classified afterwards as 3 on the INES scale and it is considered that only the firemen, who intervened without much preparation, were exposed to ionizing radiation. Repairs proved too costly (Photos 2.8, 2.9 and 2.10), the reactor was finally definitively shut, then progressively dismantled, and a sarcophagus was built around the reactor (Photo 2.11).

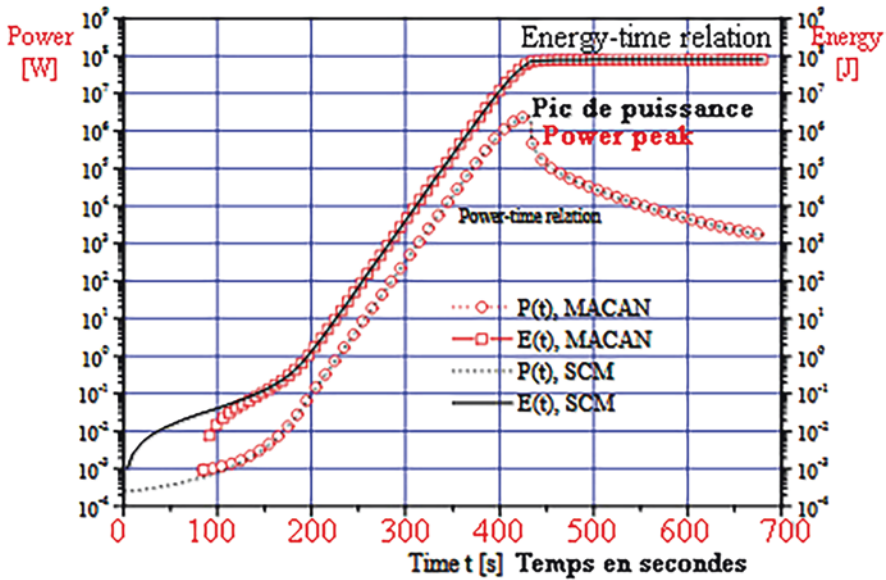
Fig. 2.16 Power excursion calculated by the MACAN and SCM calculation codes in the 1990s. It should be noted that the ordinate scales are logarithmic, i.e., each main scale is ten times the previous one. Paradoxically for the uninitiated, the power excursions are all the more violent as the initial power level is low, but the peak lasts less time because a high power leads to a higher temperature in the fuel, thus a stronger Doppler effect. A stronger Doppler effect will increase the absorption of neutrons and “crush” the power peak more quickly. We note a good match between the two calculation codes. Adapted from M. Pesić: *Some examples of accident analyses for RB reactor*, IAEA Technical meeting on Safety Analysis for Research reactors, Vienna, Austria, 5-7 June 2002)

large over-criticality, and that only the fuel has time to heat up. In the present case, the power excursion linked to a weak over-criticality led the reactor into an overpowered state for about 400 s, which must have allowed the heavy water to heat up and expand thermally. The fact that there was a partial rupture of the vessel is not mentioned in the most serious references. The presence of contaminated water sometimes reported must rather refer to the badly managed draining of the air line. Neutron physics confirms that it is the Doppler effect that shuts down the power excursion, the emergency rod drop is only effective to ensure a subcritical geometry at the end of the accident (the power excursion is often faster than the rod drop). In the Vinča accident, recent calculations showed that the excess reactivity for a 4.5 cm heavy water surge was about $+0.305 \beta_{\text{eff}}^{19}$, i.e., a relatively moderate overactivity. Physicists know that rapid power excursions occur when the excess reactivity is of the order of or greater than β_{eff} . This means that the power excursion was finally slower and therefore longer than in the very fast accidents that we will describe in the case of the SL-1 reactor. The period of the reactor, i.e., the time for which the power is multiplied by the Neper constant (aka Euler constant) $e = 2.718$, is estimated at 12.3 s, leading to a power of 2.5 Mega Watt thermal with a total energy released during the excursion of 80 MegaJoules (Fig. 2.16), approximately $2.8 \cdot 10^{18}$ fissions.

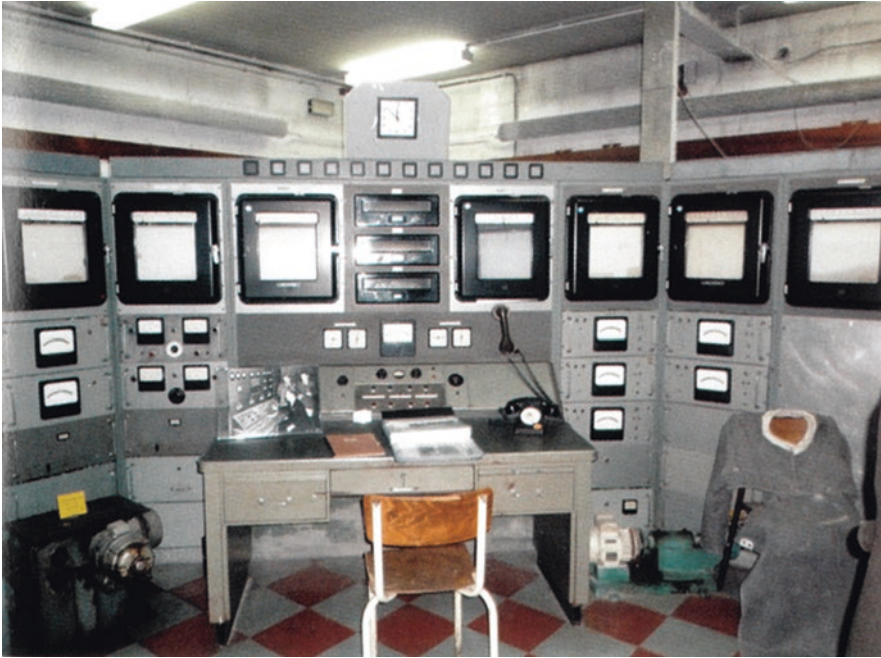
Photo 2.19 The same control room of Zoé (France) renovated at the end of the 60s. Many “head-up” recorders were installed. We can see the “Human Factors” progress brought to the control console. ZOE’s core shutdown on April 6, 1976 at 11:51 a.m. after 28 years of good and loyal service, and above all without accident! (CEA photo)

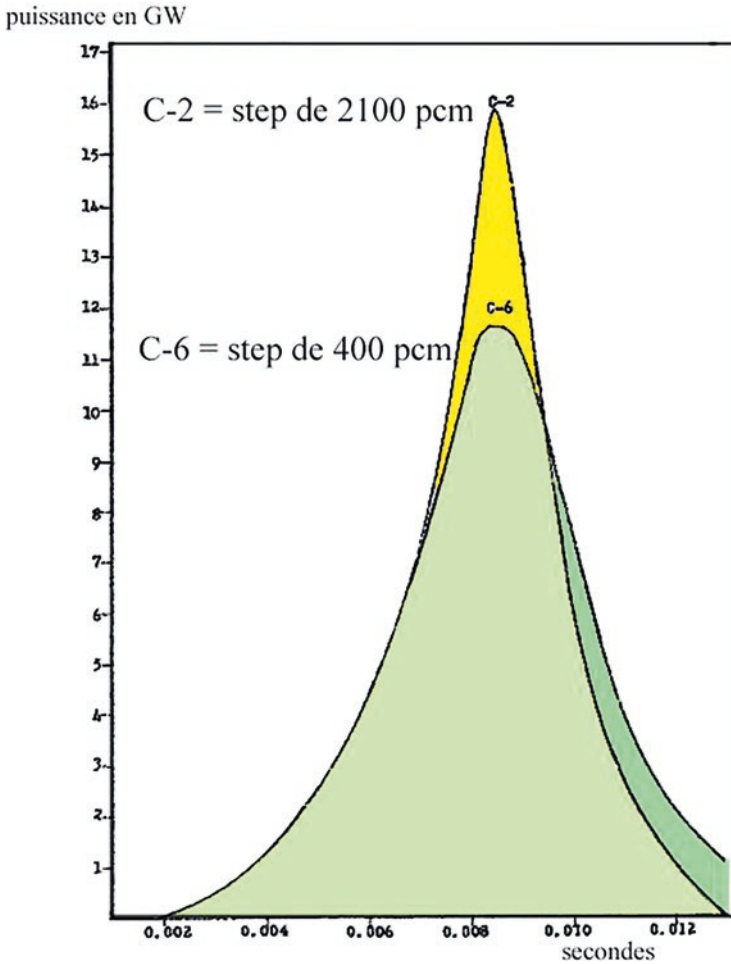
Fig. 2.29 Simulation of SL-1 response to a reactivity step reconstructing the accident (power in GigaWatt)

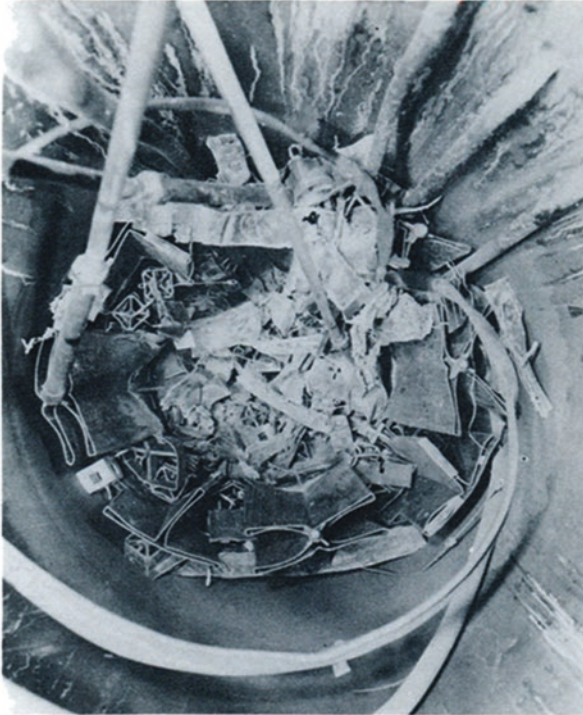
Photo 2.33 View of the core during disassembly (1962, INEL)

the reactor had melted and that 20% of the core was totally destroyed (Photos 2.32 and 2.33).

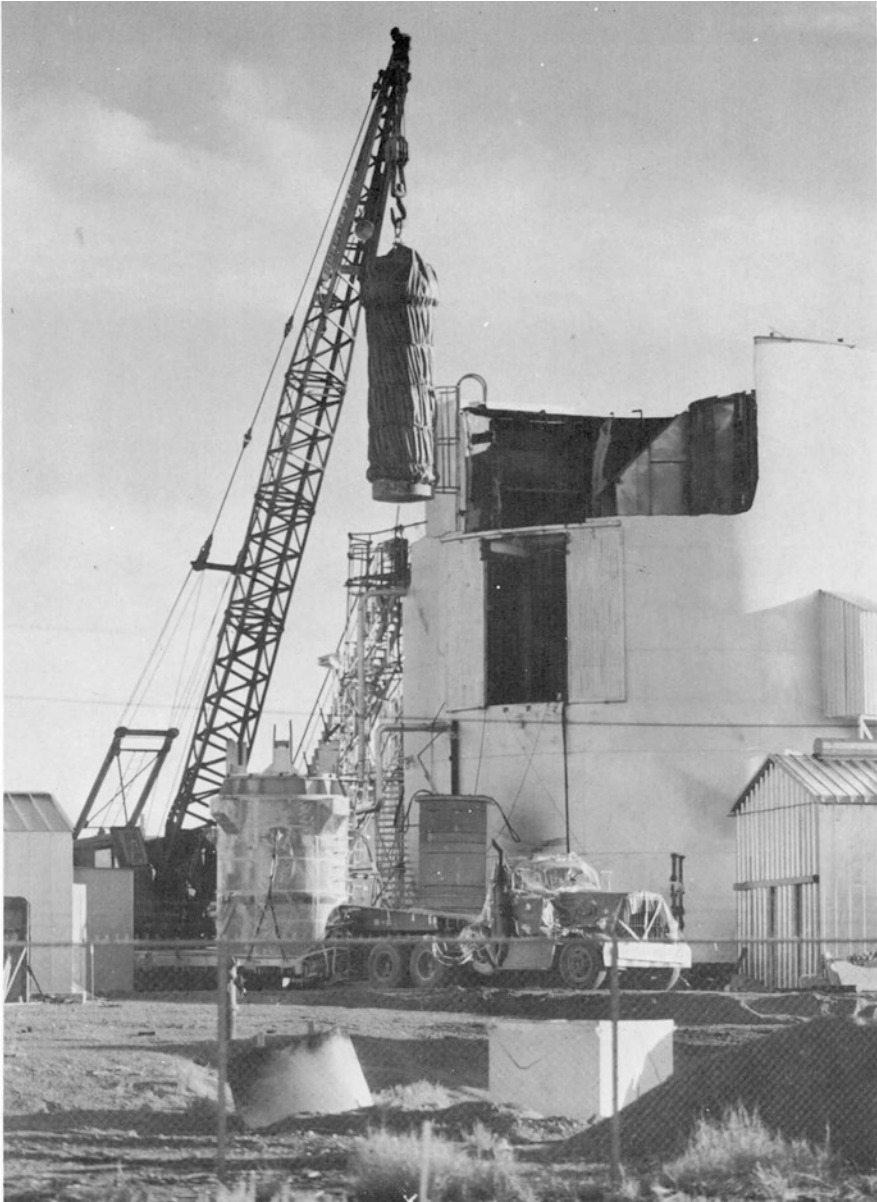
Photo 2.35 Extraction of the vessel through the reactor dome with a mobile crane. A trailer truck carries a transport cask for the vessel

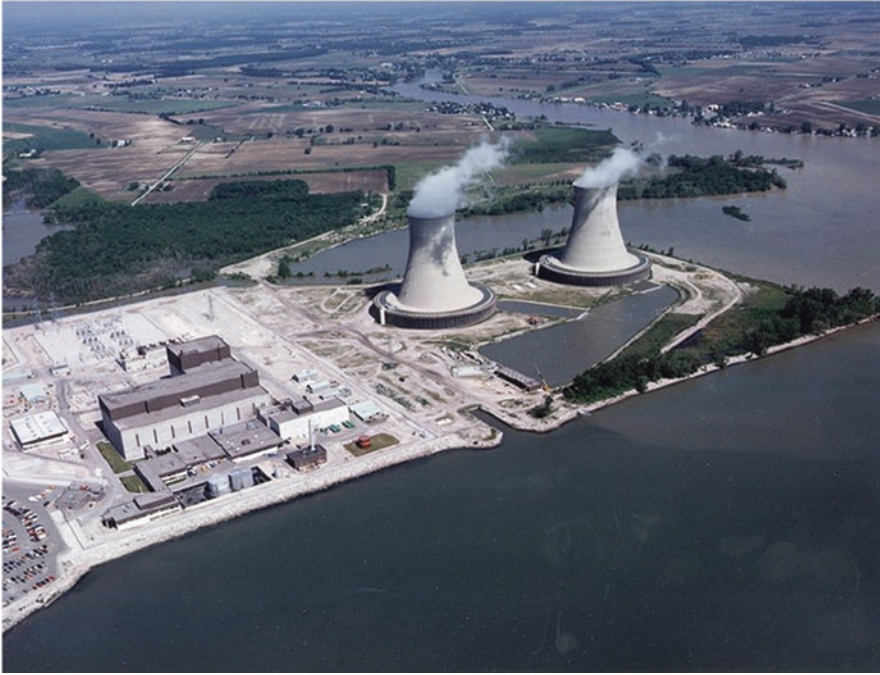
Photo 2.41 The Fermi-2 air coolers. The Fermi 2 reactor is a 1170 MWe boiling water reactor (BWR), commissioned in 1985, initially for 40 years (2025) and built by General Electric which is owned by DTE Energy and operated by its subsidiary Detroit Edison

The site also houses a 1170 MWe Fermi-2 boiling water reactor (Photo [2.41](#)). In 2016, NRC renewed the operating license of Fermi-2 for an additional 20 years through March 2045. In July 2019, NRC ordered an inspection assessing the potential of degraded paint inside a portion of the reactor possibly to impede safety systems. The inspection aimed to assess if the degraded paint inside a portion of the reactor containment at the plant could

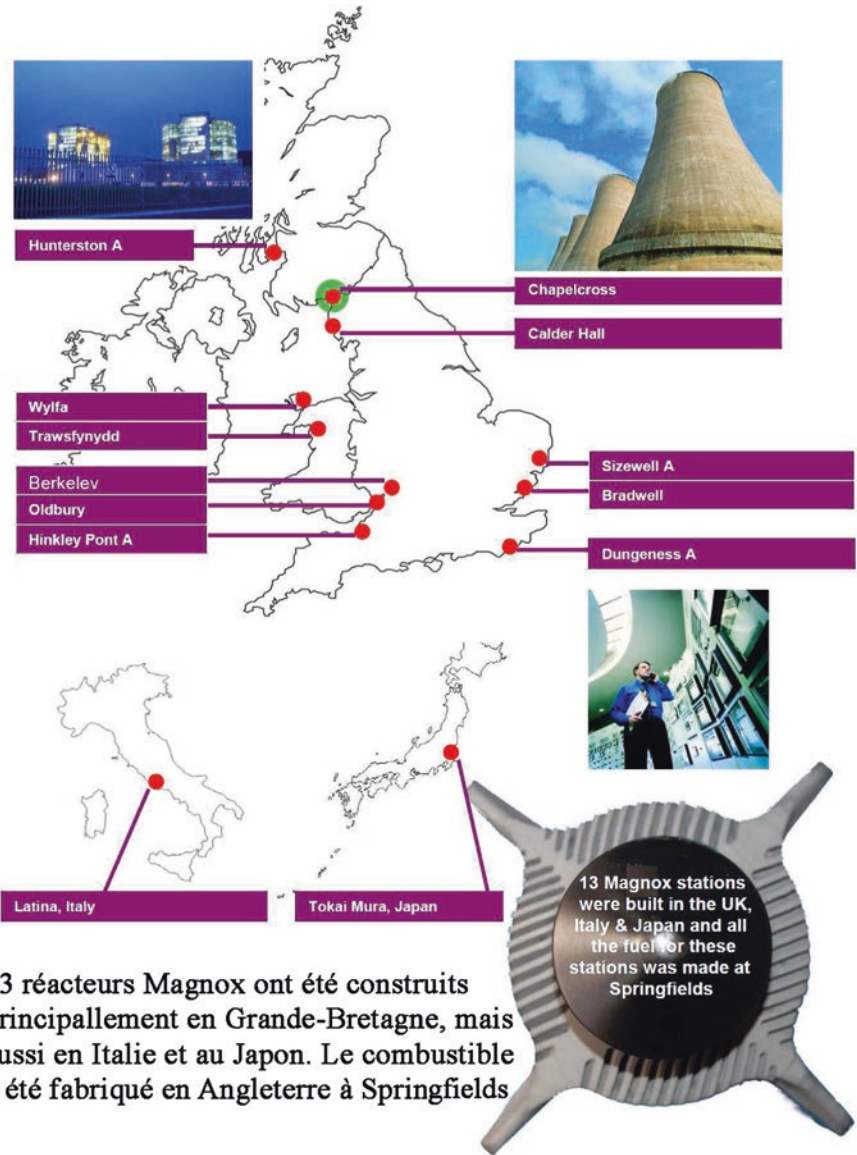
13 réacteurs Magnox ont été construits principalement en Grande-Bretagne, mais aussi en Italie et au Japon. Le combustible a été fabriqué en Angleterre à Springfields

Fig. 2.45 Implementation of the Magnox reactor type in the world. Chapel Cross, the site of the 1967 accident, is located in Scotland (green dot on the map)

Chapelcross is a site near Annan in the province of Dumfries and Galloway in southwest Scotland (Fig. 2.45), with 4 Magnoxes of 48 MWe each (182 MWth, thus a modest efficiency of 23%), which began construction in 1955

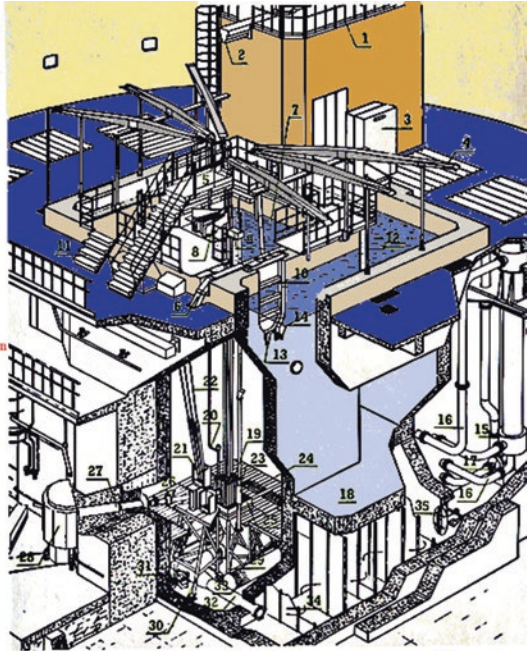
Fig. 2.53 Sketch of the Siloé pile. 1- Roof of the hot cell, 2- Rolling beam, 3- Hot cell door, 4- Loop support spider, 5- Maneuvering plunger, 6- Pool top recovery duct, 7- Large cofferdam, 8- Control rod mechanism, 9- Fission chamber mechanism, 10- Small cofferdam, 11- Pool top walkway, 12- Auxiliary work pool, 13- Cat flap for active loop passage, 14- Active loop passage, 15- Heat exchanger, 16- primary and secondary duct, 17- Primary pump, 18- Working floor and roof of the deactivation tank, 19- Core: standard fuel and control, beryllium, water boxes and plug, 20- Disconnection of the experimental loop, 21- Lead block of the measuring chambers, 22- Measuring chamber poles, 23- Fission chamber, 24- Spent fuel storage, 25- Core grid and plug, 26- Movable sock, 27- Channel for beam output, 28- Monochromator protection, 29- Reactor block stool, Chambers tools, 31- Natural convection flap, 32- Suction pipe to core /deactivation tank, 33- Primary circuit return diffuser, 34- Deactivation tank baffle, 35- Access door to the deactivation tank

- 27: Canal pour sortie de faisceau
- 28: Protection du monochromateur
- 29: Tabouret du bloc réacteur
- 30: Tabouret des chambres
- 31: Clapet de convection naturelle

- 32: Tuyauterie d'aspiration coeur- bac de désactivation
- 33: Diffuseur retour circuit primaire
- 34: Chicanes du bac de désactivation
- 35: Porte de visite du bac de désactivation

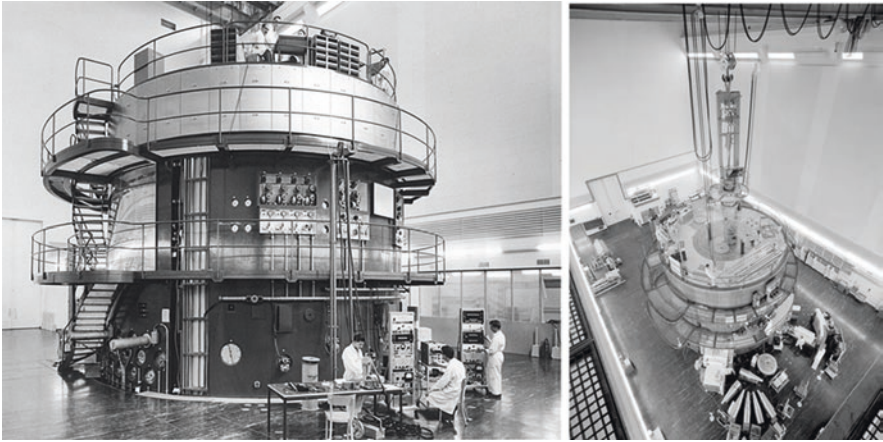
Photo 2.58 View of the service desk of Diorit. This part is very similar to what will be Lucens. Reaktor AG was founded in 1955 on the initiative of the two large Swiss companies Sulzer Winterthur and BBC Brown Boveri Baden. Among the shareholders were more than 100 Swiss companies. According to its articles of association, the company's purpose is "*the construction and operation of experimental reactors for the creation of scientific and technical bases for the construction and operation of industrially usable reactors ...*". Reaktor AG received financial support from the Swiss federal government from the beginning. The company had a heavy water reactor built, which went into operation in 1960 and was called Diorit. The reactor was to serve as a precursor to a Swiss power reactor, i.e., a Swiss nuclear power plant technology was to be developed, which was not only to be used for domestic power generation, but also for export. Relatively quickly, however, it became clear that the financial outlay for private industry was becoming too high. The facilities of Reaktor AG—including the experimental Diorit reactor—were handed over to the federal government in 1960, which established the Swiss Federal Institute for Reactor Research (EIR) as an adjunct institution of ETH Zurich. The issue of what happened to the plutonium produced by Diorit in its early days was the subject of controversy in Switzerland in 2016, as was the transfer of 20 kg of unpurified plutonium powder (less than 92% plutonium) to the United States for safe storage. The very existence of this plutonium shows an initial desire by Switzerland to produce an atomic weapon

Lucens is not the first reactor installed in Switzerland. In August 1960, researchers put into operation the “*Diorit*” reactor » (Fig. 2.54, Photos 2.57, 2.58 and 2.59) on the site of the Federal Institute for Reactor Research (IFR) in Würelingen. This facility was used to test various reactor concepts and to produce radioactive isotopes for medicine, research and industry. In 1957, the

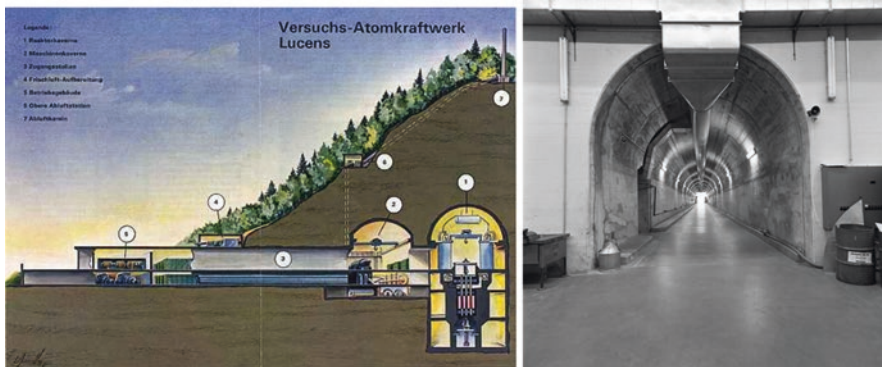
Photo 2.61 The access tunnel to the cavern reactor

An access gallery 100 m long (Photos 2.61 and 2.62) led to three caverns respectively for the reactor (Fig. 2.57), the turbine and the fuel element storage pool (Photo 2.63, Fig. 2.58). A ventilation chimney dug in the mountain allows the ventilation of the underground parts. A chimney on the surface evacuates the stale air at altitude. The supplier of the reactor was Ther-Atom. Ther-Atom was also part, with three engineering offices of the *Groupe 8 de Travail de Lucens* (GTL). Their mission was to supervise the studies, the construction management, and the tests of the CNEL. From a technical point of view, the CNEL reactor was a development of the Diorit reactor already mentioned. The Federal Commission for the Safety of Nuclear Installations, founded in 1960, was the first nuclear supervisory authority of the Swiss Confederation (CSA). It accompanied the licensing process of the CNEL from the beginning. However, the CNEL was a real challenge, because the

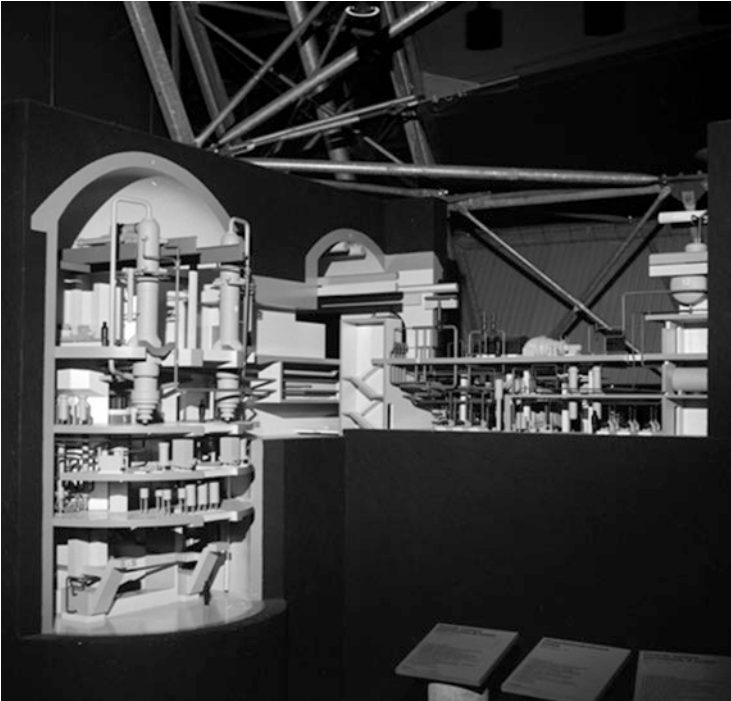
Photo 2.63 Model of the reactor cavern and the turbine cavern. One recognizes well above the reactor the two vertical steam generators of great height

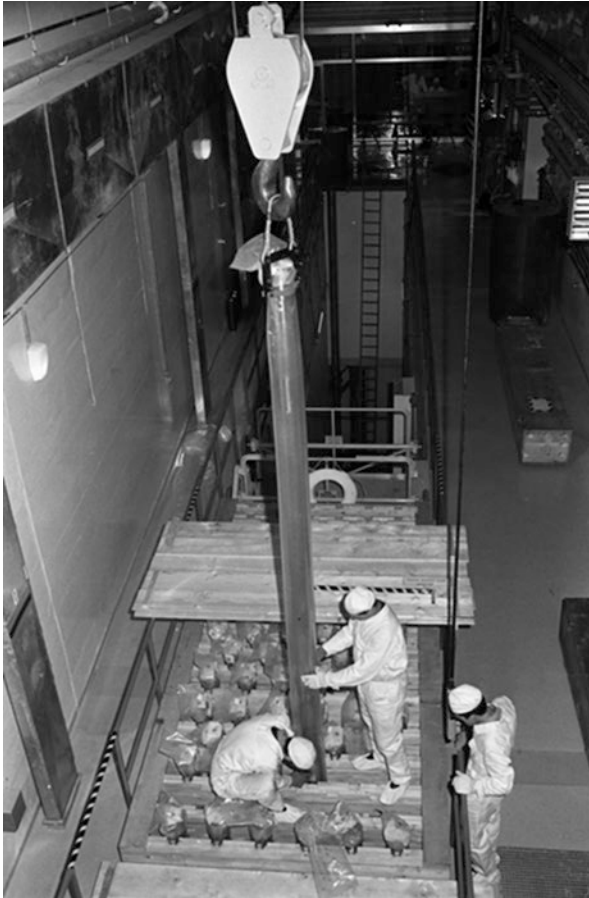
Photo 2.64 Placing a fresh fuel assembly in a storage rack. The core contains 73 such assemblies. The spent fuel assemblies are evacuated without contact by the unloading machine to the deactivation pool

types, that is, the uranium metal rods were housed in magnesium alloy cladding. Each fuel element was itself housed in its own pressure tube where the coolant circulated. This design made it possible to obtain a particularly compact reactor, requiring a containment of restricted dimensions. This containment consisted of a wall of concrete, asphalt, and aluminum about 60 cm thick that lined the artificial reactor cavern. The reactor core contains 73 fuel elements that are bathed in the heavy water calandria made of aluminum, 3.10 m in diameter and 3.16 m high (Photo 2.64, Fig. 2.60). The core is

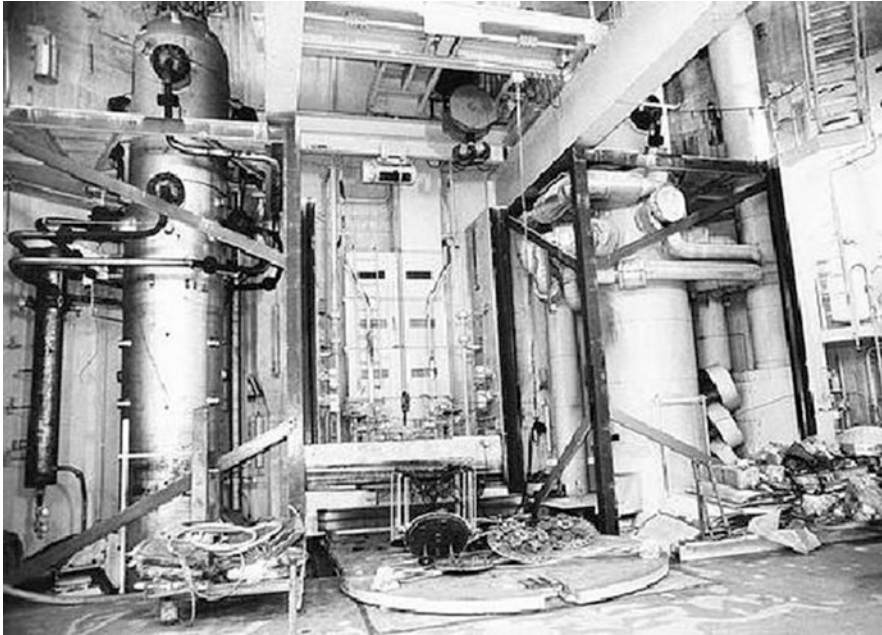
Photo 2.66 The floor at SGs level after the accident

integral with the graphite support at the bottom and free to expand at the top. The segments are made of low-alloy uranium metal (1% Molybdenum) 17 mm in diameter and 650 mm high, isolated from the carbon dioxide by a 1.75 mm magnesium cladding. Once heated by the rods, the CO_2 transfers its heat to a secondary circuit through two Steam Generators (SGs) that work as a heat exchanger to vaporize light water (Photo 2.66, Fig. 2.60).

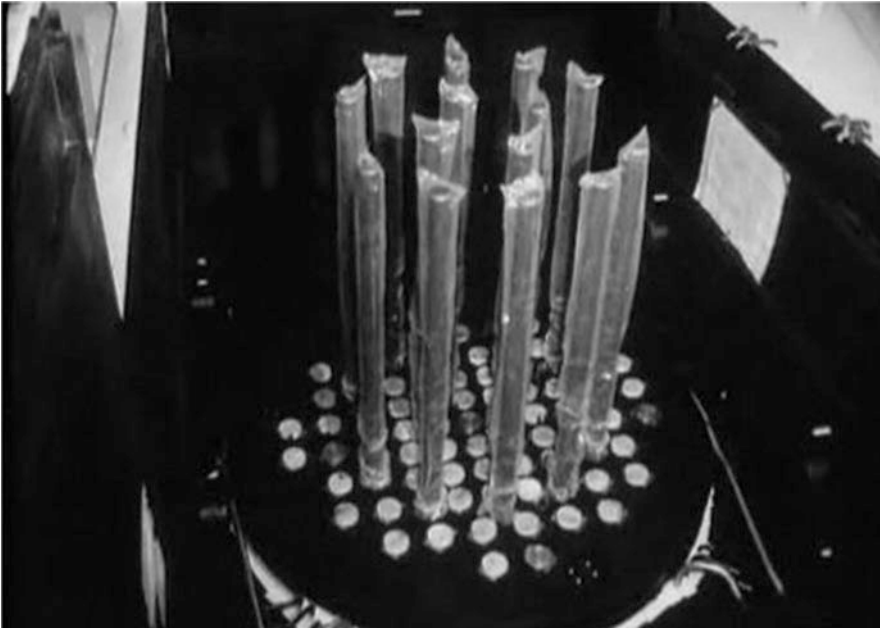
Photo 2.67 View of the upper side of the Lucens reactor vessel (photo IFSN). The control rods and shutdown control rods, wrapped in transparent plastic, can be seen emerging from the vessel cover

Four shutdown rods by gravity drop are located more in the center of the reactor (Photo 2.67). The rods consist of two concentric tubes, the central part containing a cadmium-silver alloy, two materials that are highly neutron absorbers. The rods are cooled by a flow of CO_2 .

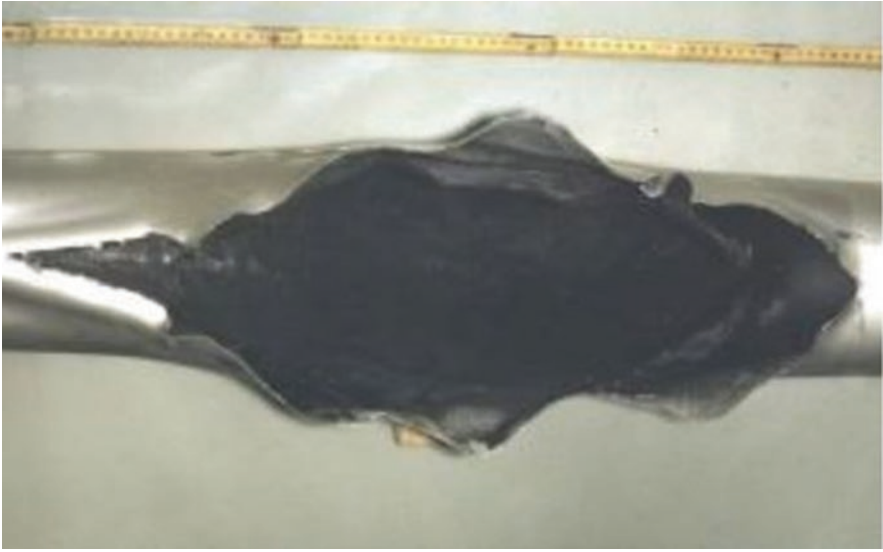
Photo 2.70 Impressive view of the cladding of fuel element 59. The cladding is completely torn

This oxidation produces hydrogen gas release and flammable magnesium oxide powder. Magnesium oxide is known to be unstable. Moreover, its instability tends to increase with high temperatures. The corrosion products formed then fell into the heat transfer gas circulation channels. It is postulated that the debris fell to the bottom of the pressure tubes and partially clogged them, reducing the flow in some channels. Fuel element 59 was insufficiently cooled due to the reduced CO₂ flow rate inherent in the pressure tube plugging. Several of the seven fuel rods in fuel element 59 (Photo 2.70) thus underwent an overheating that went unnoticed at first because not all the fuel

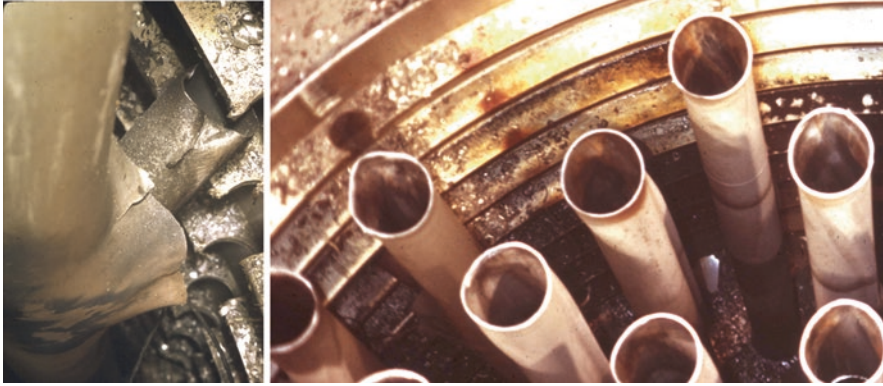
Photo 2.71 Double connection of channel 59 (left) and channel deformation (right)

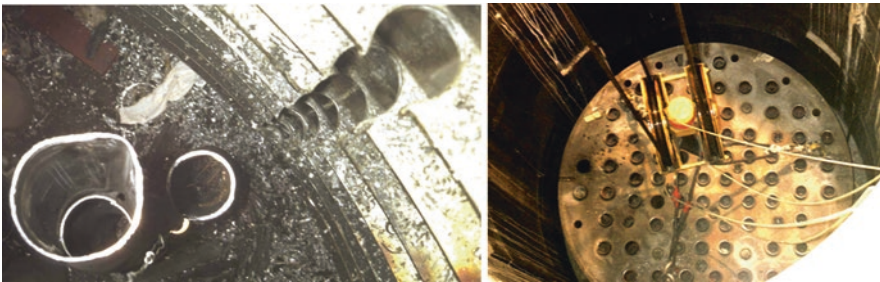
Photo 2.72 Channel 59 in top view

control rods. The overpressure led to the rupture of the four other rupture discs of the moderator calandria tank, with new projections of radioactive material into the biological shield made of water. This process continued over the next few minutes until the decompression of the primary circuit in the reactor vault was completed. (adapted and commented from <https://www.ensi.ch/fr/2012/05/31/serie-de-lucens-analyse-profonde-de-laccident>). Post-mortem examinations showed that the cladding of fuel 59 had completely burst. The dismantling from above showed the damage caused by the explosion on the double connection of channel 59 (Photo 2.72).

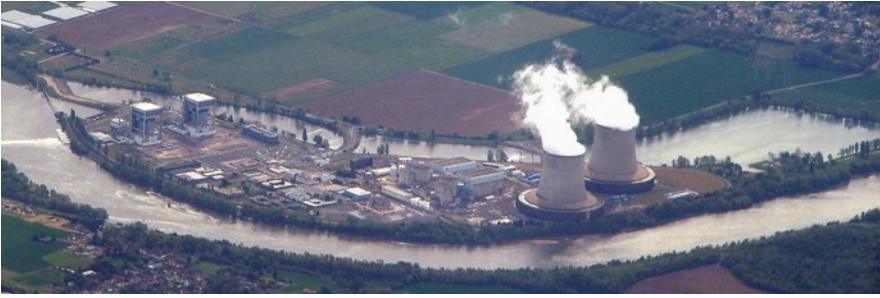
Photo 2.78 Saint-Laurent-des-eaux site. The two Natural Uranium-Graphite-Gas (UNGG) reactors are located at the far left, recognizable by their cubic shape. Two air-cooling towers in operation are located at the end of the site on the right. The two PWRs that they cool in addition to the Loire River are located just to the left of the towers, recognizable by the hemispherical shape of the reactor buildings and the next large parallelepipedal turbine buildings

The most serious accident that took place on French territory remains without question the partial fuel meltdown accident in the A1 reactor of the Saint-Laurent des Eaux plant on October 17, 1969. The Saint-Laurent-A1 plant, located on the banks of the Loire (Photos [2.78](#) and [2.79](#)), is part of the last wave of Natural Uranium-Graphite-Gas (UNGG) construction in France, coupled to the grid in 1969 and shutdown in 1990, for a capacity of 1662 MW_{th} (480 MWe net).

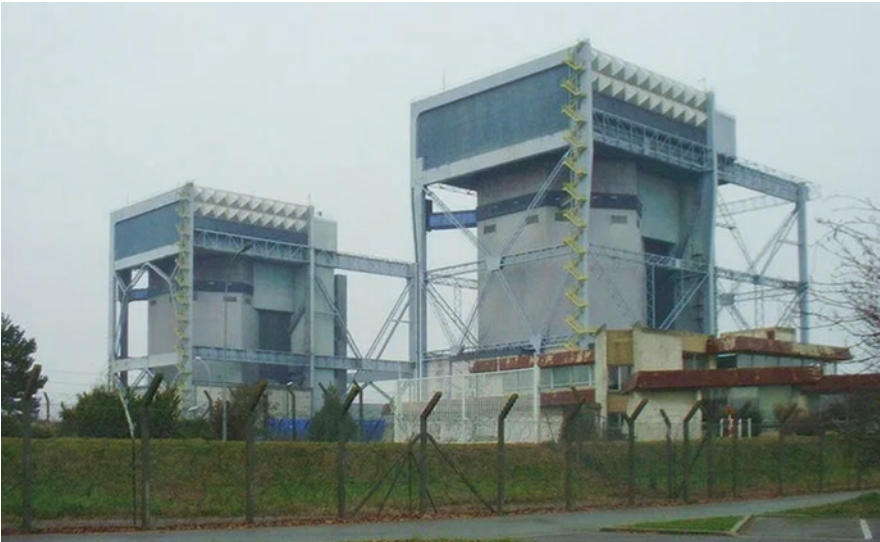
Photo 2.79 The two reactor blocks of Saint-Laurent-A1 and A2. The welded structures that surround them are characteristic of the French Natural Uranium-Graphite-Gas (UNGG) of the late 1960s

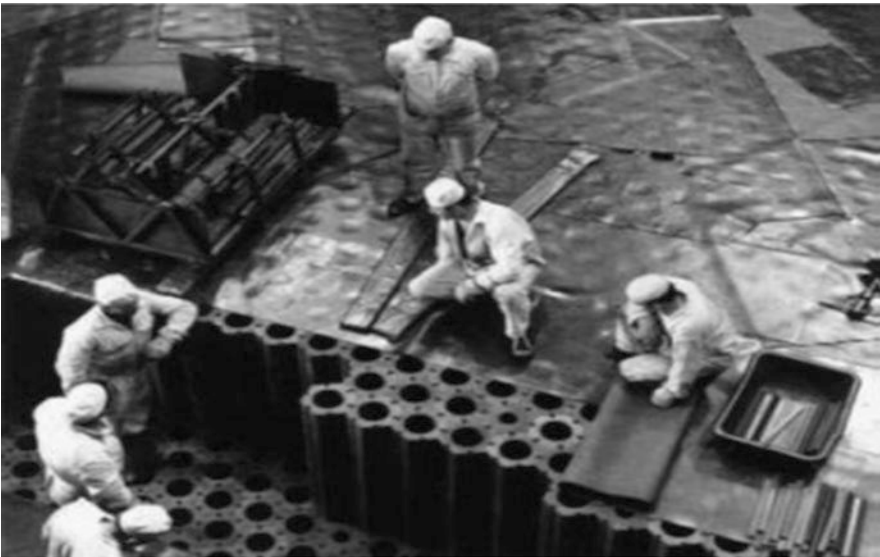
Photo 2.80 Building the graphite pile: channels through the graphite sleeves are clearly visible

The reactor (Fig. 2.66) contains 446 tons of natural uranium in the form of metal clad with a magnesium-zirconium alloy (43,865 fuel elements called cartridges in the core, 600 mm long, hollow rod 23 mm internal, 43 mm external, surrounded by a graphite fuel jacket 112 mm internal, 137 mm external). The moderator, designed to slow down the neutrons that become more efficient, is made of a stack of 2572 tons of graphite 9 m high (Photo 2.80).

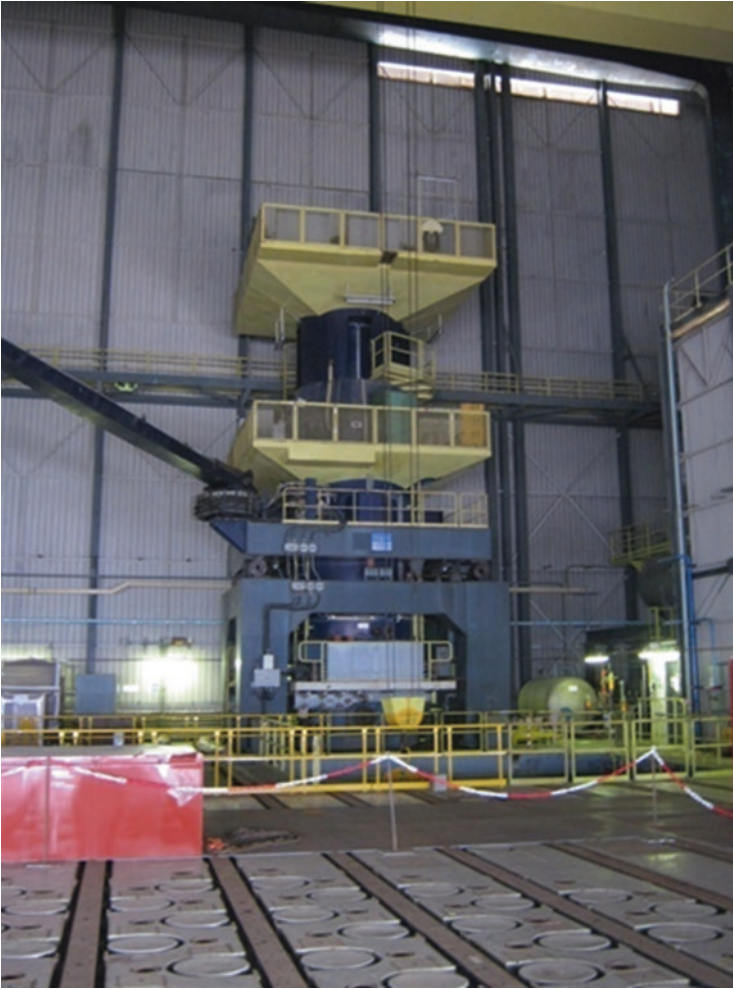
Photo 2.81 Natural uranium graphite gas reactor (first French reactor type). The Saint Laurent-A loading platform and the Main Handling Device (DPM). The rails of the fuel loading machine and the tulip-shape plugs (with circular top) closing the CO₂ channels are visible in front of the photograph (photo: Bouchacourt-Foissote-Valdenaire-ENSIB)

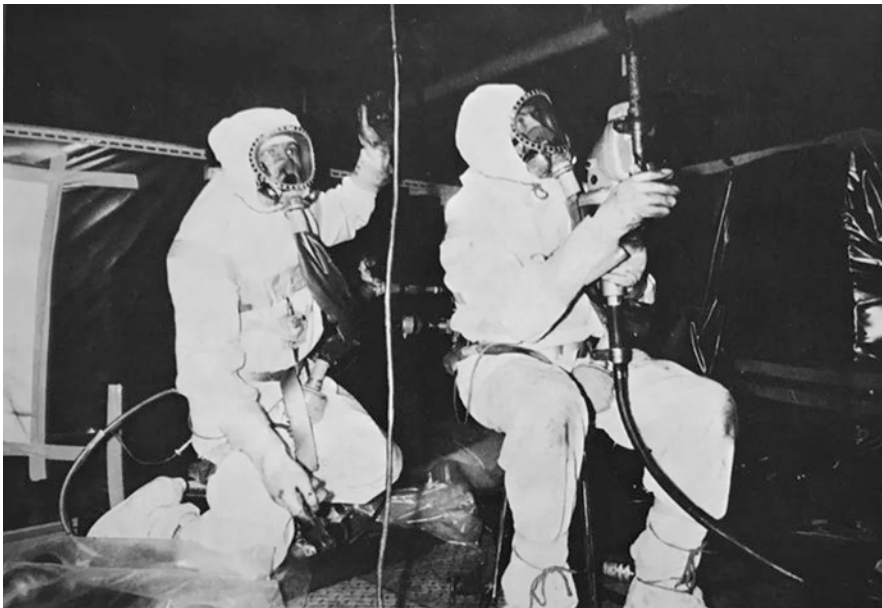
Photo 2.87 Cutting operation on Saint Laurent-A1 during post-accident repair. The operators are wearing ventilated clothing indicating a possible source of contamination

The rehabilitation of the reactor required the solution of several problems: the cleaning of as much corium and uranium debris as possible (Photos 2.86 and 2.87). EDF used to the maximum the devices controlled remotely from the upper slab such as suction hoses and remote-controlled gripping (pneumatic clamp) of the most voluminous pieces (47 kg of large debris, of which 15 kg were collected thanks to a scraper allowing to make heaps accessible to the clamp). But a human intervention was necessary to remove some debris adhering to the structures. Each of the people who entered the caisson stayed there less than 8 minutes. Because of the limitation to 3 rems per person, 105 people³⁶ intervened in the caisson maintained under vacuum, after preparation on a scale model, as well as on reactor no. 2 then under construction. They passed through the top of the exchangers after dismantling and cleaning the cell closest to the damaged channel. Dose rate predictions were carried out by the CEA on this occasion, to program the shifts between the teams. The operators entered the caisson through airlocks located at the height of the

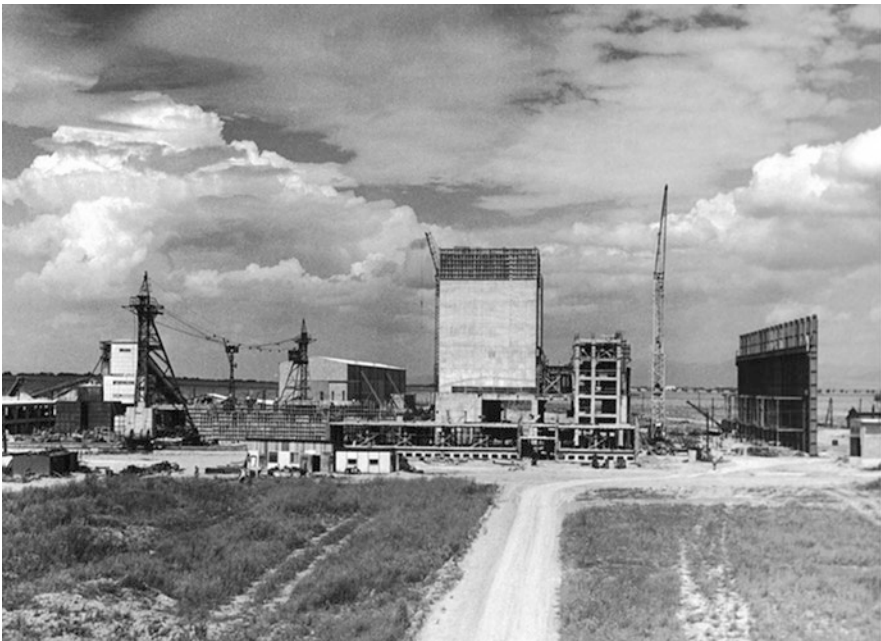
Photo 2.89 Beginning of the A1 reactor construction (circa 1959)

Czechoslovakia embarked on a nuclear program in the late 1950s. The site chosen was Jaslovské Bohunice, 60 km from Bratislava (Photos 2.89 and 2.90). Besides the A1-reactor, 4 WWER-440 reactors of Russian design (2 models 440/230 and two more recent models 440/213) were built in 1972. The construction of the reactor, a model called “KS-150” of Soviet design but entirely manufactured by the Czech company Skoda, began in 1958 (Photo 2.89). The reactor (Fig. 2.69) used natural uranium (4.5 tons in all) contained in an assembly 12 m high (!), moderated with heavy water contained in a calandria (Photo 2.91) and cooled by carbon dioxide at 65 atmospheres (65.9 bars) which passes through pressure tubes. The reactor went into operation on December 25, 1972. The reactor has a power of 143 MWe gross (93 MWe net, 560 MWth), which heats the primary circuit of carbon dioxide (Fig. 2.70) at 410 °C. The secondary circuit is composed of 6 SGs, the steam of which turns three turbo-alternators of 50 MWe each. The core can be loaded continuously, with the reactor running, just like the French Natural Uranium-Graphite-Gas (UNGG) or English MAGNOX models. A fuel loading machine moves on the loading side to

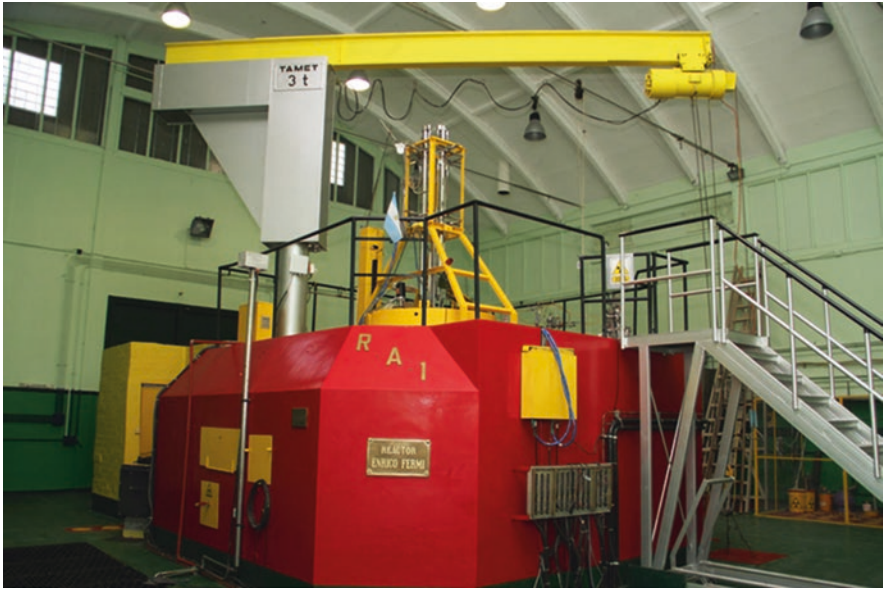
Photo 2.96 The RA-1 reactor known as “Enrico Fermi” in honor of the builder of the first-ever reactor in Chicago

The *Centro Atómico Constituyentes* (CAC) is located in the district of San Martín, Buenos Aires, Argentina (Photos 2.94 and 2.95). The center houses several facilities, such as the first nuclear reactor in Latin America (RA-1), RA for *Reactor Argentino*. A second RA-2 reactor was built with the objective of testing core arrangements for a more powerful reactor: the RA-3, which will be located at the Ezeiza Atomic Center. The CAC also has a heavy-ion gas accelerator TANDAR13. The CAC also houses a plant for the manufacture of uranium powder and a plant for the manufacture of fuel elements for research reactors, initially under the direction of the physicist Jorge Alberto Sabato (1924–1983, he founded in 1955 the Metallurgy Department of the *Comisión Nacional de Energía Atómica*—CNEA).⁴¹ The center hosts laboratories dedicated to nanotechnology, solar energy, research and materials testing. Argentina's nuclear development began in the early 1950s. In 1957, it was decided to build the first research reactor. The RA-1 reactor, built in just nine months (design power 120 kWth, now authorized to operate at 40 kWth), began operation in January 1958. It was the first reactor in South America to diverge, which is a legitimate source of pride for Argentina. Originally, the RA-1 was an *Argonaut* reactor of American design operating with enriched uranium supplied by the Americans. The RA-1 is an open vessel reactor, reflected by graphite (imported from France), and whose moderator and coolant are demineralized light water. The maximum neutron flux is $2 \cdot 10^{12}$ neutron/cm²/s against an average neutron flux of $3 \cdot 10^{14}$ neutron/cm²/s in a large PWR. In the early 1960s, the core of RA-1 was modified. Fuel rods (20% ²³⁵U enrichment) were introduced in place of the old Argonaut core design. The RA-1 facility was also the first to produce domestic radioisotopes for medical and industrial purposes. RA-1 is still used today for material activation testing, radiation damage and research onto new therapies in nuclear medicine, among other areas (Photos 2.96 and 2.97).

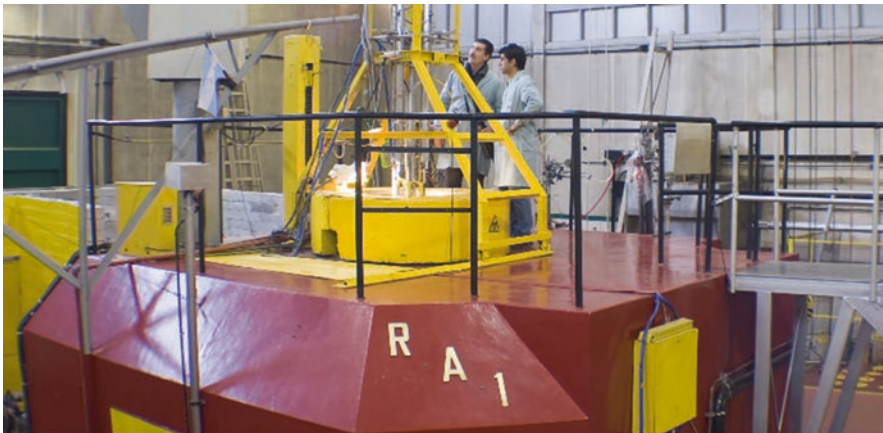
Photo 2.97 Operators working on the loading face of the RA-1 reactor

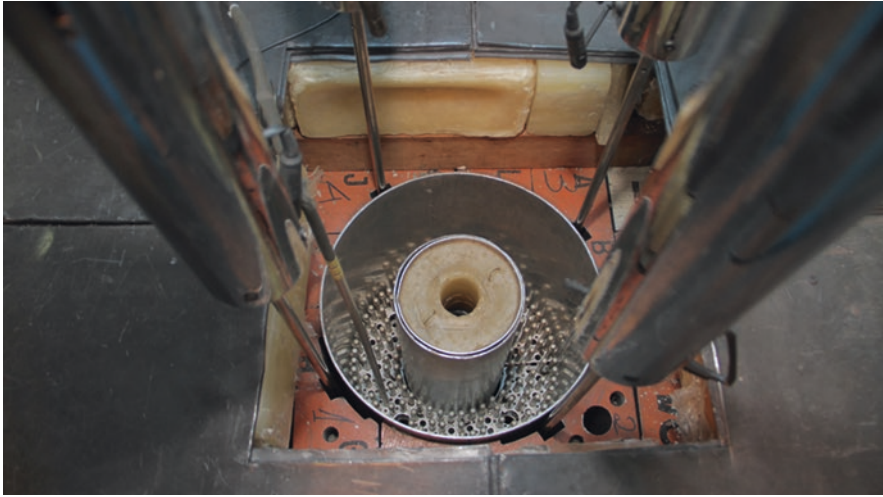
Photo 2.98 View of the Argentinean reactor RA-0

A critical facility called the RA-0 zero-power facility was first built at ACC and then transferred to the University of Cordoba. The RA-0 core has a circular ring geometry formed by two concentric and separable tanks made of anodized aluminum (Photo 2.98). It houses the fuel elements, composed of 20% enriched uranium in the form of rods, and demineralized water used as a moderator. The control rods are made of cadmium clad with stainless steel. A rapid draining of the water from the vessel completes the safety measures. As this is a very low-power reactor (maximum neutron flux of 10^7 neutron/cm²/s), no coolant is required and there is virtually no wear and tear on the fuel, so it does not need to be replaced. The RA-0 is used to train the
