Reactor Accidents in the Early Days of Nuclear Power

Abstract This chapter covers reactor accidents from the beginning of nuclear power until the 1980s. The accidents at Windscale (Great Britain), Vandellós (Spain), Vinča (Yugoslavia), SL-1 (USA), Santa Susana (USA), K-19 (USSR), Lagoon Beach (USA), Chapelcross (England), Grenoble (France), Lucens (Switzerland), Saint-Laurent-des-Eaux (France), Leningrad (Russia), Bohunice (Slovakia), and Constituyentes (Argentina) are analyzed in detail. Other less spectacular accidents are mentioned. The whole is abundantly illustrated with photos and diagrams.

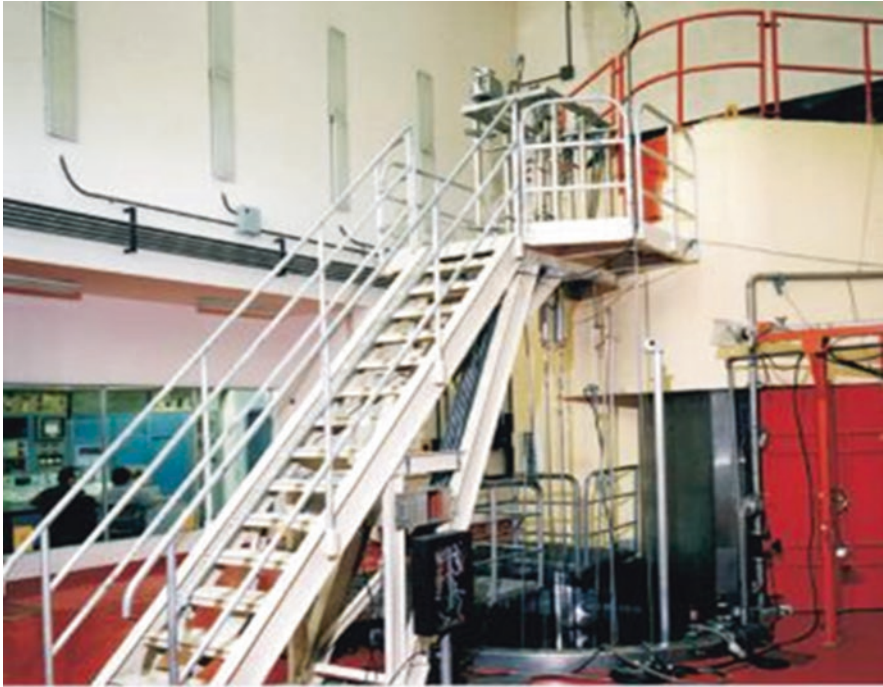
Photo 2.99 The RA-3 reactor whose main function is the production of medical isotopes such as metastable technetium 99
