Dynamical Characterization of Typical Mexican Colonial Churches

Fernando Peña and Julio Manzano

Abstract The dynamic characterization of ancient masonry churches built in the colonial era in Mexico is evaluated by means of a case study. Seismic assessment of old masonry churches is not an easy task, mainly due to the fact that the churches are large structures with complex geometries and built with materials with a highly nonlinear behavior. The case study concerns a typical church in Central Mexico. The aim of the characterization was to develop a methodology suitable for assessing the seismic vulnerability of this type of constructions. The study is based on the so-called complementary analysis approach. Thus, three steps were performed for the needs of assessment: (a) *preliminary studies*, which include the essential historical information, documentation of materials and geometry through survey of the structure and non-destructive testing; (b) *calibration and validation of numerical models*, based on the results obtained from the previous step; and (c) *dynamic characterization*. By combining the results of different types of models and analysis, this approach allows to over

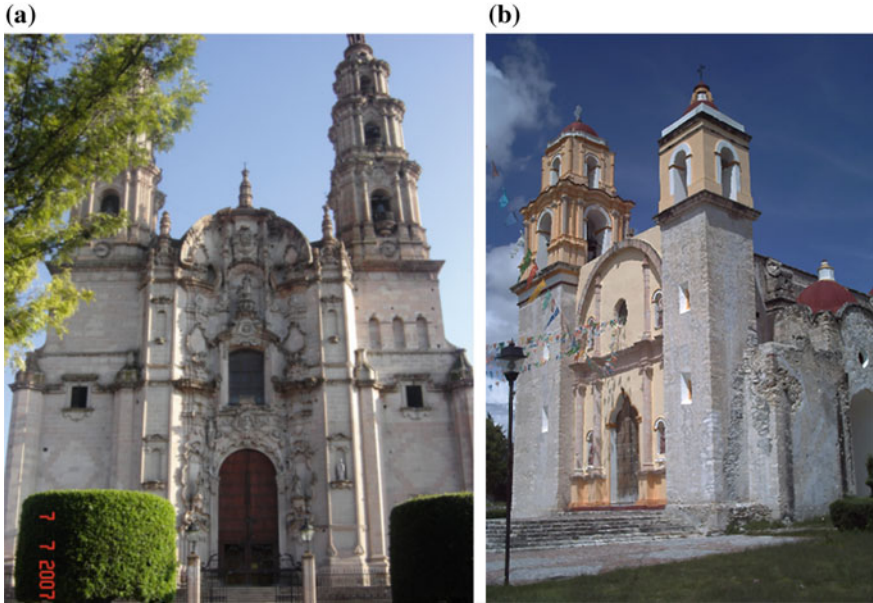
Fig. 1 Typical colonial churches built in: a low seismic risk zone (central Mexico), b high seismic risk zone (Pacific coast)

Churches built in the colonial era in Mexico, between the 16th and the 18th centuries, vary in size and architectural styles. However, churches of a particular zone follow some basic typologies (both architectural and structural), which depend mainly on the seismic zone where they were built [14, 18]. An important factor which influenced the architectural style was the experience of the ancient builders owing to the seismic activity of the country. Generally, in the Pacific's coast the recurrent destruction of the first constructions caused an evolution of the churches towards a shorter height with big buttresses and not much outer ornamentation. On the other hand, in other regions where the seismic activity is smaller, the churches remained taller and more slender (see Fig. 1). Therefore, by case studies it is possible to extrapolate the results to other similar churches.

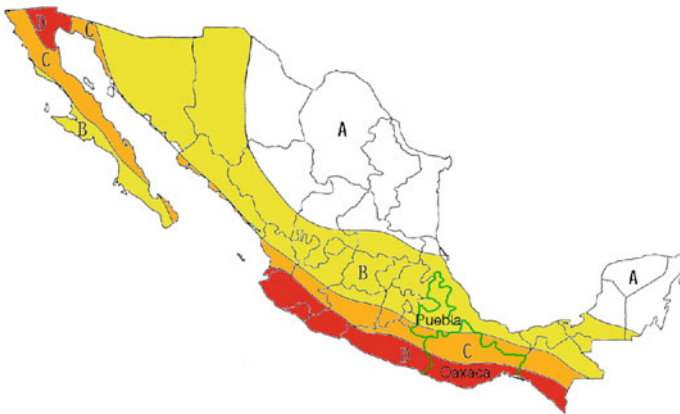
Fig. 2 Seismic zonation of Mexico [4]

The seismic activity of Mexico can be divided in four big zones: A, B, C and D (Fig. 2; [4]). These zones are delimited based on the frequency of occurrence of the earthquakes in the different regions and the expected maximum ground acceleration in a century. Zone A is the region where no earthquakes have been reported in the last 80 years and ground accelerations are not expected to exceed 10 % of the acceleration of gravity. Zone D identifies the places where earthquake occurrence is very frequent and the ground accelerations can be higher than 70 % of the gravity acceleration. It is here where the historical big earthquakes have been registered. The B and C zones are intermediate regions where earthquakes are not registered frequently and the ground accelerations recorded are not greater than 70 % of gravity.

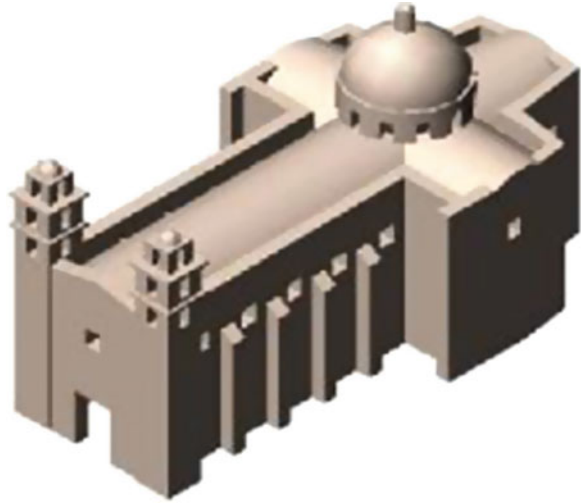
Fig. 3 Typical colonial church of central Mexico

The typical colonial church in the central Mexico has a Latin-cross floor plan. It has one or two bell towers. Roof is constituted by a quadripartite vaulting system. A hemispherical dome is placed over the transept bay and it is supported by the drum. Small buttresses are placed along the main nave (Fig. 3). In the first bay there is an intermediate floor for the chorus. The façade is composed by the main wall, which is connected with the towers and the frontispiece. The façade has, generally, two openings: the main door and a window for illumination of the chorus, which can be rectangular or circular. The height of the door is between 5 and 8 m.

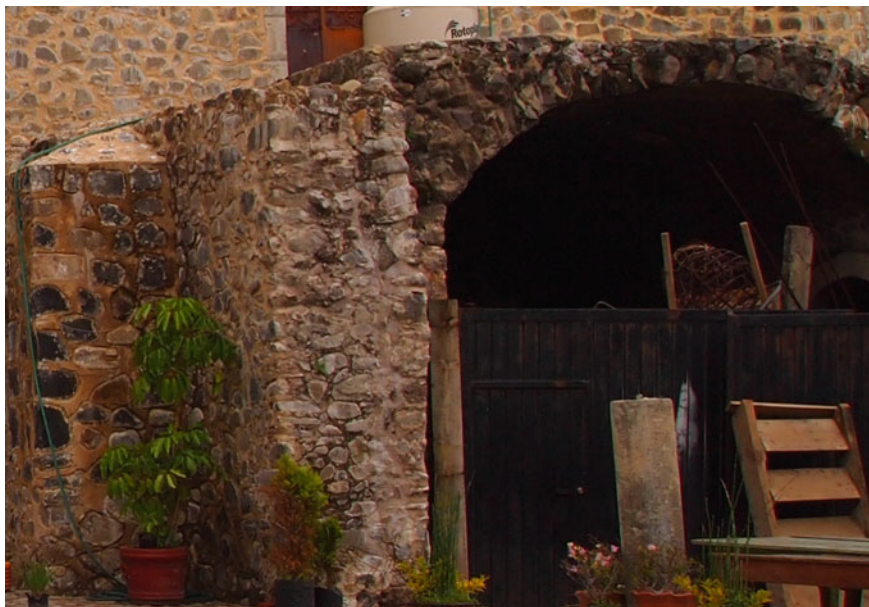
Fig. 4 Detail of a typical colonial masonry wall and arch

The main material of construction is a heterogeneous masonry constituting of stones connected with a lime-sand mortar (rubble masonry). Frequently, broken clay bricks or light-weight volcanic stones were added to the masonry. This heterogeneous masonry is a kind of pozzolanic concrete whose composition varies according to the structural element. This characteristic allowed building the structural elements as a monolithic, one leaf element. Thus no planes of weakness occur in the interior of the walls due to the different layers of the masonry (see Fig. 4). These characteristics allow modeling the material as homogeneous and isotropic [5, 15].

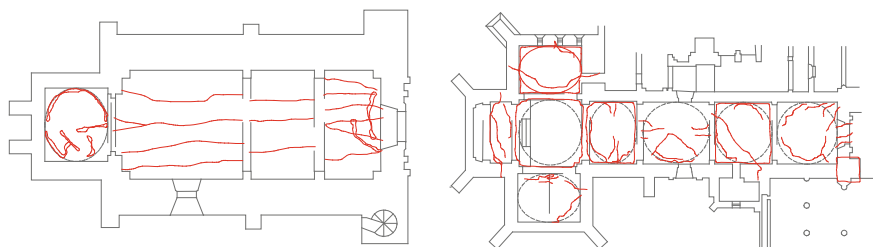
Fig. 5 Typical earthquake damages in domes and vaults

Vaults, arches and domes are very efficient for resisting their self-weight, but they are very sensitive to opening at their support, which introduces tensile stresses and could produce extensive cracking. Due to the height of the temples, supporting walls and columns experience significant lateral displacements at the top, during strong ground shaking, thus generating longitudinal cracks in vaults and cracks along the meridians in domes (Fig. 5). In most cases, this cracking does not endanger the stability of the roof, giving rise only to a redistribution of stresses. Nevertheless, when large displacements take place, the shape of the elements could change to a less stable configuration and progressively lend to collapse, especially because of the cumulative effect of subsequent earthquake motions. In this regard, domes are more sensitive than vaults to motions of their supports, which can be enhanced by flexibility of their drums. Vertical ground accelerations, which are

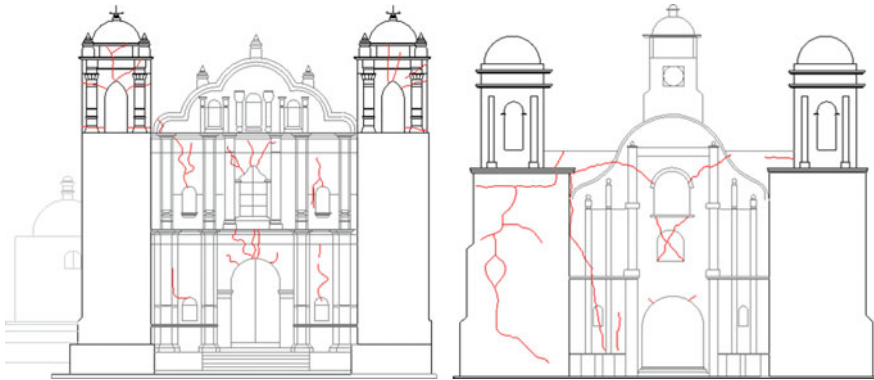
Fig. 6 Typical earthquake damages in Façades and towers

Bell towers are rather slender and weak elements, in which the ground motion is greatly amplified. Even if they are relatively low and sturdy, their failure is rather common in temples of the most seismically active areas, especially in the vertical elements and in the arches surrounding the belfry (Fig. 6). Additionally, their bending motion tends to separate them from the rest of the church or to generate shear cracking in the lower body of tower.

A façade is typically a tall and heavy wall connected to the rest of the temple. The key damages have shown that the main behavior of these elements is in the plane of the façade (Fig. 6). The out-of-plane behavior is generally less important and is only observed with the detachment of the façade from the nave, but without reaching the state of collapse [1]. This is mainly due to the presence of the towers, built integrally with the façade and not simply constructed in compliance. In fact, on the one hand these towers provide a constraint that reduces the movement out-of-plane, but also they increase the in-plane actions, and are also subjected themselves to a combination of bending and torsional distress. On the other hand, the rigidity of the vaults in the longitudinal direction coupled with the rigidity of the apse reduce the possible thrust effect of the vault over the façade. The slab of the chorus restrains the wall and reduces the façade slenderness. Thus, shear actions have a significant role in the damage patterns, especially in the joints between the façade and towers [3].

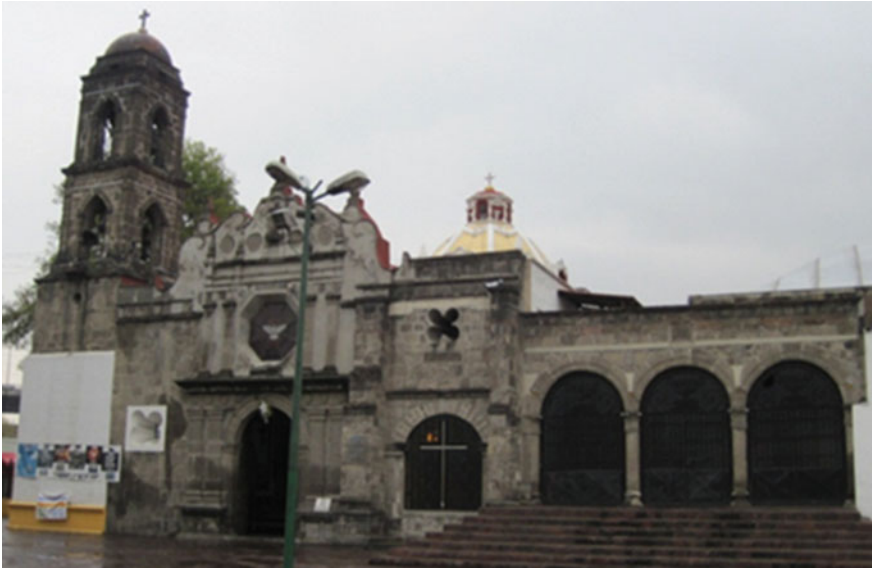
Fig. 7 Actual view of the church

For example, Figs. 7 and 8a show the façade now and in the middle of the 40s. Comparing both figures it is possible to observe significant changes in the façade. The right side window was expanded. The frontispiece is different, although there is evident effort to preserve the original style. The buttress on the right side of the main door is new. Figure 8b seems to be from the 50s of the past century. Compared with Fig. 8a, it is seen that the frontispiece is the same but without the pinnacles. The right side door and the buttress of the façade were already built but with a different architectural style.

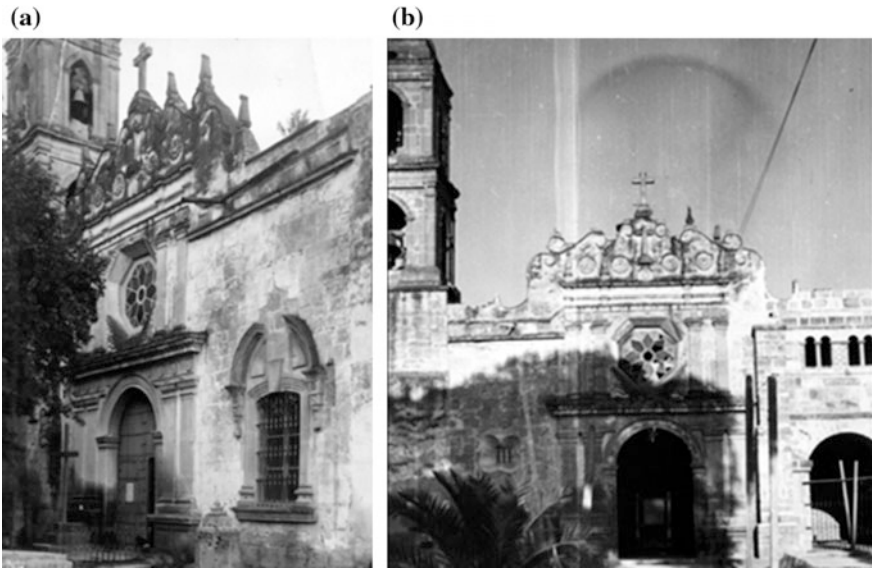
Fig. 8 View of the Façade in the of the past century [11], decade of: a 40s; b 50s

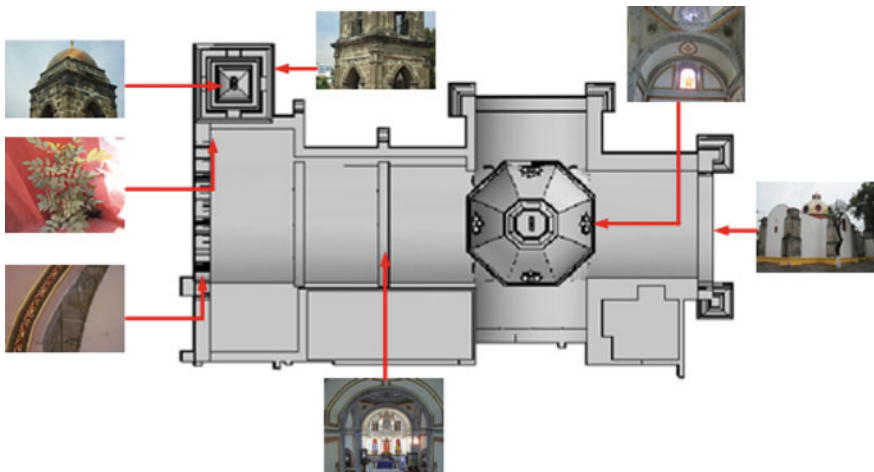
Fig. 9 Photographic survey

The church has a Latin-cross floor plan, oriented in the East-West direction. The main nave has a length of 31.5 m and a width of 7 m. The transverse nave is $14 \times 8 \text{ m}^2$. In the first bay there is an intermediate floor for the chorus. The roof is constituted by a barrel vaulting system with a thickness of 20 cm. A hemispherical dome is placed over the transept bay and it is supported by the drum. The average height of dome is 13.95 m. The church has a bell tower, 13.75 m high. The tower has a rectangular section of $3.5 \times 4.2 \text{ m}^2$ in plan. The thickness of the walls varies from 0.85 to 1 m. Trapezoidal buttresses are placed along the longitudinal walls of the nave and in the apse. Figure 9 shows the photographic survey performed.

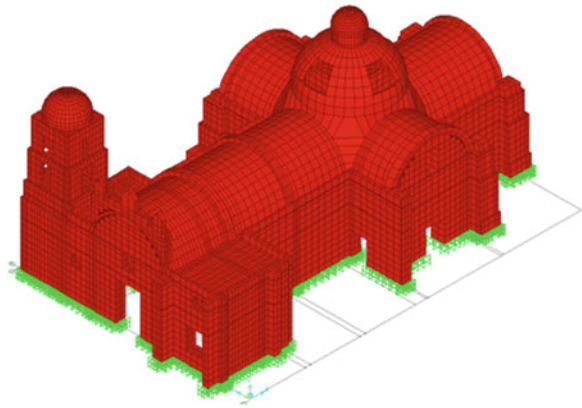
Fig. 10 Finite element model of the church

Based on the information collected, a finite element model was assembled (see Fig. 10), using rectangular solid eight-noded elements. The computer model comprised 22,509 elements, 96,066 degrees of freedom and 33,650 nodes.

Three types of materials were considered in the model. Walls, columns, buttresses, tower base and arches are modelled with properties of stone masonry. The belfry was also modelled as masonry, but having different properties from the walls, in consideration of the fact that it encompasses embedded concrete and steel reinforcement. Finally, the vaults, the frontispiece, ribs and dome were considered of reinforced concrete. Table 1 shows the mechanical properties of the materials used in the model, which were obtained from the literature [5].

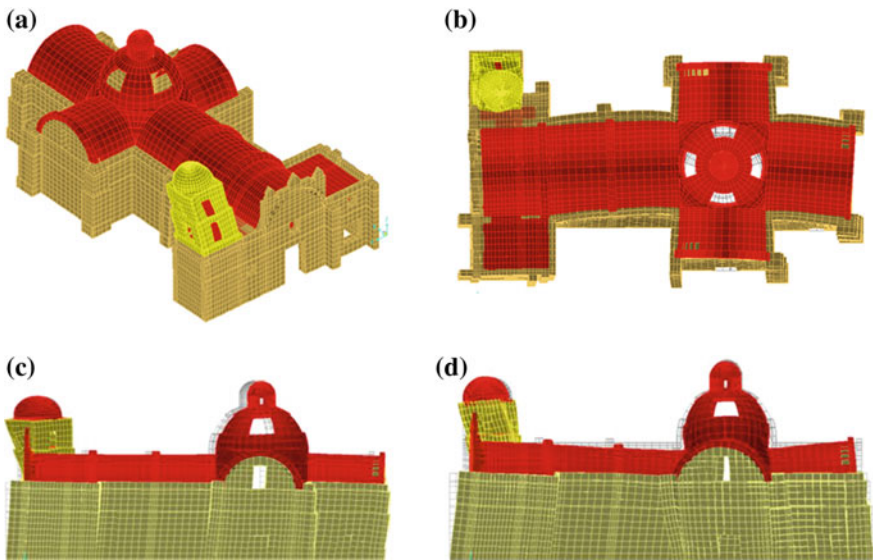
Fig. 11 Modal shapes of the uncalibrated model: **a** first mode; **b** third mode; **c** fifth mode; **d** eighth mode

A modal analysis was performed. This analysis allows firstly to check the numerical model, but it may also be used to design the ambient vibration test (see Sect. 4.1). Table 2 shows the frequencies and percentages of modal mass for the first five modes. The structure is very rigid, as the first frequency is 3.66 Hz. The first two modes correspond to the vibration of the tower, which is the most flexible part of the church (Fig. 11a). The third mode is the first mode in the transverse direction with a frequency of 5.05 Hz (Fig. 11b). The fourth and sixth modes correspond to

torsional mode of the tower, while the fifth mode is the first mode in longitudinal direction. It should be noted that all modes have a torsional component, and there is no single mode with a pure form.

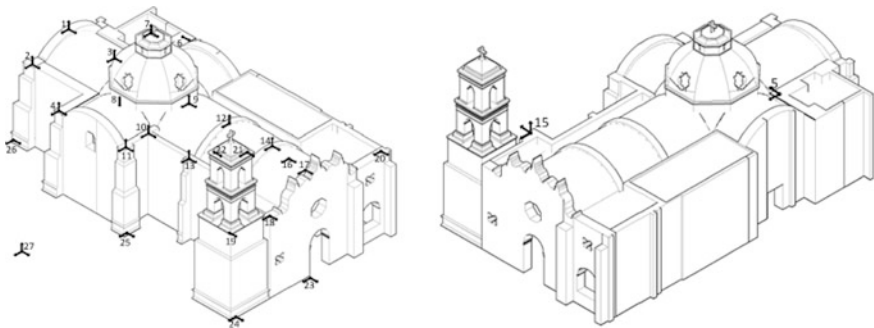
Fig. 12 Localization of the measured points

Based on the results of the finite element model and field survey, the points where the accelerometers should be placed for ambient vibration test were defined. Figure 12 shows schematically the points selected for the installation of the accelerometers. The signals obtained from the tests were processed and interpreted using a spectral analysis program. For each test, the average power spectra and the corresponding spectral ratios, phase angles and coherence between signal pairs were obtained. For these analyses, each record was processed in sections of 49.96 s, considering a 50 % of overlap between two consecutive segments and a Hanning window weighting type. The analysis of the spectra enabled obtaining several frequencies. Table 3 shows the significant frequencies of the tower, while Tables 4, 5 and 6 show the significant frequencies of the body of the church.

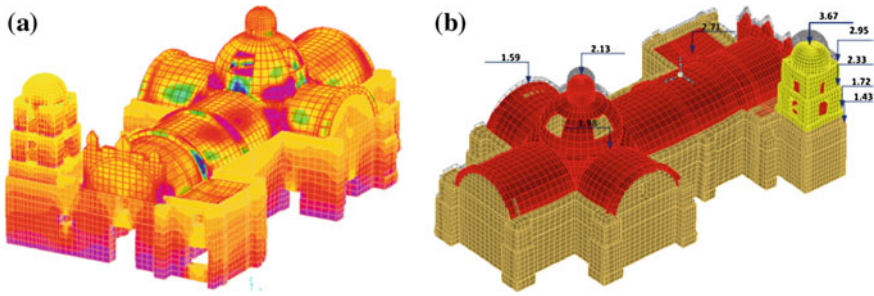
Fig. 13 Self-weight analysis: **a** map of vertical axial stresses; **b** deformed shape (in mm) 5.2 modal description

The first analysis performed was for the gravity loads of the church. The total weight of the structure is equal to 15,175 kN, corresponding to an average axial stress in the foundation equal to 0.13 MPa. Figure 13a shows the map of the vertical

axial stresses due to the self-weight, whereas Fig. 13b shows the deformed model. It is clear that the maximum compressive stresses are presented at the base of the church. These stresses are low, around 10 % of the compressive strength of the masonry. This level of vertical stresses due to self-weight is common in the colonial churches in Mexico [7].

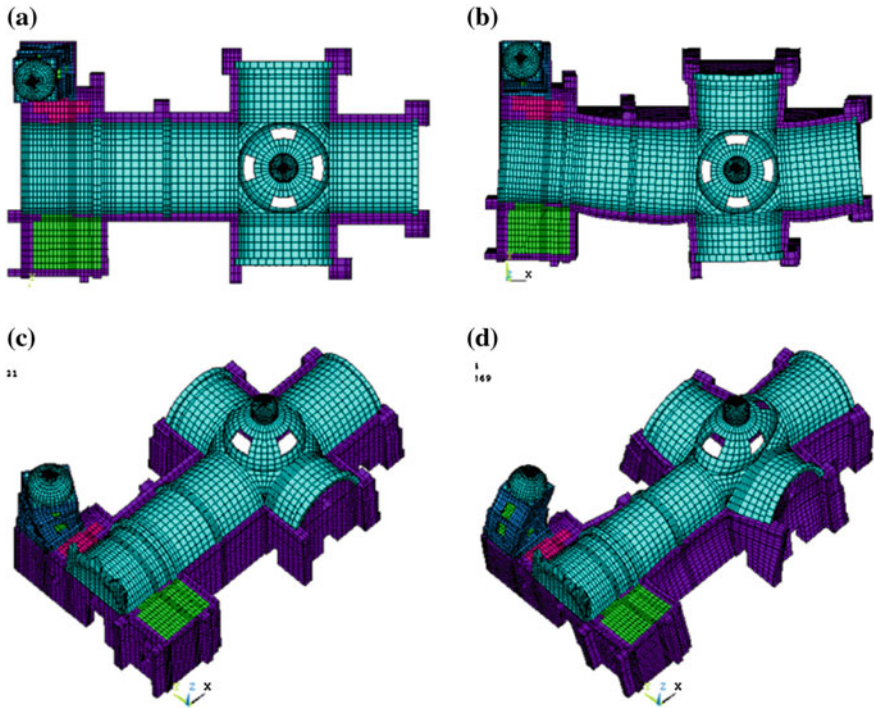
Fig. 14 Modal shapes of the calibrated model: **a** first-mode; **b** third-mode; **c** fifth-mode; **d** eighth-mode

Table 9 lists the dynamic properties of the calibrated model. It is noted that the mode shapes are virtually the same as those of the original model, with the exception of mode 5 which was exchanged with mode 6. This means that the mode 6 is now the first longitudinal mode, while the mode 5 is a torsional mode of the tower. Likewise, it is observed that the vault cannot be considered as an infinitely rigid diaphragm. Note that the motion of the plane is not uniform as it can be observed in Fig. 14.

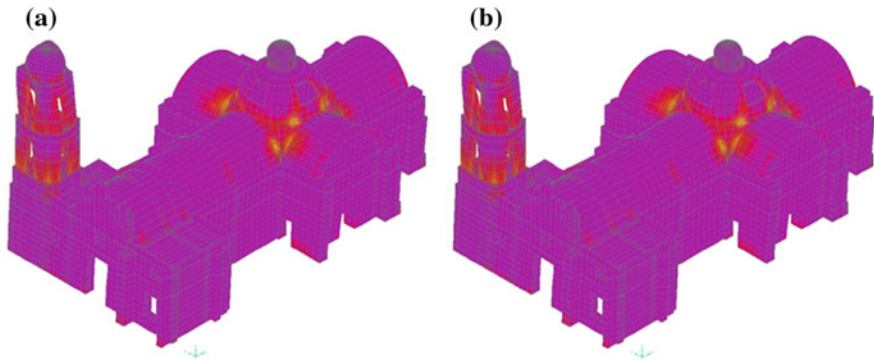
Fig. 15 Deformed shape and map of vertical axial stresses: **a** 100 % in lateral direction plus 30 % in the longitudinal; **b** 30 % in lateral direction plus 100 % in the longitudinal

Figure 15 shows the deformed shape with the map of the vertical axial stresses, when the earthquake is applied in the transverse and longitudinal direction respectively. It is noted that the analyses consider the combination of the earthquake in the two directions (100 % for one direction plus 30 % in the other). It is observed that regardless of the direction of the earthquake, the deformed shape obtained is similar in both cases. The tower has a torsional behavior, which is concentrated in

the upper body of the belfry. Likewise, the dome has undergone a slight vertical movement, which produces a stress concentration at the base of the drum.

The vertical axial stresses are also concentrated in the pillars of the belfry and at the base of the walls and buttresses. A slight vertical stress concentration can be observed in the base of the ribs, which indicates that they are working due to vertical vibration of the vaults. Furthermore, the shear is concentrated in the body of the pillars of the belfry, in the drum and the ribs. It is interesting that the walls do not show important shear stresses. This is because the church has virtually no lateral or longitudinal distortions, whereas the motion is concentrated in the tower and roof (dome and vaults). These results show a seismic behavior consistent with historical record: *the critical elements of this church are the bell tower and the roof.*
