3D Investigation of Cracking Behavior in a Ni Superalloy

Andrew Deal¹, David Rowenhorst², Brandon Laflen¹, Ian Spinelli¹,
Tony Barbuto¹, Yuchi Huang¹, Timothy Hanlon¹

Abstract

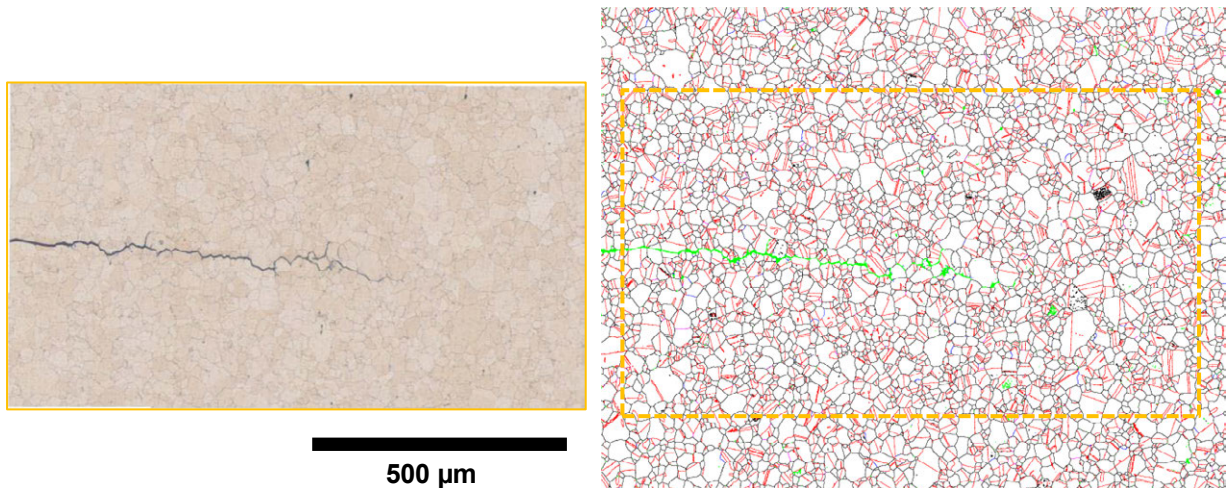
Figure 3 – Typical optical montage (L) and EBSD map (R). Black, red, and green in the map signify regular boundaries, special boundaries, and unindexed points, respectively.

Figure 2 shows the removal rate histogram for the 150 slices. The standard deviation of the mechanical material removal was $0.21\mu\text{m}$, and the overall average was $1.01\mu\text{m}$, within 1% of the target. A typical optical montage and a corresponding EBSD map are shown in Figure 3. The optical montages generally did not reveal twin boundaries. Some are visible, but most are not. However, twins were well captured by the EBSD maps, which will eventually allow for their incorporation into the reconstruction. The percentage of correctly indexing points in the EBSD maps was generally 95% or more. Cleanup was applied to the data to fill in grain boundaries, but care was taken to avoid filling the crack to aid in crack extraction. In Figure 3, $\sim 3.5\%$ of points were generated from the cleanup routine, with red indicating a $\Sigma 3$ boundary, black indicating a regular grain boundary, green representing the remaining unindexed area.
