Relationship Between Applied Stress and Hydrogen-Related Fracture Behavior in Martensitic Steel

In the present study, a relationship between the applied stress and the hydrogen-related fracture behavior in an 8Ni-0.1C martensitic steel was investigated by means of constant loading tensile tests under various applied stresses ranging from 400 to 1000 MPa. The time to fracture in hydrogen charged specimens increased from 0.5 to 30.5 s with decreasing the applied stress from 1000 to 400 MPa. Area fractions of brittle fracture surfaces, especially that of intergranular fracture surface, increased as the applied stress decreased. Orientation analysis using EBSD showed that micro-cracks observed in the vicinity of the main crack initiated along prior austenite grain boundaries regardless of the applied stress. The hydrogen-related fracture processes under various applied stresses were reconstructed by fracture surface topography analysis and the results indicated that intergranular fracture was dominant under the lower applied stress, while the fracture mode changed from intergranular fracture to quasi-cleavage fracture with progress of crack propagation under the higher applied stress.

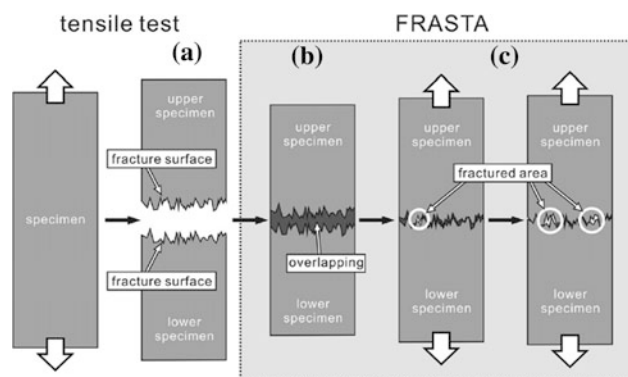
Fig. 1 Schematic illustration showing the method of fracture surface topography analysis (FRASTA) [14]

steps in the FRASTA method: (1) obtain topographic maps of conjugate area in opposing fracture surfaces, (2) overlap the two topographic maps computationally until there is no gap between them and (3) increase the relative distance between the two topographic maps. A schematic illustration of FRASTA method is shown in Fig. 1 [14].

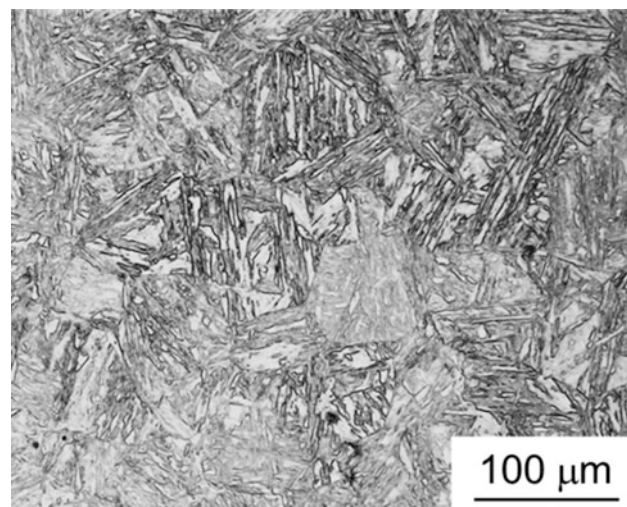
Fig. 2 Optical microscopy image of the heat-treated specimen

Figure 2 shows an optical microscopy image of the heat-treated specimen. The microstructure exhibits a typical lath martensite structure consisting of laths, blocks, packets and prior austenite grains. The stress-strain curve of the uncharged specimen at ambient temperature at a strain rate

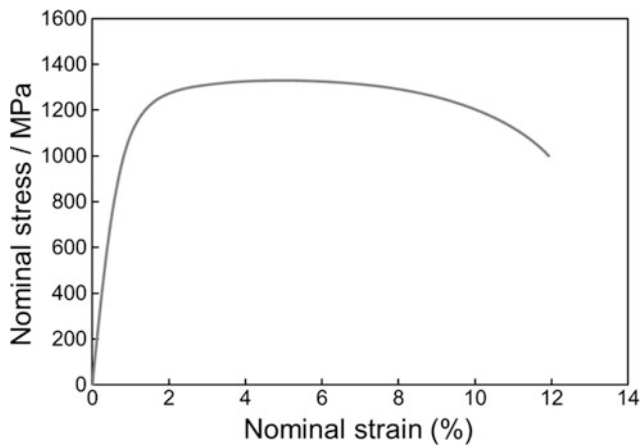
Fig. 3 Nominal stress–nominal strain curve of the uncharged specimen at ambient temperature at a strain rate of $8.3 \times 10^{-6} \text{ s}^{-1}$

of $8.3 \times 10^{-6} \text{ s}^{-1}$ is presented in Fig. 3. The 0.2% proof stress and ultimate tensile strength measured from the stress–strain curve are 928 MPa and 1287 MPa, respectively.

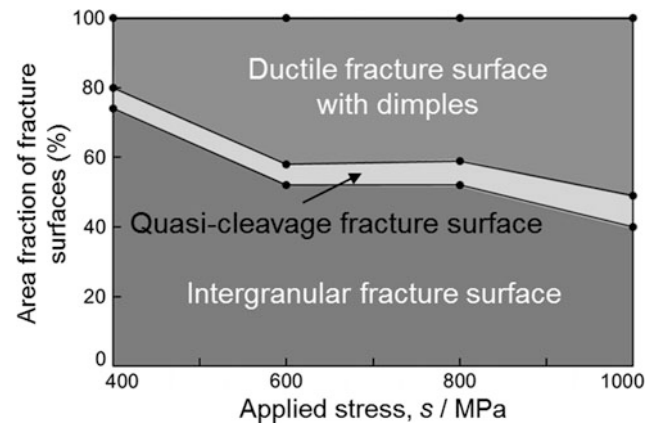
Fig. 6 Area fractions of different fracture surfaces after the constant loading tensile tests under various applied stresses

particularly that of intergranular fracture surfaces, significantly increased. The results shown in Figs. 4 and 6 indicate that the higher applied stress accelerated hydrogen-related fracture, but decreased the area fraction of brittle fracture surfaces.

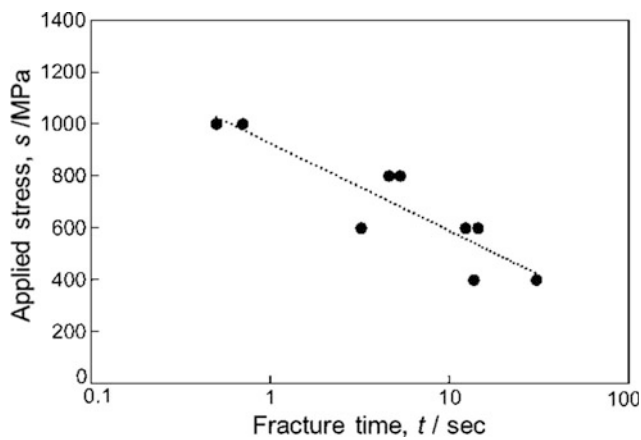
Fig. 4 Relationship between the applied stress and the fracture time in the constant loading tensile tests

Figure 4 shows the relationship between the applied stress and the fracture time in the constant loading tensile tests. While the applied stress of 1000 MPa is higher than the 0.2% proof stress, the other applied stresses ranging from 400 to 800 MPa are within elastic deformation region of the uncharged specimen. It can be found from Fig. 4 that the fracture time increased from 0.5 to 30.5 s with decreasing the applied stress from 1000 to 400 MPa. Figure 5 are SEM images showing typical fracture surfaces after the constant loading tensile test (applied stress = 1000 MPa). Intergranular fracture surface, quasi-cleavage fracture surface and ductile fracture surface with dimple patterns were observed in Fig. 5a–c, respectively. Figure 6 summarizes the relationship between the area fractions of various types of fracture surfaces and the applied stresses. As the applied stress decreased, the area fraction of brittle fracture surfaces,

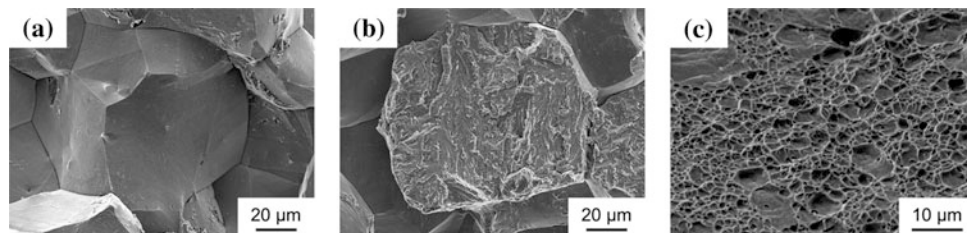
Fig. 5 SEM images showing typical fracture surfaces observed after the constant loading tensile tests (applied stress = 1000 MPa); **a** intergranular fracture surface, **b** quasi-cleavage fracture surface and **c** ductile fracture surface with dimples

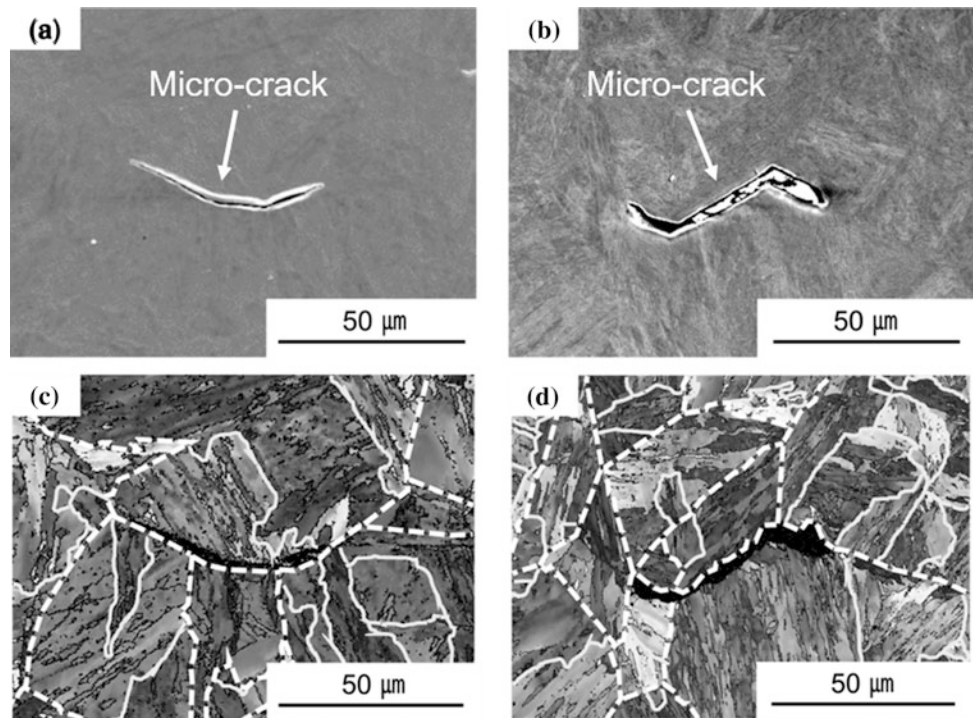
Fig. 7 a, b SEM images and c, d corresponding EBSD orientation maps showing the micro-cracks observed in the vicinity of the main cracks in the specimens tested under the applied stresses of a, c 400 MPa and b, d 1000 MPa, respectively. Packet boundaries and prior austenite grain boundaries are drawn by white lines and white broken lines, respectively

Figure 7 are SEM images showing micro-cracks observed in the vicinity of the main cracks in the specimens tested under the applied stresses of (a) 400 and (b) 1000 MPa, respectively. Figure 7c, d shows EBSD orientation maps of the same regions as Fig. 7a, b. In these figures, packet boundaries and prior austenite grain boundaries identified by crystallographic orientation analysis are drawn in white lines and white broken lines, respectively. It is obvious from these figures that the micro-cracks formed along prior austenite grain boundaries in both cases. The results indicate that the hydrogen-related fracture initiated along prior austenite grain boundaries regardless of the applied stress.

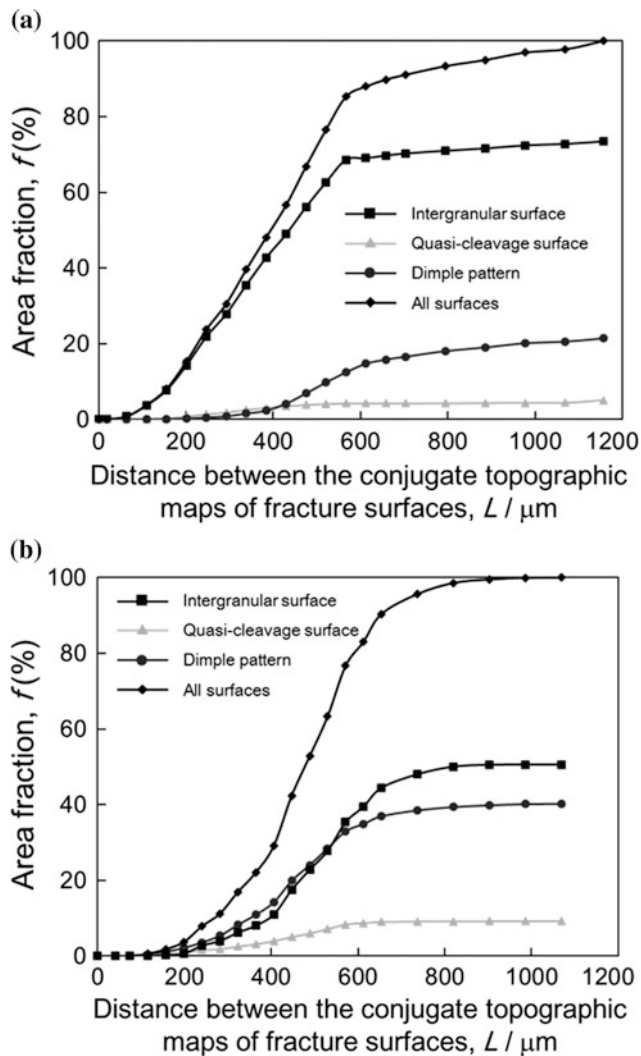
Fig. 8 Changes in fraction of each fracture mode under the applied stress of **a** 400 MPa and **b** 1000 MPa summarized as a function of the distance between the conjugate topography maps of fracture surfaces

Figure 8 summarizes changes in the fraction of each fracture surface under the applied stresses of (a) 400 MPa and (b) 1000 MPa, respectively, evaluated by FRASTA. The horizontal axis shows the distance (L) between the conjugate

topography maps of fracture surfaces. L is defined as 0 at which the first cracking occurs in the specimen. Under the applied stress of 400 MPa (Fig. 8a), intergranular fracture mainly occurred at the early stages of fracture and the fraction of ductile fracture surface with dimples increased as the fracture proceeded. It was reported that hydrogen accumulated at prior austenite grain boundaries during deformation [6]. Therefore, the results suggest that under the lower applied stress, such as a stress in elastic region, hydrogen accumulation at prior austenite grain boundaries around the crack tip is necessary for the crack propagation. When the applied stress was 1000 MPa (Fig. 8b), on the other hand, not only intergranular fracture but also quasi-cleavage fracture and ductile fracture occurred at the early stages of fracture. It is considered that under the higher applied stress, such as a stress higher than the 0.2% proof stress, cracks can propagate easily even in transgranular manner once micro-cracks form. Therefore, the fracture time decreased and the fraction of transgranular fracture surfaces, such as quasi-cleavage fracture surface and ductile fracture surface, increased as the applied stress increased.
