Arizona Department of Water Resources Land Subsidence Monitoring Program

Brian D. Conway

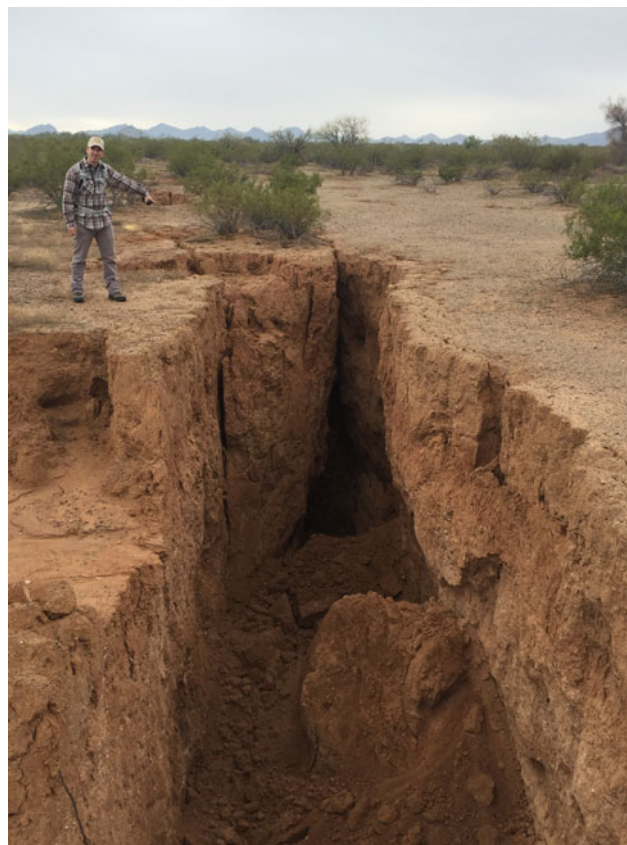
Fig. 3 Earth fissure in Pinal County, Arizona that opened in 2016

Regional land subsidence has resulted in a large number of earth fissures. Earth fissures are tension cracks that are formed from differential land subsidence occurring near the basin fringes or near shallow bedrock. Earth fissures develop as small hairline cracks in the sub-surface. Some cracks may reach the surface and others may lie hidden just below the surface. Earth fissures are usually identified after large rain events when the hairline crack intercepts surface runoff, causing erosion. The earth fissure opens up, creating what is called a fissure gulley. An earth fissure gulley can be more than 3 m wide and have depths of 10 or more meters (Fig. 3). The Arizona Geological Survey (AZGS) started mapping earth fissures in 2007 and has since mapped more than 273 km of earth fissures throughout Arizona (AZGS 2017). The AZGS has published 26 earth fissure study area maps that display all the earth fissures mapped in each study area. These maps, as well as an online earth fissure viewer and GIS earth fissure shapefiles, can be accessed at this link: <http://www.azgs.gov/efmaps.shtml>. Several of these earth fissures have impacted and damaged pipelines, highways, roads, railways, flood control structures and homes.
