Maninderpal Kaur, Claudia Lucia Piccolo,  
and Victor Chong Xing Dao

In this chapter, we survey examples of artefacts and other factors that interfere with image acquisition observed with CEDM in our clinical practices at Careggi University Hospital and Kuala Lumpur Hospital (KLH), and we highlight the necessary steps to reduce and eliminate these artefacts.

## 8.1 FFDM-Related Factors

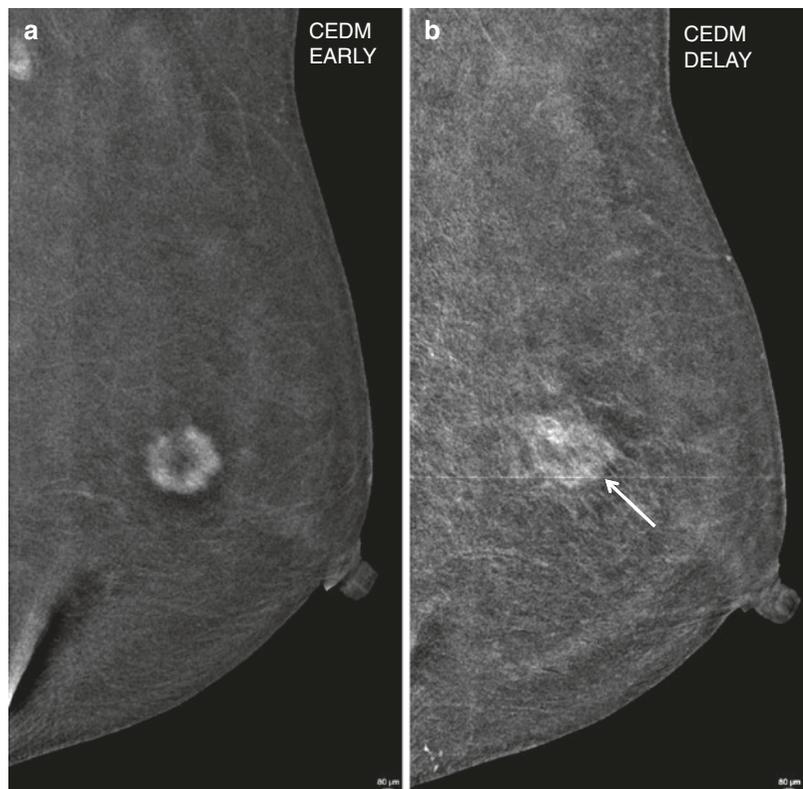
**Fig. 8.1 Motion artefact:** A 49-year-old woman with biopsy-proven invasive ductal carcinoma in the left breast underwent CEDM as part of a staging workup. **(a)** CEDM-recombined image in MLO view demonstrates an intensely enhancing well-demarcated round mass in the upper quadrant of the left breast. **(b)** CEDM delay was performed to assess the enhancement kinetics, but due to motion artefacts, the margins of the mass are blurred. *CEDM* contrast-enhanced digital mammography, *MLO* mediolateral oblique

These artefacts are commonly observed in clinical practice. To minimize the patient motion, which is the most common cause of blurring (Fig. 8.1), the technologist should apply adequate compression during the examination and remind patients to remain still during image acquisition.
