# Chapter 7

## Behavior of Composite Laminates with Drilled and Moulded Hole Under Tensile Load

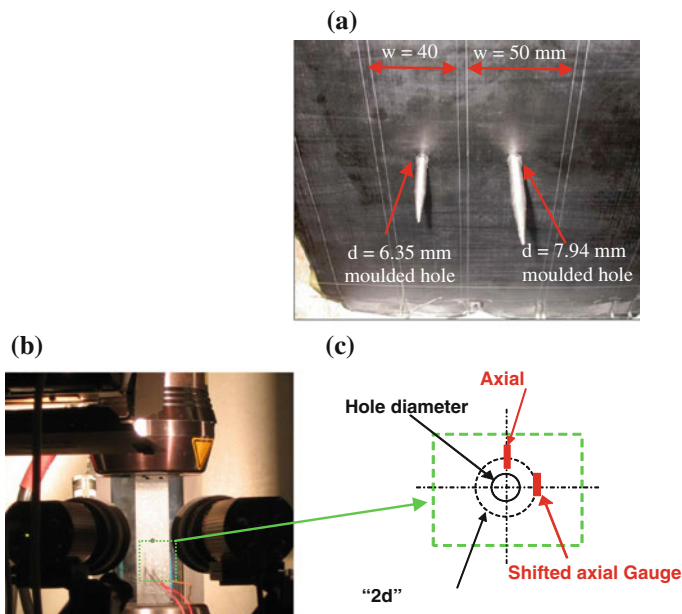
**Fig. 7.1** Specimens for the tensile tests related to **a** mother plate from the mould, **b** Experimental device with DIC, **c** Scheme of the gauges position

a circular space after polymerization (Fig. 7.1a). The displacement of the pointed steel are activate when the resin reach the viscous phase. Vacuum and pressure are applied and maintained during the period of solidification.

In order to reduce the variability due to the manufacturing process all the specimens tested are obtained from the same mother plate. Two sets of specimens were tested (Fig. 7.1a). The first set concerns the specimens with moulded holes with diameter values of 6.35 and 7.94 mm. The second set includes the drilled hole specimens with the diameter values of the moulded holes. The diameter values used in this study are usually employed in the aeronautical field. For all specimens tested

the ratio between the hole diameter and the part width ( $d/w$ ) is equal to 0.15 mm (Fig. 7.1a). The drilling is performed with a tungsten carbide drill (Twist drill).

A randomly distributed pattern is painted on the surface of the specimen for the strain field measurements thanks to Digital Image Correlation (DIC) technique (Fig. 7.1b). Moreover, on the same surface, two strain gauges (Fig. 7.1c) are pasted in the loading axis and located at a distance  $D$  (hole diameter) from the hole, which allows the axial strain measurement at two different places. Tensile tests were performed by means of an (Instron) UTM with a load capacity of 100 kN (Fig. 7.1b) at a speed of (2 mm/min). In order to better understand the different damage modes observed between drilled and moulded holes, the void content and fibre content analysis have been carried out using two methods. The first is normalized ASTM D3171 based on the dissolution of the specimen in sulphuric acid [3]. The second method is based on the image processing technique.

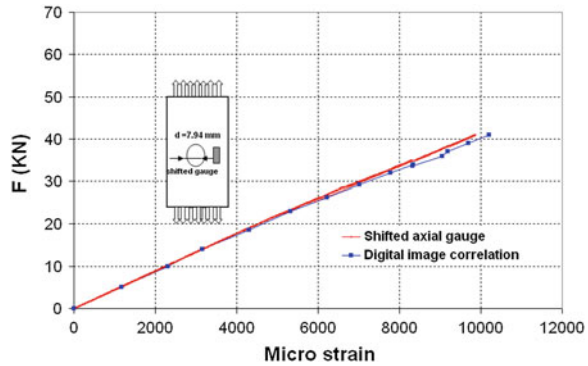
**Fig. 7.4** Load versus strains, measurement comparison between DIC technique and strain shifted gauge related to drilled specimen with a 7.94 mm drill diameter

The strain field, measured using the DIC technique, is confronted with strain gauges data. For the drilled hole, it is observed a good agreement between the two measuring techniques, with the maximum difference being about 5 %. With regard to the moulded hole specimens, the strain measurements are in good agreement with those obtained by the strain gauges when the applied load is lower than 28 kN (Figs. 7.4, 7.5). When the load reached 28 kN, damaged zones on the surface of the specimen are observed. This damage can be observed by the delamination of

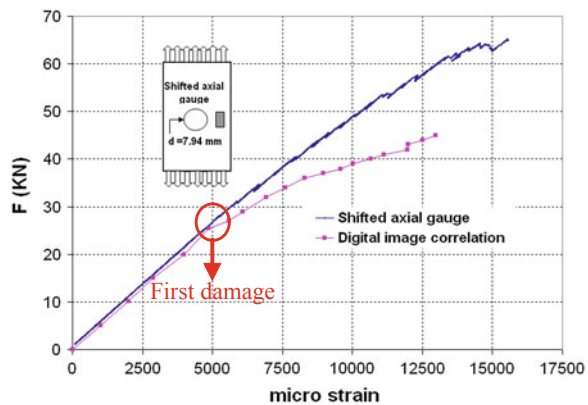
**Fig. 7.5** Load versus strains, measurement comparison between DIC technique and strain shifted gauge related to moulded specimen with a 7.94 mm hole diameter
