Chapter 8

Artifacts in SPM

8.1 Tip-Related Artifacts

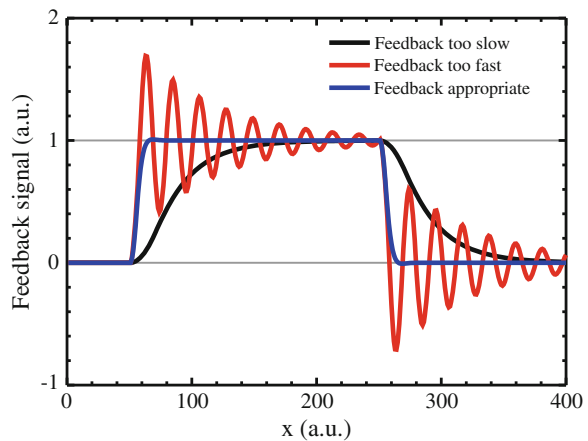
Fig. 8.7 Reaction of the AFM feedback signal to an abrupt change in the topography for too slow feedback settings (*black line*), too fast feedback settings (*red line*), and appropriate feedback settings (*blue line*)

If the feedback parameters are not optimized this can lead to image artifacts. If the feedback is too slow this will lead to blurred images; if the feedback is too fast this may lead to a feedback overshoot when the tip encounters sudden height changes such as a monoatomic step height or an other structure with high aspect ratio. In Fig. 8.7 the real signal (e.g. topography) changes from zero to one at $x = 50$ and back to zero at $x = 250$. The reaction of the AFM feedback signal to this is shown for too slow feedback settings (black line), too fast feedback settings (red line), and appropriate feedback settings (blue line). A scan in the reverse direction will show the opposite signatures.
