Developments in Geotechnical Engineering

V.V.S. Rao

G.L. Sivakumar Babu *Editors*

# Forensic Geotechnical Engineering

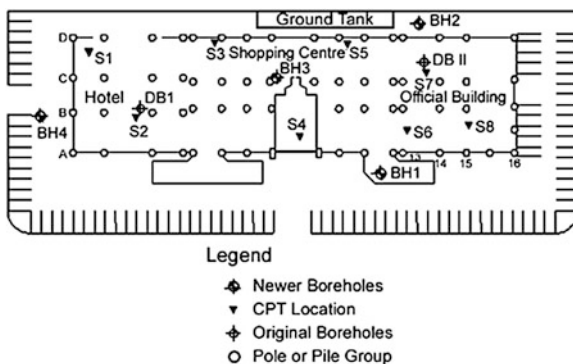
Fig. 1.1 Plan of project

Figure 1.1 shows a plan of the project site and the locations of the boreholes and cone penetration tests carried out prior to and after construction. Figure 1.2 shows the details derived from the boreholes. A layer of soft to very soft silt extended to a depth of about 11 m, underlain by stiffer silt to about 18 m. This was in turn underlain by

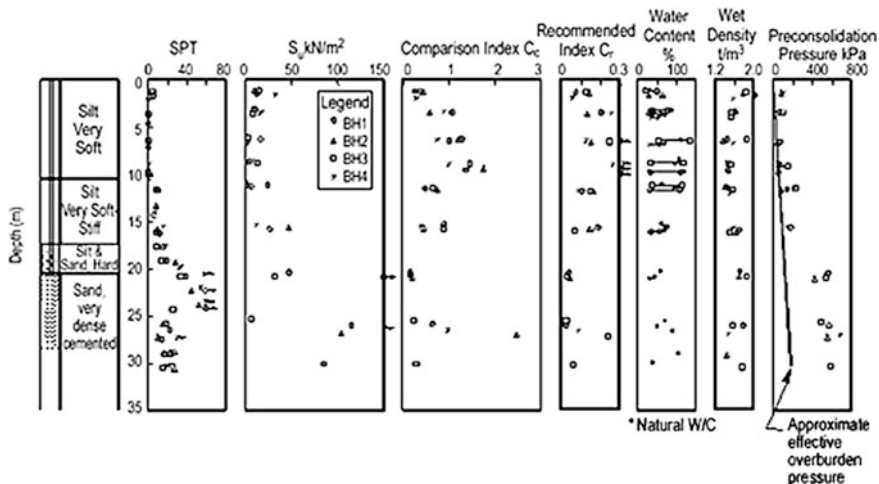
Fig. 1.2 Summary of engineering properties

very stiff and cemented layers of silt, silty sand and sand, in which the SPT values exceeded 60. The borelogs and SPT data obtained from the second investigation confirmed the earlier indications that the site was relatively uniform laterally. Laboratory testing was carried out to measure the undrained shear strength profile, and the one-dimensional compressibility characteristics. In the soft upper layer, the undrained shear strength was typically 20 kPa or less, and the compression index for the normally consolidated state was between about 0.6 and 1.7.

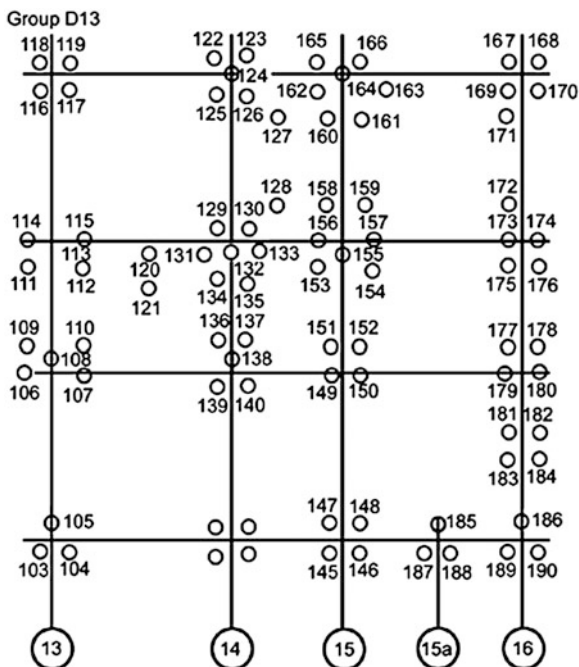
**Fig. 1.3** Layout of piles for office

Figure 1.3 shows the plan of the foundation piles, which consisted of 0.5 m diameter driven cast-in situ piles, extending to a depth of about 20 m, and founded in the cemented hard layers of silt, sand and silty sand. A total of 90 piles were used for the office building.

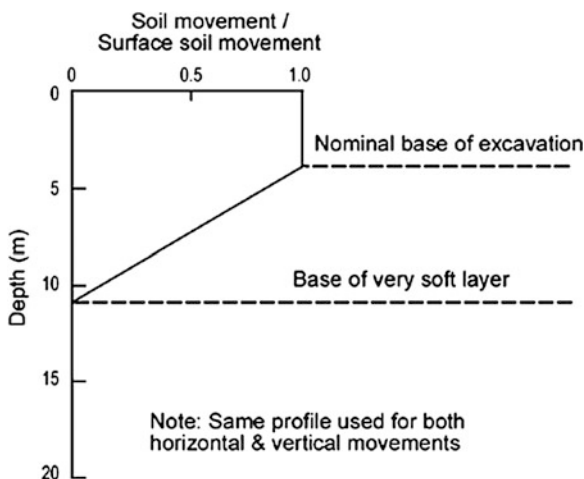
The effects of lateral soil movements were analyzed using the program ERCAP (CPI 1991), while the effects of vertical soil movements were analyzed using the program PIES (Poulos 1989). In estimating the vertical and lateral soil movements, use was made of the work of Mana and Clough (1981) and Clough et al. (1989). The assumed profile of movement (both axial and lateral) with depth is shown in Fig. 1.4. A depth of excavation of 4 m was assumed, although it was unlikely that this depth was reached in all sections of the excavation. The vertical and lateral movements appear to become relatively small at about 2–3 times the excavation depth behind the face of the excavation, and this characteristic appeared to be borne out on site. The second line of piles driven for the shopping centre (about 8–10 m away) did not appear to have suffered significant movements, at least initially. The ultimate skin friction, end bearing and lateral pressures were assessed on the basis of the laboratory measured undrained shear strength ( $s_u$ ) values. Values of Young's modulus were estimated

**Fig. 1.4** Assumed soil movement profile

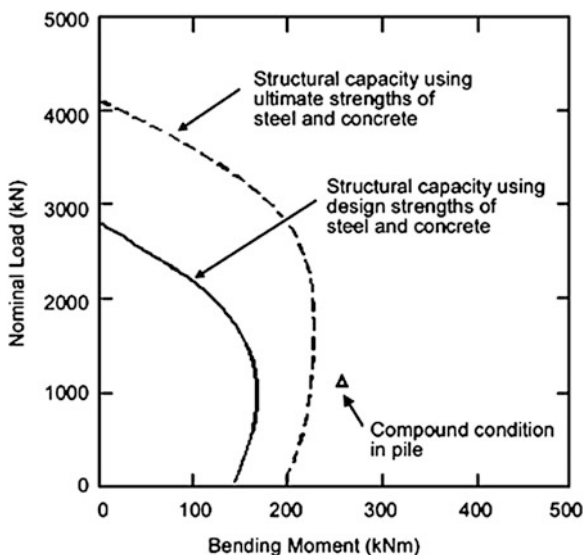
Figure 1.5 compares the maximum applied bending moment and axial load with the structural capacity of the pile section. It is clear that the ultimate pile capacity was exceeded by a substantial margin. The analysis indicates that the yield moment of the pile section of 160 kNm would be reached at a lateral soil movement of only about 10 mm. Since movements in excess of 100 mm were measured at a nearby pile group of the shopping centre, it was likely that the soil movements occurring at D13 would have been enough to cause the pile to yield at the pile head. The additional restraining force and bending moment developed in the piles could not have reasonably been anticipated by the foundation designers, and were not allowed for in the structural design of the piles.

Fig. 1.5 Structural capacity of office building piles

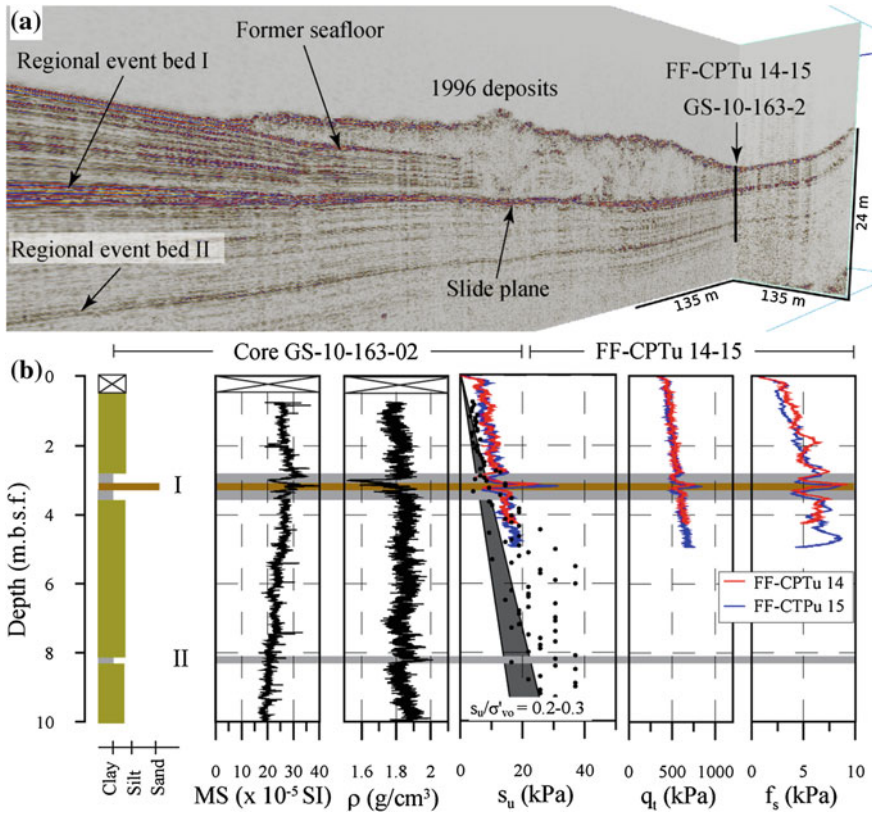
Figure 2.5 shows the results of seismic and geotechnical investigations. The upper part of the figure shows seismic evidence for the slip plane (weaker layer) as a composite seismic reflection event that is partly eroded underneath landslide debris. The lower part of Fig. 2.5 shows the results from piston core, laboratory analyses and free-fall CPTu tests (L’Heureux et al. 2012a).

The soil recovered in piston cores pushed adjacent to the slide deposit contained essentially homogeneous silty clays with shell fragments. The lithology changed suddenly at 2.9 m depth where a 45 cm thick bed, consisting of a 5 cm thick sand layer sandwiched between two distinct grey clay layers, 20 cm thick, was observed, with lows in both magnetic susceptibility and gamma density, and a very sharp peak in magnetic susceptibility and gamma density for the sandy layer. These features were confirmed by the free-fall CPTu tests. The water content for the laminated silty clay averaged 35 %.

In contrast, the water content was higher in the inferred failure zone, typically 45–65 %. Undrained shear strength ( $s_u$ ) were typically lower (4–8 kPa), whereas the ratio of undrained shear strength to effective vertical stress ( $s_u/\sigma'_{v0}$ ) fell between 0.2 and 0.3, which is a reasonable value for a normally consolidated clay. In contrast, the ratios  $s_u/\sigma'_{v0}$  for the background silt exceeded 0.3.

**Fig. 2.5** Magnetic susceptibility (MS), gamma density ( $\rho$ ), undrained shear strength ( $s_u$ ), corrected cone resistance ( $q_t$ ) and sleeve friction ( $f_s$ ) in Finneidfjord (L’Heureux et al. 2012a)

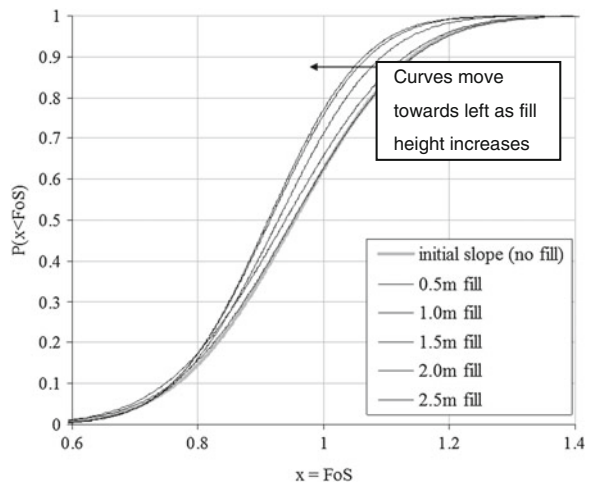
inconsistency. Introducing the weaker layer seen on the geophysical traces would bring the deterministic safety factor even lower. Cassidy et al. (2008) explored probabilistically the implications of the placement of the fill shown in Fig. 2.2. As shown in Fig. 2.7 and the top (black) curve in Fig. 2.8, increased layers of fill reduced the safety factor and the stability of the slope, with the mean calculable factor of safety against failure reducing from 0.95 to 0.91 and the probability of failure increasing to 80 %, as the fill increases to a height of 2.5 m.

**Fig. 2.7** Probability of exceeding factor of safety (FoS) of unity in probabilistic analysis for increased fill heights (Cassidy et al. 2008)

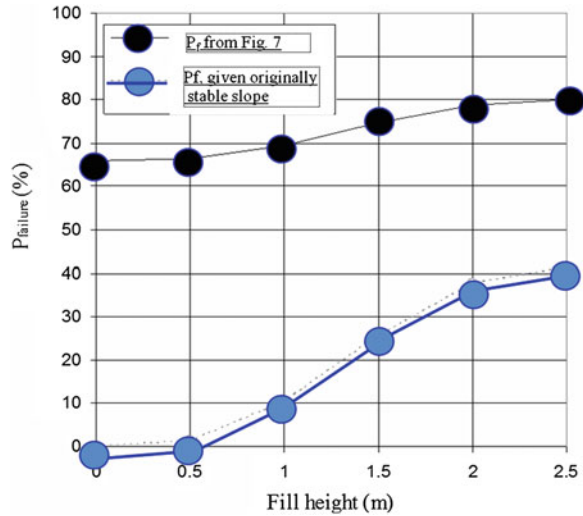
**Fig. 2.8** Predicted probability of slope failure as a function of fill height (Lacasse et al. 2013)

where FoS is the factor of safety. These results of the probabilistic analyses are shown in Fig. 2.8. The analysis suggests that by including the known fact that the slope was originally stable, the probability of failure increases from close to 0 to just over 40 % with a 2.5 m high fill (blue curve in Fig. 2.8). The increase is not linear, with initially very little effect from adding more fill, but then also tapering off between the 2 and 2.5 m scenario results. The safety was therefore marginal ( $P_f \approx 40\%$ ) with the addition of a 2 m fill. Cassidy et al. (2008) also assessed the vulnerability and consequences of the Finneidfjord slide.

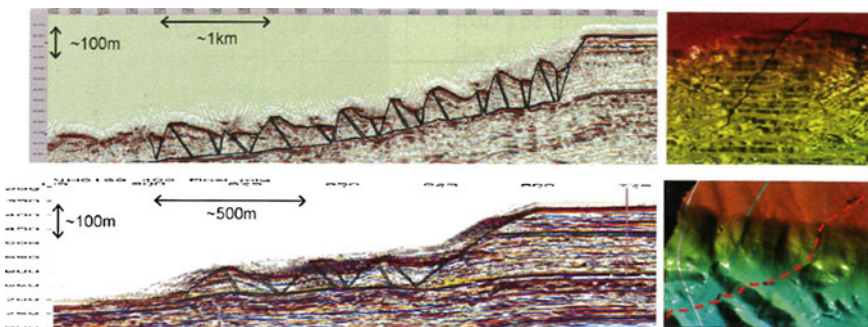
**Fig. 2.10** Bathymetry and seismic profiles in the upper headwall at Ormen Lange and interpreted morphology of slide (Kvalstad et al. 2005a)

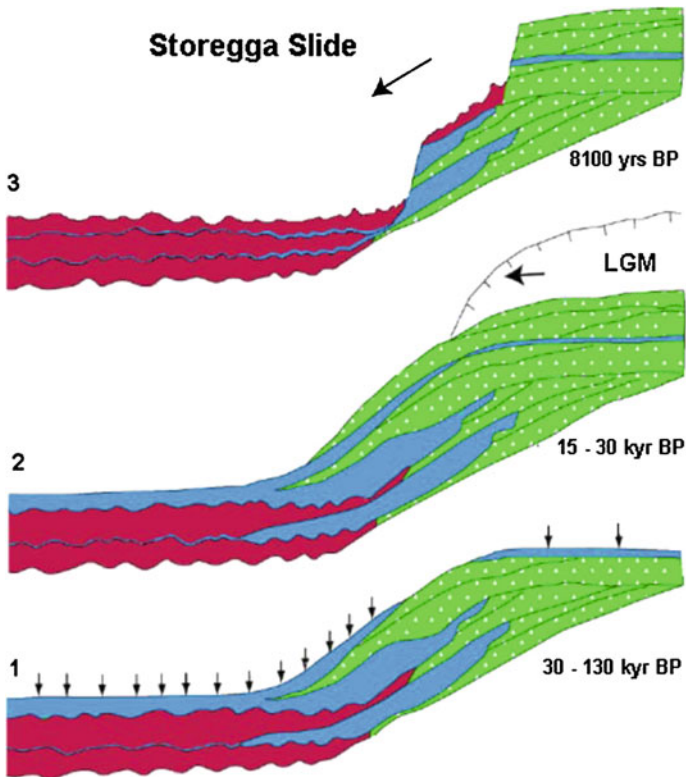
Figure 2.12 presents a schematic illustration to explain the sedimentation process leading to failure, which supports the hypothesis that major slides have occurred in the Storegga area on a semi-regular basis, related to the glacial/interglacial cyclicality.

The bottom illustration in Fig. 2.12 (denoted 1) gives the last interglacial with deposition of soft marine clays. The middle illustration (denoted 2) presents the last glacial maximum (LGM) with the ice at the shelf edge and deposition of glacial sediments. The top illustration (denoted 3) presents the topography after the Storegga slide. Dating (BP, before present) is given for each illustration. The illustration denoted 3 also shows two older slide scars that were filled with marine clays. The slip planes were found in seismically stratified units of hemipelagic

**Fig. 2.12** Schematic of the deposition and sliding processes (green glacial sediments; red slide deposits; blue marine sediments) (Bryn et al. 2005)

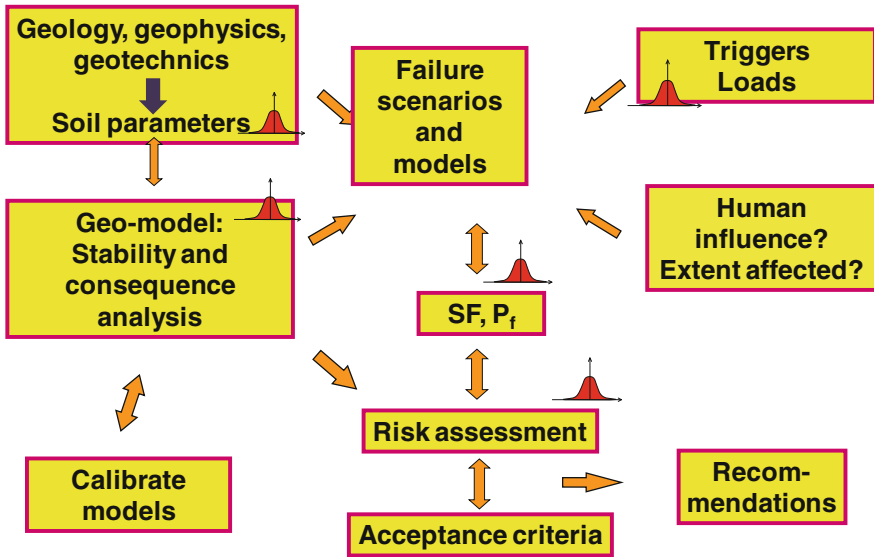
Fig. 2.13 Geohazards assessment methodology ( $SF$  factor of safety,  $P_f$  probability of failure)

In general, the geohazards assessment should include the components in Fig. 2.13, incorporating in each assessment the uncertainties in the parameters (represented in Fig. 2.13 by probability distribution functions in red).

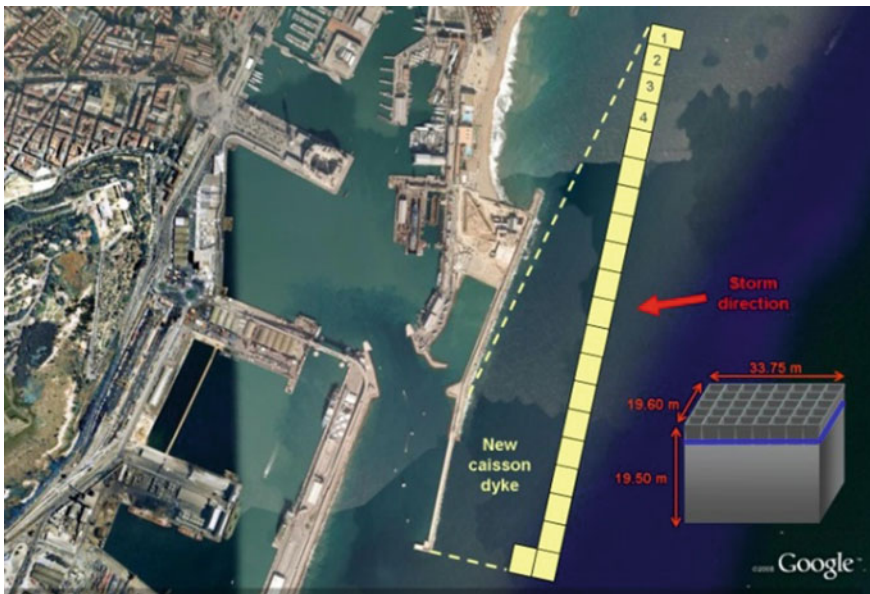
Fig. 4.1 The new caisson breakwater (background photograph Google Earth)

Dredging of the trench prepared to receive the coarse granular fill was finished on November 2000. Trench filling took the following 6 months. On May 10, 2001 the granular base was leveled and ready for the sinking of four caissons, in the position shown in Fig. 4.1 (caissons 1, 2, 3, and 4). Caisson sinking began, however, in the middle of October 2001. Cells were filled with sand some days later.

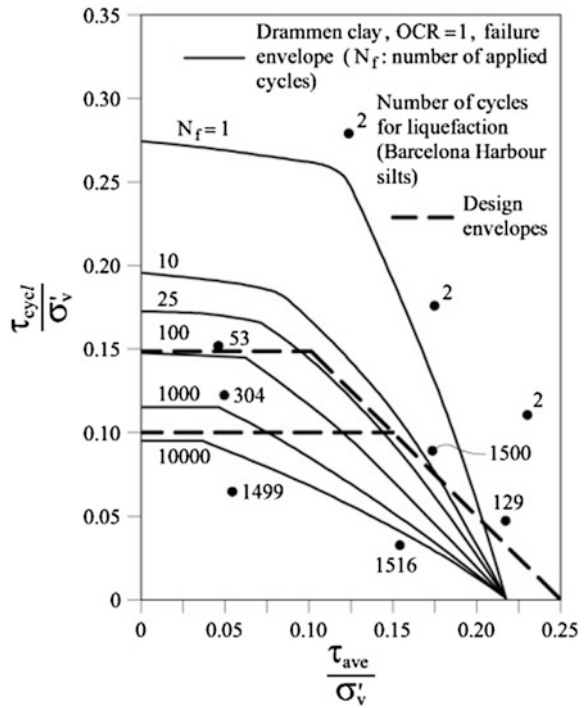
Fig. 4.10 Results of cyclic undrained simple shear tests. Also indicated in the figure is data from Drammen clay (NGI 2002)

The periodic shear stress signal is described by an average value,  $\tau_{ave}$ , a purely cyclic component,  $\tau_{cycl}$ , and a time period  $T$ . The results of tests performed are represented in a two-dimensional plot relating  $\tau_{cycl}/\sigma'_v$  and  $\tau_{ave}/\sigma'_v$  (Fig. 4.10). Each of the points in this plot indicates a combination of the pair  $(\tau_{cycl}/\sigma'_v, \tau_{ave}/\sigma'_v)$ , which leads to failure of the specimen. The number associated with each point is the number of cycles applied. Increasing  $\tau_{cycl}/\sigma'_v$  and/or  $\tau_{ave}/\sigma'_v$  leads to a progressively smaller number of applied cycles necessary to induce failure. Failure was accepted when the shear strain reached 10 %. Also indicated in the plot are the results for Norwegian Drammen clay for normally consolidated conditions.

The information given in the plot was used to isolate a safe region for a given number of stress cycles applied. Safe regions are limited by the line

*a* being defined in Eq. (4.1). Two safe regions are shown in the plot for a low and a high number of cycles (approximately 40 and 5000, respectively). In the first case, the limiting cyclic stress ratio is 0.15, provided the average stress ratio does not exceed 0.1. In the second case, the limiting cyclic stress ratio is 0.1 for average stress ratios not exceeding 0.15. Beyond this average stress ratio, the cyclic component should be reduced. This plot will be used to estimate liquefaction conditions under wave action in the manner indicated later.

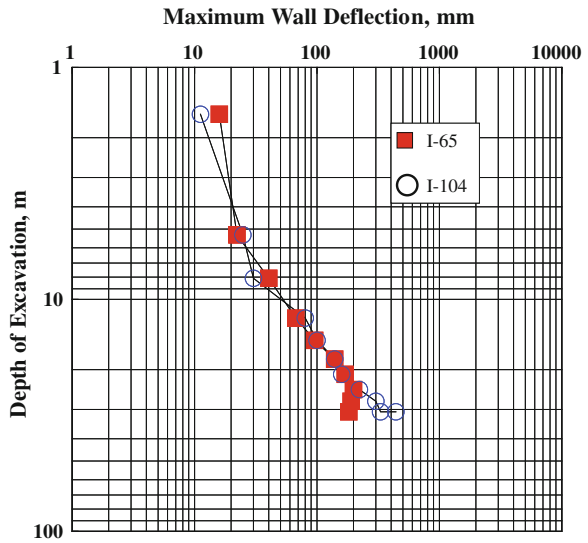
**Fig. 9.5** Deflection paths for diaphragm walls

30.5 m 4 days earlier. There were two inclinometers, i.e., I-65 and I-104, available for monitoring wall deflections. Figure 9.4 shows the wall deflection paths, which are the plots of maximum wall deflections versus depth of excavation in a log-log scale, for these two inclinometers (Hwang et al. 2007). Wall deflections on the two sides of the excavation were about the same till 9 March, 2004, when excavation reached a depth of 25 m, and deflections of 198 and 215 mm were recorded by Inclinometers I-65 and I-104, respectively. Subsequently, there was a period in which I-104 was not read because it was damaged. When monitoring resumed on 26 March, the deflection of the southern wall was found to have increased by 67 to 282 mm while the readings for Inclinometer I65 on the north were fairly steady in this period. The readings for Inclinometer I-104 kept on increasing while those for I-65 remained to be steady subsequently, presumably, because of the asymmetry of ground conditions. In fact, I-65 appeared to move outward by 27 mm and the maximum deflection reduced from 202 mm on 26 March to 175 mm on 20 April, as depicted in Figs. 9.2 and 9.4. On the other hand, Inclinometer I-104 moved inward by 90 to 441 mm in the 3-day period from 17 April to 20 April as shown in Fig. 9.5.

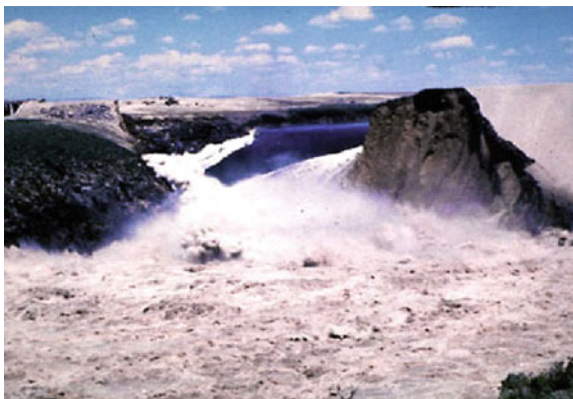
**Photo 10.1** Teton Dam, Idaho, June 5, 1976 from [http://en.wikipedia.org/wiki/Teton\\_Dam](http://en.wikipedia.org/wiki/Teton_Dam)

Hydraulic fracture in the core was considered as most likely the key mechanism estimated by desk work with laboratory aids.

The Panel had quickly identified piping as the most probable cause of the failure, and then focused its efforts on determining how the piping started. Two mechanisms were possible. The first was the flow of water under highly erodible and unprotected fill, through joints in unsealed rock beneath the grout cap, and development of an erosion tunnel. The second was “cracking caused by differential strains or hydraulic fracturing of the core material.” The Panel was unable to determine whether one or the other mechanism occurred, or a combination.

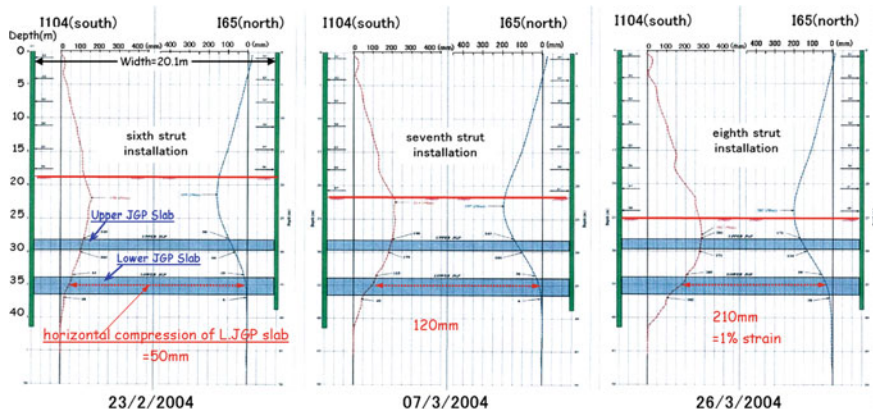
Fig. 10.2 Deflection of retaining wall of the failed section

Though under emergency, the measurement was not made daily. However, the obtained data gives clear tendency of the deformation as shown in Fig. 10.2. Two things should be noted.

One is the deflection of retaining wall. The other is the horizontal compression of JGP slab. It should be noticed not only the increment of the maximum deflection itself but also the difference between south and north walls. As shown in Figs. 10.2 and 10.3, the maximum deflections at sixth and seventh excavation level show the same order of 160 and 200 mm for north and south sides.

few percents. Since the horizontal length of the JGP slab is about 20 m, 20 cm of the compression at 8th strut stage (Fig. 10.2) corresponds to 1 % of compression strain, which was the design allowable strain. The instrumentation and monitored data really had provided not only before the failure but also after the failure to give constrains of the possible mechanism discussed in forensic engineering process.

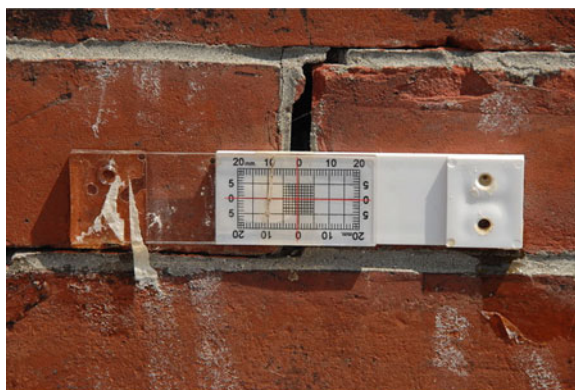
**Photo 10.2** Mechanical type of gap sensor ([http://en.wikipedia.org/wiki/Strain\\_gauge](http://en.wikipedia.org/wiki/Strain_gauge))

Photo 10.2 shows a simple and yet accurate monitoring device to measure gap movement for foundation of Hudson–Athens Lighthouse (U.S. National Register of Historic Places) in the Hudson River in the state of New York in the United States.

The two halves of the device are rigidly attached to the foundation wall on opposite sides of the crack. The red reference lines are on the transparent half and the grid is on the opaque white half. Both vertical and horizontal movements can be monitored over time. In this picture, the crack can be seen to have widened by approximately 0.3 mm (and no vertical movement) since the gage was installed.

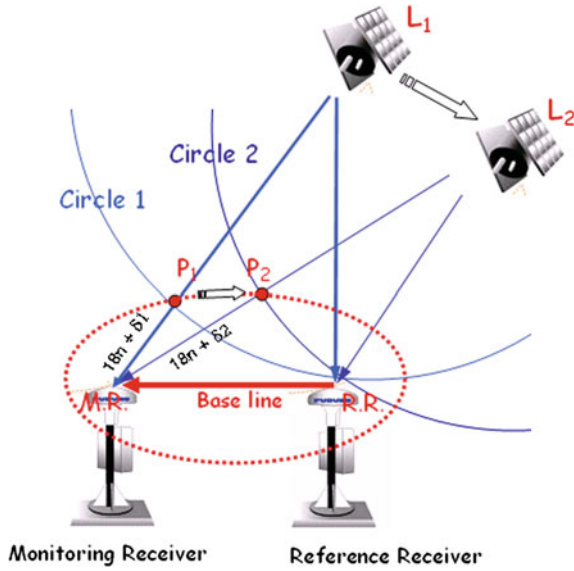
Fig. 10.6 Determining wave number of integer bias for carrier phase tracking of GPS method

The most time consuming process is to estimate the wave number  $n$ . Satellite is moving over the receivers from  $L1$  to  $L2$  along the known orbit. Using four GPS satellite signals, the phase difference as  $\delta$  is obtained for every satellite. As shown in Fig. 10.6, point  $P$  is the crossing point between ray path from satellite to the monitoring receiver and the equidistance circle (Circle 1 in Fig. 10.6). As the satellite moves from  $L1$  to  $L2$ , the crossing point  $P1$  moves to  $P2$ . Since the radius of the circle is very long compared with baseline, the arc from  $P1$  and  $P2$  to the reference receiver (RR) is considered as a straight line. The locus of the points  $P1$  and  $P2$  forms an elliptical orbit (Fig. 10.7).

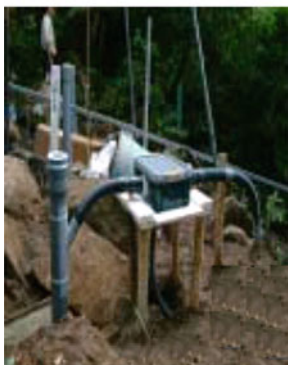
**Fig. 10.13** Monitoring slope instability by vertical pipe with optic cable

Nakano et al. (2003) reported a case history of the application of the BOTDR to identify sliding surface by inserting a pipe equipped with optical fiber in a slope as shown in Fig. 10.13.

An optical fiber was fixed along a plastic pipe. The fiber cable was given some pretension strain. The pipe strain gage of optical fiber gives continuous change of the strain compared to conventional pipe strain measurement that gives only

discrete points. As shown in Fig. 10.13, the strain shows continuous change from compression to extension that corresponds to bending deformation at the depth of 10–11 m. This depth was considered as a sliding surface.

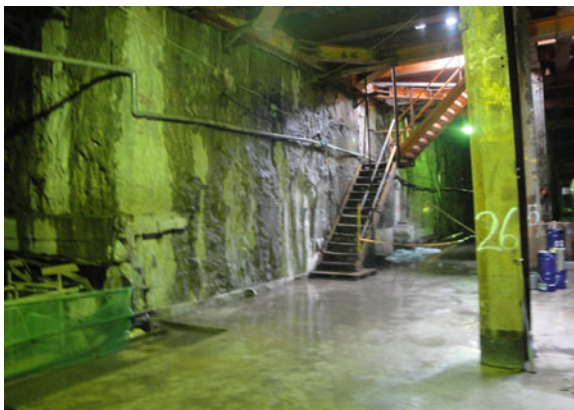
Wall deflections were measured at an excavation located in eastern Taipei. The maximum excavation depth of the site is 22.85 m and it was retained by a 43 m deep and 1.2 m thick diaphragm wall. Eight-level internal bracing were adopted to provide additional horizontal supports. It is also noted that depth of bedrock on site was various, from 28 to 40 m below surface level. It was found that a large wall displacement (up to 115–135 mm) was measured and Fig. 14.3 presents a comparatively poor quality of wall constructed on the site. It was constructed using hydraulic grab-type machine and it was reported by the contractor that appearance of rock affects the quality of the wall. Observations here did reflect the quality of wall and this might not be pointed out during the design stage.

**Fig. 14.3** Quality of diaphragm wall

Further, as shown in Fig. 14.3, the quality of wall could not be predicted before commence of the design but could possibly be detected after wall installation. The design of the excavation should thus be revised after wall installation because of the quality of wall. Moreover, conducting independent check could increase the reliability of the design and it cost less for design change before commence of construction of an underground project. It is thus recommended that independent checks shall be delivered and revision of design should be concerned from time to time in order to reduce the risk. The employer might not be capable to carry out tasks stated above and it is suggested that special consultants with expertise can be recruited for it.

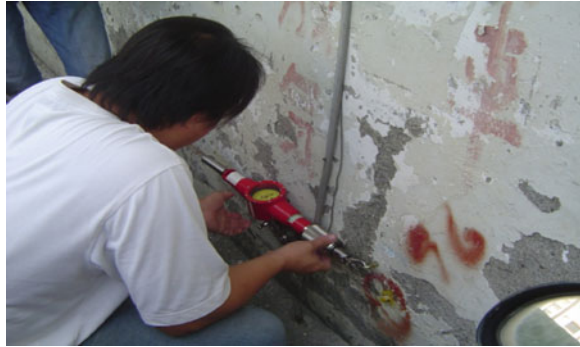
**Fig. 14.7** Measurement using tape extensometer

At last, the other example also in Kaohsiung Metro was raise here to demonstrate the effectiveness of instrument. A 37-year-old building stood 1–4 m from a 20.1 m deep excavation and the excavation was retained by 0.8 m thick and 42.0 m deep diaphragm walls. The horizontal props using H-type steel were adopted to stiffen the excavation. Except monitoring of ground performances caused by the deep excavation, structure performance was measured and taken as base of damage assessment. Boscardin and Cording (1989) recommended that the damage to the structure is closely connected with horizontal strain and angular distortion and the device-like horizontal tape extensometer, as shown in Fig. 14.7 was used to measure the distance between two nails on façade of the building and expansion or shortening in comparison with previous measurement for the distance between two nails could thus be determined. Horizontal tensile or compressive strain could be interpreted also.

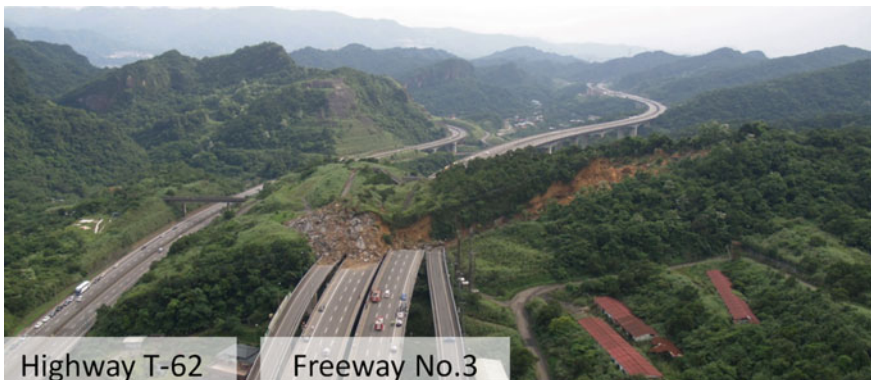
Fig. 15.1 Freeway No. 3 Landslide (after Liao and Lee 2011)

On 14:33 on April 25, 2010, a severe dip slope slide occurred at 3k + 100 of National Freeway No. 3 (Fig. 15.1). The slide has a length of approximately 185 m from the top to roadside, and a width of about 155 m at the bottom along the freeway. Total area of the slide exceeds  $14,000 \text{ m}^2$ . Thickness of the sliding mass was in a range of 15–20 m. Debris generated was in an amount of near  $200,000 \text{ m}^3$ . Such massive debris ran across Freeway No. 3 within seconds and crushed four vehicles. Also shown in the figures, dip angle of the failure plane was in a range of  $12^\circ$ – $15^\circ$  which was in line with the dip angle of sandstone and shale–sandstone alternation layers. There were no rainfall or earthquake events recorded prior to the failure for weeks. During the slide, major amount of ground anchors were ripped off by massive forces generated by debris. However, serious corrosion was observed on damaged ground anchor components indicating that deterioration of anchors was quite aggressive inside the studied slope.

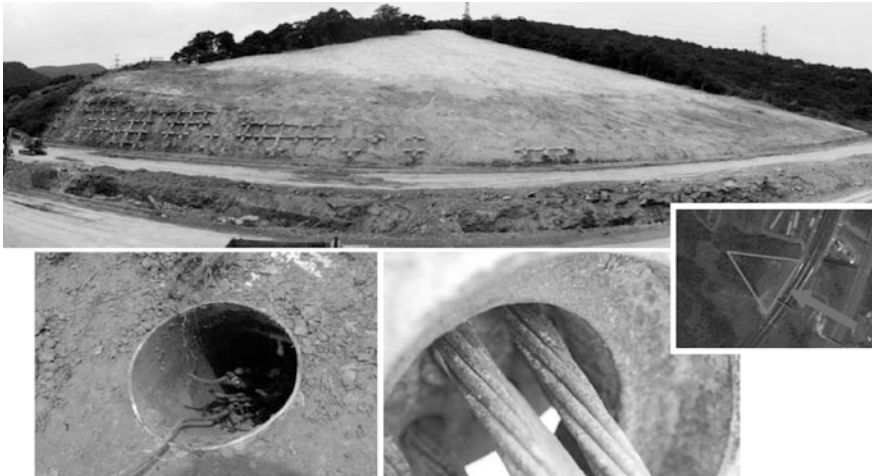
**Fig. 15.5** Failure plane of the studied slope (Lee et al. 2013)

During the process of slope sliding, a large amount of ground anchors were ripped off by the massive forces generated from the sliding mass. Serious corrosion observed in the ground anchor components indicated the abundance of groundwater in the slope (Fig. 15.5). There were no anchor found detached from the fixed end.

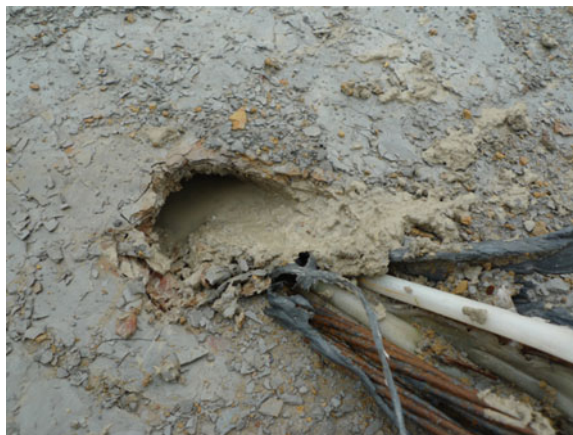
**Fig. 15.7** Unsealed free anchor end found from anchor remained on sliding surface

Investigation of ground anchor construction records indicates that, during anchor construction, the standard operation procedure to let the entire anchor hole filled with cement grout first and then inserted the tendon assembly to the hole. However, it was found from the anchor holes left on the sliding surface (Fig. 15.7), the annular space between anchor hole and plastic sheath in the free length was not fully sealed with cement grout. Nor was the space inside the plastic sheath. Obviously, some cement grout leaked out through the cracks and joints inside the slope or simply a malpractice during anchor construction. Since all the anchors were inclined downward, the annular space easily became the storage space for the perched groundwater inside the slope. Figure 15.8 illustrates that a schematic drawing of voids under anchor head could be resulted by poor anchor construction

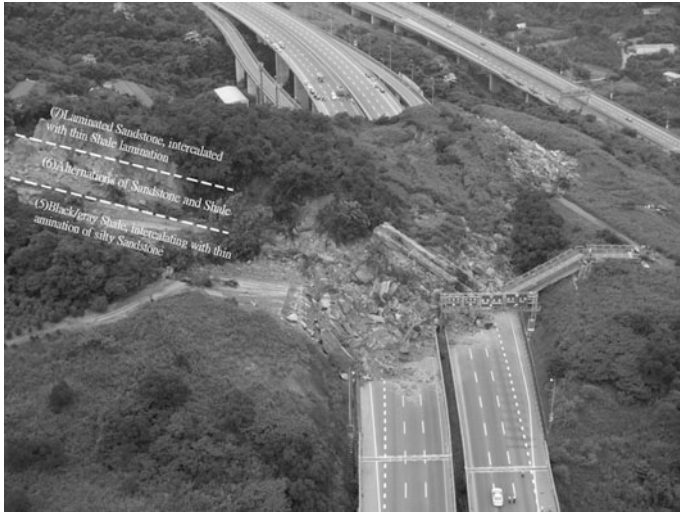
**Fig. 15.10** Aerial photo of dip slope failure (Lee et al. 2013)

The 3D analysis models were developed based on field survey data,  $5 \times 5$  m digital elevation model (DEM) data, and aerial images. The 3D geomorphology model was first built using DEM and field survey data as the base model to define modeling boundary conditions. Numerical model was then developed by transforming the base model into a FDM model with three-dimensional grid lines. In these numerical models, important geological conditions including groundwater infiltration, outcrop location, and potential sliding plan are taken into consideration while setting up model details. Photos preserved at construction and failure stages are valuable information for building the models. Figure 15.10 indicates that failure plane was truly developed along the sandstone–shale alternation layer. Such a potential sliding layer could also be observed during construction as shown in Fig. 15.11 (Lee et al. 2013).

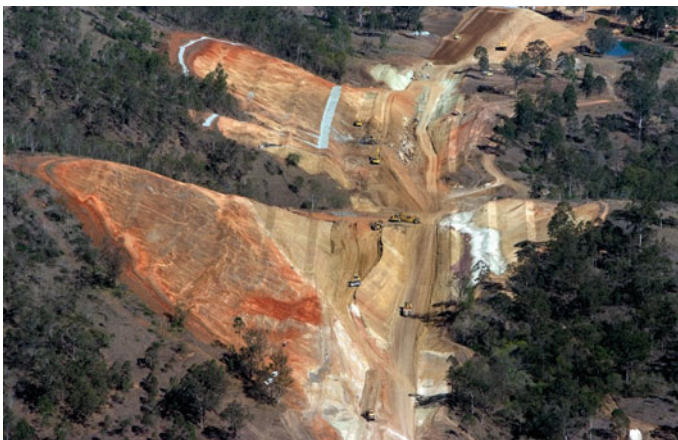
**Photo 16.1** Oblique aerial view of Cut 3 and 4. July 2007

Cuts 3 and 4 are located between Chainage 9450 and Chainage 10,250 of Package B-Springfield to Bundamba Creek Section of the SWTC. The original design of the earthworks at Cuts 3 and 4 comprised benched cuts of 63 and 46 m height, respectively, with batters of 1:1.5 to 1:2, to be determined on conditions actually encountered (see Photo 16.1: Oblique aerial view of Cut 3 and Cut 4 during construction, July 2007).

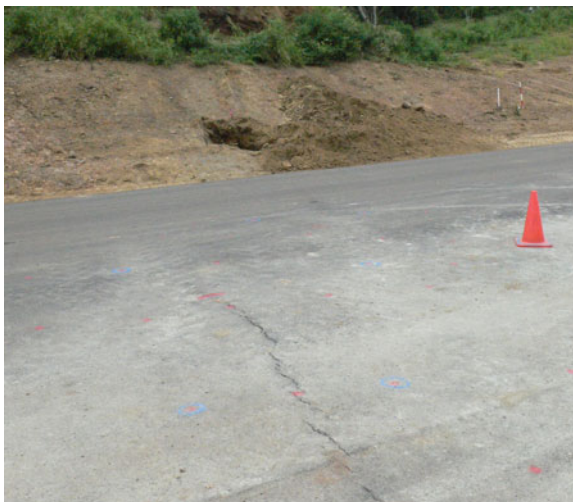
**Photo 16.2** Shear movement in road pavement, Cut 3. February 2008

In association with the slumping, some relative displacement was also evident along a geological contact which tracked south-west up the slope (Refer Photo 16.3). Within a few days, shear cracking became evident in the asphalt of the road pavement at the base of the cut (see Photo 16.2), as well as an extension of the shear

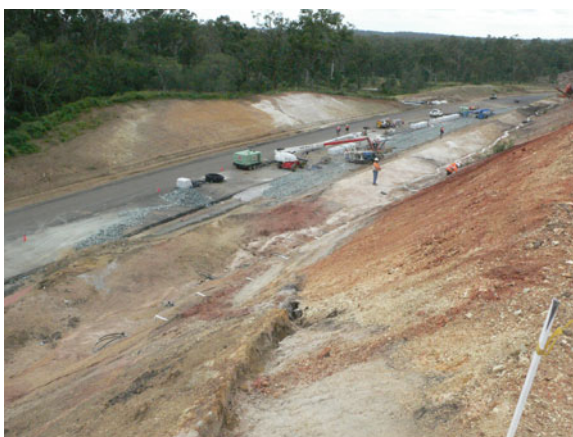
**Photo 16.3** Movement along contact zone, Bench 2 to Bench 3, Cut 3 south. February 2008

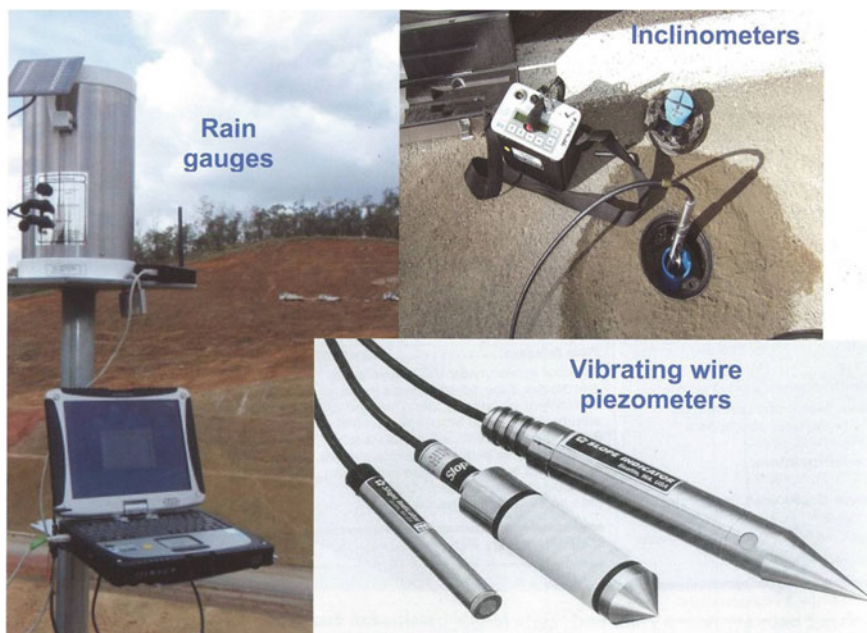
**Fig. 16.2** Geotechnical instrumentation

- Inclometers. A total of 46 inclinometers have been installed and monitored by the DTMR. A number of installations have been duplicated where excessive movements have rendered the original installations unusable (see Fig. 16.1—location of instrumentation, and Fig. 16.2).

- Groundwater monitoring from Vibrating Wire Piezometers. Piezometers installed in boreholes by the DMR have been read using data loggers (see Fig. 16.2).
- Geophysical surveys. As part of the additional geotechnical investigations, the stratigraphy and structures in the vicinity of Cuts 3 and 4 have been investigated by a Ground Magnetics Survey conducted by Terra Search Pty Ltd. The results have been incorporated within the Geological Plan of the landslide area (Fig. 16.3).
- Laboratory testing. A series of ring shear tests were undertaken on remoulded material recovered from the shear surface sampled from core drilling.

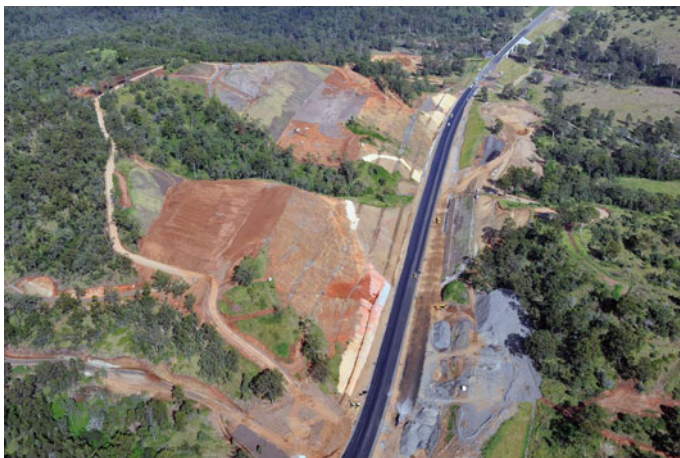
**Photo 16.4** Cut 3 south and Cut 4 south, after crest removal March to June 2009

In addition, permanent borehole pumping facilities have been installed from batters at selected locations in Cut 3 south and Cut 4 south. An oblique air photo showing remedial works commenced in March 2009 is presented as Photo 16.4.

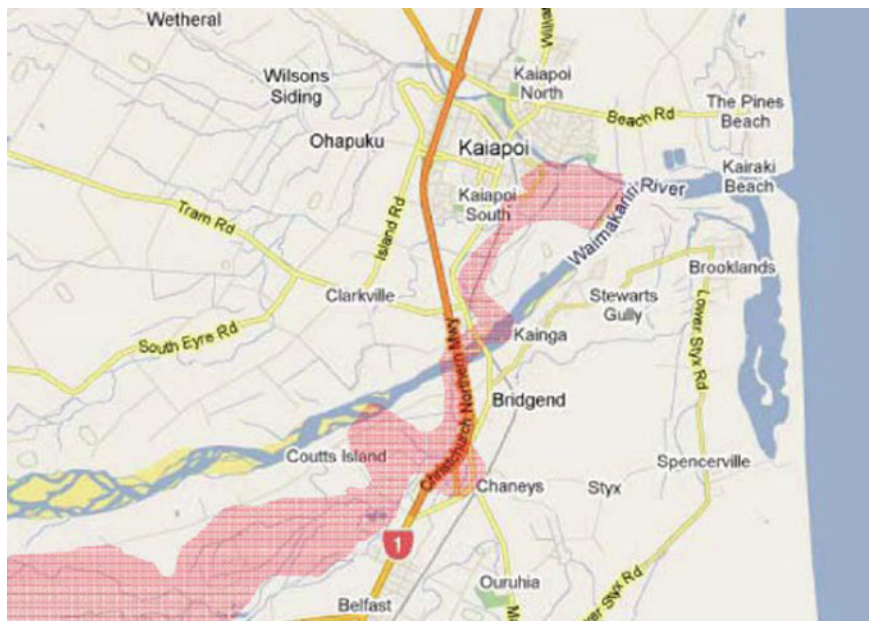
**Fig. 17.1** River channel position in 1865 (in red) is presented in present day Google map (Cubrinovski et al. 2010)

The city of Christchurch and the nearby town of Kaiapoi (17 km from CBD) are situated near to the east coast of Canterbury plains, which is the largest flat land in New Zealand, formed by glacial fed rivers (Cubrinovski et al. 2010). Christchurch and Kaiapoi are 450 and 5 km<sup>2</sup> (approx.) in size with a population of 350,000 and 5,000 (approx.), respectively. The city was mainly swamp land and regularly flooded by Waimakarri River prior to the establishment of the city in 1850. The Waimakirri River had two major branches: South and North. The position of branches were significantly changed over time and contributed to upper geological formation. The position of the south branch of Waimakirri River as in 1965 is superimposed in present day Google map by Cubrinovski et al. (2010) as shown in Fig. 17.1. The build-up area on old river channel in Kaiapoi has suffered significant

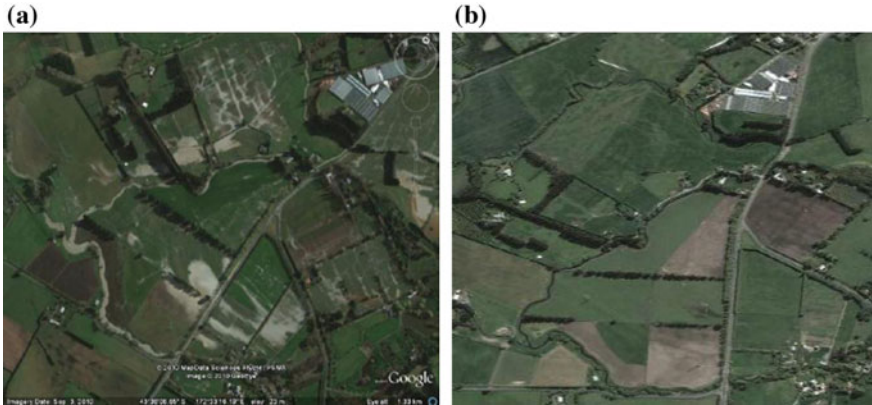
**Fig. 17.6** Large liquefied site at Hoon Hay, Christchurch, New Zealand; **a** viewed as in Google Earth on 28 of September, 2010 by first author (Google 2010), **b** as viewed on Google map on 15 of December, 2012

The severity of liquefaction was also captured by Google Eye (2010). The images of liquefied sites of Christchurch and Kaiapoi were available in Google Earth week after the earthquake. It gave an opportunity to see ariel view of large liquefied site as shown in Figs. 17.6 and 17.7. The Google Earth, along with ariel photography, was later used in identifying large liquefied site. The light colour of ejected sand

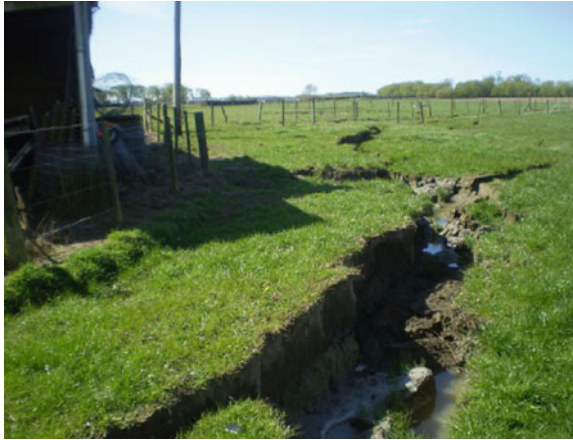
**Fig. 17.9** Lateral spreading at South Kaiapoi, Christchurch, New Zealand

An example of lateral spreading is shown in Fig. 17.9. The site was close to the shed as shown in Fig. 17.10b. Electronic distance metre was used for recording the lateral spreading opening and settlement. GPS, as shown in Fig. 17.10a, was used during this study to keep trace of transects as shown in blue line in Fig. 17.10b. First an intersect was set in the field to interest most of the lateral spreading.

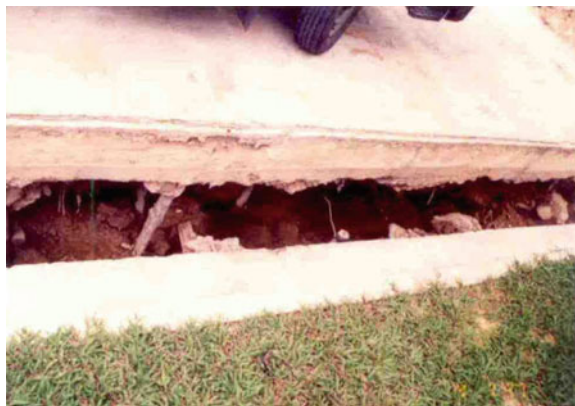
Fig. 18.1 Significant ground movement observed at an excavation site

During the cause of temporary excavation for the construction of basement in marine clay in a project in Singapore, significant soil movements (see Fig. 18.1) were observed at one side of the site when the excavation reached a depth of 2.7 m. A number of inclinometers installed at the site recorded over 200 mm lateral soil movement while settlement markers revealed soil settlement of over 100 mm at some places. Inspection of the excavation site revealed a diagonal corner strut had buckled, see Fig. 18.2. Remedial action taken at the site included additional lateral supports to stabilise the soil movements. Excavation subsequently continued till the intended basement level. Repair of adjacent properties in the vicinity needed to be carried out which involved substantial cost.

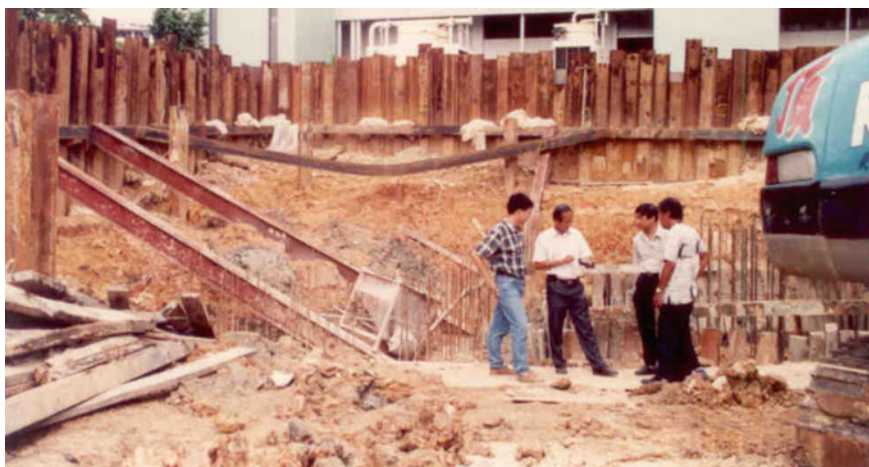
Fig. 18.2 Problem of diagonal corner steel strut

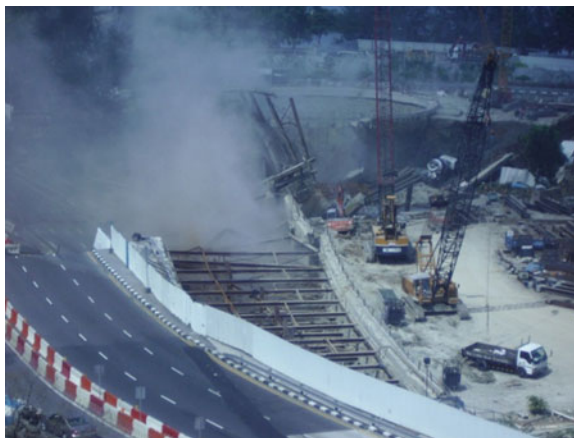
**Fig. 18.10** Eyewitness's photograph on Nicoll Highway Failure

To improve the transport system for its residents, Singapore has been building underground railways since the mid-80s. The construction of the subway station is often carried out by cut and cover method. Such excavation in thick soft marine clay often causes significant lateral soil movements. The original Nicoll Highway Station location has a marine clay stratum as thick as 50 m deep and land reclamation was carried out in 1950s. The station was constructed by excavating down to 36 m with retaining walls using diaphragm with 10 levels of lateral steel struts as well as the soft clay beneath the station base being improved by jet grouting prior to excavation. On 20 April 2004 and upon reaching an excavation depth of 33 m with 9 level struts and top jet grouting layer beneath excavation level removed, a massive retaining wall failure occurred, see Fig. 18.10.

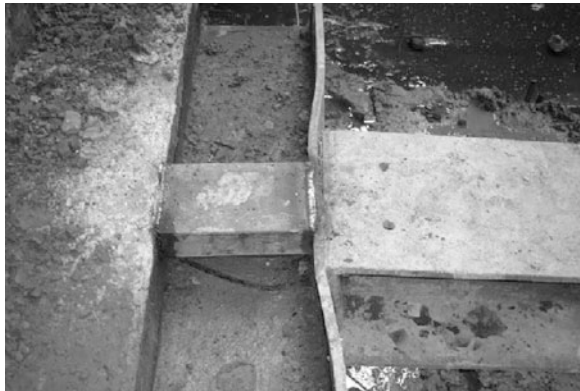
**Fig. 18.13** C-channel stiffener (COI 2005)

The failure of the waler-strut connection at the 9th level strut was examined in detail (Tan et al. 2005). It was established in February 2004 that the plate stiffener (Fig. 18.12) in the waler-strut connection was replaced by the C-channel stiffener (Fig. 18.13). After the failure, laboratory tests were conducted by structural expert to evaluate the performance of the two types of stiffeners. Figure 18.14 shows that

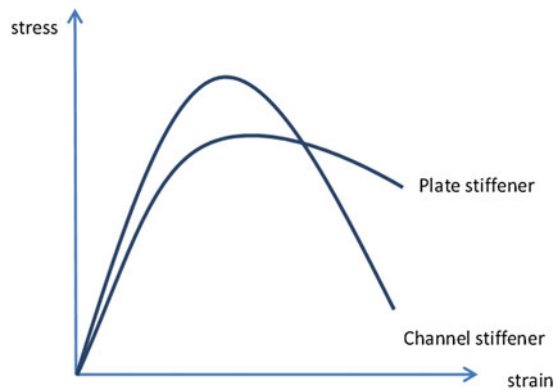
**Fig. 18.14** Performance of  
plate versus C-channel  
stiffener

the C-channel stiffener would undergo a major reduction in resistance under high deformation as it is generally brittle in nature while the load-displacement response of the plate stiffener is ductile in nature. The replacement of plate stiffener by the

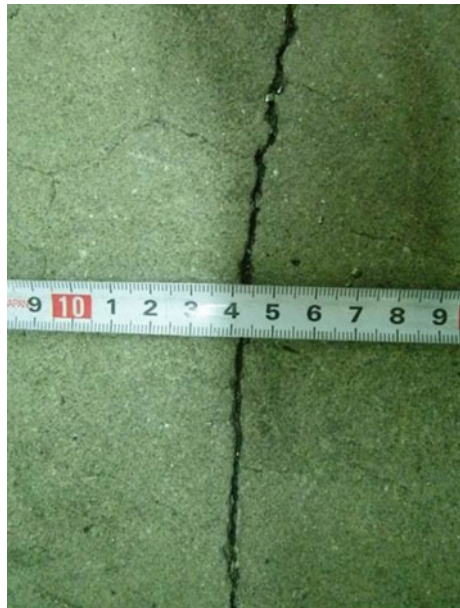
**Photo 20.1** Crack in the concrete floor

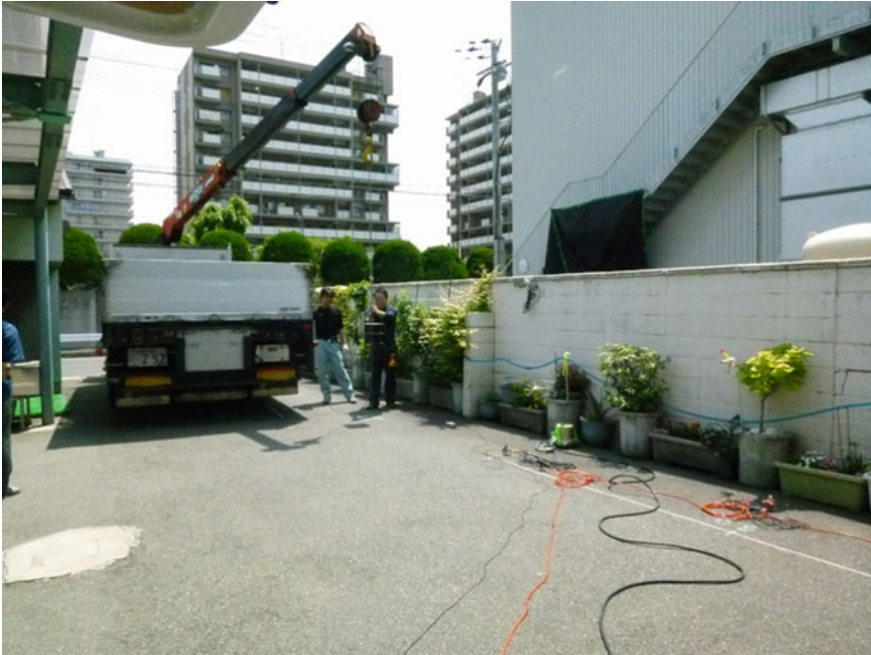
**Photo 20.2** Experiment of dropping weight

If the weight is dropped at the center of the array under homogeneous conditions of the ground, horizontal motion will be predominant in the radius component. The recorded wave contains some comparable levels of the tangential component. This may be due to the incomplete symmetry of the dropping mass as shown in Photo 20.2 and some inevitable small setting errors of seismometer as well as inhomogeneity of the present ground.

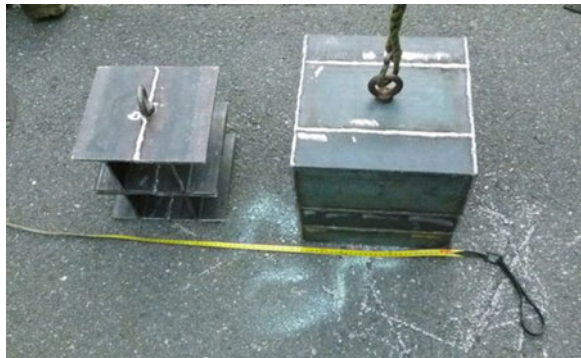
**Photo 20.3** Dropping weight

The apparent width of the pulse wave of the vertical component is found as 0.035–0.04 s at the distance of 2 and 12.5 m from the source (Photo 20.3).
