Developments in Geotechnical Engineering

V.V.S. Rao

G.L. Sivakumar Babu *Editors*

# Forensic Geotechnical Engineering

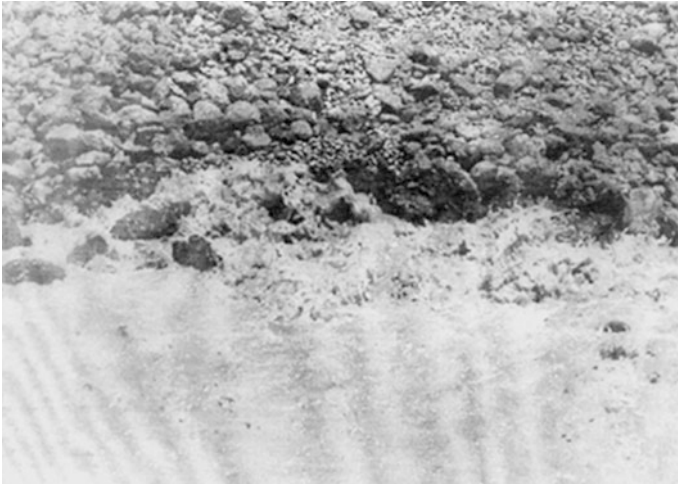
**Fig. 21.2** The exit point of the leak as it appeared in the afternoon of August 16, 1984. Water surfaces under a substantial head and carry large quantities of suspended solids. The picture gives an idea of the grading of the latrine chunks used in the toe drain

water loss as it could be seen on August 16: the water sprung under a substantial head. Manual soundings indicated that the water was passing between the artificial clay blanket and the transition material next to the toe drain. In the evening of August 16, the total water loss was gauged as 300 l/s.

On August 16, at 8 h, the drain pipes discharged 22 l/s while water daylighted at three different points along the toe drain between Ch. 1+890 and 1+910. The combined discharge from toe drain and drain pipes was gauged, at a Parshall flume downstream, as 57 l/s. Water was initially muddy and carried small clay lumps. Later the water became dark-gray and carried sand, too. Between 10 and 12 a.m. of August 16, the quantity of water rushing from the toe drain diminished appreciably to suddenly increase to a much larger flow, at 13 h about. Figure 21.2 shows the

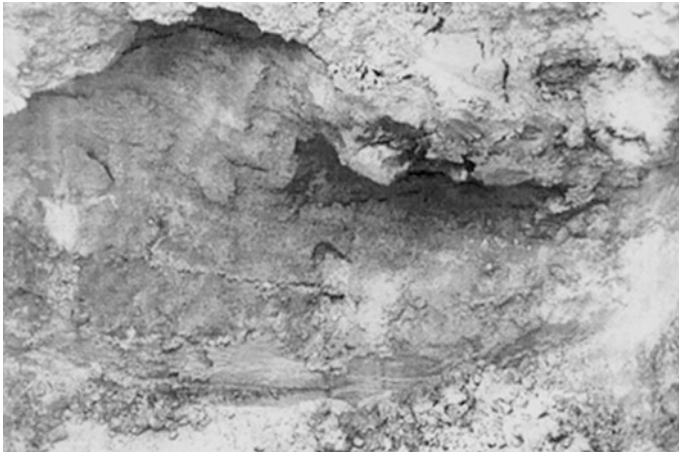
**Fig. 21.3** The cavity across section 50 m u/s from the dam axis. The wine red material is the sand +gravel used to plug the leak. The cavity *upper half* is within the artificial clay blanket. The *lower half* of the cavity has been cut through the natural foundation

Borings allowed to detect, along 5 of the 9 lines, an approximately elliptical cavity, 2–3 m wide and 0.5–1.5 m high. At both ends, the cavity ran within the clay of the artificial blanket. In the center portion near the dam axis, the cavity was lower, reaching into the sandy silt of the natural foundation. The cavity seemed to run almost straight along Ch. 1+900 with only one visible bend 10 m from its d/s end. Part of the cavity was standing and was filled with muddy water. Clay lumps were found over its bottom at two sections.

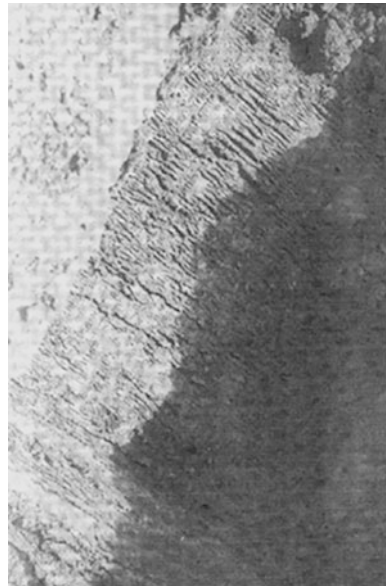
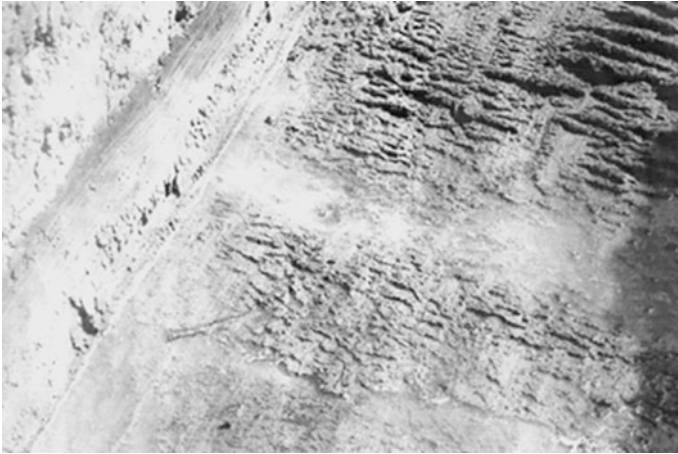
**Fig. 21.10** The exploratory pit where a model piping was observed. The gray material is the sandy silt present over most of the foundation under the dam. The picture was taken immediately after excavation completed. The pit was excavated with backhoe and was about 90 cm wide

About 2 min after excavation completed, water surfaced on the bottom of the pit. The flow soon concentrated at four small pipes with visible transport of very fine sand and suspended clay particles imparting to the water a milky appearance. The sequence of Figs. 21.10, 21.11 and 21.12 shows one pipe as it evolved in the lapse of 10 min. Visual observation suggested that the size of each pipe was not larger than 10 mm.

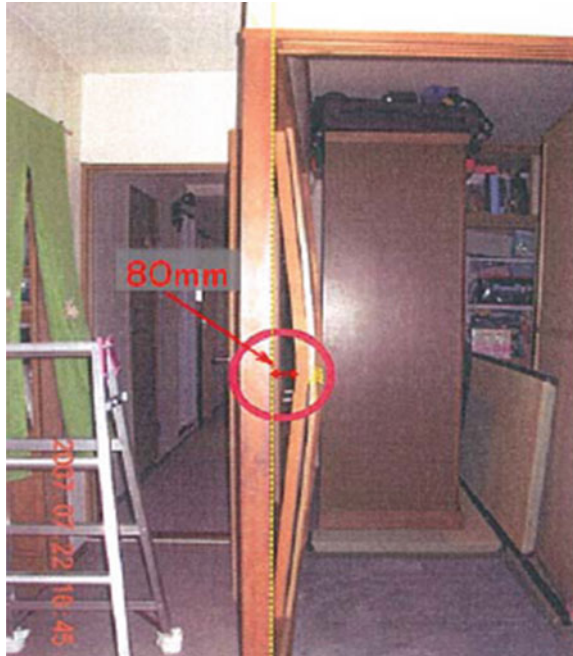
**Photo 26.1** Buckling of a vertical door frame

Photo 26.1 shows buckling of a vertical door frame, the base of which was displaced upward by the heave of the floor of the room.

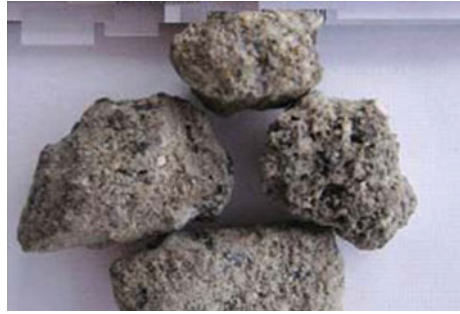
**Photo 26.2** Pieces of steel slag found in the filled soil

Most of the fills showed very high  $\text{pH} \geq 11$  and the natural soil showed  $\text{pH} = 6\text{--}7$ , which shows possible mixture of the steel slag with filled soil or lime.

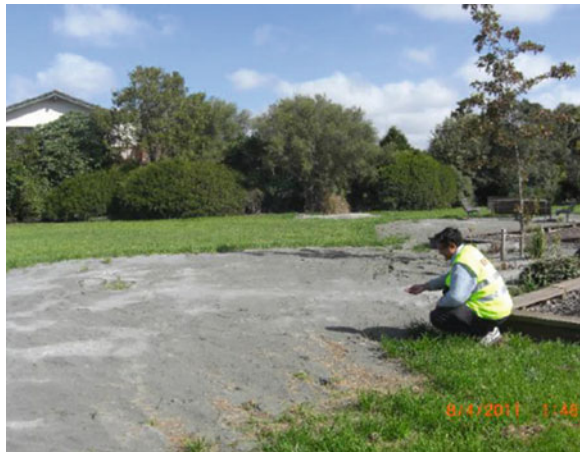
**Fig. 28.2** Sand boils due to soil liquefaction

On the ground extensive liquefaction-induced sand boils were evident in all the zones identified in Fig. 28.1. An example of a sand boil is presented in Fig. 28.2. When buildings are situated on liquefiable soils they have suffered settlement and/or rotation. An example of a single storey residential structure that suffered rotation is presented in Fig. 28.3. These structures were supported on a ring beam founded on short piles that penetrate about 1 m below the ground surface. Following liquefaction the piles were able to settle into the ground and any differential settlements between piles resulted in the rotation of the building. Such widespread liquefaction has also induced lateral spreading of even gently sloping ground. An example of lateral spreading of an embankment adjacent to the Avon River is presented in Fig. 28.4.

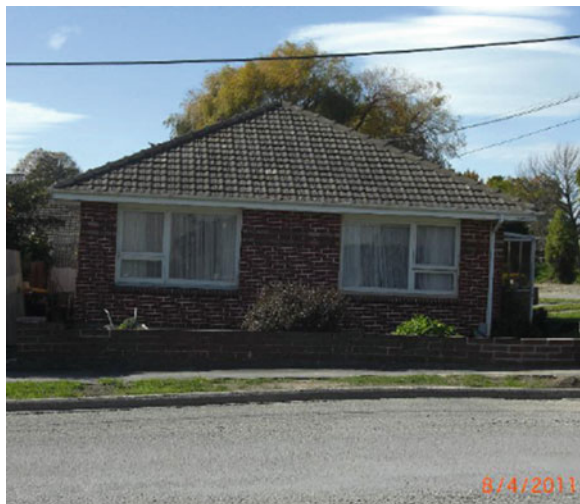
**Fig. 28.3** Settlement/rotation of a residential building

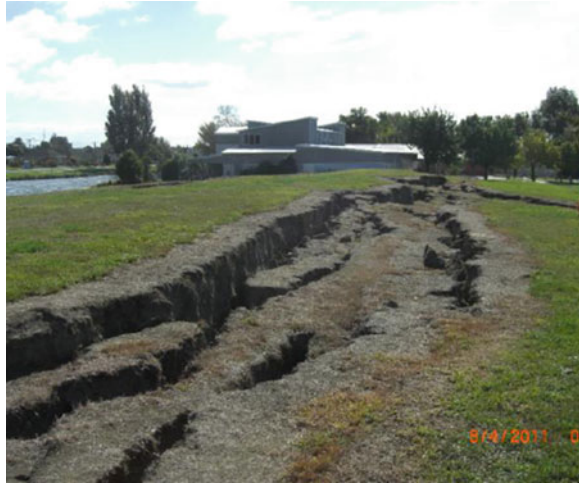
**Fig. 28.4** Lateral spreading following soil liquefaction

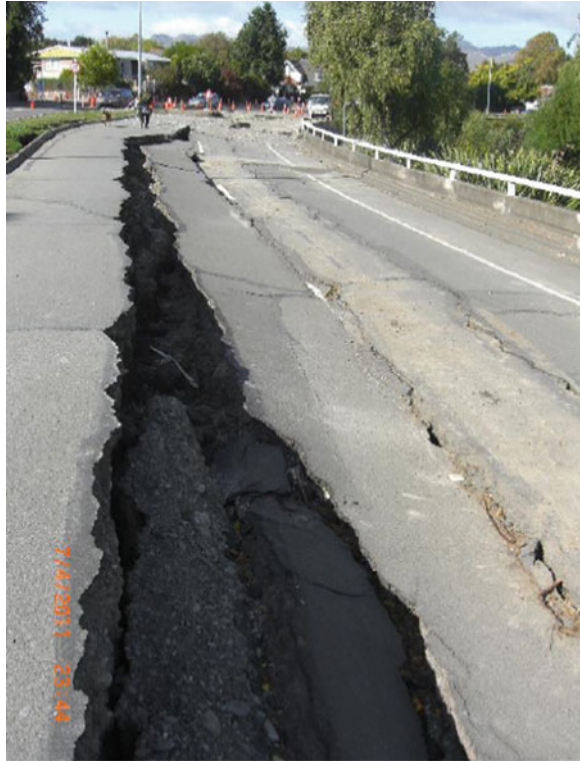
**Fig. 28.5** Failure of a retaining wall

When infrastructure such as retaining walls or bridge abutments are present in lateral spreading ground they attract additional loading that can cause their failure. This was also observed following the Christchurch earthquake as illustrated in Fig. 28.5 that shows a failed retaining wall due to underlying lateral spreading towards the river on the right-hand side. The most significant failures in this earthquake due to the liquefaction and lateral spreading were the piles supporting bridge abutments. There were many examples of these and only a few will be considered here. In Fig. 28.6 the ‘back rotation’ of an abutment wall of a bridge is presented. The lateral spreading of the backfill towards the river caused the bridge abutment to suffer back rotation by a few degrees. This mechanism of failure occurred due to the high axial stiffness of the bridge deck with very little scope for axial shortening due to the lateral spreading of the river banks. The RC square piles supporting the abutment have failed in shear as seen in Fig. 28.6.

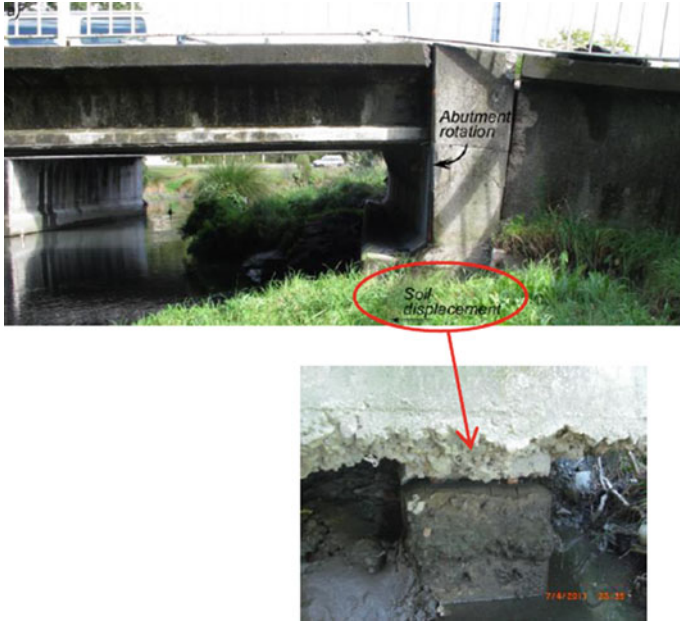
**Fig. 28.6** Lateral spreading induced abutment rotation and shear failure of a square RC pile supporting the abutment

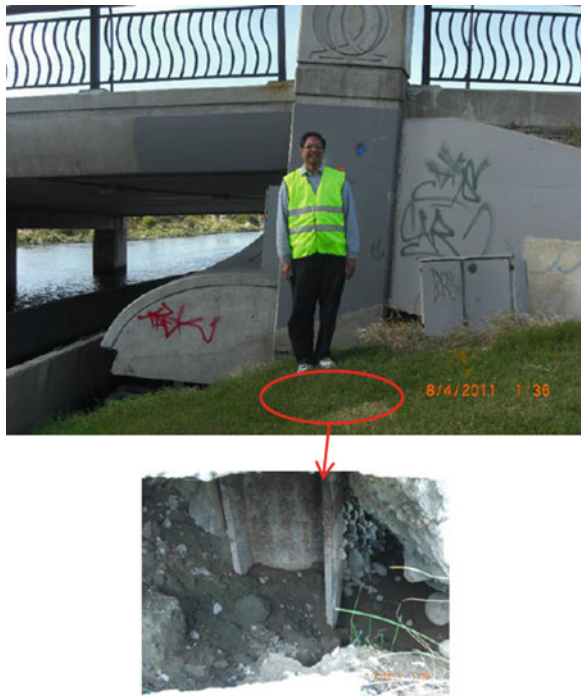
**Fig. 28.7** Back rotation of a bridge abutment supported on steel H piles that formed plastic hinges at pile heads

Similar observations were made in the case of a bridge abutment supported on steel piles. In Fig. 28.7 the back rotation of a bridge abutment supported on steel H piles is presented. Again lateral spreading of the backfill towards the river caused the abutment to suffer rotation inducing large shear and moment loads on the pile heads. The bridge deck has high axial stiffness and therefore did not allow any axial shortening of the bridge. Steel H piles supporting the abutment are quite strong in shear and therefore they failed by forming plastic hinges at the pile heads. However, the overall failure mechanism for this bridge abutment is similar to the previous case of abutment on RC square piles.

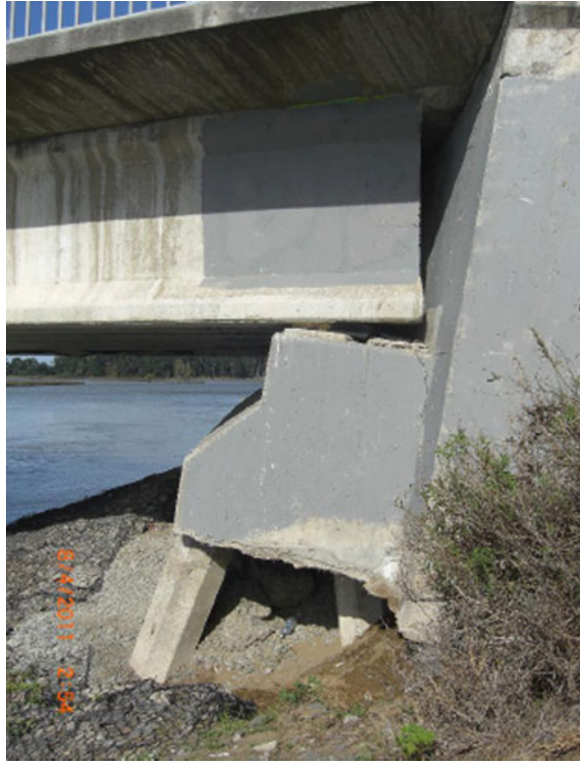
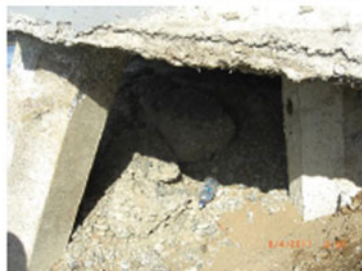
**Fig. 28.8** Back rotation of a bridge abutment supported on battered pile group

expansion joints were present. This meant that the lateral spreading of backfill caused the back rotation of the bridge abutment as seen in Fig. 28.8. The abutment was supported on battered piles which failed by forming plastic hinges at the pile heads. This was evident by the spawling of concrete seen at the back of the front leading pile. Also closer inspection revealed tension cracks at the front of the leading pile.

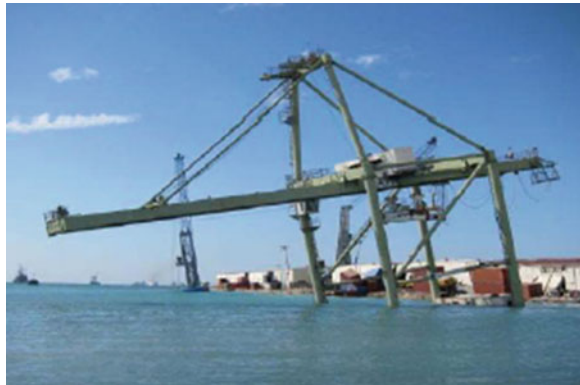
**Fig. 28.9** Settlement of container crane in Port-au-Prince

Soon after the earthquake, it became clear that extensive liquefaction has occurred in the vicinity of the main port in the capital city, Port-au-Prince. Excessive settlement of container crane structure as shown in Fig. 28.9 made the use of port to receive emergency relief from rest of the world impossible. This situation highlighted the importance of designing critical facilities such as ports and harbours to withstand earthquake loading.

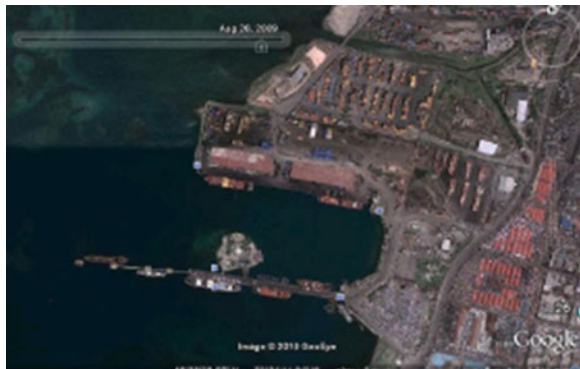
**Fig. 28.10** Pre earthquake satellite image of the port

Comparison of the pre- and post-earthquake images reveals the extent of damage to the port facilities as shown in Figs. 28.10 and 28.11. Comparing these two satellite images it can be seen that several sections of the south wharf have collapsed and the entire section of the north pier has collapsed.

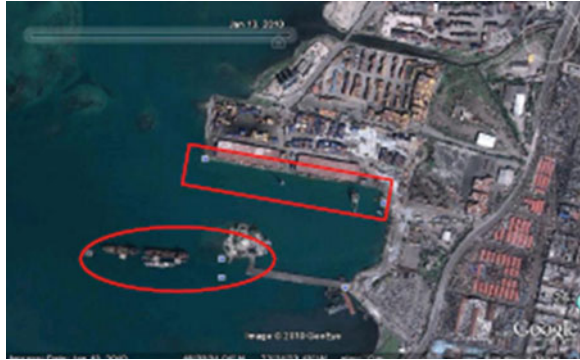
**Fig. 28.11** Post-earthquake satellite image of the port

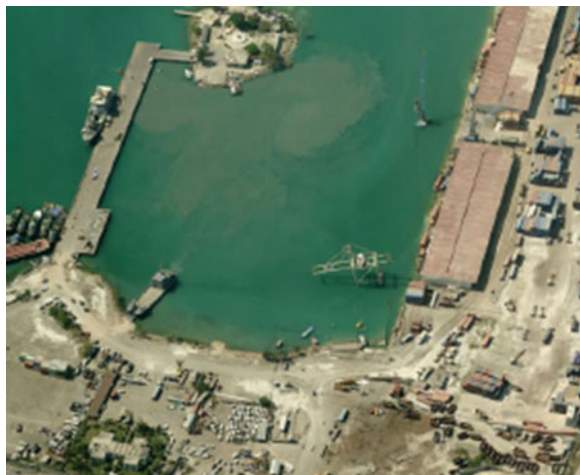
**Fig. 28.12** Pictometric image showing the damaged crane structure

and give a perspective of damage suffered by the structures. An example of these pictometric images is shown in Fig. 28.12 that clearly depicts the damage to container crane seen in Fig. 28.9.

In addition to the above aerial imagery, the EEFIT field mission was also able to obtain valuable data on performance of the port structures. The island seen near the top left-hand corner in Fig. 28.12 has suffered excessive settlement following liquefaction. As a result, connecting bridge and wharf structures supported on pile foundations showed severe damage. In Fig. 28.13 the damage suffered by the bridge is shown. As the pier structure and the approach abutment on the island side settled, the bridge decks cracked to allow for these settlements. This caused the ‘self-articulation’ of the bridge. Similarly, a wharf structure suffered excessive damage as the pile foundations supporting the wharf settled into liquefied and laterally spreading soil. This is shown in Fig. 28.14 which depicts the formation of plastic hinges at the pile heads.

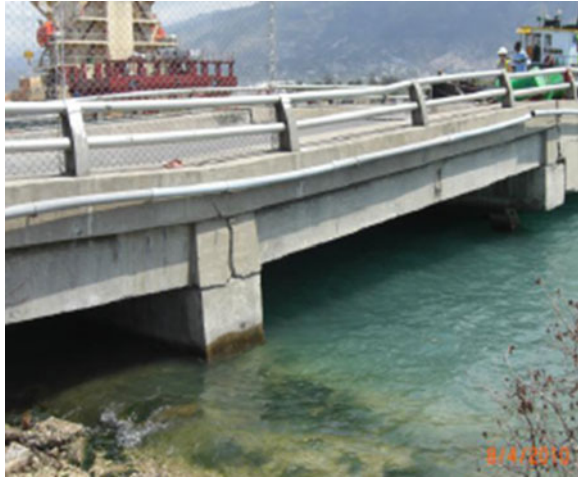
**Fig. 28.13** Settlement of piers cause self-articulation of the bridge deck

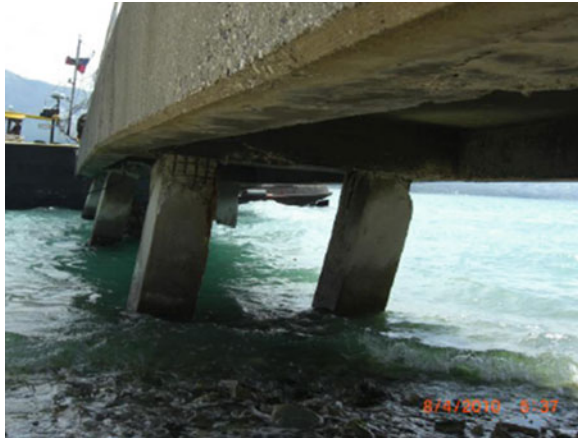
**Fig. 28.14** Hinging of piles supporting a wharf structure

Comparing Figs. 28.14 and 28.15 and previous cases of bridge abutments in Sect. 28.2, it can be concluded that the failure mechanism of piles in liquefiable soils derived from dynamic centrifuge tests was validated from the observations following the Christchurch and Haiti earthquakes.

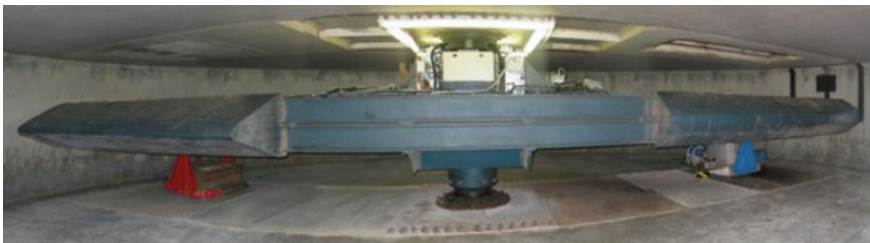
Fig. 28.17 The Cambridge 10 m diameter Turner beam centrifuge

Physical modelling in earthquake engineering with reduced scale experiments in the centrifuge is now widely considered as ‘the’ established experimental technique of obtaining data in controlled conditions to help engineers and researchers to understand the mechanisms involved in the response of soil-structure systems to seismic loading. This experimental approach recreates the stress state in soils which is a fundamental requirement to observe realistic soil behaviour. In Fig. 28.17 a view of the 10 m diameter Turner beam centrifuge at Cambridge is presented.

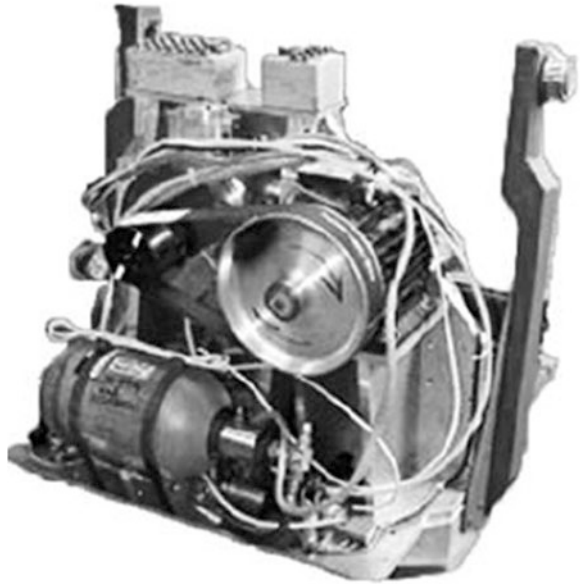
**Fig. 28.18** A view of the SAM earthquake actuator

The current earthquake actuator at Cambridge relies on stored angular momentum (SAM) to deliver powerful earthquakes at high gravities was developed and is in operation for 14 years, Madabhushi et al. (1988). In Fig. 28.18 the front view of the SAM actuator is shown, while in Fig. 28.19 a view of the SAM actuator loaded

The SAM earthquake actuator is a mechanical device which stores the large amount of energy required for the model earthquake event in a set of flywheels. At the desired moment this energy is transferred to the soil model via a reciprocating

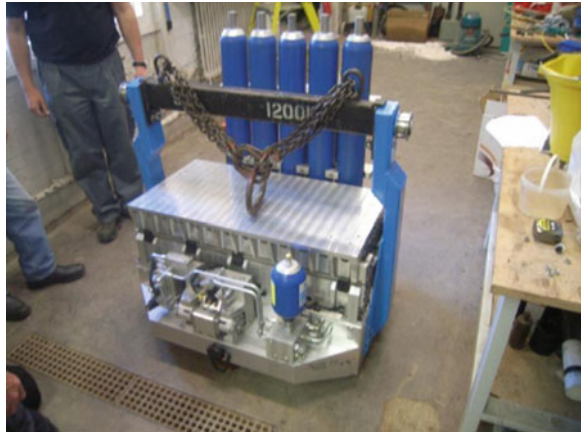
**Fig. 28.20** A view of the new servo-hydraulic earthquake actuator developed at Cambridge University

More recently, a new servo-hydraulic earthquake actuator was developed to enhance earthquake testing capabilities at Cambridge, Madabhushi et al. (2012). This device is able to complement the capabilities of SAM actuator with the ability to simulate desired realistic earthquake motions such as a Kobe earthquake motion or Northridge earthquake motion. This device was custom-built to adapt to the existing services and configuration of the 10 m Turner beam centrifuge shown in Fig. 28.20. Its maximum operational g-level is limited to 80 g. The specifications of this actuator are presented in Table 28.2.

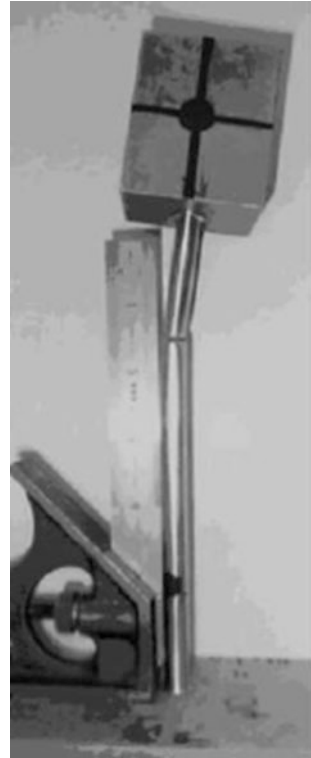
**Fig. 28.26** Buckled pile

Interesting as the above results and their implications are, a few queries arise. Firstly, compared to Fig. 28.23 in which the plastic hinging in the pile occurs close to the base of the pile, the location of the plastic hinge in the centrifuge test occurs quite a way up as seen in Fig. 28.26. As plastic hinges form when the maximum bending moments exceed the plastic moment capacity of the pile section, clearly the liquefied soil below this level must be offering some support to the pile. This may be due to the monotonic shearing of the liquefied soil demanded by the deforming pile causes dilation and therefore a temporary reduction of the excess pore pressure.

This can cause the liquefied soil to gain some strength temporarily and offer resistance to pile buckling. As a result the pile cannot buckle at the base but can only do so higher up, where the soil dilation is compromised due to inflow of water from surrounding soil.

The centrifuge model was tested with 50 g and subjected to a base acceleration of 0.2 g at the bedrock level. This caused the loose sand to liquefy fully which was confirmed by excess pore pressure measurements as shown in Fig. 28.24. The piles have suffered buckling failure as seen in Fig. 28.25. After the test the model piles were extracted from the soil model to examine the location of plastic hinge formation. As seen in Fig. 28.26, the plastic hinging occurred at approximately  $\frac{1}{4}$  of the length below the pile head.

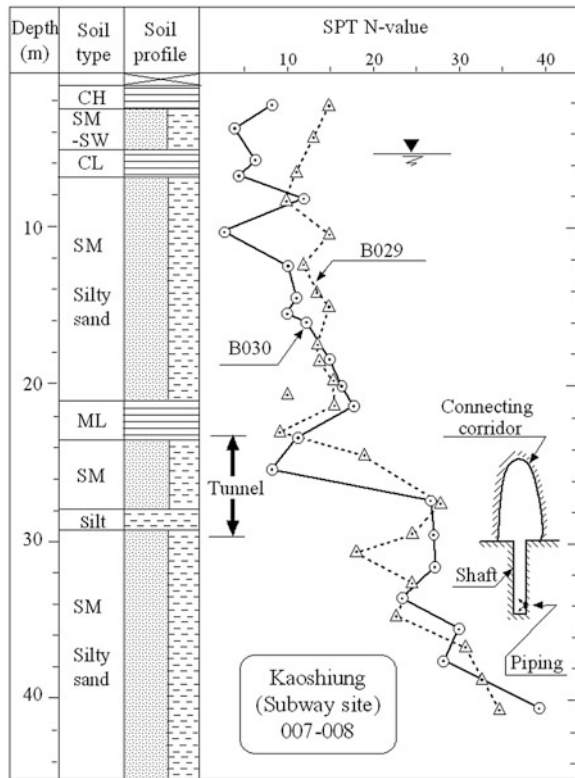
Fig. 29.5 Soil profile at the site of collapse

The soil profiles at the locations BO29 and BO30 shown in Fig. 29.2 are indicated in Fig. 29.5, where it can be seen that the deposits are comprised predominantly of silty sand with occasional layers of low-plasticity clay (CL) to a

depth of 40 m. The blow count, N-value, in the standard penetration test is shown to increase with depth and to have a value of 20–30 at the depth where the sump for water collection was excavated.

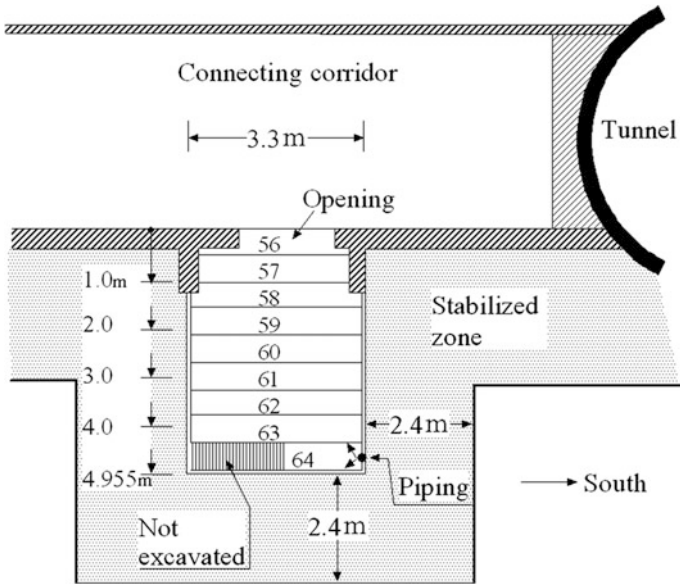
Fig. 29.8 Details of the excavation for the sump and initiation of piping

On December 4, 2005, the piping occurred at 3:30 p.m. at the very last stage of excavation of the sump. A block of silty sand was detached from the south wall at the bottom of the excavation which is located at a depth of 35 m from the ground

surface. The circumstance at this time at the bottom of the sump excavation is illustrated in details in Fig. 29.8.

It is believed that the mud water flowed into the sump from the bottom through a single hole probably with a diameter of about 30 cm. This assumption would hold true in the light of the fact that the zone stabilized by the jet grouting could not so easily broken down in the horizontal direction, and a weak zone might have existed in the form of vertical pipe.

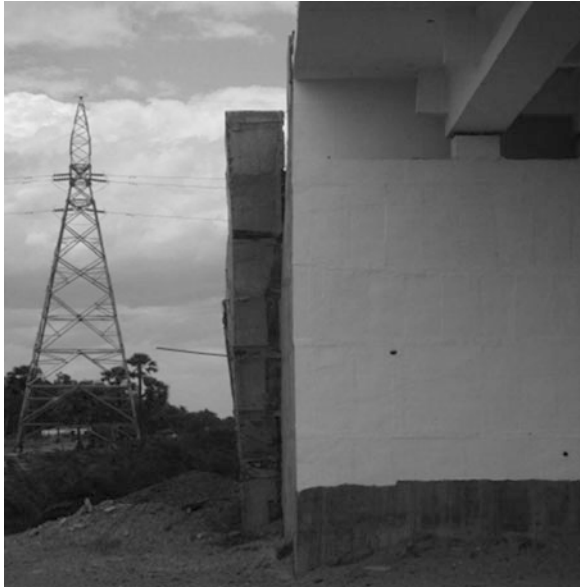
**Fig. 30.3** Maximum lateral displacement of wall

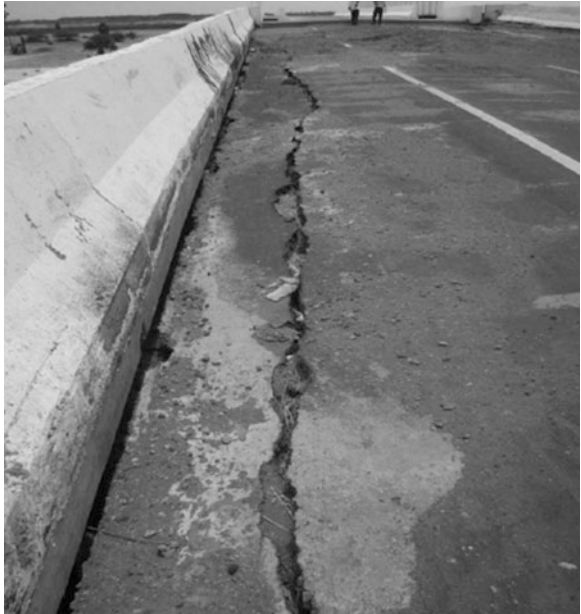
**Fig. 30.4** Distress on the flexible pavement surface

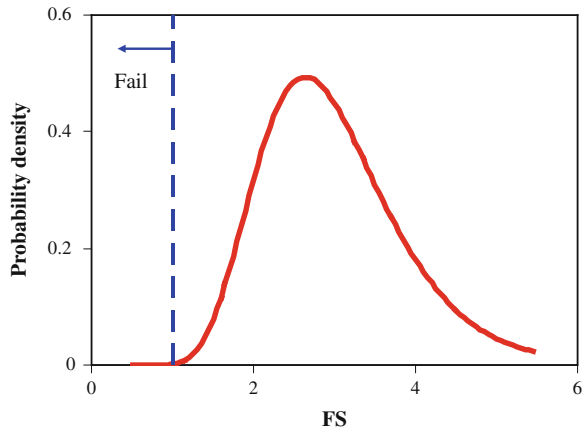
**Fig. 31.1** Lognormal distribution of FS

The observed performance,  $\overline{\text{FS}}$ , can be viewed as a sample mean (of sample size 1) from a *population* of factors of safety such as that shown in Fig. 31.1. It is obvious that a low value of  $\overline{\text{FS}}$  near to 1 is not impossible, although it is “unlikely” if the population follows a lognormal distribution with  $\mu = 3$  and  $\theta = 0.3$ . A naïve interpretation is that “failure” (as in  $\overline{\text{FS}} < 1$ ) is always possible and geotechnical variability is responsible, rather than human errors. Sowers (1993) noted that the majority of foundation failures were due to human shortcomings. This naïve interpretation essentially misses the key principle of hypothesis testing described below.

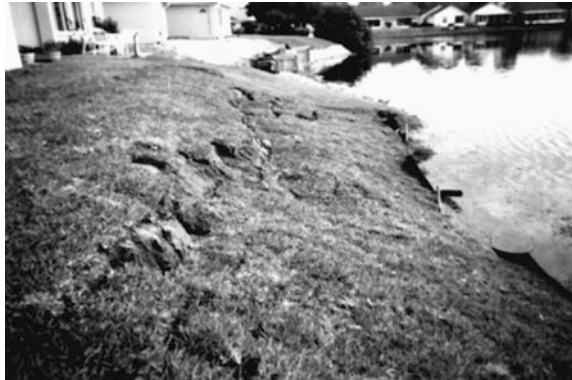
Fig. 33.6 Recurrence of sheared slope

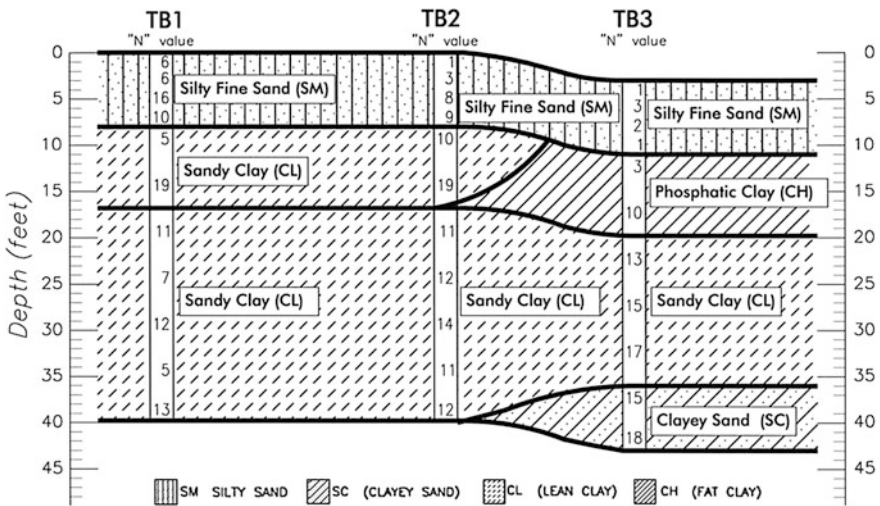
Fig. 33.7 Subsurface stratigraphy

Subsurface conditions beneath the site were evaluated by advancing several test borings. Typical subsurface conditions, as illustrated in Fig. 33.7, consisted of very soft, loose low strength subsoils to 15.0 ft depth. These low strength subsoils

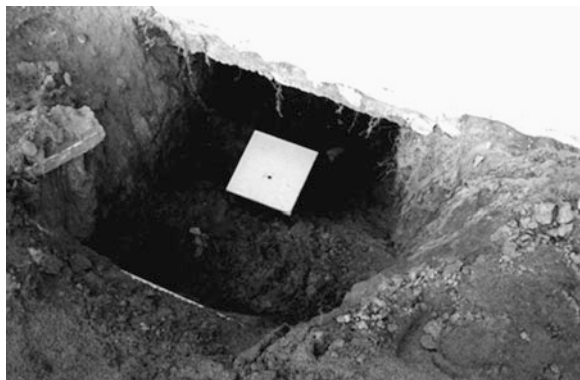
**Fig. 33.8** View of helical support anchor in place

Figures 33.8, 33.9, 33.10, 33.11, 33.12, 33.13, 33.14 and 33.15 illustrate various sequences of the underpinning and bulkhead stabilization program.

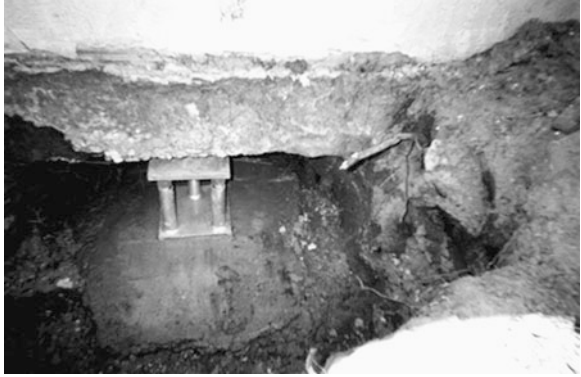
**Fig. 33.9** View of support cap and bracket assembly under the footing

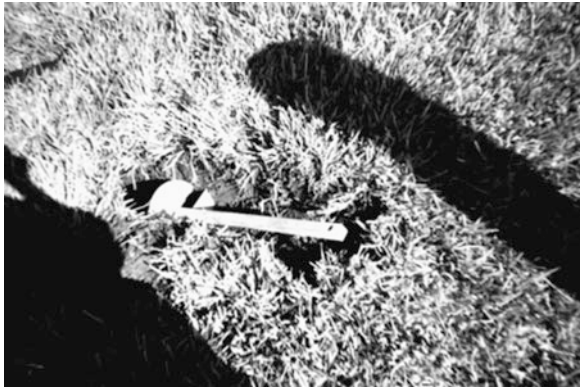
**Fig. 33.10** Setting up of the tie back helical anchor

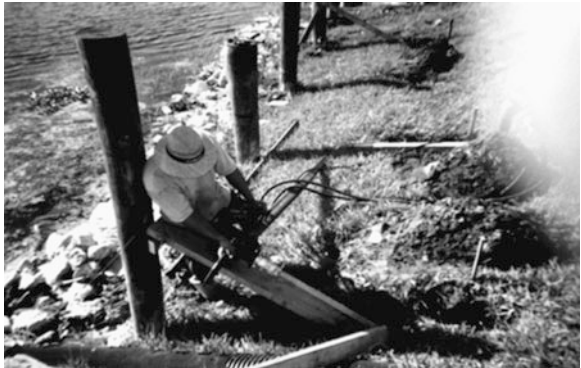
**Fig. 33.11** Hydraulic setup for achieving torque/resistance capacity

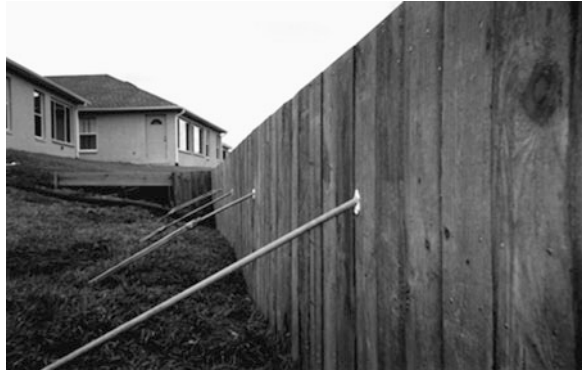
**Fig. 33.12** Close-up the helical anchor tie back with timber bulkhead

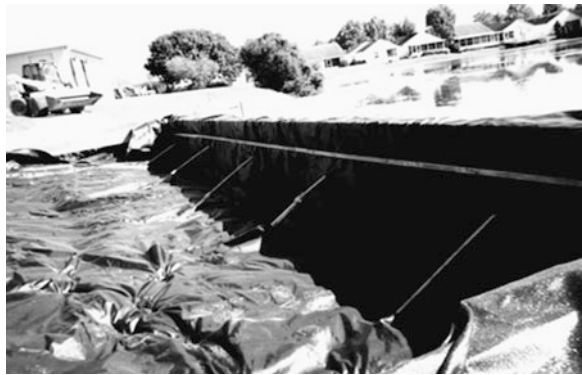
**Fig. 33.13** Close-up of geotextile lay down and wrap up on timber bulkhead

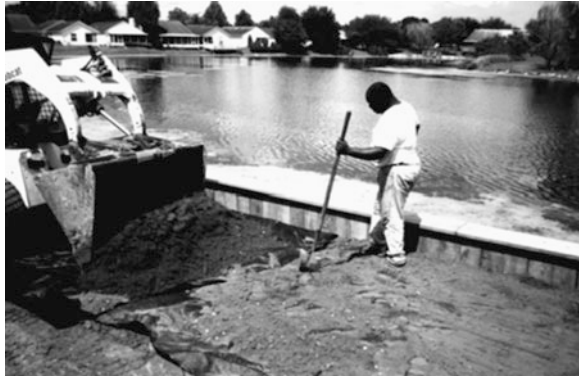
**Fig. 33.15** Additional fill being dozed into the anchored geotextile

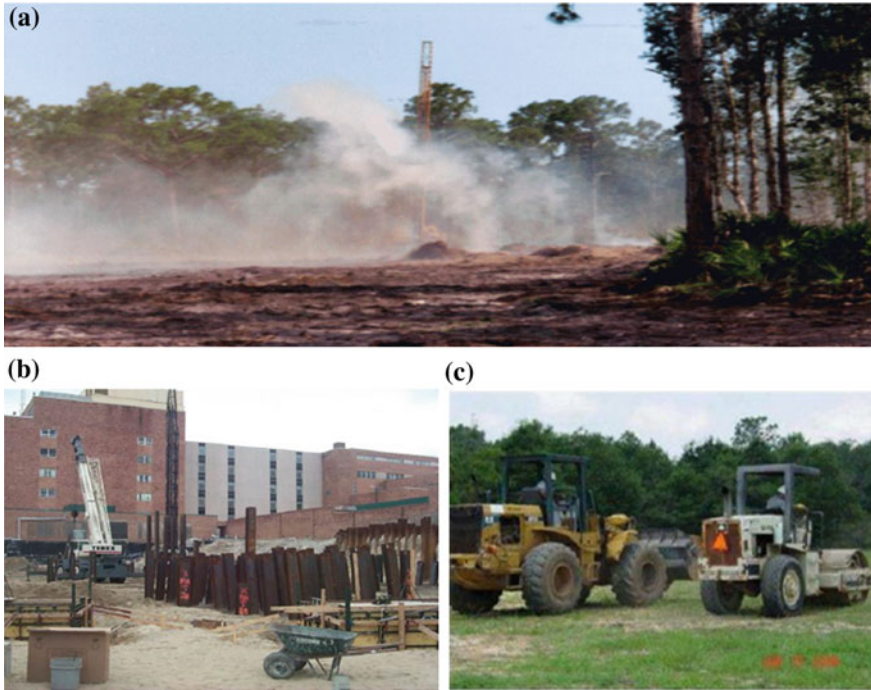
**Fig. 34.1** Sources of construction vibrations. **a** Rock blasing at construction site. **b** Pile installation at hospital. **c** Vibratory compactor near surgical center

Construction activities can affect structures and their occupants in different ways. Most types of construction activities, such as soil and rock excavation, driving of piles and sheet piles, quarry and construction blasting (often carried out in densely populated areas and/or close to sensitive structures), and installations generate noise and vibrations that may result in annoyance and be the suspected cause of cracking or other damages. Construction work as illustrated in Fig. 34.1 can often take place in densely populated areas and close to residential structures.

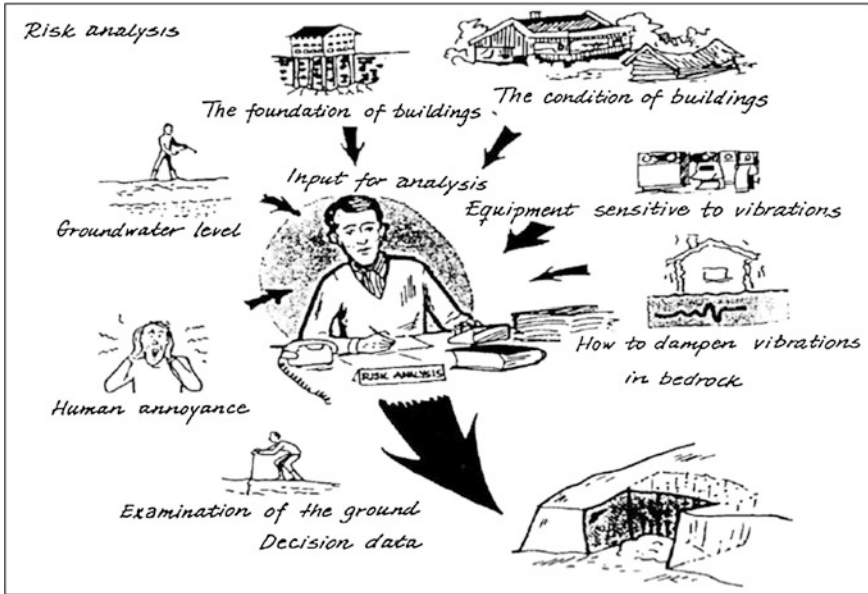
Fig. 34.2 Factors included in a Risk Analysis (Holmberg et al. 1984)

This aspect is enhanced by the increasing awareness of the public concern, issues of environmental issues, vibration-sensitive electronic equipment and machinery (Massarsch 2000). Accordingly, many agencies frequently require that a forensic risk analysis be performed prior to issuance of construction permit. A risk analysis requires due perusal of many factors and consequences on humans, buildings, and installations as illustrated in Fig. 34.2.

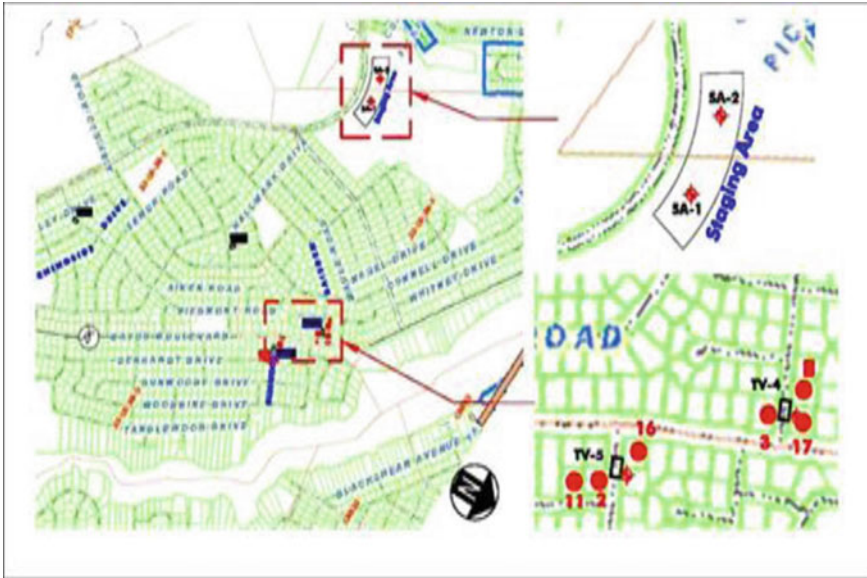
**Fig. 34.6** Structure layout, with treatments vaults (TV), staging area test section (SA-1 and SA-2)

Twenty homeowners from a residential subdivision in the Florida Panhandle (refer to Fig. 34.6), claimed damage including cracking to their properties during construction of various portions of city's storm water treatment/enhancement project. Legal filing stated that "while site work and construction was being performed and proceeding at the project the tenants and/or owners of the various residences experienced severe vibrations, shaking and rattling of the windows and other fixtures and personal property in their respective homes." They argued that their houses have been damaged as a result of the construction activities related to vault construction. These construction activities included excavation dewatering, sheet
