Chapter 7

Characteristic Features of Deformation and Fracture in Hydrogen Embrittlement

7.1 Fractographic Features

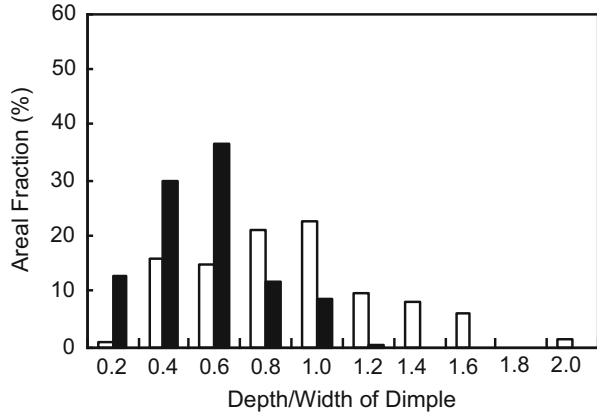
Fig. 7.1 Area fractions of dimples with different depth/width ratio on fracture surfaces of a low-carbon medium strength steel subjected to a three-point bending test with/without hydrogen precharging. The open and filled bars indicate non-charged and hydrogen-charged specimens, respectively (Nagumo et al. [6])

The fracture surface at a three-point bending test of a mildly hydrogen-precharged low-carbon medium strength steel exhibited patterns consisting of mostly primary and secondary dimples [6]. Hydrogen precharging caused rather enlargement of primary dimples while secondary dimples were refined. The area fractions of dimples with different depth (h)/width (w) ratio are shown

in Fig. 7.1 [6] for hydrogen precharged and uncharged specimens. The area fraction of shallow dimples ($h/w < 0.5$) increased by hydrogen precharging. It implies that hydrogen reduces the extent of plastic deformation on dimple formation and thus the energy dissipated during ductile crack propagation.

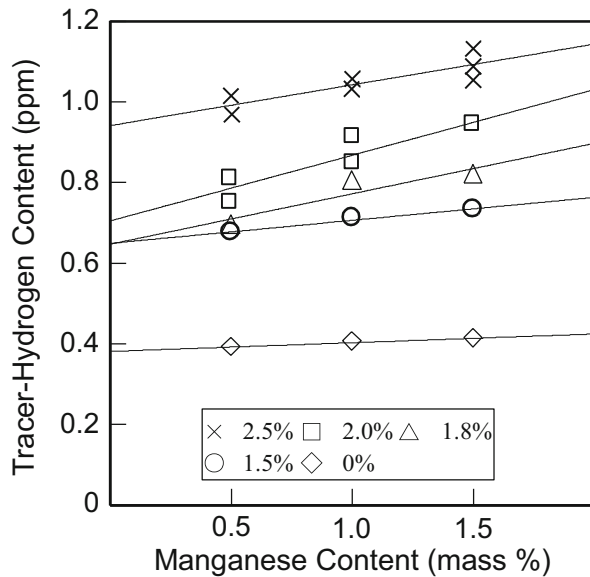
Fig. 7.8 The amounts of hydrogen absorbed to saturation in specimens given various amounts of prestrain. The three martensitic steels with different Mn contents are used for Figs. 7.6 and 7.7 (Nagumo et al. [25])

A crucial issue concerning IG fracture is the involvement of plasticity in embrittlement. A useful tool to detect lattice defects is to utilize tracer-hydrogen as shown in Figs. 3.2 and 6.25. Figure 7.8 [25] shows the amounts of hydrogen absorbed to saturation in specimens given various amounts of strain. The amount of absorbed tracer-hydrogen represents the densities of trap sites. The amounts for the

three steels are almost the same when straining was not given. On the other hand, a substantial increase by straining appeared more pronouncedly for higher manganese contents. As described for Figs. 3.2 and 3.10, TDA is a useful tool to examine the nature of strain-induced defects. Figure 7.9 [25] shows TDA curves of tracer-hydrogen introduced into three states of the 1.5 % Mn specimens, *i.e.* unstrained, prestrained to 2 % and annealed at 250 °C for 1 h after straining. The increase in the amounts of tracer-hydrogen totally disappeared by annealing the strained specimen at temperatures as low as 250 °C, indicating that lattice defects that interact with tracer-hydrogen are vacancies rather than dislocations. Thus, the origin of the effect of manganese contents is reasonably ascribed to the density of strain-induced vacancies. Precipitation of carbides along martensite boundaries was observed, but quantitative differences of microstructures that specify the three steels were not definite. Related degradations of tensile properties are described in Sect. 8.2.

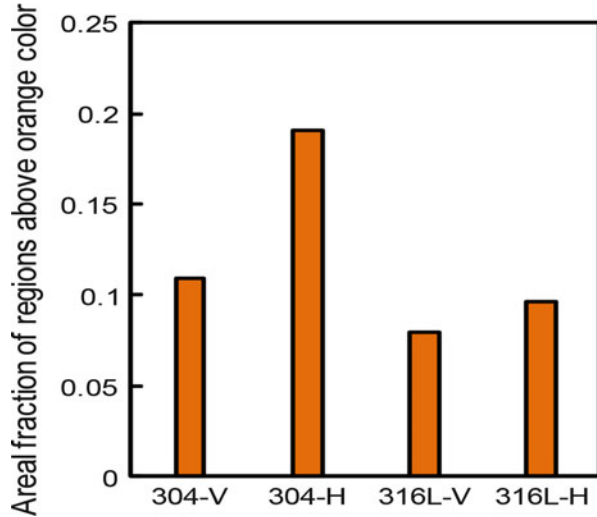
Fig. 7.14 Areal fractions of highly strained regions of orange and red colors in Fig. 7.13. Data for Type 316 L are also added. Suffixes “V” and “H” denote without and with hydrogen charging, respectively (Hatano et al. [8])

The strain distribution is not uniform, and increased areal fractions of bright (orange and red) regions imply enhanced strain localization. A substantial decrease in tensile ductility by hydrogen appeared in Type 304, while Type 316 L was immune to hydrogen. Enhanced strain localization by hydrogen was observed also for Type 316 L, but it was to a less extent compared to Type 304. Figure 7.14 [8] shows a quantitative comparison of strain localization in terms of area fractions of orange and red color regions for Types 304 and 316 L steels strained to 24 % with and without hydrogen charging. Evidently the hydrogen effect to enhance strain localization is much more distinct in Type 304 than Type 316 L. The preferential strain localization in Type 304 is ascribed to stacking fault energy. The decrease in the stacking fault energy enhances strain-hardening and resultant phases such as stacking fault and ϵ -martensite act as barriers for the extension of slip. High densities of fine stacking faults and streaks of ϵ -martensite characterize microstructures of hydrogen-charged and deformed Type 304 austenitic steel [8]. Deterioration of crystallinity associated with strain localization is described in following Sect. 7.3.

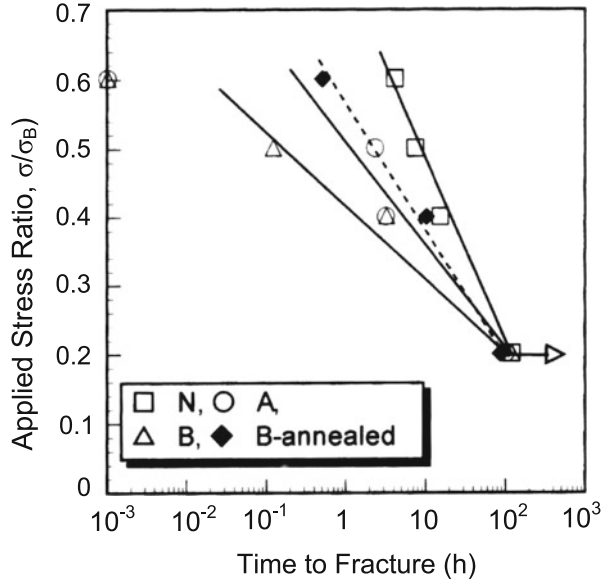
Fig. 7.20 Delayed fracture diagrams for prefatigued Si-Cr martensitic steel. □, N (without prefatigue); Δ, B (prefatigued close to failure); ◆, B (annealed at 200 °C for 1 h after prefatigue); ○, A (prefatigued to about one half of fatigue life) (Nagumo et al. [51])

Figure 7.20 [51] shows promoted delayed fracture by prefatigue for the Si-Cr martensitic steel used for Fig. 6.16. Prefatigue was applied by rotational bending for cycles about a half (Treat-A) of or close (Treat-B) to the fatigue life at the applied stress amplitude level of 640 MPa [51]. The two types of specimens were successively subjected to sustained-loading delayed fracture tests in 20 % NH₄SCN aqueous solution at 50 °C. Specimens without prefatigue (Treat-N) were also tested for comparison. Fracture of specimens given prefatigue for cycles close to the fatigue life, Treat-B, took place substantially earlier. However, annealing of the fatigued specimens at temperature as low as 200 °C for 1 h reduced the degradation caused by prefatigue. The results imply that damage accumulated during prefatigue plays a common function in failure as that created during delayed fracture test and that damage introduced by prefatigue is mostly vacancies without forming flaws such as voids and cracks.
