Machine-Vision-Assisted Performance Monitoring in Turning Inconel 718 Material Using Image Processing

Abstract Machining performance monitoring is the utilization of different sensors to determine the condition of processes. Machine vision system has been used to monitor the state of both cutting tool and workpiece during turning process. The turning experiments on Inconel 718 material have been performed in a precision lathe using coated carbide cutting tool in dry conditions. Cutting tool and machined surface images were acquired using machine vision. Image features of machined surface and cutting tool were extracted by processing the images. Image features such as wear area and perimeter have been considered to characterize tool wear state; consequently, machined surface state was characterized by means of image histogram frequency. Further, trends have been plotted with image features extracted from both tool and machined surfaces. Results indicate that monitoring of turning performance could be effectively accomplished by plotted trends.

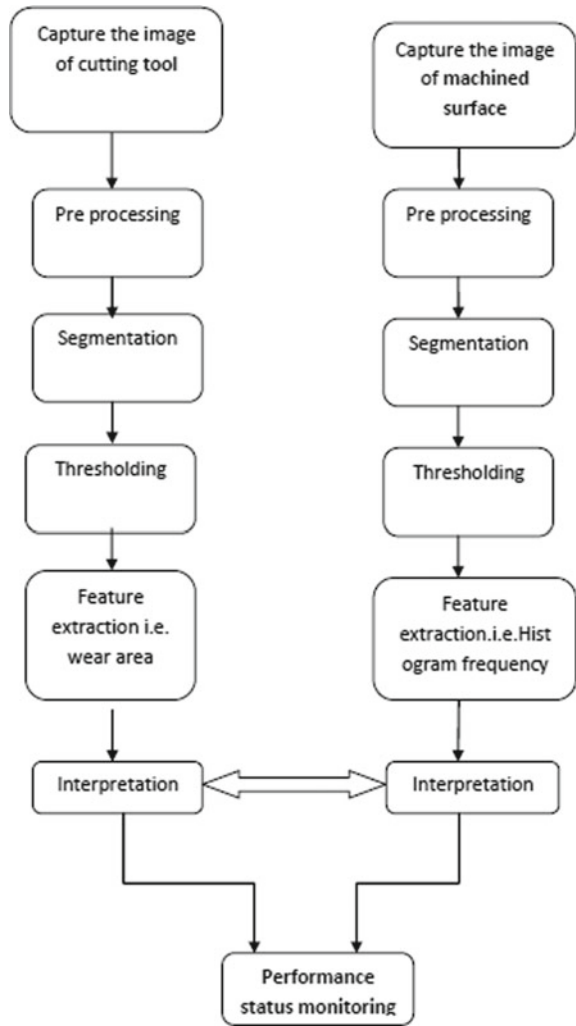
Fig. 1 Flow chart of performance monitoring using image processing

Performance monitoring could be carried out by capturing the information given by cutting tool and the workpiece. Flow chart of performance monitoring using image processing is as shown in Fig. 1.

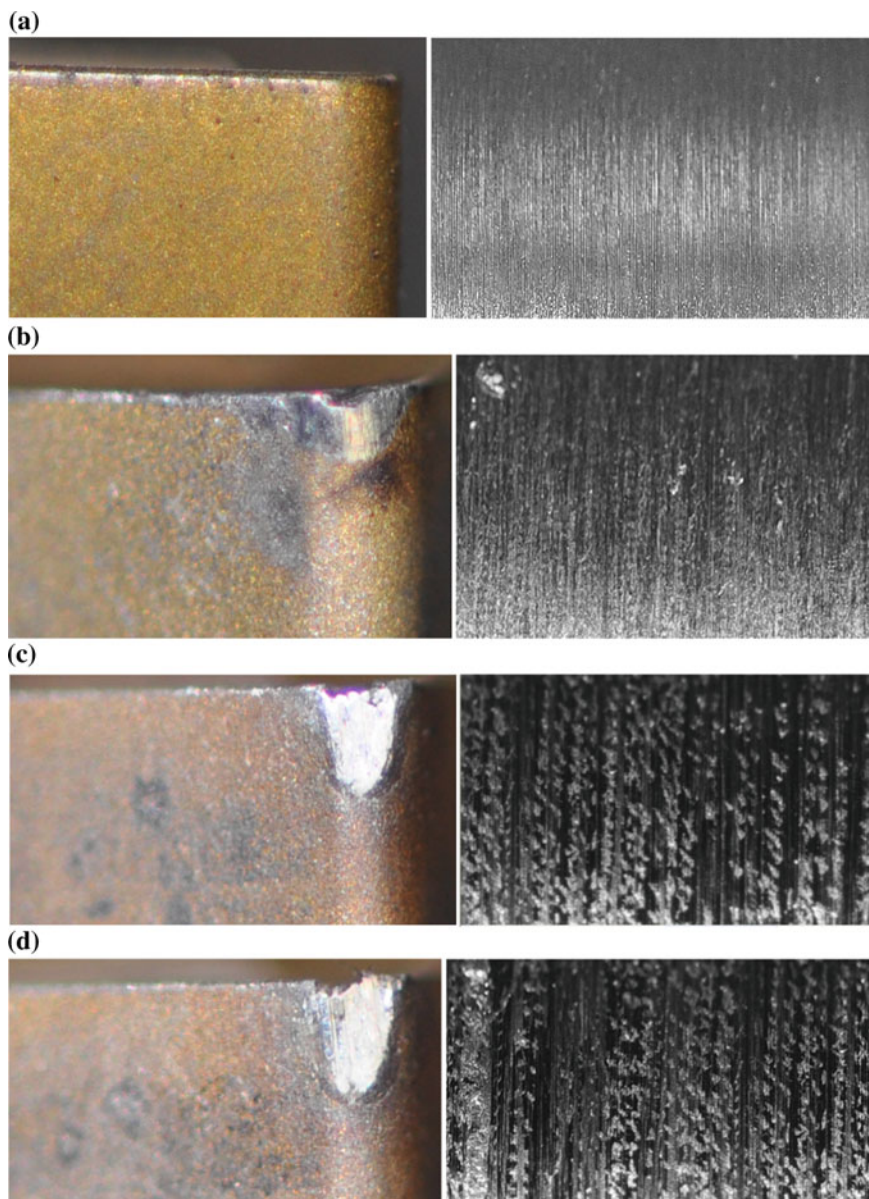
Fig. 2 A series of tool images and corresponding machined surface samples are taken during performance monitoring in turning nickel-based super alloys (Speed = 450 rpm, DOC = 0.2 mm and feed = 0.07 mm/rev)

A series of tool images and corresponding machined surface samples are taken during performance monitoring in turning nickel-based super alloys is as shown in Fig. 2. The initial status of both tool and workpiece is as shown in Fig. 2a, which corresponds to the original unused state. With usage, the tool worn out and hence produces unacceptable, deteriorated machined surface as shown in Fig. 2d. It is also observed that worn tool causes irregularities such as microparticle deposits and feed marks on machined surface are as shown Fig. 2b, c.

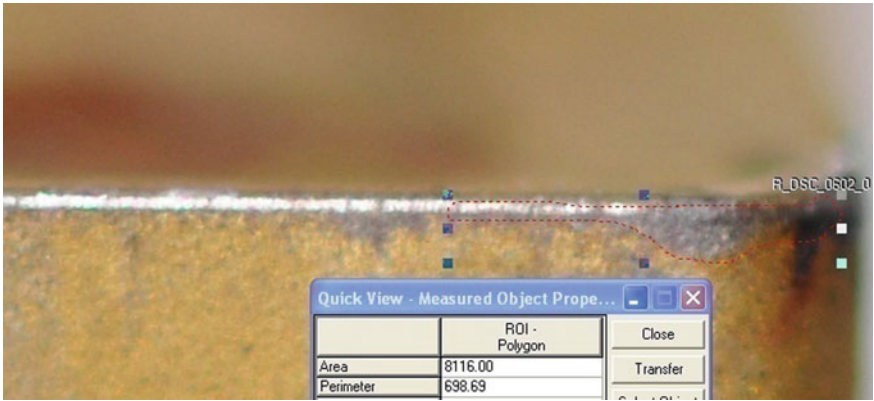
Fig. 3 Wear area and perimeter of cutting tool image

Machine vision system was utilized to capture cutting tool images, and processing of acquired images was done using view flux software. Extraction of image feature that accurately characterizes the tool wear state is made, i.e., wear area and perimeter. $\text{Wear Area} = \text{Area of the cutting tool wear region, the number of pixels within the wear region as shown in Fig. 3.}$

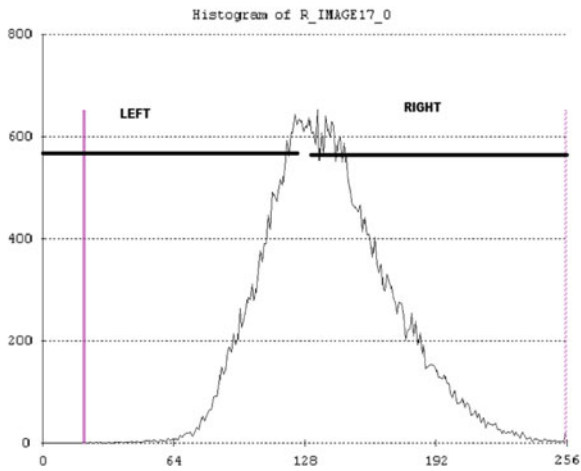
Machined surface image having Ra=0.5μm

Gray scale image of machined surface

Fig. 4 Histogram of machined surface of initial run having Ra = 0.5μ, with the speed 710 rpm, feed 0.05 mm/rev and depth of cut 0.2 mm for Inconel 718 material

Histogram of an image is defined as the graphical depiction of gray-level intensity variations as per the roughness of the machined surface. Left side of image histogram represents smaller intensities, and right side represents large value of intensities. To

monitor the machined surface roughness, right side of histogram is preferable as the metal surface exhibits high reflectivity and hence gray level 125 has been considered as reference point to compute the histogram frequencies. In Fig. 4, smooth-machined surface having surface roughness $R_a = 0.5 \mu\text{m}$, gray level 125 approximately having frequency 600.

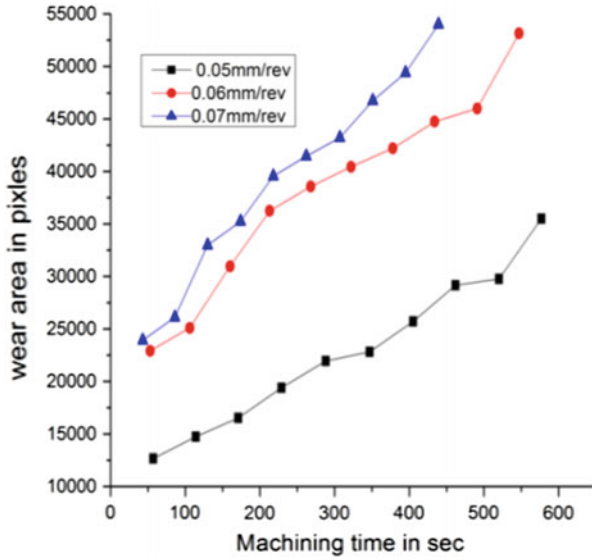
Fig. 5 Wear area versus machining time for Inconel 718 material

It is clearly observed from Figs. 5 and 6 that machine vision features such as wear area and perimeter follow the trend till the measured flank wear of 0.3 mm. As the flank wear measurement crosses 0.3 mm, due to rapid wear of the tool, the values of the measured features increase drastically. Since the behavior of the measured features follows the established trend, the features themselves are potentially dependable information carriers of performance status during machining of Inconel 718 work material using coated carbide inserts.

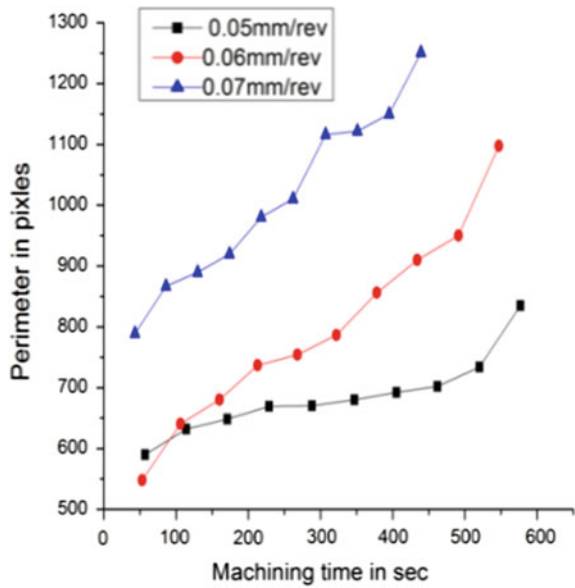
Fig. 6 Wear perimeter versus machining time for Inconel 718 material

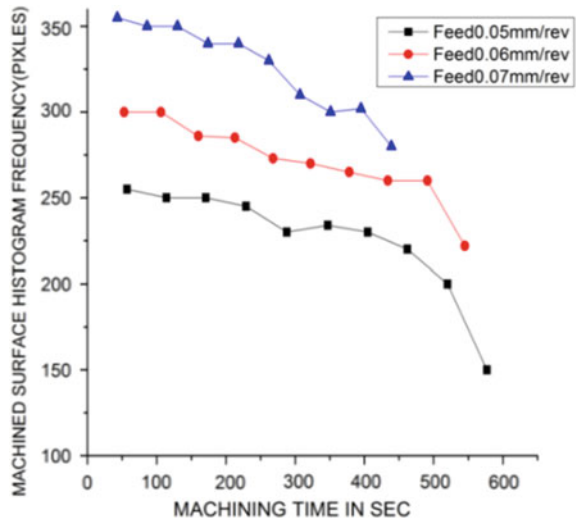
Fig. 7 Histogram frequency versus machining time for Inconel 718 material

Image histogram frequency presents machined surface status in terms of surface roughness as depicted in Fig. 7. The image histogram frequency plots at different feed rates are observed to be almost constant until the flank wear of 0.3 mm and beyond which they dropped to alarming levels indicating the deterioration of machined surface roughness. Arithmetic mean of surface deviation, Ra, captured using stylus method has been adopted to ascertain the surface roughness. By observation, it is inversely related to the image histogram values. Ra has been plotted against machining time as shown in Fig. 8. Beyond flank wear of 0.3 mm, Ra increases rapidly more or less at the same instance at which the image histogram plot drops.

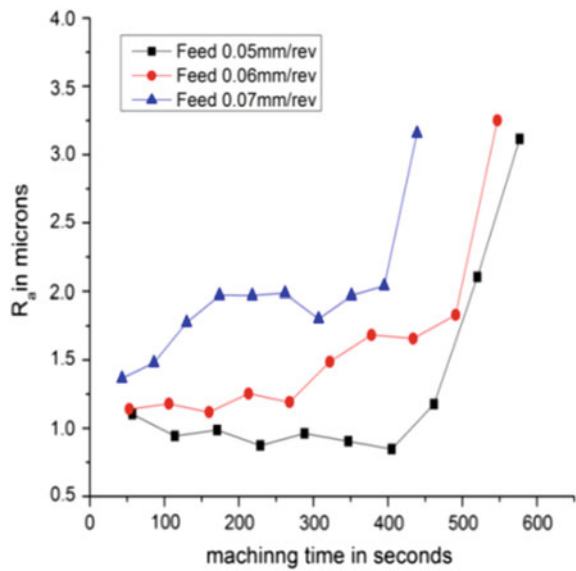
Fig. 8 Ra versus machining time for Inconel 718 material

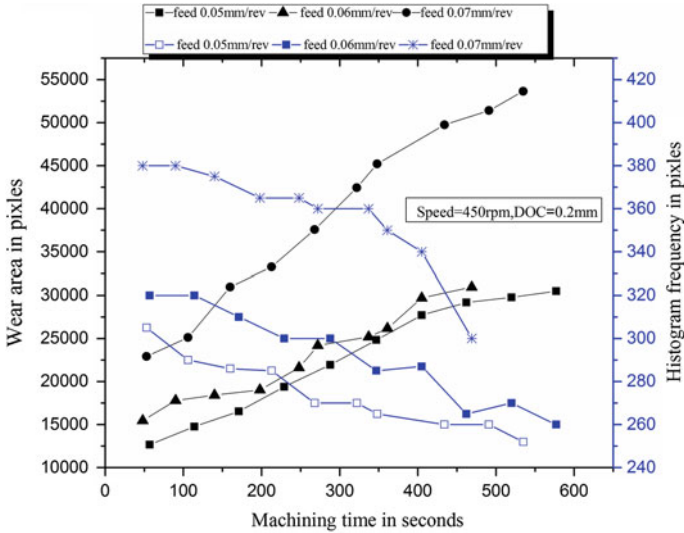
Fig. 9 Correlation of histogram frequency and wear area progression with machining time for Inconel 718 material

Image histogram frequency of the machined surface plays a major role with respect to tool status measured in terms of wear area as is evident from Fig. 9 for different conditions of machining. When the measured flank wear is beyond 0.3 mm, the

image histogram values drops, termed as last values, indicating the tool unworkable life. Wear area and flank wear are higher at feed of 0.07 mm/rev than 0.05 mm/rev and 0.06 mm/rev. The wear area of the insert grows faster at 0.07 mm/rev, and the generated surface is very rough. The same trends have been observed for all considered cutting conditions.
