Time–Frequency Analysis of Strong Ground Motions from the 2011 Sikkim Earthquake

Shalin Mathew, Mohammed Ayub Ifan, Jayaprakash Vemuri,
and K. V. L. Subramaniam

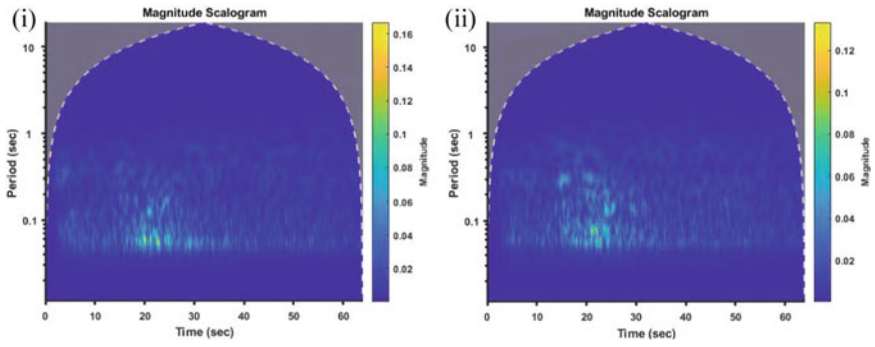
Figures 8, 9, 10, 11, 12, and 13 (i, ii) show the CWTs for the six stations. In general, the CWT figures show the presence of high-frequency waves. In all the six towns, the high-amplitude waves contained high-frequency content of around 10 Hz, representing a low period of 0.1 s. However, in some towns, the high-amplitudes waves were observed at multiple frequency ranges. For example, the transverse record from Gezing town shows high-amplitude waves at multiple low periods, ranging from 0.04 to 0.2 s. Similarly, in the radial record from Singtam town, the high magnitude seismic waves are distributed over a low period range of 0.05–0.2 s. The damage

due to this horizontal ground motion in Singtam town is also clearly corroborated with the observation from the reconnaissance surveys (rows 16, 17, Table 1). The CWTs of ground motions from Mangnan town show high-amplitude waves having a period of 0.1–1.2 s. This is also clearly corroborated with the observed damage to 1 and 2 storey structures in Mangnan town, as recorded in the reconnaissance survey (row 14–15, Table 1). Similarly, Gangtok town experienced multiple high-amplitude waves at various multiple frequencies causing damage to 1–4 storey structures (row 5–13, Table 1). In Chungthang town, the high-frequency–high-amplitude content was observed for a very short duration. Further, the response spectra as observed (Fig. 14) exhibit a peaky behaviour, corroborating the above observations. Overall, these observations indicate the high hazard to low-rise structures, prevalent in the region, which typically have low natural periods.
