# Modelling of an Embankment Failure Using Flow-3D

**Abstract** Embankment dam failures are concerning to many people in society today, including dam engineers, federal, state, and local officials. The effects of dam failure will cause more harm than good, leading to the losses of lives, properties being damaged, economic and environmental issues. The embankment dam breaching is a complex process between hydraulics and soil erosion processes that requires an analysis of hydrodynamic parameters such as breach outflow hydrograph, peak outflow rate and failure time, and geometric parameters; breach depth,  $H_b$ , and top breach width,  $B_t$ . With the aid of simulation techniques such as Computational Fluid Dynamics (CFD), it is possible to understand the behaviour of embankment breaching processes. In this paper, modelling of an embankment breaching using FLOW-3D allows modellers to open doors to plenty of experiments to breaching in the near future. This paper focuses on analyzing the modelling breaching embankment for different sediment sizes of embankment material to investigate the patterns of breached outflow, breach width, dam breach depth. Moreover, the study also investiga

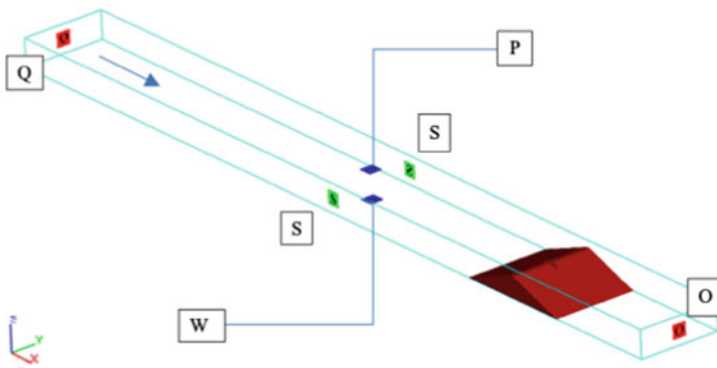
Fig. 2 Boundary conditions of the model setup

The simulation was run for 400 s using the sediment scour physical model. The embankment sediment was set to be 0.1 (fine), 0.4 (medium) and 0.8 mm (coarse) with an inflow rate of 0.012 m<sup>3</sup>/s. The initial state of the solution for transient fluid flow problems must be known in order to find a solution and, in a manner similar to what is done with boundary conditions, the initial conditions are assumed, approximating the true state at time  $t = 0$ . The Boundary conditions used are Volume Flow Rate (Q), Outflow (O), Symmetry (S), Wall (W) and Specified pressure (P), and the location to apply the boundary conditions is shown in Fig. 2.

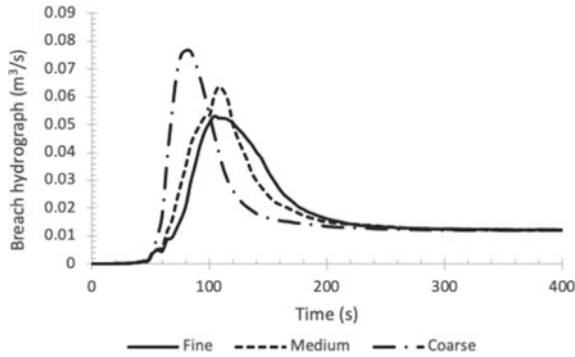
Fig. 3 Breach outflow hydrograph for different sediment sizes

The modelling of breaching embankment with different sizes of sediments diameter showed that the breaching occurs slower when the sediment is finer as compared to larger sediment embankments. This is because the fine sand seems to be more resistant to erosion. Figure 3 shows the peak outflow hydrograph for coarse sand with a diameter of 0.8 mm is 0.0768 m<sup>3</sup>/s, and for fine sand with a diameter of 0.1 mm, the peak is 0.0532 m<sup>3</sup>/s. The outflow hydrograph is measured at the outlet of the channel where the v-notch is installed. Meanwhile, for medium sand with a diameter of 0.4 mm, the peak outflow hydrograph is 0.0638 m<sup>3</sup>/s. As for the failure time where the breaching started, the coarse sand obtained a failure time of 80 s, while that of the fine sand had a failure time of 104 s. The failure time for the medium sand is 108 s which is almost as similar to the failure time for the fine sand (Fig. 5).

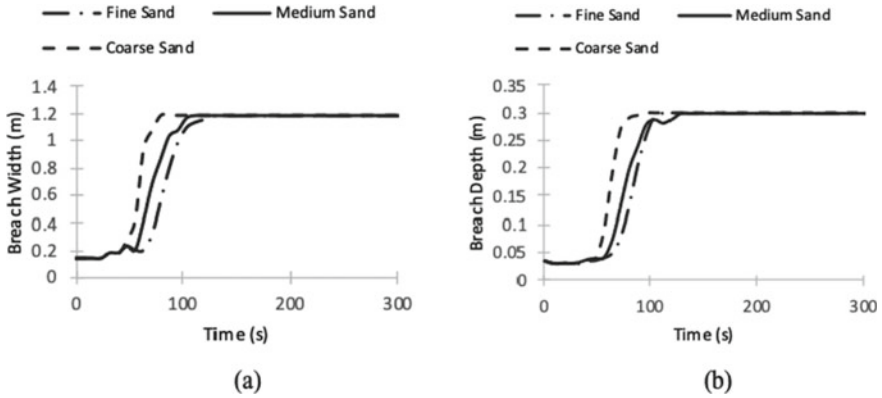
Fig. 4 a Breach width and b breach depth against time

In the breaching process, the flowrate plays an important role in the erosion and scour of the embankment, the widening and deepening process of the breach, and the flood propagation process downstream. Figure 4 illustrates the breach profiles – failure lines patterns with sediment size of 0.4 mm and inflow rate of 0.012 m<sup>3</sup>/s at time 40, 60, 80, 100, 120 and 140 s, respectively. As breach depth increases and the height of the embankment reduces, the downstream slope angle of the embankment decreases, as can be observed in Fig. 4. The details of the breach patterns with respect to the free surface profiles and hydrostatic pressure is shown in Fig. 6.

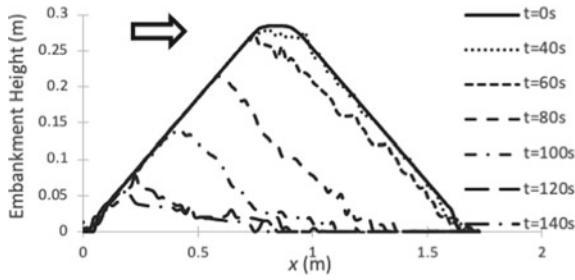
**Fig. 6** Progression of breaching profiles at various time intervals

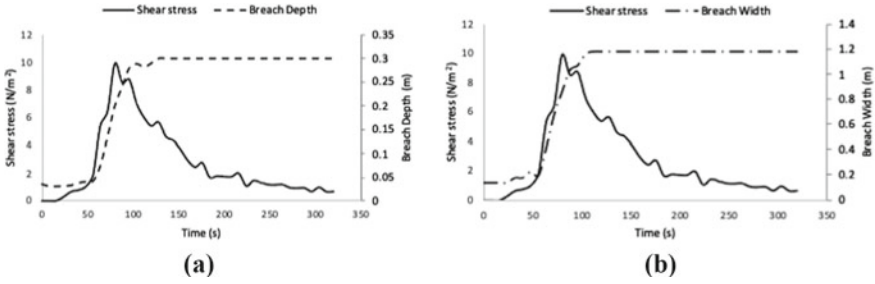
**Fig. 9** Shear stress against **a** breach depth and **b** breach width

The maximum value of shear stress at cross-section is plotted against time and compared with breach depth and breach width, as shown in Fig. 9. The results indicate an increasing gradient of the curve of the rate of shear stress, the breach depth and the breach width at the beginning of breaching, then slowly, the rate of shear stress starts showing a decreasing gradient. At this point, the breach depth and the breach width hit a constant, reaching their maximum depth and width. Table 1 indicates the summary of the maximum shear stress obtained in relation with breach width and breach depth for  $t = 40$  s,  $t = 60$  s,  $t = 80$  s,  $t = 100$  s,  $t = 120$  s, and  $t = 140$  s.
