## Microstructure of wood-fibre-plaster composites

R. S. P. COUTTS, J. V. WARD

CSIRO, Division of Chemical and Wood Technology, Private Bag 10, Clayton, 3168, Victoria, Australia

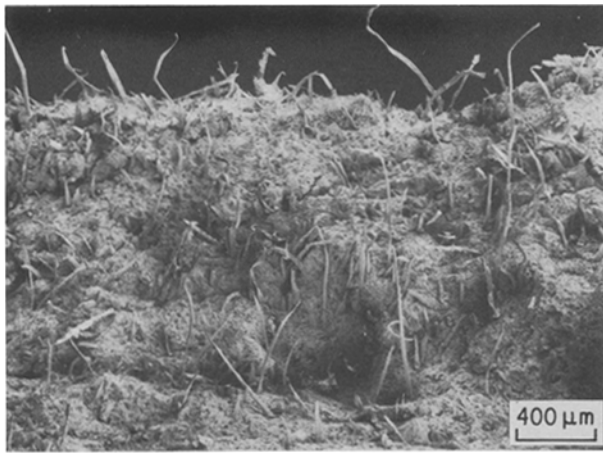
Figure 3 Uneven fracture surface of WFRP (4% fibre by mass), suggesting considerable increase in fracture energy.

When a relatively low level of wood fibre (2% by mass) is introduced into the matrix material, a composite is formed which has a ten-fold increase in the value of fracture toughness (0.52 kJ m<sup>-2</sup> [2]). SEM studies of the WFRP fracture surface (see Fig. 3) show that it is very uneven, which suggests a much greater fracture surface energy was generated. At high magnification it can be seen (Fig. 4) that the fibres have been both fractured and pulled out of the matrix during loading to failure and considerable energy was thus consumed.

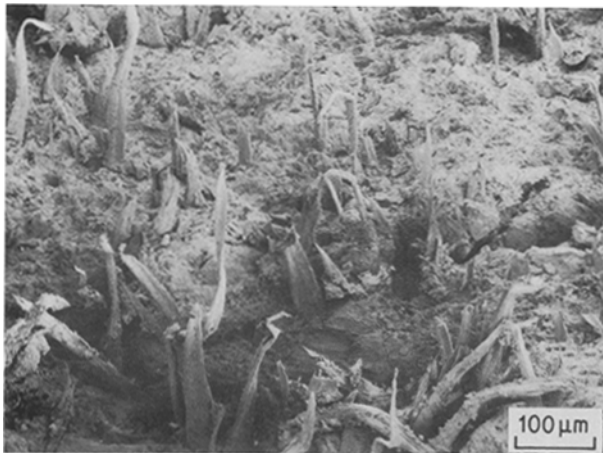
Figure 4 High magnification of WFRP fracture surface, showing fibres both fractured and pulled-out from the matrix.

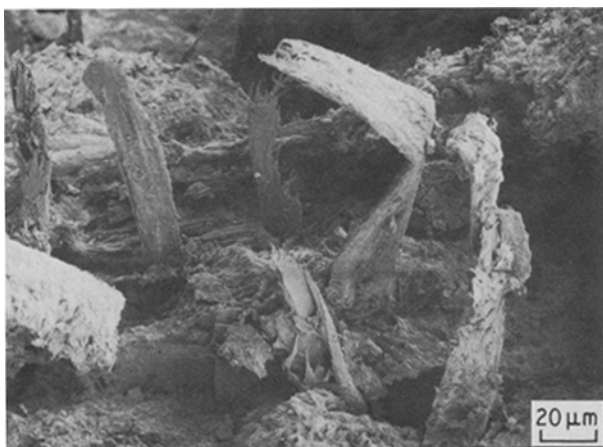
Figure 5 Fibres failed in tension with some showing “buckling”.

the matrix does not restrict the buckling behaviour. Fig. 5 shows a number of fibres that have failed in tension by what seems to be a buckling of the fibre.
