Effects of aging heat treatment on machinability of alumina short fiber reinforced LM 13 aluminum alloy

Abstract In this paper, the surface integrity (R_a and R_{max}) has been investigated with various aging heat treatment and machinability parameters in an aluminum-silicon based (LM-13) MMCs, produced by infiltration method. The composites have been subjected to heat treatment at different temperatures and times which was discussed in detail in an earlier publication (Altunpak and Akbulut, Teknoloji 8(4):331–339, 2005). In the milling of alumina short fiber reinforced LM-13 aluminum alloys, the surface integrity decreased when feed rate increased. It was found that increasing amount of fiber reinforcement and solutionizing temperature has a significant effect on the surface integrity and sub-surface damage of the materials. Increasing the solutionizing temperature and fiber reinforcement produced higher R_a and R_{max} values. Microhardness measurement indicated that the sub-surface damage and the hardness increased by increasing the feed rate and fiber content.

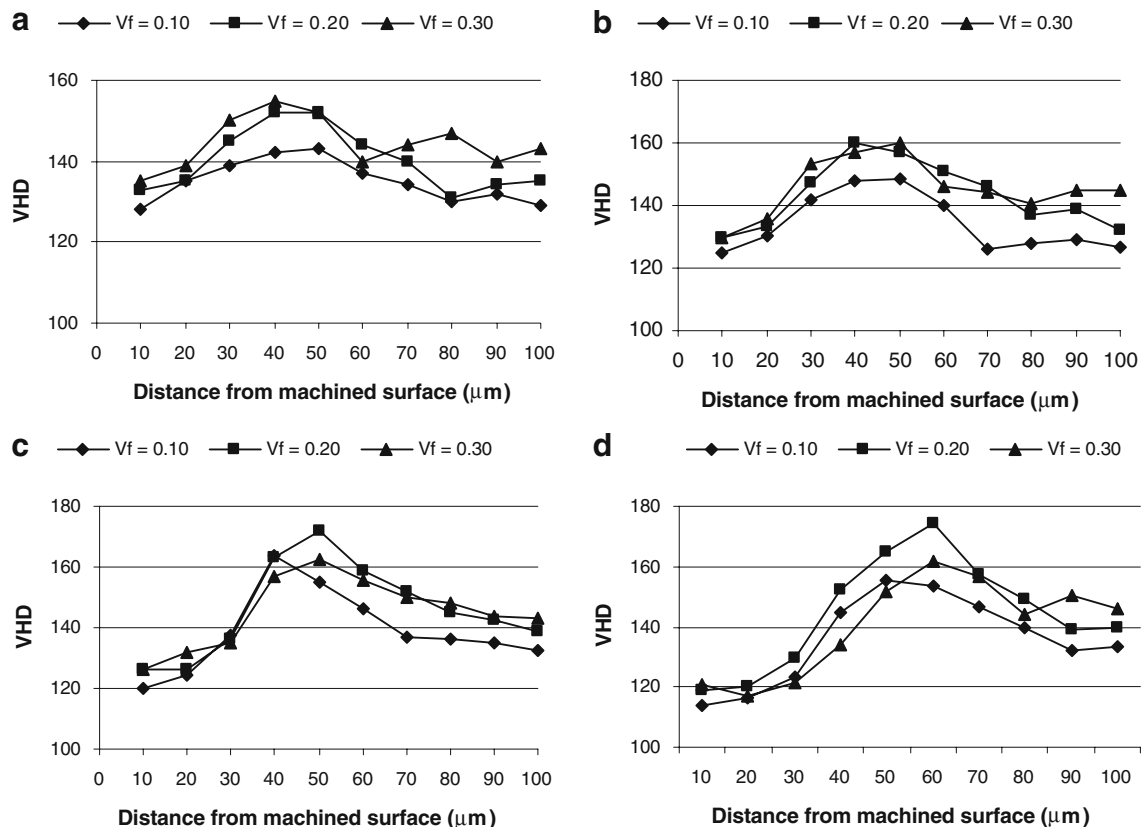
Fig. 8 Variation of microhardness of cross-section of machined surface **a** feed rate=50 mm min^{-1} **b** feed rate=78 mm min^{-1} , **c** feed rate=126 mm min^{-1} , **d** feed rate=200 mm min^{-1} (solution treated at 535°C and subjected to aging treatment)

Increasing the feed rate which leads to plastic deformations resulted in an increasing sub-surface hardness of the machined surface. It can be seen from Fig. 8a–d that microhardness measurements in the machined cross-sections indicate that about 10–15 μm away from the cutting surface, the plastic deformation and the hardness significantly were increased by increasing the feed rate and fiber content. But in general, some microhardness values of 30 vol% fiber reinforced matrix alloy were lower than that of 20 vol% fiber reinforced matrix alloy. This attributed to the poor bonding resulted from porosity between matrix and fibers because of insufficient infiltration (Fig 4). Moving further away about 40–50 μm from the machined surface, the hardness starts to decrease. El-Gallab and Sklad attributed this to the reduction in the surface roughness with increase in the feed rate and the cutting speed. Increasing of the cutting speed, feed rate, and/or depth of cut were also resulted to increase in the depth of the affected layer [1, 11].
