Evaluation of crack nucleation site and mechanical properties for friction stir welded butt joint in 2024-T3 aluminum alloy

Abstract In this paper, metallographic observations, hardness measurement, and static and fatigue tests were conducted to investigate the discontinuity states which become crack nucleation sites in friction stir welded butt joints in 2-mm-thick 2024-T3 aluminum alloy and static and fatigue properties of the joint. Because different types of surface finish can be used depending on the application of the joint, several types of surface conditions were tested to evaluate their effect on crack nucleation sites and static and fatigue life. Indentation hardness tests revealed that typical hardness reduction is not necessarily observed on the section of the welding line. Based on fatigue test results, it was confirmed that there are several types of crack nucleation sites for friction stir welding (FSW) joints depending on the surface finish, and the features of the fracture surface also differ depending on the site. Furthermore, the type of discontinuity state affects the fatigue life of the FSW joint.

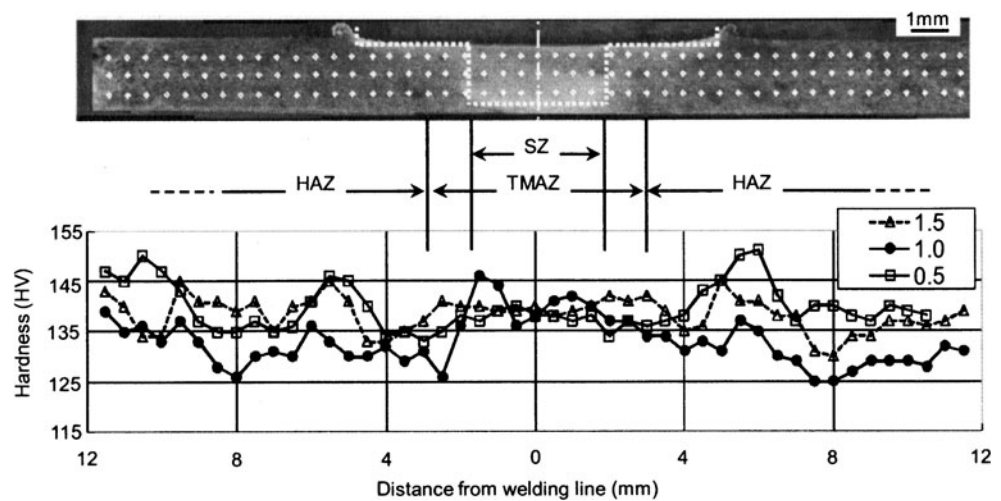
Fig. 4 Hardness profile on welding line

Figure 4 shows the hardness distribution in a section perpendicular to the welding line and an optical micrograph of the section together with the tool dimension. The average hardness values of the base material in the middle and near the surface are 127 and 137 HV, respectively. From this figure, it is considered that there is no typical hardness drop

region in this welding condition. Also, it appears that the hardness distribution through the thickness direction does not significantly change in the base material and HAZ. However, in the TMAZ and the weld nugget, plastic flow and heat input change the thickness hardness distribution.

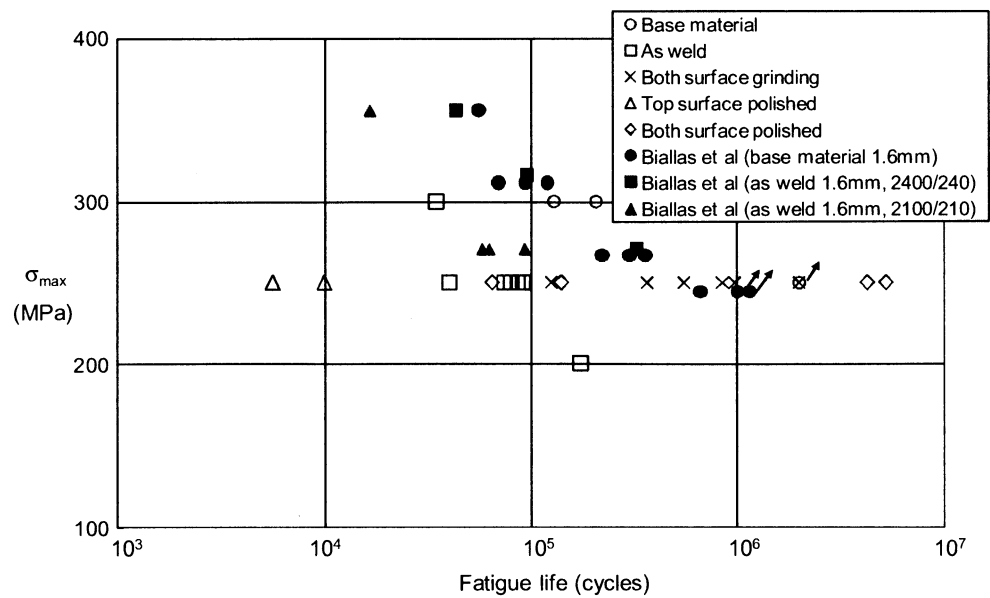
Fig. 5 Fatigue test result

Figure 5 shows the S–N data for the FSW specimens. The test results for the base material with the as-received surface condition are also shown in the figure. The average fatigue life and variation coefficient for each condition are summarized in Table 3. This figure shows that the fatigue properties of the “as weld” specimens are apparently lower than those of the base material. The specimens fractured at about 170,000 cycles at the maximum stress of 200 MPa, while the base material indicates run-out (2,000,000 cycles) at 250 MPa. Most of the specimens fractured in a vicinity of a burr as shown in Fig. 6. In other cases, an LOP becomes the crack nucleation site (Fig. 7). The average fatigue cycles for “both surface grinding” specimens are about an order of magnitude greater than for the “as weld” specimens. However, only one specimen reaches run-out in this test, and then, the fatigue property of the FSW joint for the condition is not the same as that of the base material.

is also shown in Fig. 5. It is shorter than that of the base material and 2400/240 joints, and the observed pores are considered to be detrimental to fatigue strength in that welding condition.
