Evaluating the effect of coolant pressure and flow rate on tool wear and tool life in the steel turning operation

Anselmo Eduardo Diniz · Ricardo Micaroni · Amauri Hassui

Abstract High-pressure coolant (HPC) delivery is an emerging technology that delivers a high-pressure fluid to the tool and workpiece in machining processes. High fluid pressure allows for better penetration of the fluid into the cutting zone, enhancing the cooling effect, and decreasing tool wear through lubrication of the contact areas. The main objective of this work is to understand how tool wear mechanisms are influenced by fluid pressure under different cutting speeds in the finish turning of AISI 1045 steel using coated carbide tools. The main finding was that the use of a lower cutting speed ($v_c=490$ m/min) in dry cutting resulted in tool life close to that obtained with cutting fluid, but when the cutting speed was increased ($v_c=570$ m/min), the high-pressure coolant was effective in prolonging the life of the cutting tool. It was also concluded that, regardless of the cutting speed and cooling/lubrication system, the wear mechanisms were the same, namely abrasion and attrition.

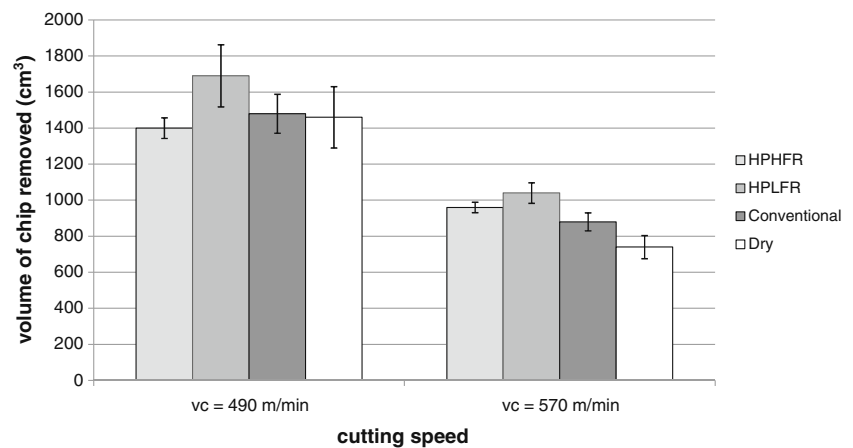
Fig. 2 Volume of material removed per tool life in all cooling conditions and cutting speeds

Figure 2 shows the results of tool life, measured in volume of chip removed per tool life of all the experiments. It is worth to remain that each test condition was carried out three times. Therefore, in the figure, it is presented the

mean value and the dispersion of these tests. The following points can be seen in this figure:

1. For $v_c=490$ m/min, the cooling condition with HPLFR presented a slightly longer tool life than the other conditions. Cooling was not very effective at this cutting speed, even under high pressure. In fact, increasing the amount of high-pressure fluid even caused a slight decrease in tool life. Therefore, since the use of fluid did not significantly increase tool life, dry cutting could be used at this cutting speed.

2. For $v_c=570$ m/min, the use of high-pressure cutting fluid prolonged tool life more than conventional cooling and dry cutting. At this cutting speed, cooling effectively increased tool life and the use of high pressure was effective, providing longer tool life than conventional cooling. In other words, at this high cutting speed, the tool temperature was very high, so it had to be reduced using a cooling system, such as the high-pressure fluid system, that would allow the fluid to get close the workpiece-tool interface. This is better explained in the analysis of the Fig. 5 where it will be seen traces of cutting fluid in the border of the flank wear land when high pressure fluid was used.

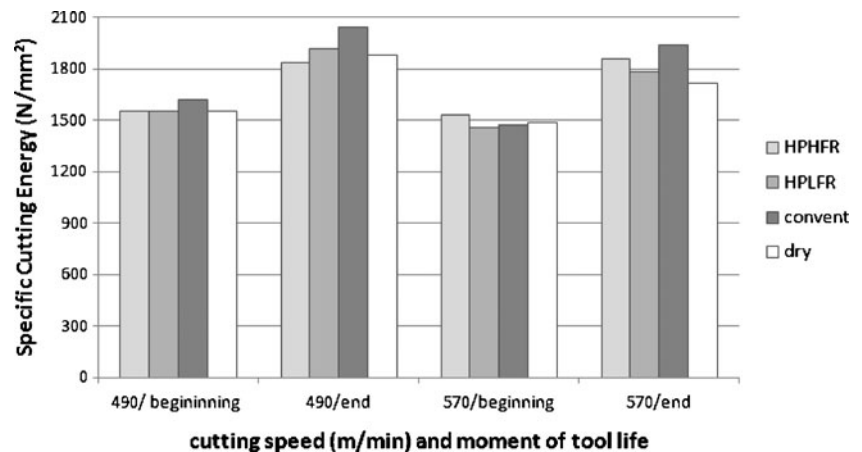
Fig. 7 Specific cutting energy in the different cutting conditions tested

Figure 7 shows the specific cutting energy (cutting force per undeformed chip area or cutting power per volume of chip removed per minute) at the beginning and end of tool life in all the cutting conditions employed here.

An analysis of Fig. 7 reveals several points: (a) the cooling conditions did not affect the specific cutting energy at either the beginning or the end of tool life. At the end of tool life, the differences in specific cutting energy in all the cooling conditions were a little greater, but not sufficient to state that the specific energy values were different. This fact also suggests that, even when injected under high pressure, the fluid did not reach the interfaces, which would have lubricated the contacts, thus decreasing the cutting power and, consequently, the specific cutting energy; (b) the specific cutting energy decreased slightly as the cutting speed increased; (c) the increase in specific cutting energy from the beginning to the end of tool life was, on average, 22% at the cutting speeds and cooling conditions used, as expected, since tool wear damages the shape of the cutting edge, making cutting more difficult.
