Influence of cutting speed and tool wear on the surface integrity of the titanium alloy Ti-1023 during milling

Abstract This study focuses on the machined surface integrity of the titanium alloy Ti-10V-2Fe-3Al (Ti-1023) during face milling. Surface roughness, machining defect, microhardness, and microstructure variations are investigated at different cutting speeds and tool average flank wear (VB) values. Experimental results show that surface roughness increases when cutting speed is increased from 40 to 100 m min^{-1} and decreases when cutting speed is increased from 100 to 300 m min^{-1} by using a new tool. Moreover, surface roughness values are stable when cutting speed is increased by using a worn tool at $VB=0.2$ mm and increases when VB is increased. As for defects, the machining defect is determined to be dependent on cutting speed and tool wear directions. Microhardness is decreased to 35 μm beneath the machined surface at different cutting speeds by using a new tool. The influence of tool wear on hardening is significant, with the depth of hardening being less than 55 μm by using a worn tool at $VB=0.2$ mm and reaching 130 μm at $VB=0.35$ mm. No significant phase trans

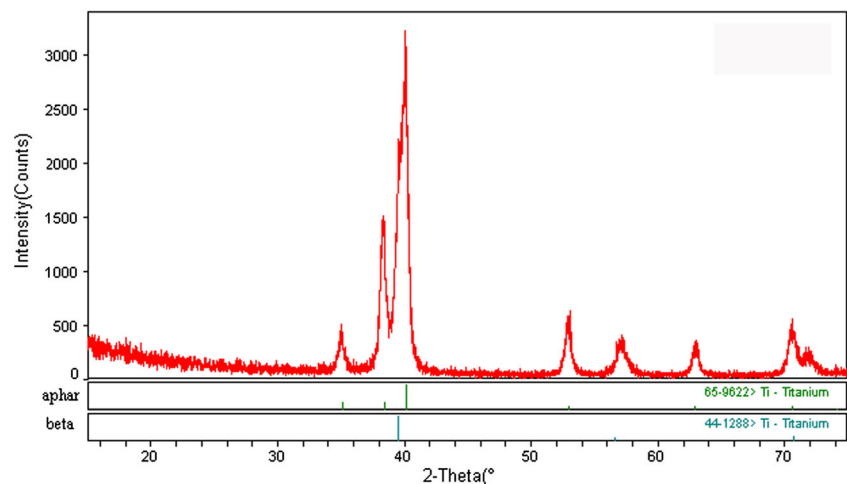
Fig. 1 Phase composition analysis

Ti-1023 is a near- β titanium alloy type (Fig. 1). The β -phase proportion typically varies from 40 to 50 %. The β phase in pure titanium has a body-centered cubic structure and remains

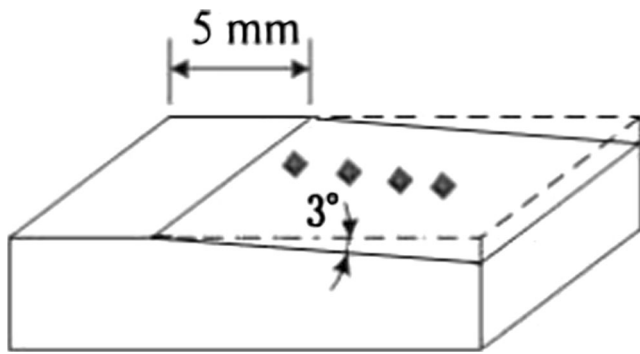
Fig. 2 Microhardness test specimen

machined surface at an end-face distance of 5 mm, the 3° angle chamfered face is cut via walking thread cutting. Then, the chamfered face is ground and polished, as shown in Fig. 2. If the indentation for microhardness measurement is penetrated at every 57 μm of the chamfered face until the hardness of the bulk material is attained (~ 375 HV), then every 3- μm depth beneath the machined surface can be calculated. Microhardness measurements are repeated thrice for each inspection point to obtain average values.

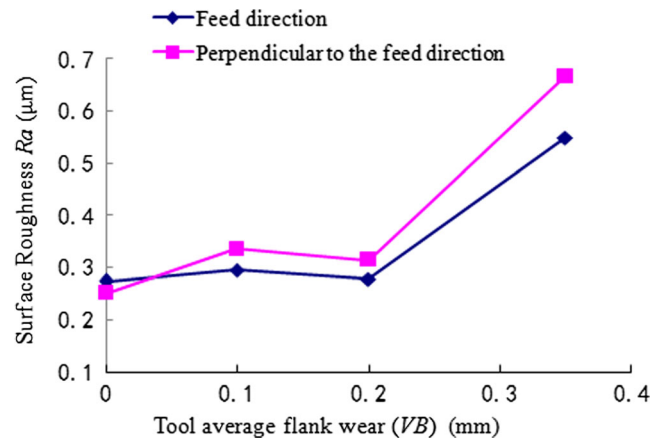
Fig. 4 Influence of VB on surface roughness ($V_c=40$ m min⁻¹, $f_z=0.08$ mm tooth⁻¹, $a_p=1$ mm, $a_e=20$ mm)

Surface roughness perpendicular to the feed direction is greater than that in the feed direction (Fig. 4). When VB increases from 0 to 0.2 mm, roughness decreases. However, when VB reaches 0.35 mm, roughness increases significantly. This result can be attributed to high tool wear at the cutting edge close to the nose and the fracture at the nose. In addition, tool edge radius r_ϵ is altered with tool flank face wear (Fig. 5). Under point O in metal slip line OM , plastic deformation layer h_m significantly increases. Thus, tool flank friction extrusion is enhanced, cutting force is increased, the generated elastic deformation and plastic deformation are increased, lateral flow and uplift effect rise, and roughness values in both directions are increased. Weon Kim K. et al. [31] reported that when tool

edge radius decreases, cutting temperatures and the generated forces decrease. Tool wear is best maintained at $VB < 0.2$ mm in finish machining of titanium to decrease surface roughness.

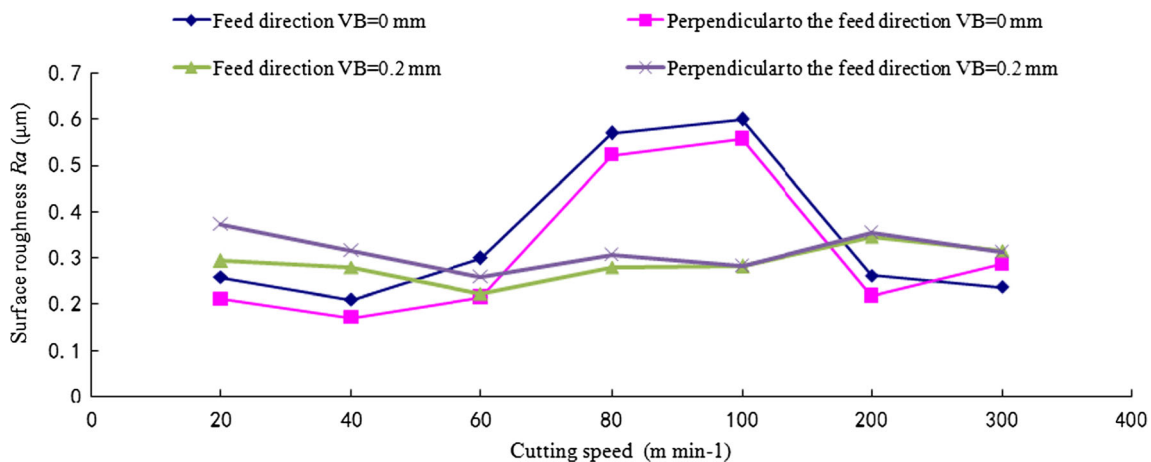
Fig. 3 Influence of cutting speed on surface roughness

Ra is affected by many factors [7, 8, 29]. The effects of cutting speed and VB on surface roughness are investigated in this study. Average Ra data recorded from each cutting condition during the experiments are shown in Fig. 3. In this figure, surface roughness in the feed direction and perpendicular to the feed direction decreases initially, increases within the range of 40–100 m min⁻¹, and then decreases at greater than 100 m min⁻¹, with increasing cutting speed when a new tool is used. The valleys of surface roughness in both directions are observed at cutting speeds of 40 and 300 m min⁻¹. However, the peak of surface roughness is observed at the cutting speed of 100 m min⁻¹. Surface roughness values in both directions range from 0.2 to 0.6 μm. Cutting temperature is low at the cutting speed of less than 40 m min⁻¹. Consequently, surface micromelting is thin, plastic deformation is small, and tool contour is copied on the machined surface. Thus, the texture of the machined surface is regular and smooth, and surface roughness decreases accordingly. Within the range of 40–100 m min⁻¹, as cutting speed increases, the effect of cutting forces on the intermittent cutting process increases, the degree of strain hardening of the materials becomes severe, and resistance to deformation in the shear zone increases. Consequently, cutting vibration increases with increasing cutting speed. Moreover, machined surface defects

As shown in Fig. 3, surface roughness values in the feed direction are slightly lower than those perpendicular to the feed direction obtained by using a worn tool at VB=0.2 mm. Surface roughness values in both directions are less than 0.45 μm. This result can be attributed to the grooves of the cutting edge and flank topography mapping generated on the worked surface. Roughness values are stable at cutting speeds ranging from 40 to 300 m min⁻¹. This result can be attributed to deformation on the flank face or the adherence of the

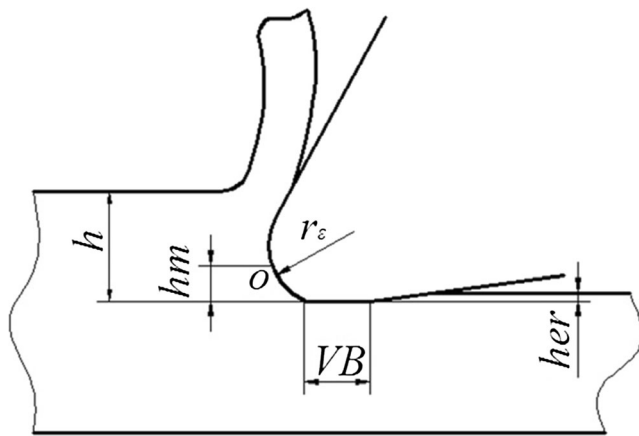
Fig. 5 Diagram of the machined surface forming process

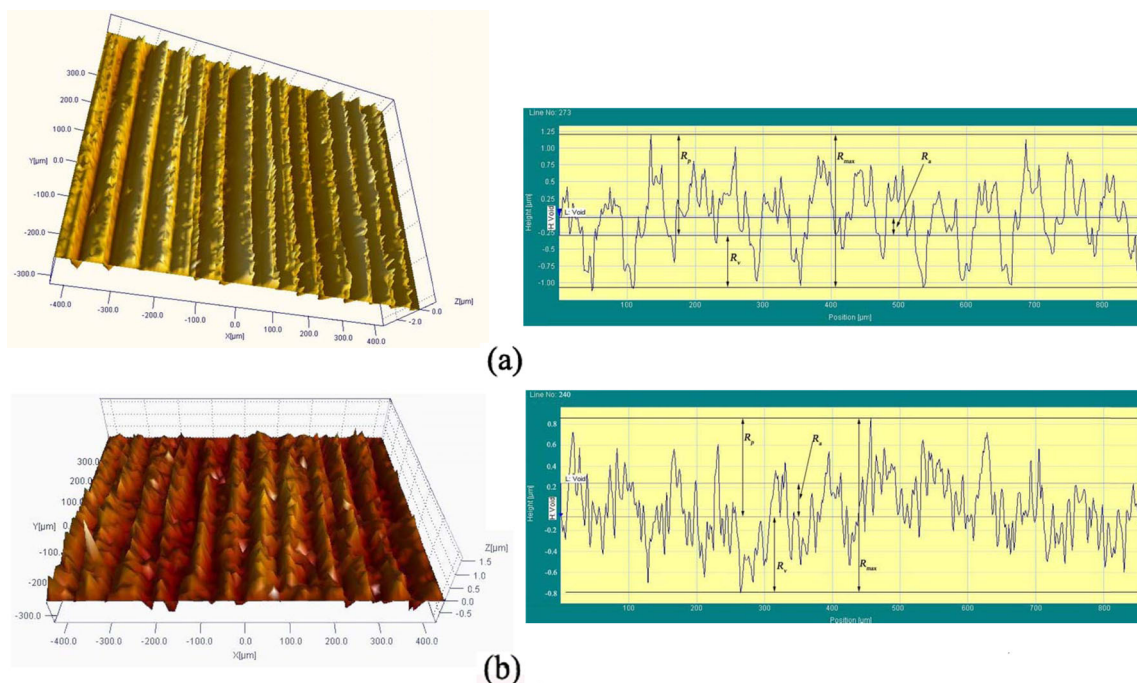
Fig. 6 Surface topography. a $VB = 0$ mm, $V_c = 40$ m min⁻¹. b $VB = 0.2$ mm, $V_c = 40$ m min⁻¹

Surface topography (Fig. 6) explicitly shows the track movement of the cutting edge. The shape of the cutting edge is copied on the machined surface. 3D surface topography images contain more information than those obtained from a surface profilometer. We noted that 3D image covers ($857 \mu\text{m} \times 638 \mu\text{m}$) of the machined surface samples rather than straight-line measurements are obtained by using a surface profilometer (in Fig. 6, the left side shows 3D surface topography images, whereas the right side shows 2D wave images). The average value of surface roughness R_a can be calculated by using peak height R_p and valley depth R_v of the machined surface waves. We noted that R_{max} (the maximum height of roughness) describes the sum of the maximum R_p and the maximum R_v of the contour curve at the reference length. When the amplitude observed by 3D surface topography is small, the produced surface roughness is uniform, and thus, good. The examination of machined surface samples by a new tool cutter presents better topography amplitude than the examination made by a worn tool cutter. This finding can be attributed to tool wear at the cutting edge close to the nose that results in large groove marks.

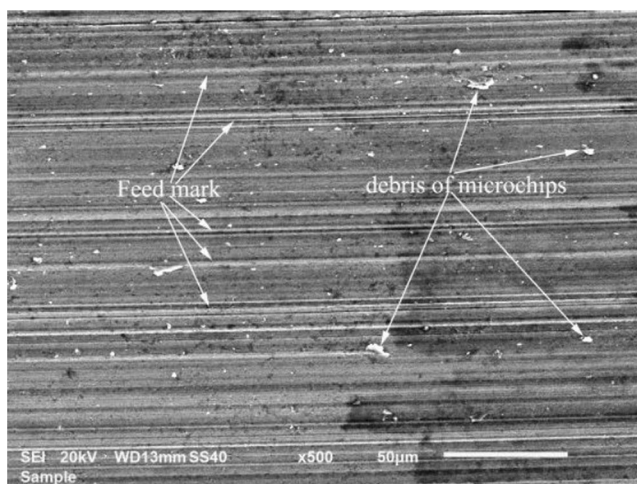
Fig. 7 Lay pattern produced by a new tool ($V_c=40 \text{ m min}^{-1}$, $f_z=0.08 \text{ mm tooth}^{-1}$, $a_p=1 \text{ mm}$, $a_e=20 \text{ mm}$)

Feed mark This defect is observed on all machined surface samples. Feed mark is a natural defect that results from feeding. Figure 7 shows an image of a typical feed mark. A high cutting speed and an intensive flank wear produce a significant feed mark on the machined surface. The machined surface is characterized by feed marks without scratches or pits at a cutting speed of less than 40 m min^{-1} by using a new tool. We noted that feed marks are produced by tool rotation caused by cutting speed (V_c) and tool toward movement owing to feed speed (V_f) together map the lay pattern [12]. In addition, many microchip debris are frequently and clearly observed. This defect is caused by random fractured chips deposited on the machined surface.

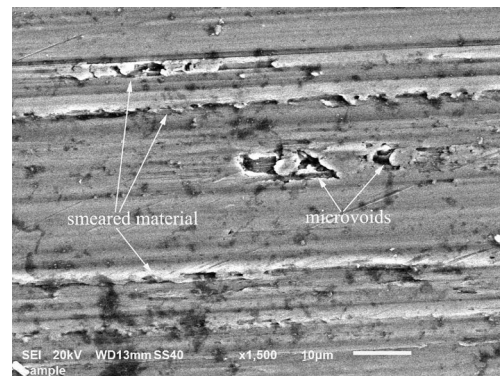
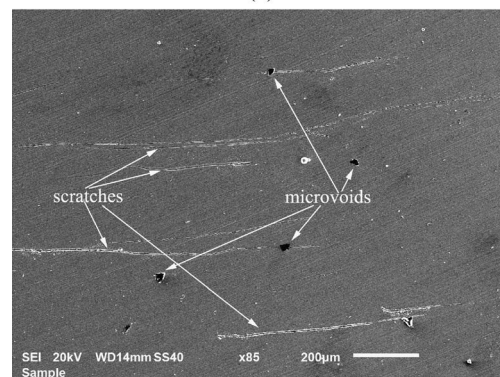
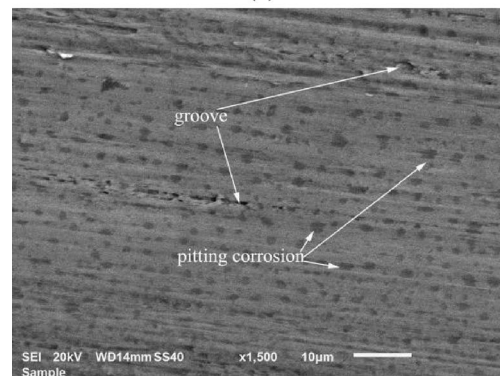
Fig. 8 Tearing surface (smearing material and surface microvoids. **a** $V_c=300 \text{ m min}^{-1}$, $f_z=0.08 \text{ mm tooth}^{-1}$, $a_p=1.0 \text{ mm}$, $a_e=20 \text{ mm}$ at the initial cutting; microvoids and scratches. **b** $V_c=300 \text{ m min}^{-1}$, $f_z=0.08 \text{ mm tooth}^{-1}$, $a_p=1.0 \text{ mm}$, $a_e=20 \text{ mm}$, worn tool $VB=0.2 \text{ mm}$; groove and pitting corrosion. **c** $V_c=300 \text{ m min}^{-1}$, $f_z=0.08 \text{ mm tooth}^{-1}$, $a_p=1.0 \text{ mm}$, $a_e=20 \text{ mm}$, worn tool $VB=0.2 \text{ mm}$)

Smear material With prolonged machining, smearing of the workpiece material occurs, and feed marks become less sharp, as shown in Fig. 8a. Smearing can be caused by the side flow of a workpiece material under the squeezing action between the minor flank face and the machined surface when the tool moves along the feed direction.

Microvoids Surface microvoids are randomly located on the workpiece surface. Surface microvoids, as shown in Fig. 8a, b, are associated with the carbide particles in the workpiece material, the particles peeling off the cutting tool, and built-up edge (BUE). Given that the carbide particles in the material, a small part of the cutting tool, and a part of BUE are harder than the workpiece material, the hard particles cannot be deformed at the plasticized layer. Hence, the hard particles crack to relieve strain. Then, these particles are removed from the machined surface, thus leaving the chip and microvoids on the machined surface. Surface microvoids, which can affect

Scratches and groove Scratches and grooves on the substrate can be observed clearly in Fig. 8a, b. When a tool is worn, the increase in the contact area of the tool–workpiece interface can aggravate the rubbing action of the tool against the workpiece, thus contributing to severe plastic deformation on the workpiece surface region. Large pieces of material from BUE

Pitting corrosion Figure 8c shows the occurrence of pitting corrosion on the tearing surface, which can be attributed to the high local cutting temperature generated by high cutting speed ($V_c=300 \text{ m min}^{-1}$, cutting temperature exceeds $1,000 \text{ }^\circ\text{C}$; Fig. 9). The tool–workpiece interface becomes the melt layer, phase transformation occurs on the surface layer, and a significant number of oxides and metal debris adhere to the machined surface.

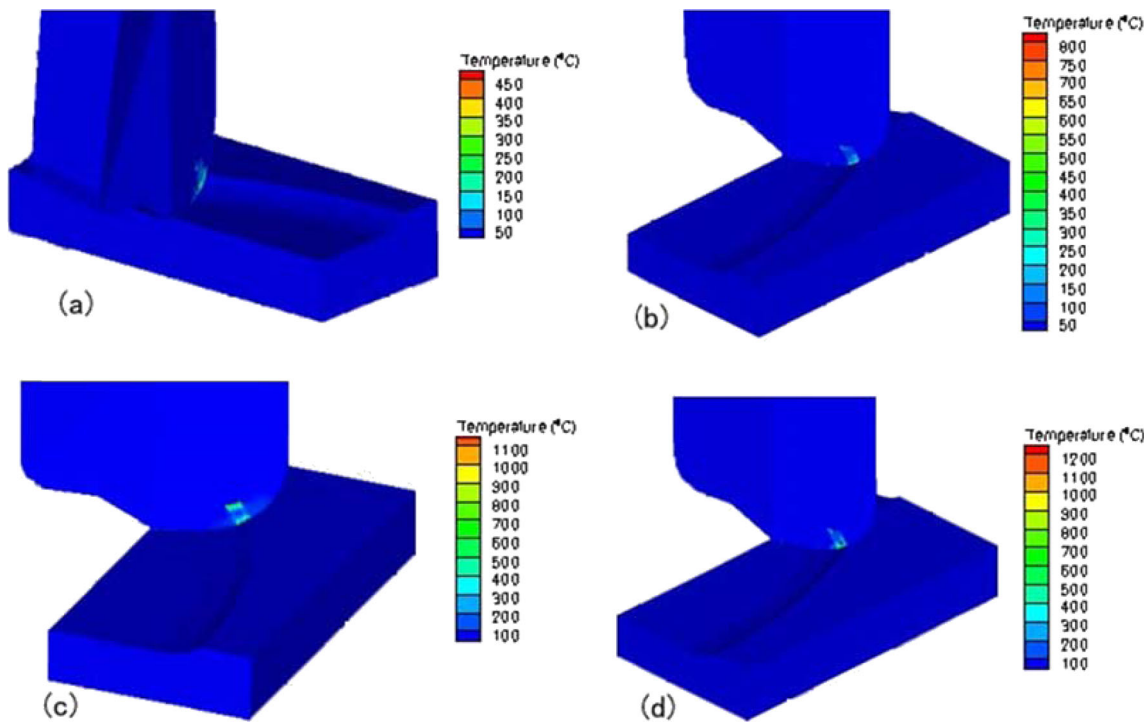
Fig. 9 Temperature distributions on the tool–chip interface. **a** $V_c=40 \text{ m min}^{-1}$, **b** $V_c=100 \text{ m min}^{-1}$, **c** $V_c=200 \text{ m min}^{-1}$, **d** $V_c=300 \text{ m min}^{-1}$

Temperature distribution on the tool–chip interface is analyzed by using the commercial finite element analysis software Third Wave AdvantEdge™. The cutting temperature finite element analysis parameters are listed in Table 4 and shown in Fig. 9. Temperature is measured at different locations at cutting speeds of 40, 100, 200, and 300 m min^{-1} . Cutting temperature exceeds $800 \text{ }^\circ\text{C}$ when cutting speed is over 100 m min^{-1} . Metal melting and phase transformation occur at high temperatures (T-1023 solution aging temperature is $760 \text{ }^\circ\text{C}$ [25]).

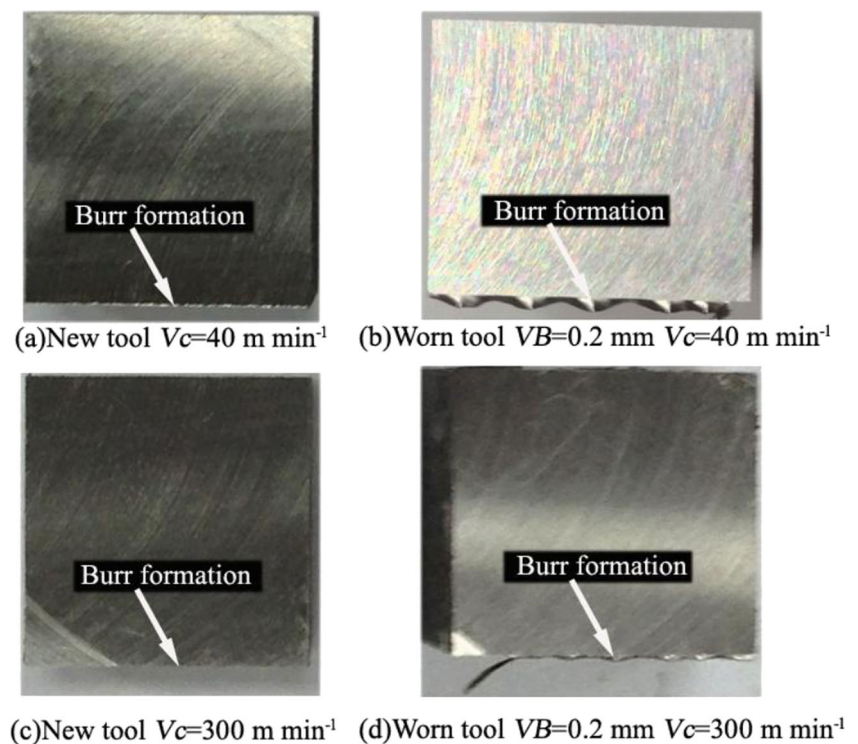
Fig. 10 Burr formation

Figure 10 shows the surfaces and machining burrs of the workpiece in the area where the tool exits the cutting zone during titanium milling at different cutting speeds and VB values. Similar to the surfaces generated in free orthogonal milling, burr formation increases when VB increases. Burr formation is generally more pronounced at low cutting speeds than at high cutting speeds. When VB increases, the effect of notch wear also increases. In the notch wear area, a well-defined material separation is hindered. Hence, chip formation and chip flow are affected. Furthermore, a part of the material in the peripheral zone of the workpiece is not removed as chips but remains on the workpiece as burrs. Consequently, an increase in burr formation is also observed with an increase in VB, as shown in Fig. 10a, b, c, d. Simultaneously, burr increases notch wear of the tool. Machai and Biermann [38] showed that notch wear at the major cutting edge may be caused by fatigue damage resulting from the fin-shaped chip and the sawtooth-shaped burrs. When cutting temperature at the tool–workpiece interface significantly increases with cutting speed greater than 300 m min^{-1} (Fig. 9), cutting force is reduced, the generated plastic deformation decreases, and burr

formation during prolonged cutting reduces mechanical effect at the major cutting edge. We also observed that the size of the burr decreases with the significant increase in cutting speed, as shown in Fig. 10a, b, c, d.

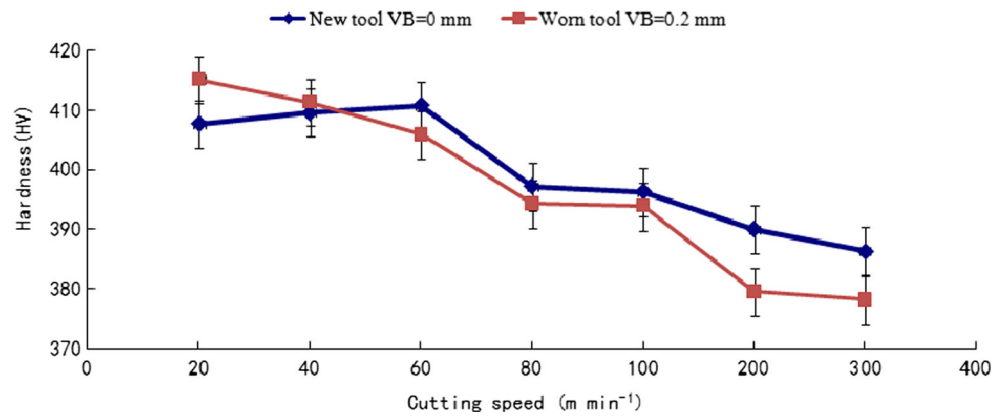
Fig. 11 Surface microhardness

The results for machined surface microhardness are shown in Fig. 11. This figure shows that microhardness increases initially and then decreases with the increase in cutting speed when a new tool is used. At cutting speeds less than 60 m min^{-1} , the plastic deformation of the cutting area increases, the strengthening effect of plastic deformation is enhanced, and machined surface hardness increases with the rise in cutting speed. At cutting speeds greater than 60 m min^{-1} , the contact time of the tool flank with the materials is short, plastic deformation of the cutting area decreases, cutting temperature increases, and the machined surface is fully softened with the rise in cutting speed. Hence, machined surface hardness decreases. Wear on the cutting edge affects the microstructure. Surface hardening occurs when machining is conducted by using a worn tool at different cutting speeds (Fig. 11). The microhardness of the machined surface decreases with increasing cutting speed. This result can be attributed to the deformation on the flank face and high machining pressure at low cutting speed. However, softening of the machined surface material is probably caused by high cutting temperature on the tool–workpiece interface at high cutting speeds.

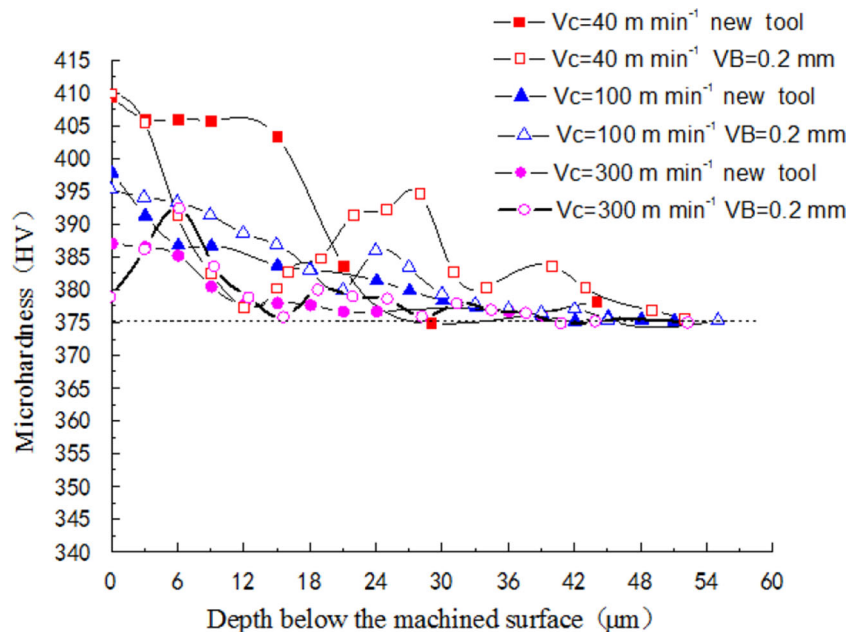
Fig. 12 Microhardness below the subsurface

The depth of hardening below the machined surface in this study is shown in Figs. 12 and 13. As shown in Fig. 12, microhardness exhibits the same trend at different cutting speeds with a new tool or a worn tool. However, the depth of hardening by a worn tool is greater than that by a new tool. Microhardness on the machined surface starts with a value higher than that of the bulk material when a new tool is used. The starting value is approximately 9 % higher than bulk material hardness. Microhardness decreases to the hardness of the bulk material (~375 HV) at a depth of approximately 20 to 35 μm below the machined surface. The softening region cannot be observed in Fig. 12. However, for VB=0.2 mm, the starting value on the machined surface is less than 6 %, which is higher than bulk material hardness. Microhardness decreases to 378 HV at a depth of approximately 15 to 20 μm below the machined surface, reaches its peak at 30 to 40 μm, and then decreases gradually to the hardness of the bulk material at cutting speeds less than 100 m min⁻¹. However, this starting value on the machined surface is approximately

similar to bulk material hardness. Then, hardness increases to 393 HV at a depth of approximately 6 to 8 μm below the machined surface and decreases gradually to the hardness of the bulk material at cutting speeds greater than 100 m min⁻¹. Hence, the softening region can be observed in Fig. 12. The generated hardness mainly results from corner radius extrusion, severe friction between the tool flank and the machined surface, high pressure during chip formation, cutting heat in the cutting area, and poor thermal conductivity of Ti-1023. Work hardening occurs when high machining pressure and temperature are generated during machining [8]. In addition, milling is an interrupted cutting process. When the milling tool (entry) starts milling the workpiece, heat accumulation occurs. Correspondingly, when the milling tool (exit) stops milling the workpiece, cooling occurs. Hence, internal work hardening is an accumulation of the cyclic process. In Fig. 13, when cutting speed is within the range of 20 to 100 m min⁻¹ by using a new tool, the depth of hardening is approximately 25 to 35 μm. However, the depth of hardening decreases with

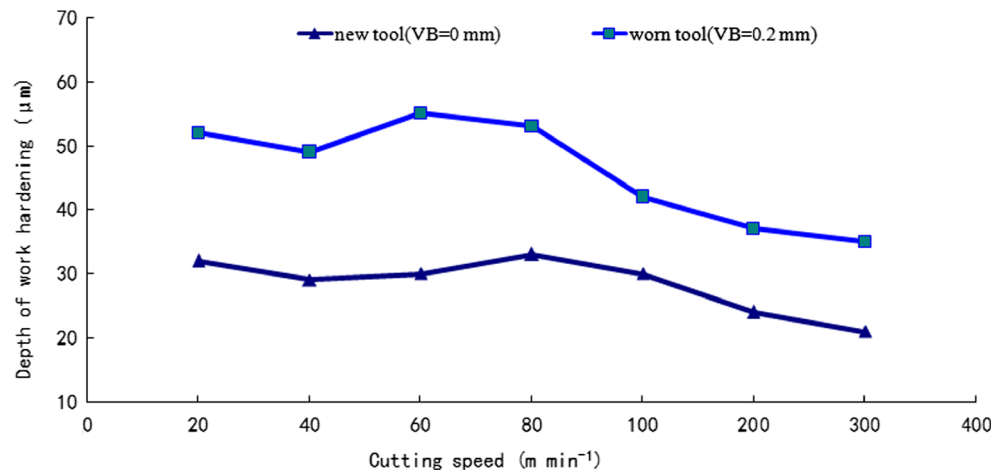
Fig. 13 Depth of hardening at the subsurface

the increase in cutting speed when cutting speed exceeds 100 m min^{-1} . When machining is conducted by using a worn tool at $\text{VB}=0.2 \text{ mm}$, the depth of hardening is approximately 35 to 55 μm . Therefore, the depth of hardening decreases with the increase in cutting speed.

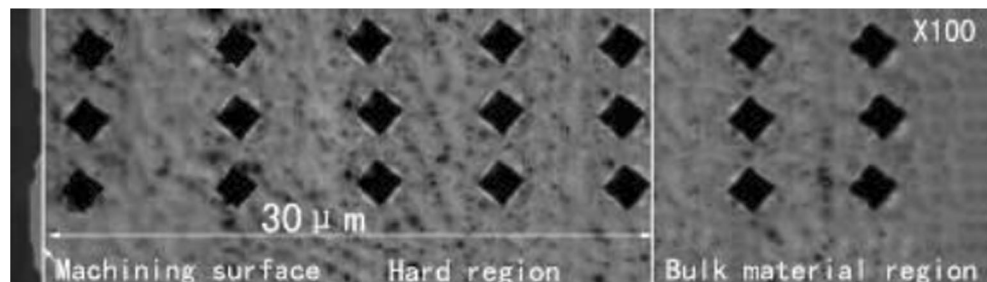
Fig. 14 Hard region beneath the machined surface

The subsurface of the machined samples can be divided into two regions, as shown in Fig. 14, i.e., hard and bulk material regions. Plastic deformation and grain size are directly related to hardness values. We conclude that microhardness modification on the machined subsurface may result in high temperature because Ti-1023 has low thermal conductivity [39].

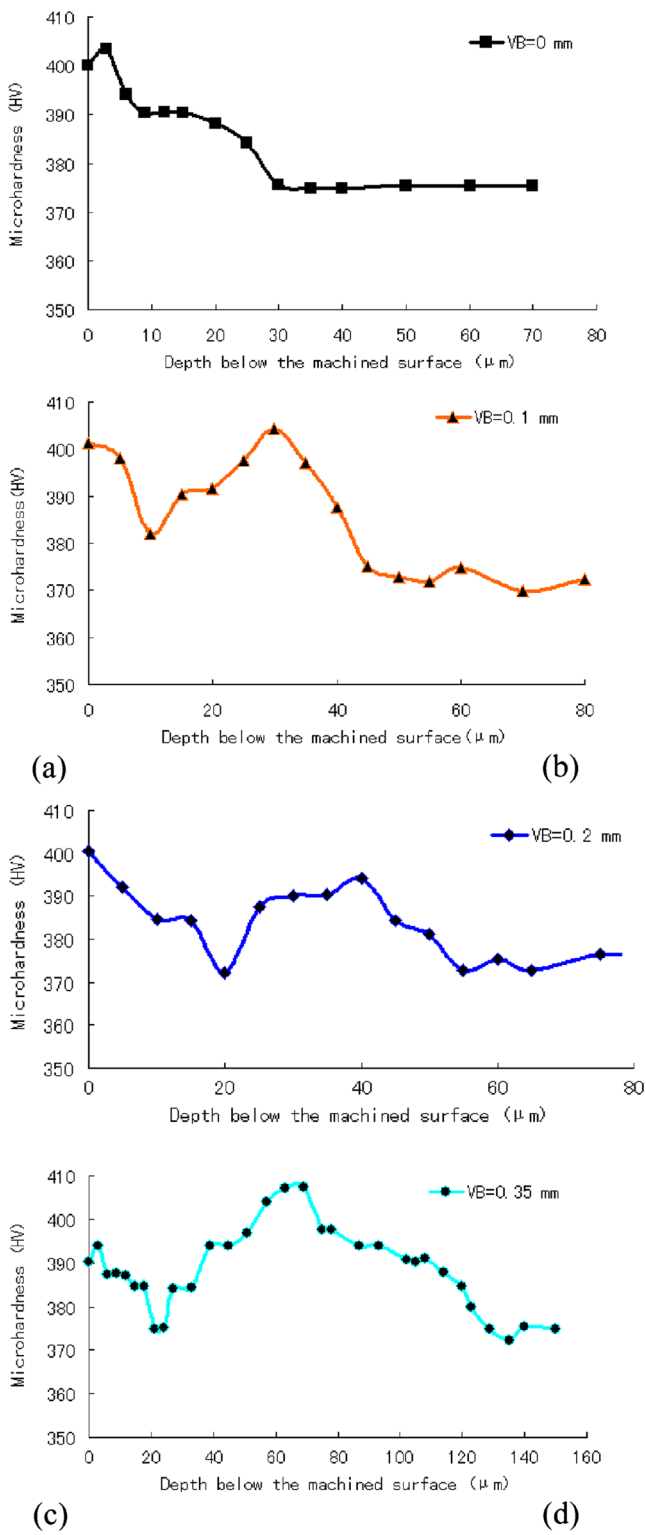
Fig. 15 Influence of VB on the depth of hardening ($V_c=60 \text{ m min}^{-1}$, $f_z=0.08 \text{ mm}$, $a_p=1 \text{ mm}$)

Figures 15 and 16 show the depth of hardening below the machined surface at different VB values. As shown in Fig. 15, microhardness exhibits the same trend at different VB values. When $\text{VB}=0$, as shown in Fig. 15a, microhardness (400 HV) decreases to the hardness of the bulk material. When $\text{VB}=0.1 \text{ mm}$, as shown in Fig. 15b, microhardness decreases from 400 to 383 HV at a depth of 10 μm below the machined surface, reaches a peak at 30 μm , and then decreases again to matrix hardness. When $\text{VB}=0.2 \text{ mm}$, as shown in Fig. 15c, microhardness decreases from 400 to 378 HV, exhibits a valley at a depth of 20 μm below the machined surface and a peak at 40 μm , and then gradually decreases again to matrix hardness. When $\text{VB}=0.35 \text{ mm}$, as shown in Fig. 15d, microhardness decreases from 390 to 375 HV, exhibits a valley at a depth of 20 μm below the machined surface and a peak at 407 HV and 68 μm , and then gradually decreases again to

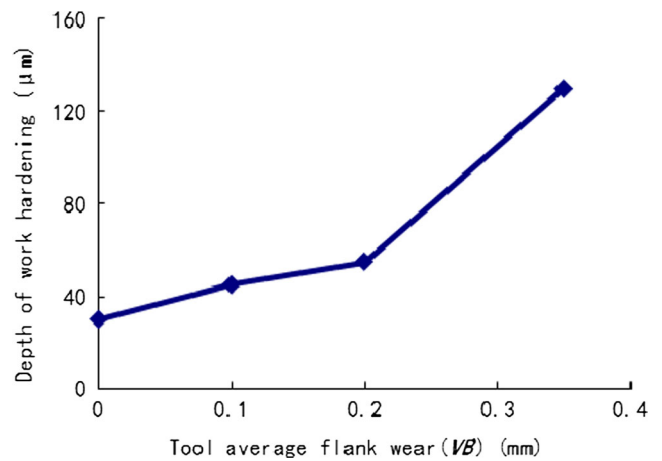
Fig. 16 Influence of VB on microhardness $V_c=40 \text{ m min}^{-1}$ ($V_c=60 \text{ m min}^{-1}$, $f_z=0.08 \text{ mm tooth}^{-1}$, $a_p=1 \text{ mm}$)

matrix hardness. Microhardness on the subsurface follows the “surface enhancing–thermal softening–restrengthening–stabilizing” process, wherein the hardening and softening regions appear. Surface hardening is consistent with the finding of Chen [40] during high-speed milling of Ti-6Al-4V. In Fig. 16, when VB ranges from 0 to 3.5 mm, the depth of hardening increases by approximately 30 from 130 μm . Tool wear influence on the hardened layer is evident, and the depth of hardening increases with increasing VB. Subsurface hardening and the softening zone appear when $\text{VB}\geq 0.1 \text{ mm}$.

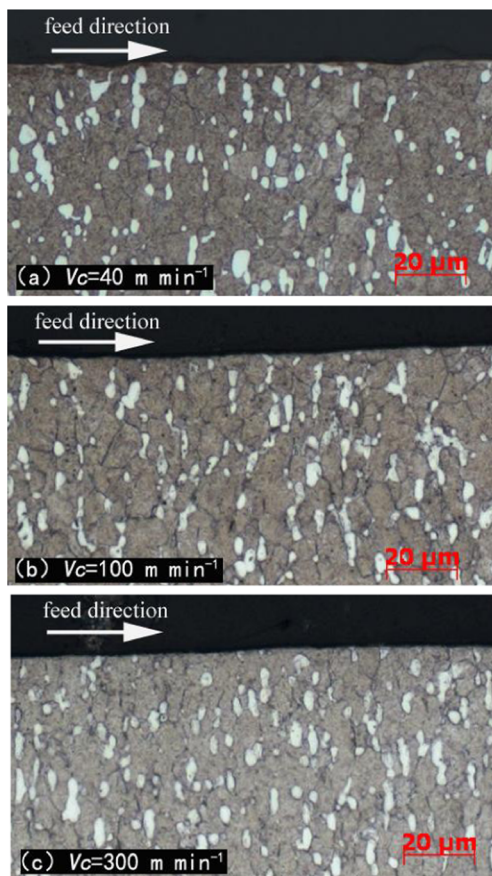
Fig. 17 Influence of cutting speed on subsurface microstructure (initial wear, $f_z=0.08$ mm tooth⁻¹, $a_p=1$ mm)

Cross sections of the machined surface samples produced by new and worn tools at different cutting speeds are shown in Figs. 17, 18, and 19. Subsurface microstructural deformation caused by machining consists of deformed grain boundaries in the direction of cutting (Fig. 18) and elongation of grains (Fig. 19). These types of defects are typically reported during machining of titanium alloys [7, 8]. Observations of Figs. 17, 18, and 19 enable us to conclude that the microstructure at the top region to several micrometers beneath the machined surface tends to exhibit plastic deformation. Plastic deformation seems to follow the same direction as feed speed. From observations of the recorded images, we noted that the severity of plastic deformation on the subsurface immediately beneath the machined surface is controlled by cutting speed and tool wear.

Figure 17 shows the cross section of the subsurface microstructure from the machined surface at different cutting speeds when using a new tool (initial wear). No significant microstructural alteration or deformed grain

resulting from low cutting pressure and cutting temperature was observed. The subsurface microstructure near the surface tends to exhibit plastic deformation. This form of microstructural alteration is typically associated with the highly localized surface heating caused by abusive machining or a worn tool [20]. Slight plastic deformation of a layer of the machined surface is observed at different cutting speeds of 40, 100, and 300 m min⁻¹, as shown in Fig. 18. By contrast, a considerably deformed area can be observed for samples generated by a worn tool, with $VB=0.2$ mm at different cutting speeds. With the increase in cutting speed from low to high, plastic deformation and deep alteration of the microstructure decrease. Plastic deformation on the machined surface is caused by high cutting pressure at high temperature during the machining process. Prolonged machining by using a worn tool from the initial wear to $VB=0.35$ mm produces severe plastic deformation and deep alteration of the microstructure on the machined surface, as shown in Fig. 19. A shallow layer of considerably deformed material can be formed at high temperature and high cutting pressure produced during cutting. Thus, the findings are consistent with the expected behavior described previously.

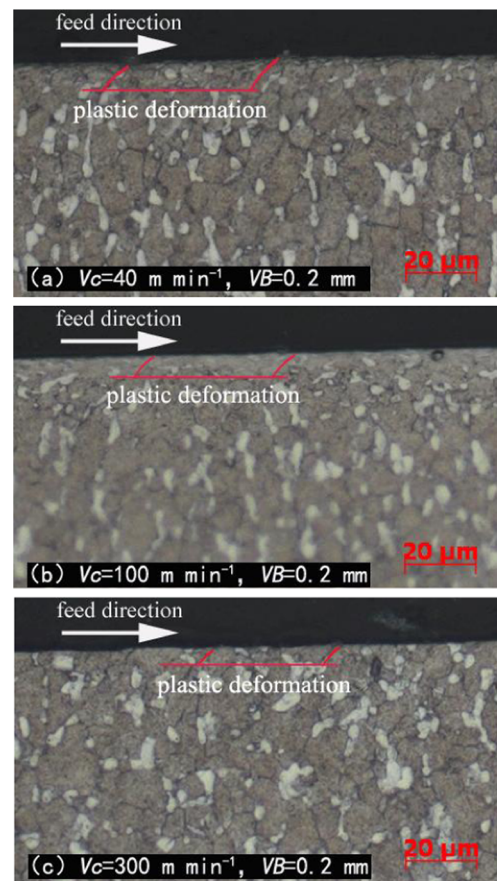
Fig. 18 Influence of cutting speed on subsurface microstructure (tool average flank wear $VB=0.2$ mm, $f_z=0.08$ mm tooth⁻¹, $a_p=1$ mm)

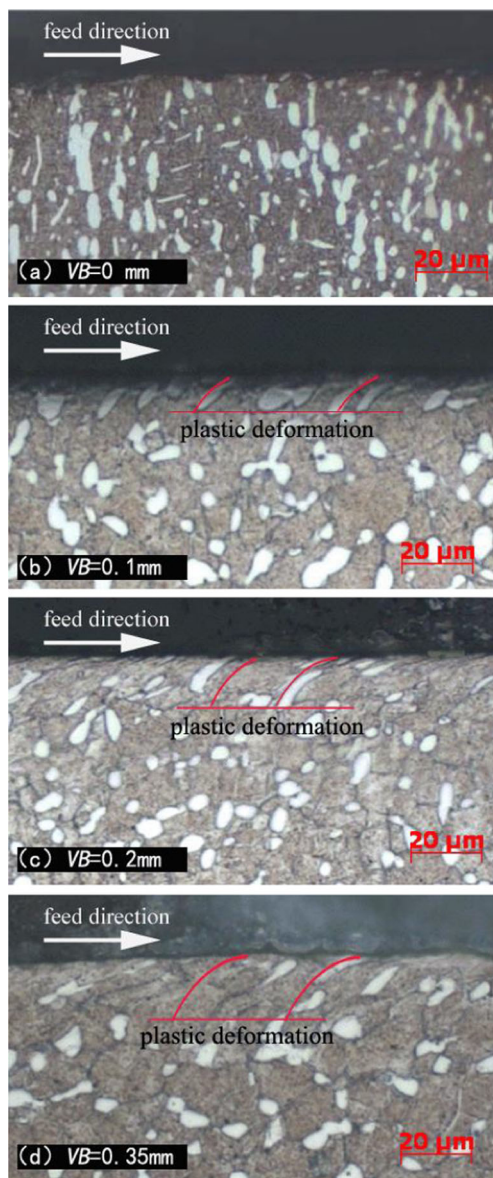
Fig. 19 Influence of VB on subsurface microstructure ($V_c=60 \text{ m min}^{-1}$, $f_z=0.08 \text{ mm tooth}^{-1}$, $a_p=1 \text{ mm}$)

temperature increase significantly. This finding can be attributed to the plastic deformation or microstructural alteration of the subsurface, as shown in Fig. 19. Tool wear is best controlled at $VB < 0.2 \text{ mm}$ in finish machining of titanium to decrease the depth of the hardening layer.
