New technique of radial-additive friction stir repairing for exceeded tolerance holes

Abstract

Keywords Radial-additive friction stir repairing · Exceeded tolerance holes · Magnesium alloys · Microstructures · Mechanical properties

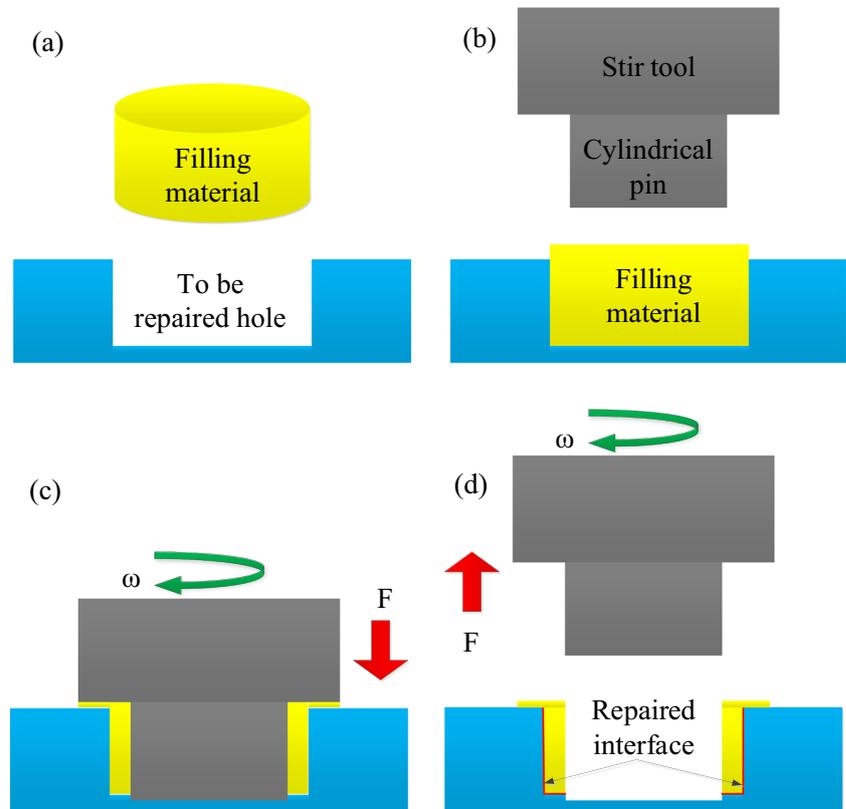
Fig. 1 Schematic of R-AFSR: (a) drilling, (b) filling, (c) repairing, and (d) retracting stages

Figure 1 indicates the schematic of the R-AFSR process. A rotating tool was composed of a threaded cylindrical pin and a concave concentric-circles-flute shoulder. The FM and base metal (BM) were heterogeneous. The R-AFSR process included the drilling, filling, repairing, and retracting stages. A pinless tool and a cylindrical right-handed thread pin tool were used. Firstly, a pinless tool was plunged into the workpiece, thereby obtaining a cylinder-shaped hole (Fig. 1a). Secondly, the FM was put into the hole before the repairing process (Fig. 1b). Thirdly, the rotating tool was gradually plunged into the workpiece to a designed depth and dwelled for a few seconds (Fig. 1c). Finally, the exceeded tolerance hole was repaired after the rotating tool was retracted, obtaining high-quality repairing interfaces (Fig. 1d).

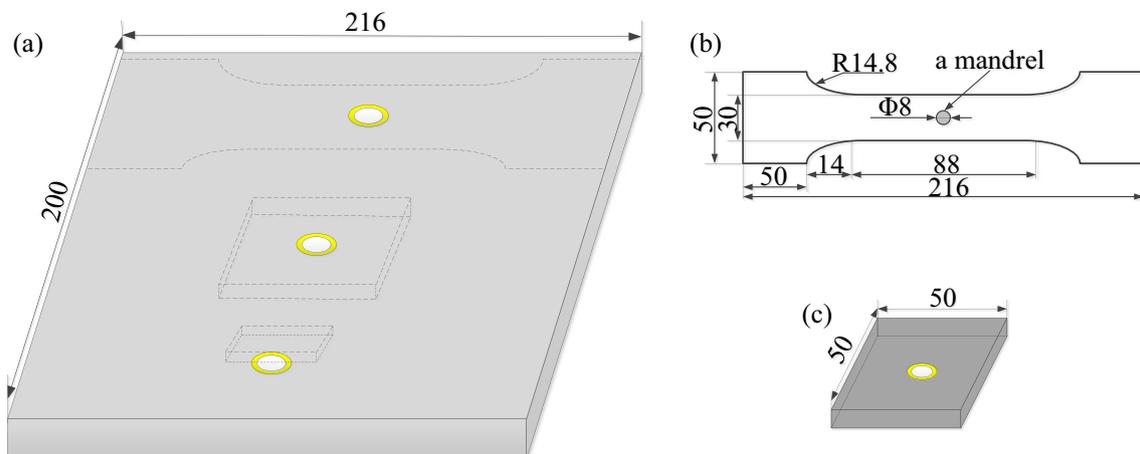
Fig. 2 Schematics of mechanical specimens: (a) testing plate, (b) tensile sample, and (c) compressive shear sample (unit, mm)

The specimens after repairing were cut by an electrical discharge cutting machine to conduct microstructural and mechanical characterizations (Fig. 2). The microstructural specimens were etched by picric acid (4.2 g picric acid, 10 ml H₂O, 10 ml acetic acid, and 70 ml ethanol) and then observed by an optical microscope (OLYMPUS, GX71) and scanning electron microscope (SEM, HITACH-SU3500). To evaluate the mechanical properties of R-AFSR holes, two mechanical testing methods were used, including tensile tests and compressive shear tests. Three tensile specimens were prepared for each parameter with reference to GB/T2651-2008 (ISO 4136:2011). Schematic of the tensile specimen is presented in Fig. 2b. In addition, the repaired region was filled with a mandrel before tensile tests. Tensile tests at room temperature were performed under a constant crosshead speed of 3 mm/min. In this study, the standard hole and the repaired region were investigated for tensile tests, and these holes had the same diameter. Moreover, a self-designed compressive shear apparatus is shown in Fig. 3a, and the sample is presented in Fig. 2c. The compressive shear strength formula is $P=F/S$, where F is compressive shear force (N) and S is compressive shear area (m²). Fracture surface morphologies of tensile specimens were observed by a SEM (HITACH-SU3500). The microhardness of the repaired region was measured by the microhardness tester (HVS-1000) at a load of 100 g for a dwelling time of 10 s. The measured locations were 0.5 mm and 1.5 mm distances away from the top surface of the repaired region, and the interval between the two measured points was 0.25 mm (Fig. 3b).

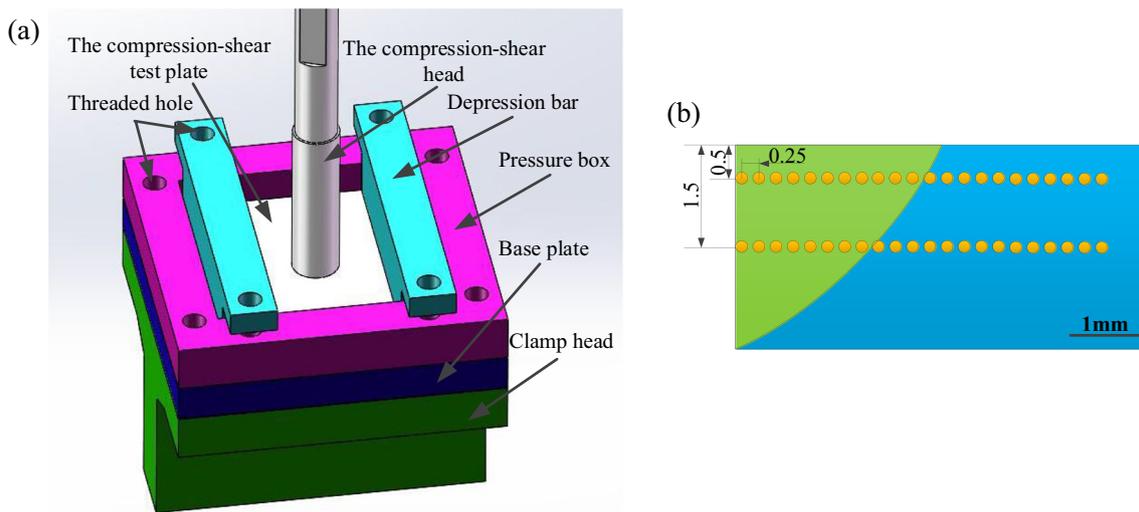
Fig. 3 Schematics: (a) compressive shear apparatus and (b) locations of the measured points for hardness (unit, mm)

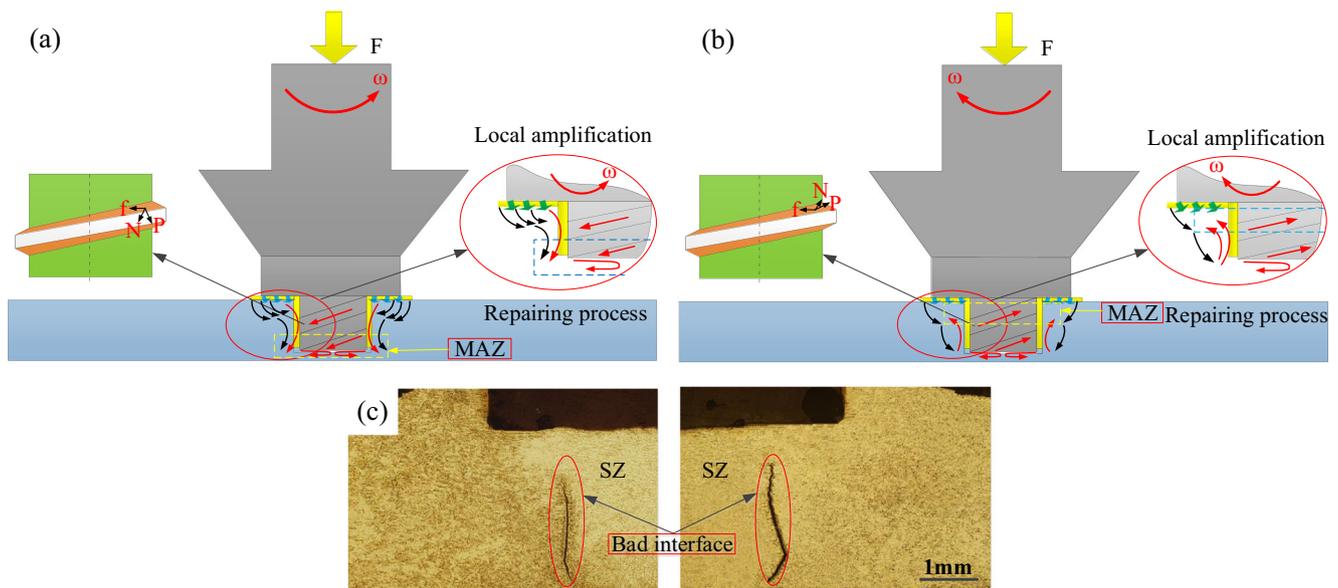
Fig. 4 Schematics of material flow at the repairing stage under different rotating directions: (a) anticlockwise and (b) clockwise; (c) cross-sections of the repaired regions at anticlockwise

Figure 4a and b displays the material flow models at the repairing stage when the tool rotates anticlockwise and clockwise, respectively. At the repairing stage, the threaded pin drives the plastic materials to vertically flow. The materials in the threaded grooves undergo two forces, which are the positive pressure (p) provided by the side wall of threaded grooves and the friction force (f) between the plasticized materials and the side wall of threaded grooves. The resultant

force between p and f dominates the flow direction of the plasticized materials around the rotating pin. In this study, the right-handed thread pin transfers the materials downward or flow upward when it rotates anticlockwise or clockwise (Fig. 4a and b). In Fig. 4a, much more materials are accumulated around the pin tip, forming material accumulated zone (MAZ). The MAZ pushes the FM between the pin and the BM to move upward, which is detrimental to the atom diffusion bonding between the FM and the BM. Moreover, not only does the tool shoulder prevent the FM between the pin and the BM from flowing upward, but also the continuously plunging shoulder drives the materials to transfer downward. Therefore, when the right-handed thread pin rotates anticlockwise, kissing bond easily appears in the center of the stir zone

(SZ) or the bottom near the boundary between the FM and the BM (Fig. 4c). When the rotating tool rotates clockwise, the materials driven by the pin flow upward, thereby forming the MAZ beneath the tool shoulder (Fig. 4b). The materials in the MAZ are driven to flow downward, and then provide big force on the FM, which is beneficial to improving the atom diffusion. Therefore, for the R-AFSR process, the defect-free repaired region can be attained when the tool pin rotates clockwise.

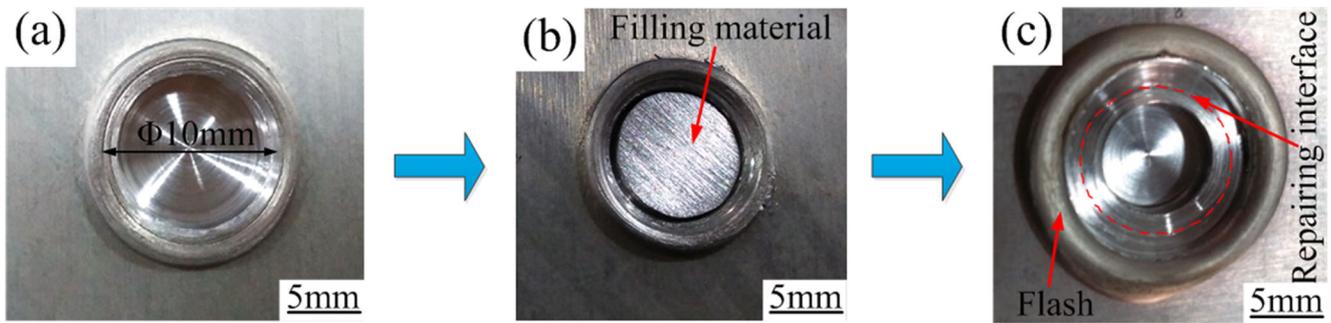
Fig. 5 Surface morphologies at different stages at a rotating velocity of 1400 rpm: (a) drilling stage, (b) filling stage, and (c) retracting stage

Figure 5 depicts the surface morphologies of the repaired regions at different stages. In Fig. 5a, a cylinder-shaped hole with a depth of 2.5 mm is obtained by the rotating pinless

tool. At the drilling stage, the flash defects are formed around the repaired region because some materials are squeezed out. At the filling stage, an extra FM with a diameter of 10 mm is put into the hole, as presented in Fig. 5b. The repaired region after the retracting stage is displayed in Fig. 5c. The gap between the FM and the BM is completely filled and repaired. The hole with a diameter of 10 mm is transformed into a hole with a diameter of 8 mm by the cylindrical right-threaded pin. At the repairing stage, the tool pin is plunged into the FM and extrudes the materials out of the repairing zone, further enlarging the flashes around the hole. Therefore, compared with the flashes in Fig. 5a or b, the flash in Fig. 5c at the retracting stage is larger. Based on good surface formation of the repaired region (Fig. 5c), it is concluded that the R-AFSR process has potential to repair the exceeded tolerance hole.

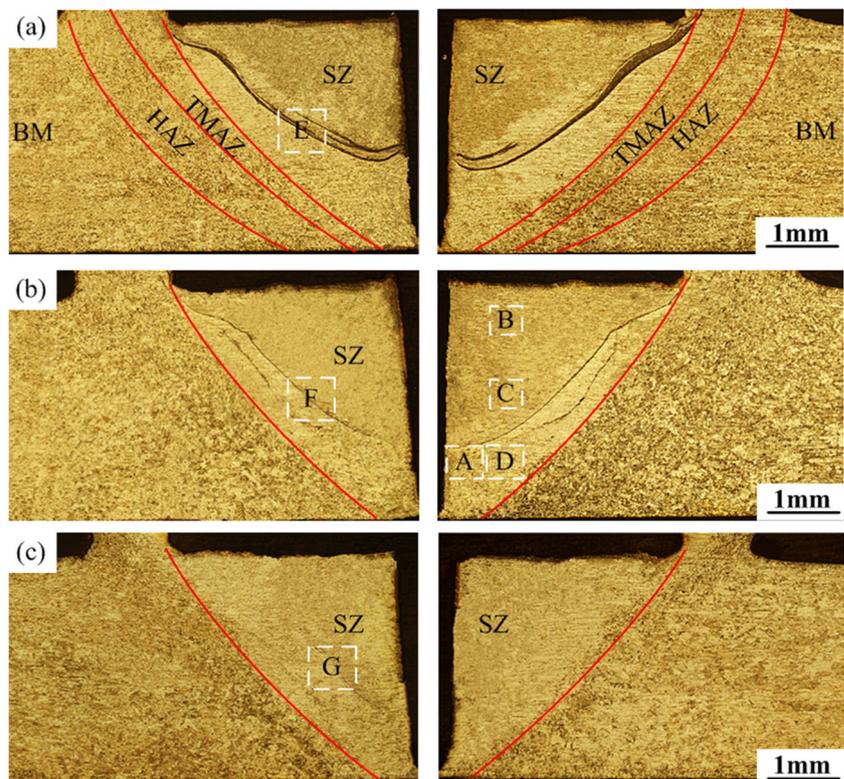
Fig. 6 Macrostructures of the repaired regions under different rotating velocities: (a) 1200 rpm, (b) 1400 rpm, and (c) 1600 rpm

Figure 6 presents the macrostructures of the repaired regions at the rotating velocities of 1200 rpm, 1400 rpm, and 1600 rpm, correspondingly. The exceeded tolerance hole can be successfully repaired. The repaired region is divided into four typical zones, namely, BM, heat-affected zone (HAZ), thermo-mechanically affected zone (TMAZ), and SZ, as shown in Fig. 6a. The SZ presents a funnel shape, resulting from the combined actions of the rotating pin and shoulder. The repaired interface displays a black line in Fig. 6a due to severe thermo-mechanical flow, which is composed of fine and equiaxed grains. As the rotating velocity increases, the black line is gradually narrowed. Moreover, the repaired region without thickness reduction is successfully attained,

which increases the area of load bearing and improves mechanical properties. The FM and the BM near the rotating shoulder are sufficiently mixed at the repairing stage, so there is no black line near the top surface of the repaired regions (Figs. 6a and b). With the increase of rotating velocity, the materials experience higher temperature, which easily result in the growth of the fine grains. This is the reason why the black line in Fig. 6c disappears at the rotating velocity of 1600 rpm.

As mentioned above, there exist some black lines in the SZ (Fig. 6). In order to explicit these lines, the enlarged views of the typical locations are displayed, as shown in Fig. 9. These black lines contain amounts of fine grains. As the grain size decreases, the line becomes black. Niu et al. [30] put forward passive-filling friction stir repairing (P-FFSR) of AZ31-B magnesium alloys and found that a large number of fine grains existed at the interface between the extra FM and the BM. In this study, the phenomenon in Fig. 9 is similar to that reported by Niu et al. [30], which is also contributed to the grinding process between the FM and the BM. For the R-AFSR process, the heat input increases with increasing rotating velocity, thereby heightening the peak temperature and increasing the growth of grains. Therefore, the grains, which form the black line, have the increasing size with the raise of rotating velocity, leading to the reduction of black line (Fig. 9). From Figs. 8 and 9, it is also known that the top of the SZ consists of the grains with larger sizes and the grain size increases with the raise of heat input, which is another reason why the top of the SZ in Fig. 6c has no black lines.

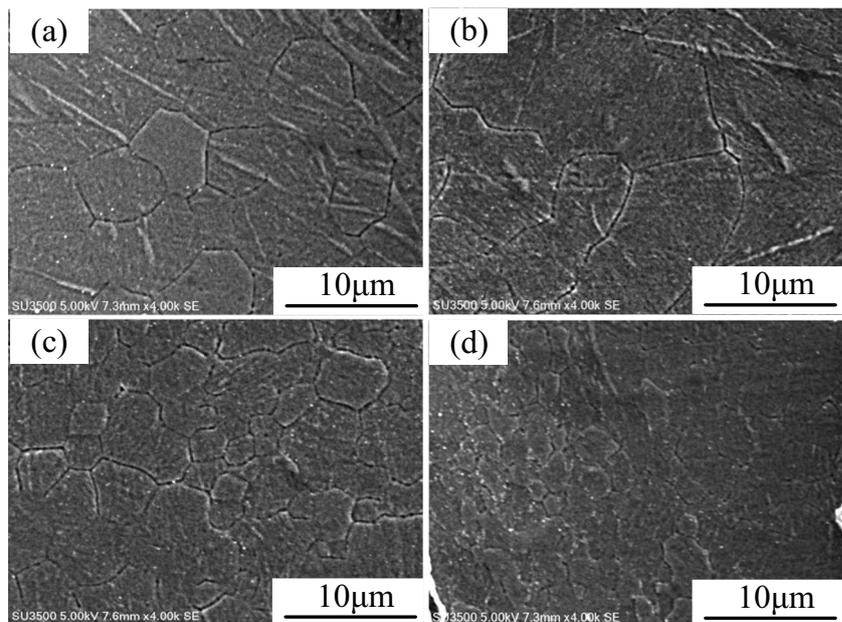
Fig. 7 Microstructures of the typical zones in the repaired region at the rotating velocity of 1400 rpm: (a) BM, (b) HAZ, (c) TMAZ, and (d) black line

Figure 7 illustrates the microstructures at the BM, HAZ, and TMAZ of the typical joint. The microstructures in the BM present inhomogeneous grains (Fig. 7a). The materials in the HAZ

only undergo the thermal cycle, resulting in the coarse grains. During the R-AFSR process, the temperature in TMAZ is higher than that in HAZ because the materials in the TMAZ undergo both the thermal cycle and the mechanical stirring. Therefore, the TMAZ of the repaired region for Al alloys is characterized by the elongated and deformed grains. Compared with Al alloys, Mg alloys own low stacking fault energy and low recrystallization temperature. Consequently, dynamic recrystallization (DRX) easily occurs in the TMAZ of FSW or FSR process of Mg alloys [28]. In this study, the microstructures in the TMAZ in Fig. 7c are featured by the fine and equiaxed grains, which are much smaller than those in the BM. Moreover, compared with the BM, HAZ,

and TMAZ, the grain in the black line is formed by the finer grains (Fig. 7c), which is because of the severe thermo-mechanical flow.

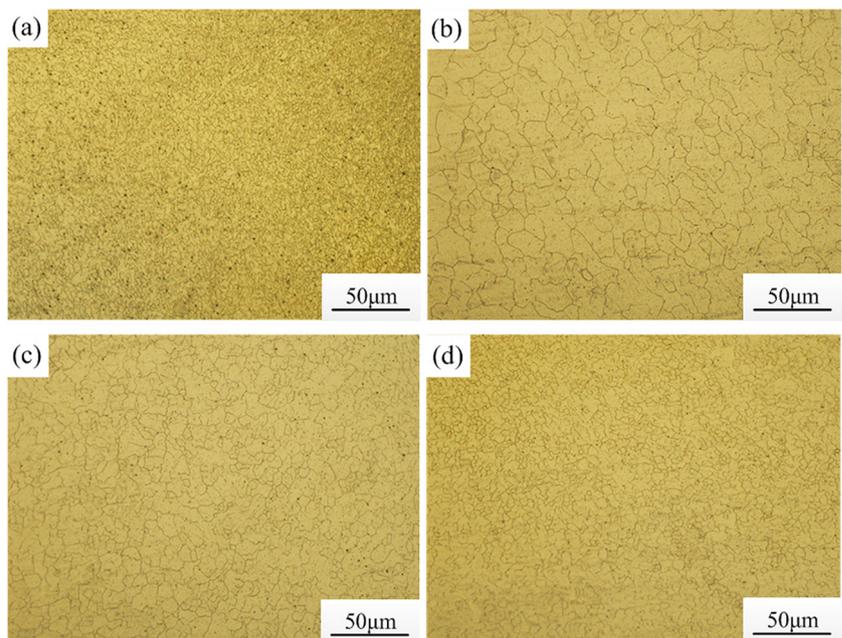
Fig. 8 Microstructures of typical locations marked in Fig. 6b: (a) A, (b) B, (c) C, and (d) D

Figure 8 displays the microstructures of typical locations in the SZ at 1400 rpm. The SZ is characterized by the fine and equiaxed grains owing to the DRX induced by high peak temperature and strain rate [29]. As mentioned above, the materials contacting with the rotating pin possess the high flow velocity, and the adjacent materials undergo the flow velocity that decreases with increasing the distance from the pin. Therefore, the grain size in the SZ increases with distancing away from the repaired region due to the differences in peak temperature and material flow behavior. The grain sizes in locations A and D are, respectively, 3.5 µm and 6.5 µm (Figs. 6a and b). Along the thickness direction, the materials in the top of the SZ experience higher flow velocity and peak temperature than those in the middle or bottom of the SZ because

of the rotating shoulder. Consequently, the grain size in location D is smaller than that in location C. The grain size in location C is 8.6 µm. The grain size of 9.9 µm in location B is the largest.

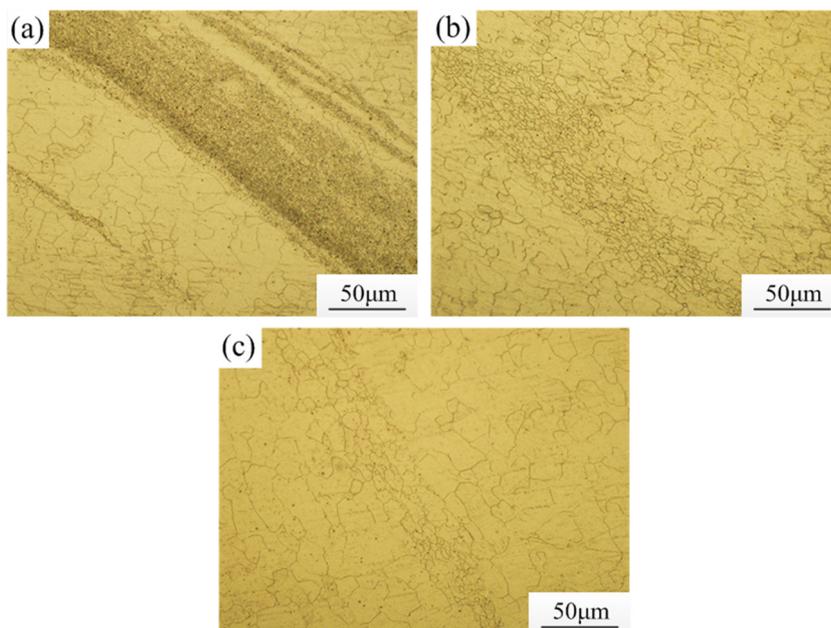
Fig. 9 Microstructures of the repaired interfaces in Fig. 6 under different rotating velocities: (a) E, (b) F, and (c) G

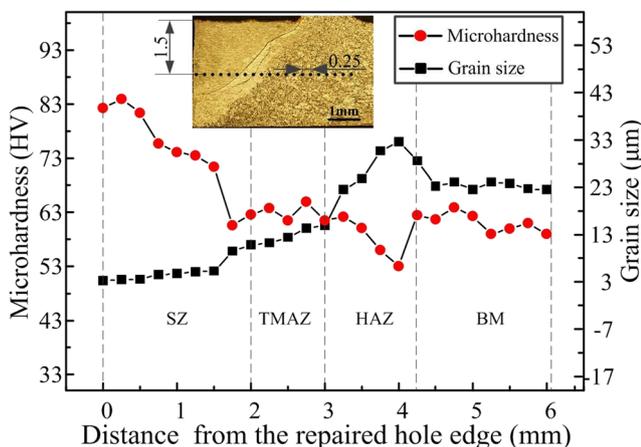
Fig. 10 Grain size and microhardness distributions of the typical repaired region

Figure 10 displays the distribution curves in grain size from the SZ to BM. The grain size increases firstly and then decreases from the SZ to BM, while the grain size in the HAZ is the largest. Figure 10 displays the microhardness distribution

of the repaired region at 1400 rpm. Two measured lines are, respectively, 0.5 mm and 1.5 mm away from the top surface of the repaired region. Both of the lines have the similar distribution. According to the Hall-Petch formula, the finer the grain size, the higher the microhardness. The grains in the SZ are greatly refined by the rotating tool, so the microhardness values in the SZ are higher than those in other regions. The HAZ consists of the coarse grains, so the microhardness values in the HAZ are the smallest.

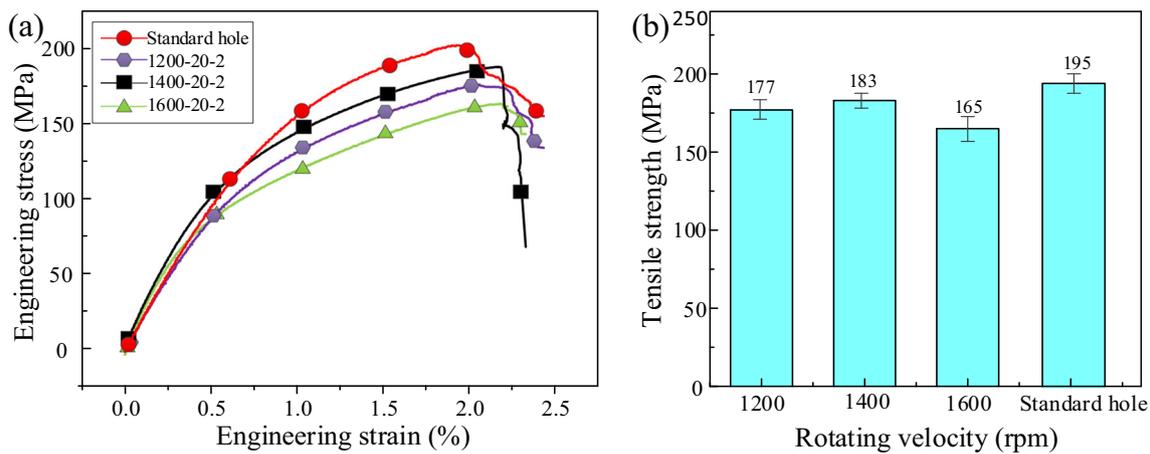
Fig. 11 Tensile results of the repaired regions: (a) engineering stress-strain curves, (b) tensile strength

Figure 11a and b exhibits the engineering stress-strain curves and ultimate tensile strengths of the repaired regions at different rotating velocities, correspondingly. The ultimate tensile strength of the standard hole is approximately 195 MPa. The ultimate tensile strengths of the repaired regions firstly increase and then decrease with the increase in the rotating velocity. Moreover, the ultimate tensile strength of the superior repaired region reaches the maximum value of 183 MPa at

1400 rpm, which is equivalent to 93.8% of that of the standard hole. The tensile strength of the repaired region is improved when the rotating velocity varies from 1200 rpm to 1400 rpm. However, the tensile strength decreases when the rotating velocity increases from 1400 rpm to 1600 rpm. This reduction of tensile strength is attributed to the softening regions induced by the heat input and interfacial defects. Therefore, selecting reasonable process parameters is extremely essential for the R-AFSR process to obtain the high-quality repaired regions.

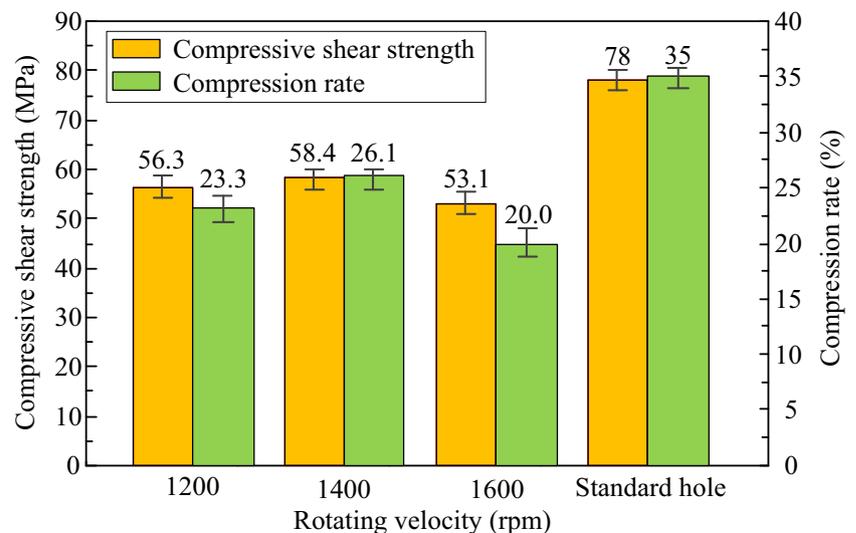
Fig. 12 Compressive shear strengths and compression rates at different rotating velocities

Figure 12 displays the compressive shear strengths and compressive rates of the repaired regions at different rotating velocities. Rotating velocity plays an important role in compressive shear strengths and compressive rates. With the increase of rotating velocity, both compressive shear strengths and compressive rates of repaired regions firstly increase and then decrease. Similar to the tensile strength, the compressive shear strength and compressive rate of the repaired region reach the maximum values of 58.4 MPa and 26.1% at the rotating velocity of 1400 rpm, equivalent to 75% and 74.6% of those of the standard hole. As a matter of fact, the

compressive shear strength of the repaired region is closely related to interfacial behaviors and heat input. The atomic diffusion near the joining interface is an important factor. In addition, low heat input causes poor material flow, leading to the formation of interfacial defects. High heat input causes material softening, thereby deteriorating mechanical properties. When optimum heat input is achieved, the best mechanical properties can be obtained in the repaired region.

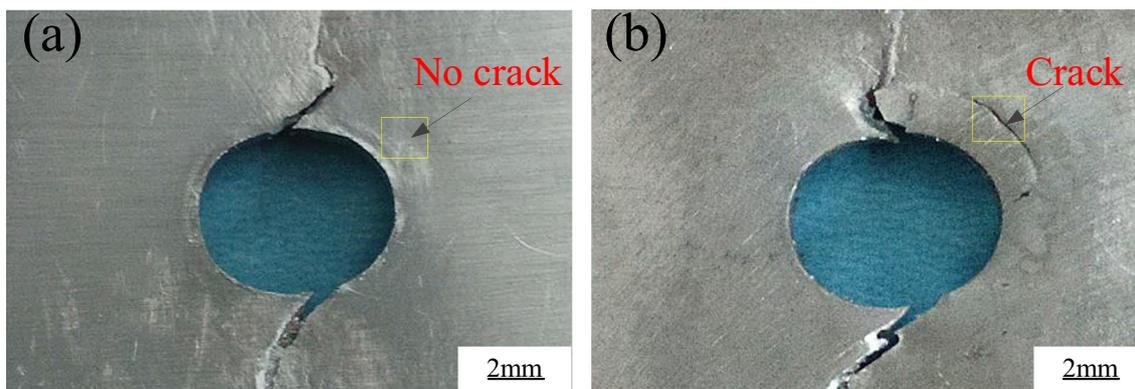
Fig. 13 Enlarged views of fractured tensile samples under different rotating velocities: (a) 1400 rpm and (b) 1600 rpm

Figure 13 displays the fracture surface morphologies of the tensile fractured samples at 1400 rpm and 1600 rpm. The crack appears near the interface between FM and BM of the repaired region at 1600 rpm rather than 1400 rpm, which verifies that the interfacial bonding strength at 1600 rpm is much lower than that at 1400 rpm. Figure 14 displays the fracture surface morphologies of the standard and repaired regions after tensile tests. The fracture locations at different

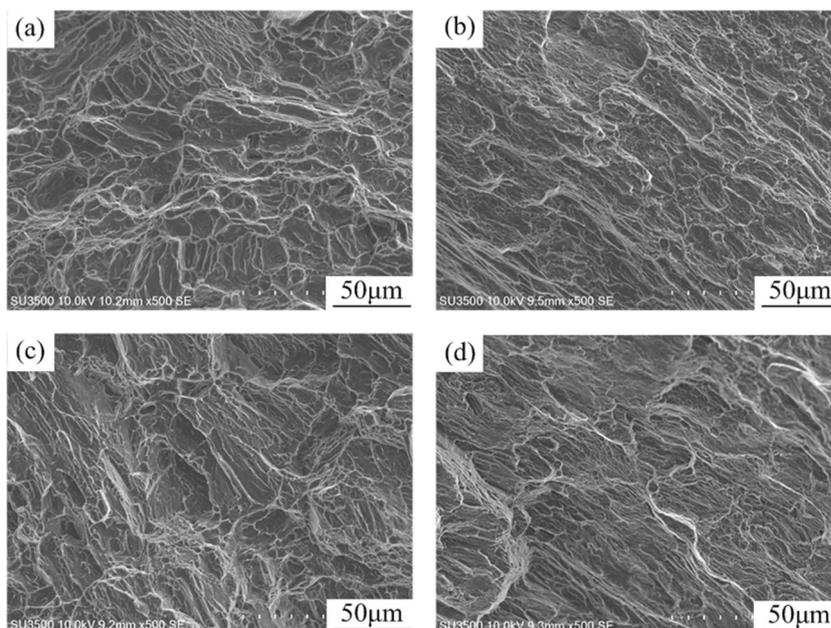
Fig. 14 Fracture surface micrographs of tensile fractured samples: (a) standard hole; repaired regions: (b) 1200 rpm, (c) 1400 rpm and (d) 1600 rpm

rotating velocities are all the same. The fracture surface of the standard hole (Fig. 14) is characterized by the dimples with several tearing ridges, exhibiting the typical ductile fracture. Moreover, the other samples at different rotating velocities present the similar fracture surface morphologies containing the dimples with varied size and depth (Fig. 14b–d), indicating the typical ductile fracture and good metallurgical bonding.
