Drilling performance of small holes on C_f/SiC composites with brazed diamond grinding rods

Keywords C_f/SiC composites · Brazed diamond abrasive rods · Entrance/exit defects · Hole wall defects · Tool wear

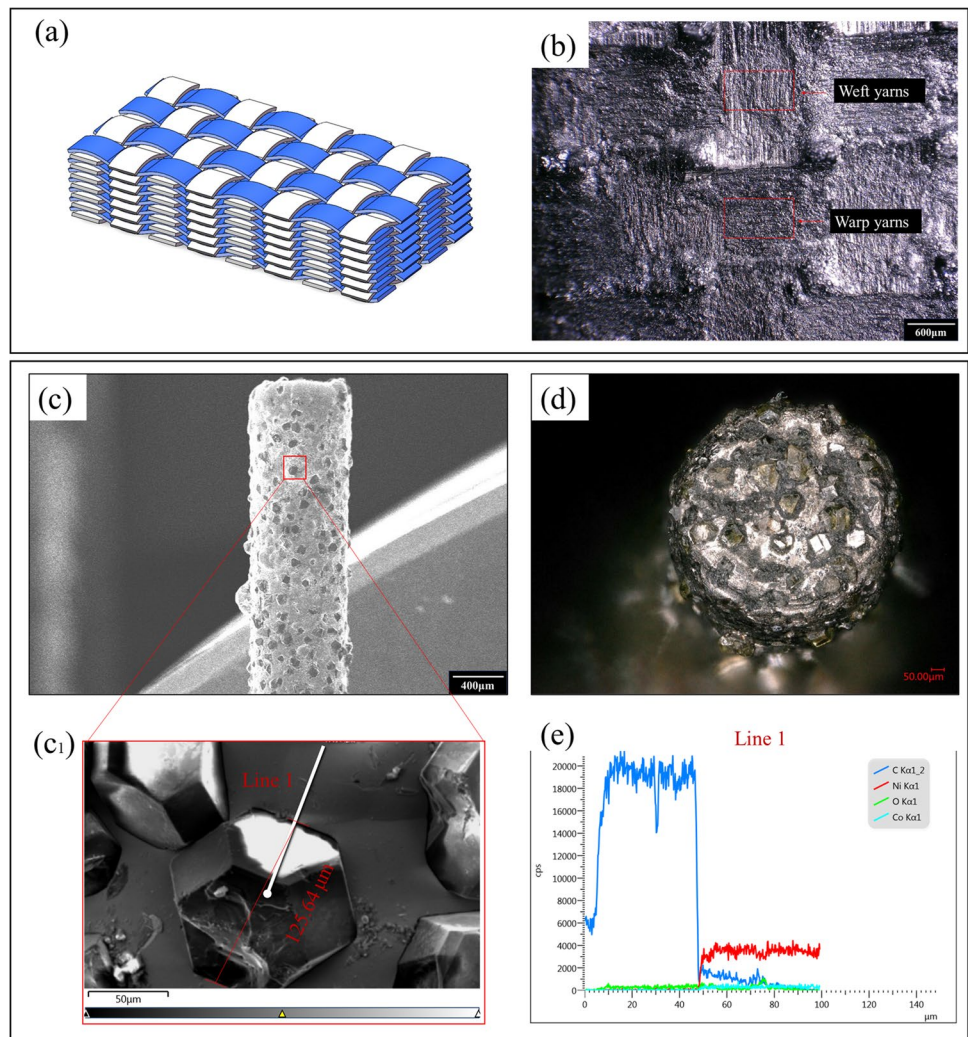
Fig. 1 C_f/SiC composites and grinding tool: **a** the schematic diagram of 2D C_f/SiC composites, **b** surface morphology, **c** sidewall morphology of brazed diamond grinding rod, **d** top morphology of brazed diamond grinding rod and **(e)** Line EDS of grinding tool

The material examined in this study comprises 2D C_f/SiC composites, with dimensions of 10 mm in length, 10 mm in width, and 5 mm in height. These composites consist of two types of fiber bundles: warp and weft, depicted in Fig. 1(a) and 1(b). Table 1 presents the mechanical properties of the 2D- C_f/SiC_s . Figure 1(c) and 1(d) illustrate the utilization of a brazed diamond grinding rod as the grinding tool. Figure 1(e) depicts the brazing bond, which employs BNi_2 brazing material. BNi_2 brazing material, predominantly composed of nickel, boron, and silicon, provides the grinding rod with good high-temperature strength, oxidation resistance, and corrosion resistance. The abrasive grains employed are artificial polycrystalline diamond (PCD) grains, ranging in size from 100 μm to 150 μm . As seen Fig. 1(c₂), single-crystal diamond grains were cuboctahedra, consisting of square {100} and triangular {111} faces, along with strong impact toughness and thermal stability. Notably, the {100} and {111} faces randomly contacted the C_f/SiC composites. The base material of the grinding rod is cemented carbide, with overall dimensions of 50 mm, featuring a cutter head portion measuring 20 mm in length and 1 mm in diameter.

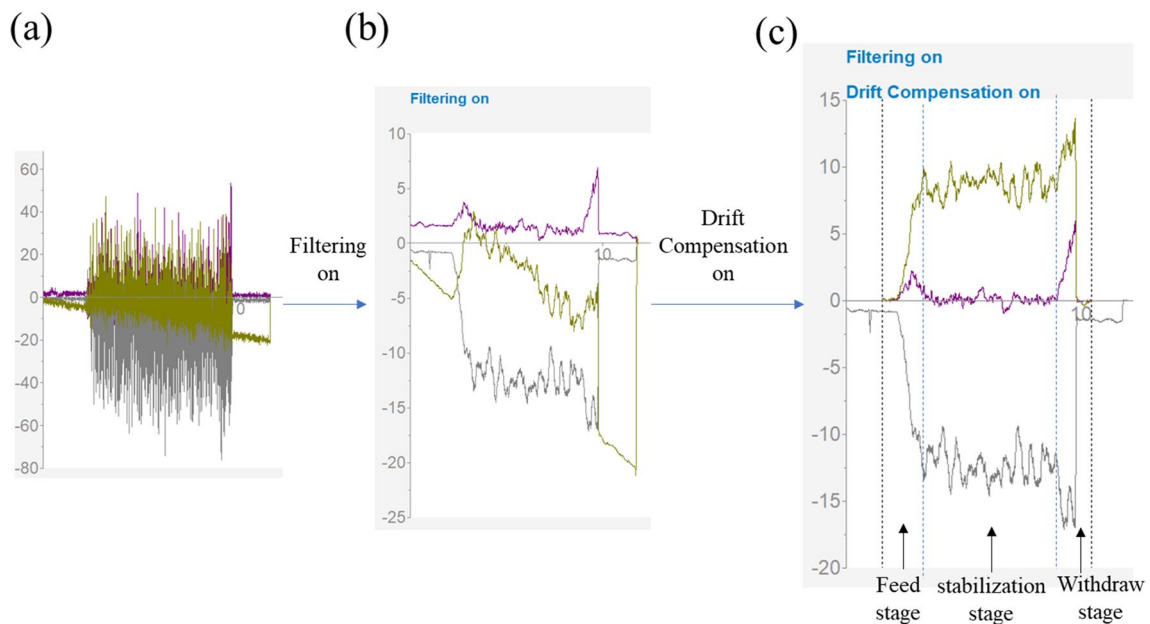
Fig. 3 The diagram of the (a) original grinding force signal, (b) filtered signal and (c) drift compensated signal

Grinding force is an important parameter for monitoring the grinding process and affects the wear of the grinding rod and the quality of the machined hole. In Fig. 3, measurements in three directions, namely F_x , F_y , and F_z , conducted during the experiment, are shown. The grinding process is divided into three stages: the feed stage, the stabilization stage, and the withdrawal stage. A sampling frequency of 10 kHz is employed throughout the experiment. Initially, the force signals from the dynamometer are inputted into the Dynoware program. Subsequently, signal drift is rectified by utilizing the software's drift adjustment feature. Thirdly,

the program's 10 kHz low-pass filter capability is harnessed to filter the force signal. Low-pass filters are instrumental

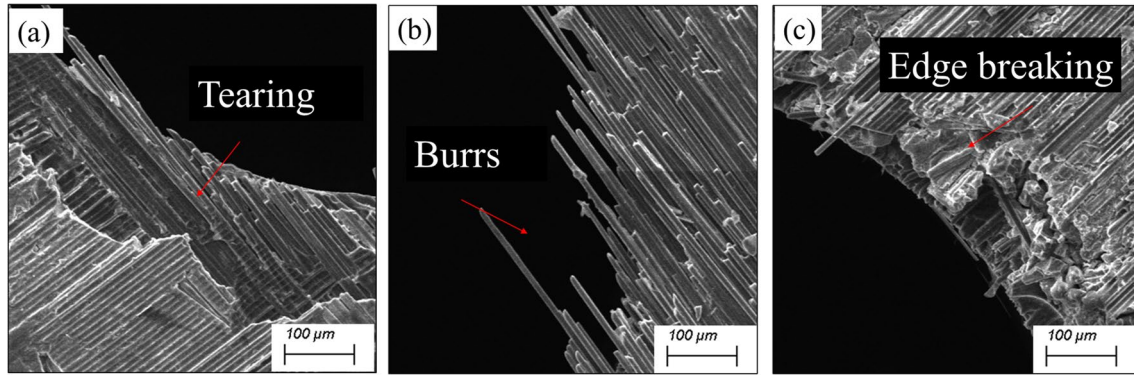
Fig. 5 Defects of hole entrance and exit

The quality of the hole entrance and exit significantly influences the assembly performance. Thus, the forms of damage at the hole entrance and exit were studied, the damage assessment criteria were established, and the influence of the process parameters on the morphology of these entrances and exits was explored. In $C_f/SiCs$, delamination is relatively uncommon due to the strong support from the SiC matrix. Therefore, the study primarily focuses on tearing and burring defects. Figure 5(a) illustrates that tearing occurs when the grinding rod applies significant pressure on the final layer of $C_f/SiCs$ during the drilling out stage, causing the carbon fibers to separate axially from the SiC and break. This separation leads to tearing defects. According to Fig. 5(b), some separated but intact carbon fibers spring back in the absence of grinding forces, forming a burr at the hole exit. Moreover, Fig. 5(c) indicates that spalling of the SiC matrix due to excessive radial forces and radial runout at the neck of the grinding rod results in edge-breaking defects.

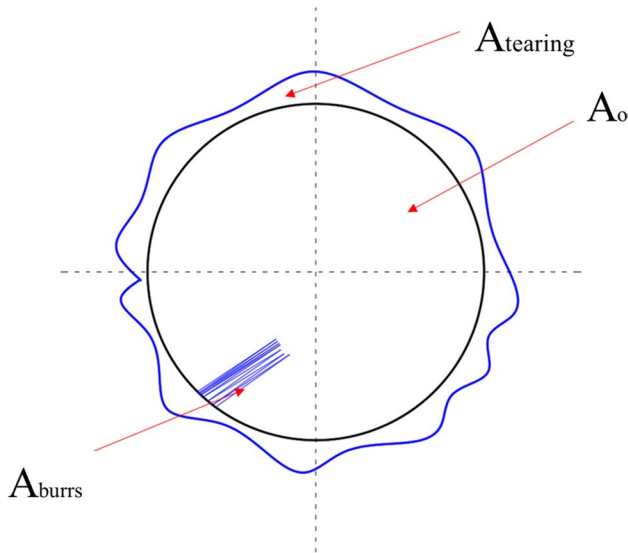
Fig. 7 Schematic diagram of hole entrance/exit damage factor

To visualize the damage at the hole entrance and exit, the surfaces were analyzed using the Keens VHX-6000 high-resolution microscope. Figure 7(b) shows the identification of tear and burr defects on the surfaces of the hole entrance and exit using the microscope's 3D contour recognition function. Figure 7(c) introduces the method for quantifying the degree of tear and burr defects through a damage factor (F_d), calculated as per Eq. (1).

$$F_d = \frac{A_t + A_b + A_o}{A_o} \tag{1}$$

where A_t represents the area of tearing, A_b denotes the area of burrs, and A_o denotes the area of the machined hole.

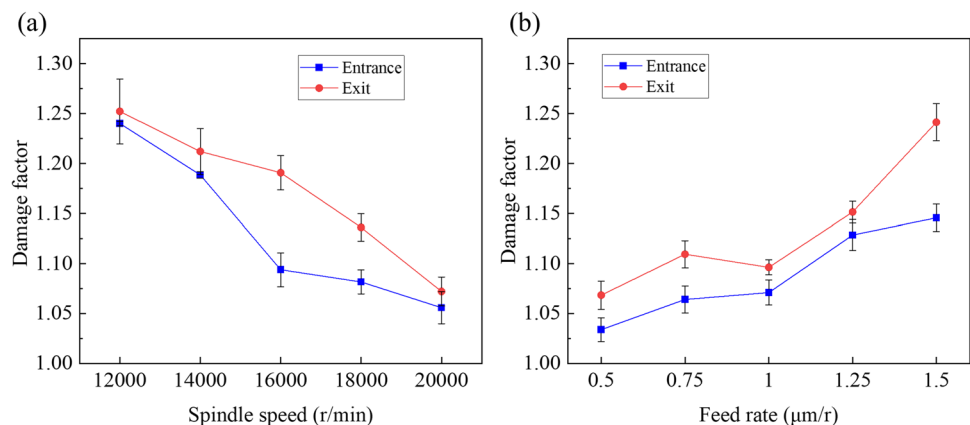
Fig. 8 The damage factor at different (a) spindle speeds and (b) feed rates

Figure 8 shows that the damage factor at the hole exit exceeds that at the hole entrance. This discrepancy arises because the lower layer of material provides stronger support to the top layer during grinding, resulting in lesser tearing and burring at the hole entrance. As illustrated in Fig. 8(a), the damage factor for both the hole entrance and exit decreases with an increase in n . Conversely, Fig. 8(b) shows that the damage factor increases as f is reduced. The reduction in the squeezing impact of the abrasive grains on the final layer of Cf/SiCs with lower n and f values leads to a decrease in tearing and burring defects, explaining the reduction in F_z .

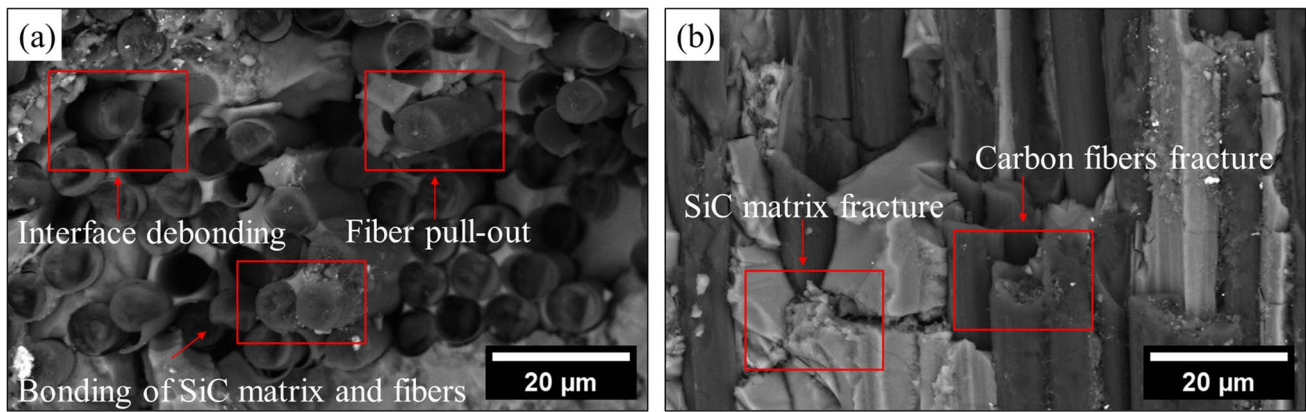
Fig. 10 The defects of C_f/SiCs machined surface: **a** Interface debonding, fibers pull-out, bonding of SiC matrix and fibers, and **b** SiC matrix fracture and carbon fiber fracture

The hole wall of $C_f/SiCs$ cannot reach the smoothness of the metal materials, attributed to the significant differences in mechanical properties between carbon fiber and the SiC matrix. The $C_f/SiCs$, prior to machining, exhibit inherent defects such as pores. As shown in Fig. 10, the grinding process introduces new machining defects on the hole wall. The primary damage forms in carbon fiber include fiber pull-out, fiber fracture, and interface debonding, whereas the SiC matrix primarily exhibits brittle fracture. Due to the

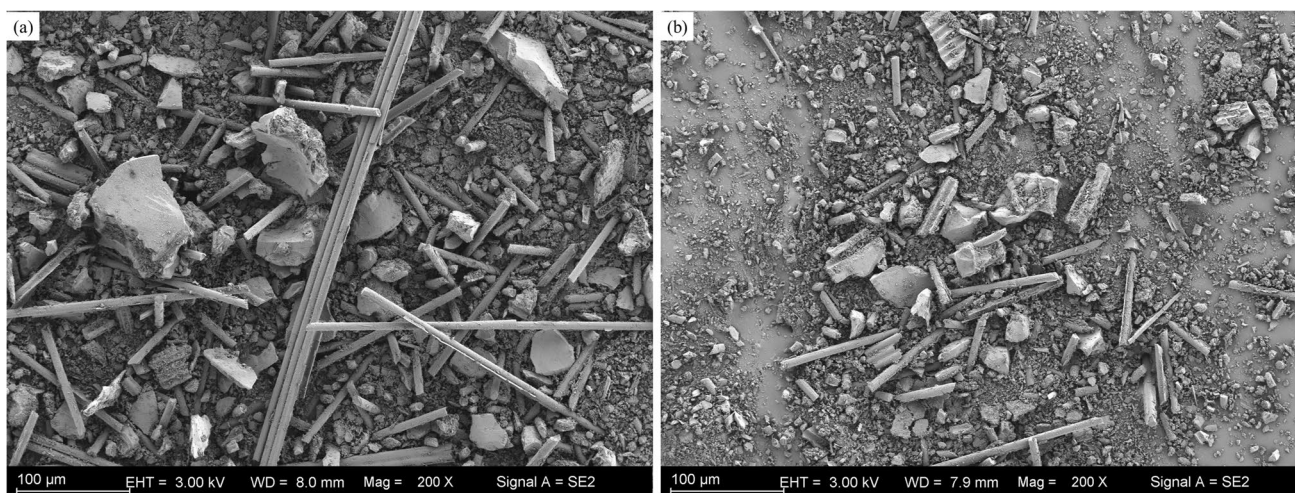
Fig. 14 The morphology of carbon fiber chips and SiC chips

The morphologies of C_f/SiC s chips are shown in Fig. 14. Carbon fiber chips are in the form of long strips and SiC chips are block-shaped. Process parameters significantly influence chip morphologies. The chip morphology at a large f is shown in Fig. 14(a), where long carbon fiber chips and larger SiC chips are observed. The chip morphology at small f is shown in Fig. 14(b), displaying short carbon fiber chips and fine SiC chips. A low n and high f resulted in the cutting edge removing more C_f/SiC s per unit time, increasing chip thickness and, consequently, a larger volume of SiC chips and longer carbon fibers. The removal of a large volume of the SiC matrix causes carbon fiber debonding, resulting in carbon fiber bundle chips. Conversely, higher n

and lower f result in the cutting edge removing less C_f/SiC s per unit time, decreasing chip thickness, thus shorter carbon fiber chips and a smaller volume of SiC chips are observed, with almost no carbon fiber bundle chips evident.
