Understanding performance of transmission and distribution insulators at very low temperature conditions

Abstract

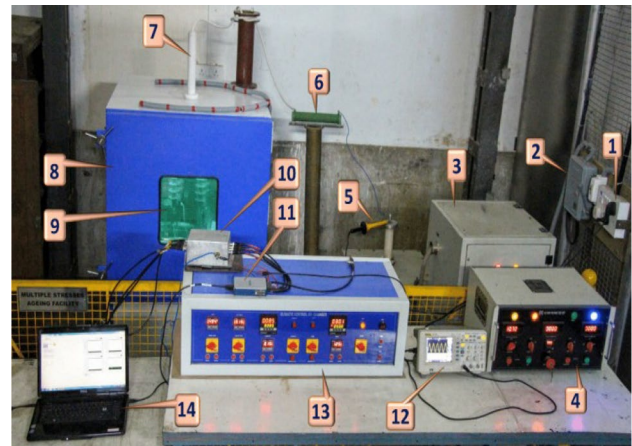
Figure 1 shows the block diagram of the experimental arrangement. The setup consists of a specially fabricated aging chamber of size 2.5 × 2.5 × 2.5 ft with arrangement for high-voltage (HV) connection and provision for leakage current (LC) measurement. In addition, the chamber is designed to accommodate UV lamps, heater and humidifier

Fig. 1 Developed multistress aging facility. 1: AC 230 Volt, 50 Hz power supply, 2: 400 Volt, 50 Hz power supply, 3: HVAC source, 4: HVAC control panel, 5: high-voltage probe, 6: current-limiting resistor 15 k Ω , 500 W, 7: high-voltage bushing, 8: aging chamber, 9: UV-protected glass, 10: shunt box, 11: NI cDAQ for LC measurement, 12: digital oscilloscope, 13: climate chamber control panel, 14: NI cDAQ data acquisition in LabVIEW environment

to produce multiple environmental stresses simultaneously. In the present experimentation, only low temperature zero and –20 °C with ac voltage of 10 kV rms is continuously applied during the experimental duration. An HVAC source of 30 kVA with output voltage 0–30 kV rms fed with input of 400 V rms and 50 Hz power supply embedded with over voltage and over current protection for the electrical safety. A resistive shunt of 10 k Ω is used to measure the LC at the ground side by tapping the voltage across it. Source voltage and LC are monitored using RIGOL make digital storage oscilloscope DS1102E (100 MHz, 1 GSa/s).

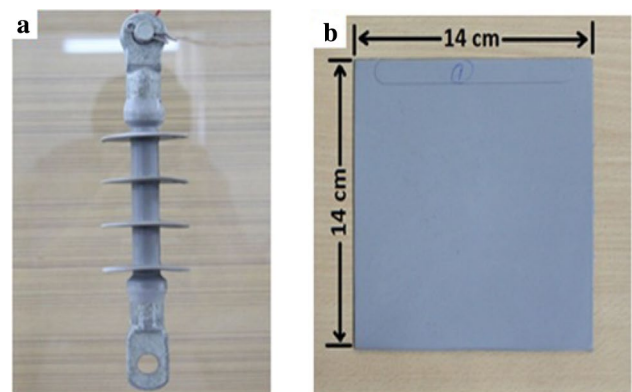
Fig. 2 a Full-scale insulator b the flat sample

Figure 2 shows the distribution class full-scale HTV SIR insulator samples of creepage length 347 mm and flat samples used for the study. The rated voltage is 11 kV rms line to line. Four samples of the full scale and three of the flat slab

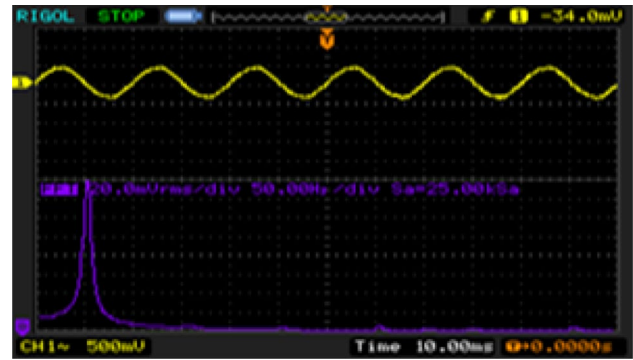
Researchers [7] have reported the presence of various harmonics in the leakage current related to some phenomenon taking place on the surface of insulator. Figure 3 represents a sinusoidal waveform which has almost no distortion. The leakage current measurements were conducted at regular intervals for both zero and sub-zero conditions for entire experimental duration. The motivation behind such experimentation is the simulation of conditions which prevail in the extreme northern portions of the country; a typical leakage current measurement conducted at 350 h at 0° conditions is presented in Fig. 3.

Fig. 3 Leakage current after 350 h of experimentation at 0° with electric stress applied

The leakage current waveform is nearly sinusoidal; this is due to the fact that no nonlinear phenomenon like partial arcing/discharges is taking place along the path of the leakage current. The prominent presence of fundamental component in the leakage current is an indicator that the surface is dry and shows no thermal degradation. This phenomenon was observed till for 1000 h of experimentation with only a minor increase in magnitude, and the measured peak value was about 50 microamps.

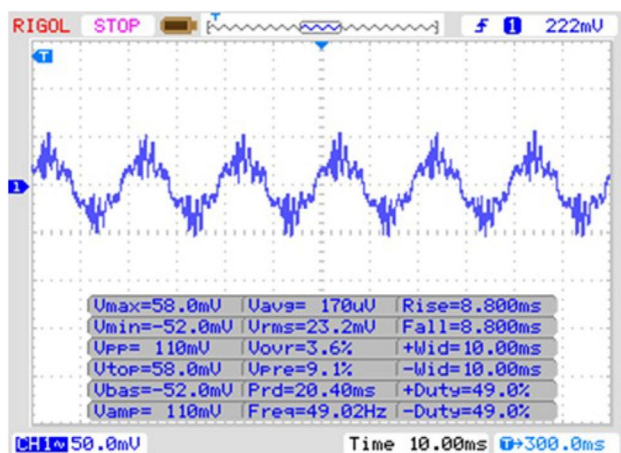
The experimentation is conducted at low humidity and low temperature conditions, the formation of water droplets on the surface is very low, due to this related phenomenon like dry-band arcing, water droplet corona may not occur. Leakage current is observed due to the inherent surface conductivity of the silicone rubber surface. This was verified based on the leakage current waveform during the initial stages of the experimentation. Because of singularity at the triple point near the high-voltage electrode, silicone rubber and air junction are the point of high field zone. The electric field enhancement at the triple junction is the main reason for the distortion of the leakage current. Moreover, the literature [7] reports the presence of various harmonics in the leakage current related to some phenomenon taking place on the surface. Figure 4 represents a typical sinusoidal waveform which has considerable distortion in the waveform measured after 48 h of experimentation for –20 °C with continuous voltage stress applied, and the measured peak value of leakage current is 5.8 microamps.

Fig. 4 Leakage current after 48 h of experimentation at $-20\text{ }^{\circ}\text{C}$

is lower. Similarly, measurements conducted at 900 h represented in Fig. 6 show more distortion compared to the leakage current measured at 500 h of experimentation. Figures 4, 5, 6 show the leakage current was only due to the surface resistance of the silicone rubber.

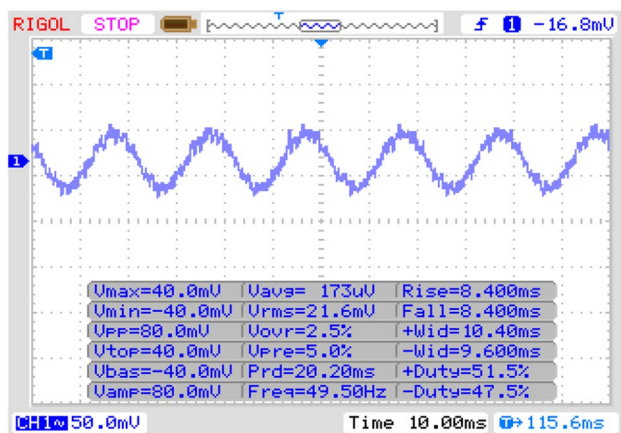
Figure 5 shows the leakage current waveform measured after 500 h of experimentation, and the waveform presents both the magnitude and level of distortion in the waveform

Fig. 5 Leakage current after 500 h of experimentation at $-20\text{ }^{\circ}\text{C}$

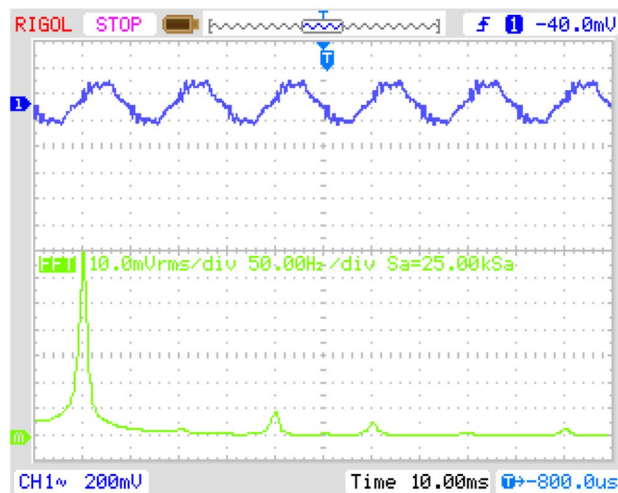
Fig. 7 Leakage current just after pollution and energizing

Figure 7 shows the leakage current measured immediately after applying the pollution slurry, while Fig. 8 shows the measured leakage current after about 547 h of experimentation. In both the cases the value of current peak is nearly 10 microamps. The application of pollution has caused the peak current to increase in comparison with the earlier conditions. The higher current is due to the wet nature of the pollution slurry. This causes the evaporation of the water and formation of dry bands resulting in the

formation of arcs. These arcs distort the current which can be seen from the FFT plot in Figs. 7 and 8, respectively.

The FFT waveforms of leakage current after application of the pollution show the presence of lower-level odd harmonics. This can be attributed to minor arcing phenomenon which may be occurring on the surface of the insulator [7].

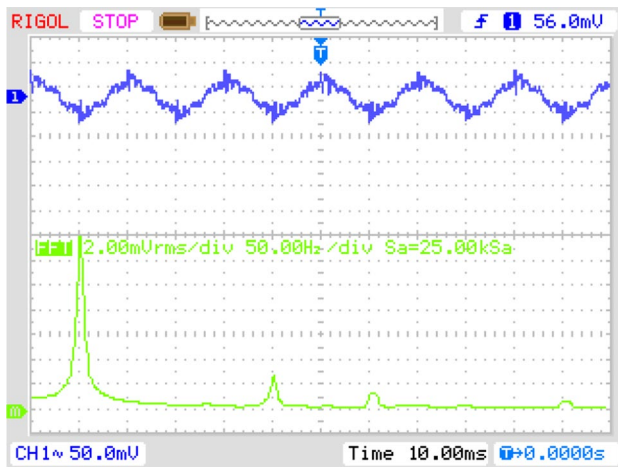
Fig. 8 Leakage current after 547 h of contamination at $-20\text{ }^{\circ}\text{C}$

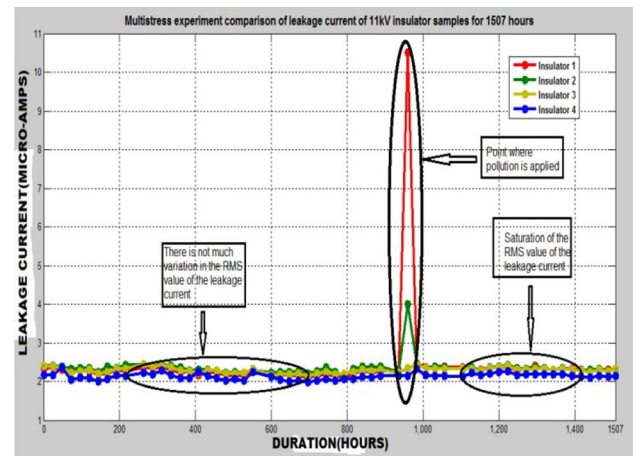
It is obvious from Fig. 9 that peak magnitude in the leakage current is due to the conduction of the pollution layer. As mentioned, the pollution slurry was applied only to insulator 1 and 2 and hence a sudden rise in the magnitude is observed

Fig. 9 Leakage current for total experimental duration

after 960 h. Later within few hours, the leakage current settles down to lower value. This has been consistent with the fact that pollution does not affect the surface degradation much.

Apart from the dry-band arcs causing the leakage current to distort, influence from the discharges arising near the triple-point singularity may also contribute. Any form of arcing phenomenon will make the waveform symmetrical; hence, it can be inferred that in case of normal/non-polluted conditions the source of harmonics is mainly discharges at the triple point and source harmonics. After application of the pollution layer, the magnitude of the leakage current has increased; this causes evaporation of water resulting in the formation of dry bands causing minor arcs superimposed on the leakage current, hence the generation of lower harmonic components, with progress in experimentation the increase in number of harmonics is not considerable. Figure 9 shows the graphical plot of the RMS values of four insulators: 1 and 2 are polluted after 960 h and 3 and 4 are non-polluted.

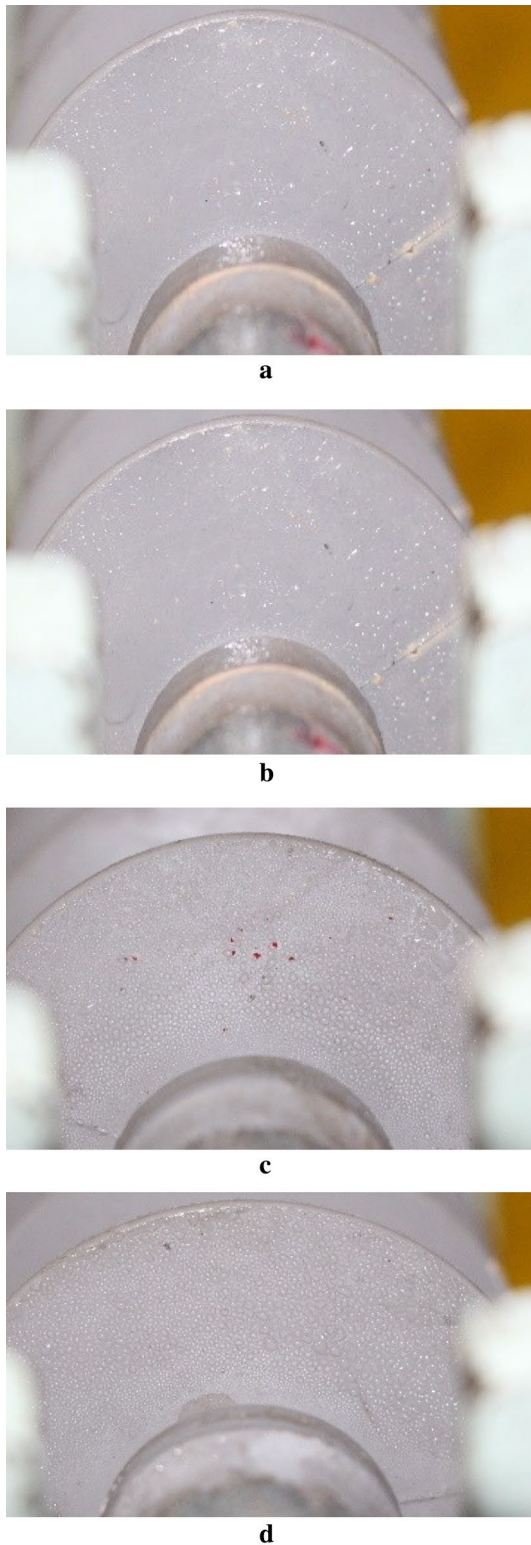
Figure 10a–d is compared with the standards to obtain wettability class measurement as shown in Table 1.

Fig. 10 Water droplets on **a** insulator1 **b** insulator2 **c** insulator3 **d** insulator4

From the wettability class measurements, it is seen that two insulators 1 and 2 for which pollution was applied have degraded to WC5. This is due to the dry-band arcing phenomenon occurring after the application of the pollutant causing the degradation. The phenomenon of surface discharge and its impact on the insulator surface has been lucidly dealt in the literature [2, 4, 5, 8]. Further, to understand the degradation in detail FTIR and SEM analyses on the insulators are conducted, and results are analyzed and presented.

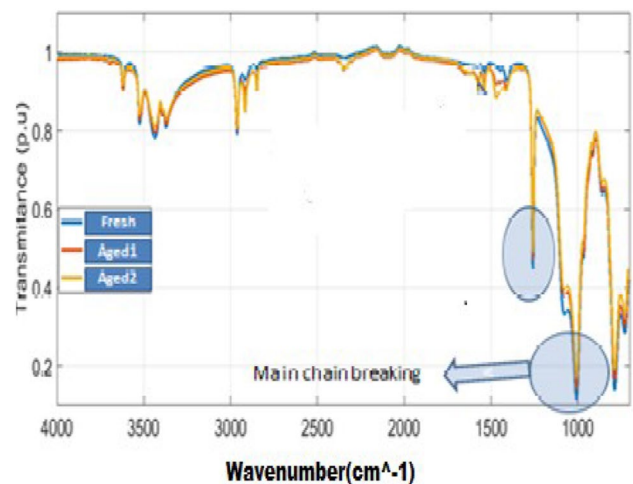
Figure 11 shows the FTIR plot of the samples aged under the 0° cold climate with electrical stress. The period of experimentation was 1000 h. It is observed from the FTIR plot for the range $3700\text{--}3500\text{ cm}^{-1}$ that minor change is observed; this change is due to the silanol that is formed in the aged samples due to slight oxidation effect. The oxidation effect can be accounted due to the discharges that may have originated from the triple junction of the insulator, air and the metal fitting that are simultaneously present. Under dry condition the possibility of discharges taking place is very remote, the main chain breakage seen in Fig. 11 is also insignificant. Thus, the FTIR analysis at 0° conditions does

Fig. 11 FTIR analysis of aged and fresh sample after 1000 h of experimentation under 0° temperature and electrical stress

not exhibit degradation on the material surface and not much change was observed in leakage current waveforms for a period of 1500 h of experimentation due to the dry and low humid conditions.

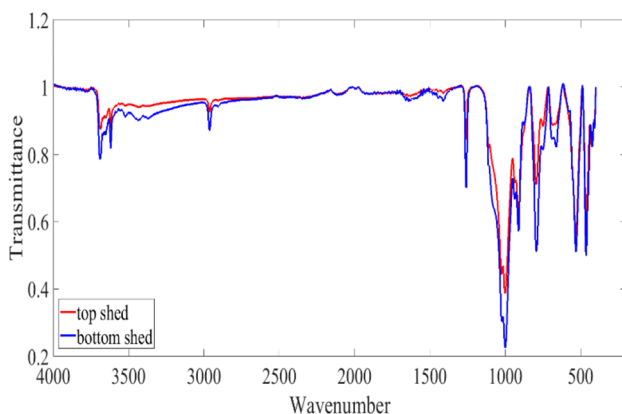
From Fig. 12 it is seen that for polluted insulator 2, there is a considerable distinction between the plots of the top shed and bottom shed. The band $3500\text{--}3700\text{ cm}^{-1}$ refers to the interacting --OH (hydroxyl) group, and the band $3200\text{--}3500\text{ cm}^{-1}$ refers to the non-interacting --OH group. The intensity of this region for top shed is comparatively less compared to the bottom shed. Moreover, the --Si--CH_3 symmetrical stretching peak is also less for the top shed which is approximately located at 2961 cm^{-1} (Fig. 13).

Similarly, the --Si--C vibration peak at 1261 cm^{-1} is less intense for the top shed compared with the bottom shed. The band from $900\text{ to }1200\text{ cm}^{-1}$ refers to the main chain --Si--O--Si-- stretching. The intensity peak for the insulator 2 top shed is less compared to the bottom shed. But for the non-polluted insulator 3 the main bands pertaining to PDMS almost overlap. This kind of behavior is mainly due to the dry-band discharges taking place more intensely at the high-voltage end

Fig. 12 FTIR of insulator 2 conducted after 1250 h

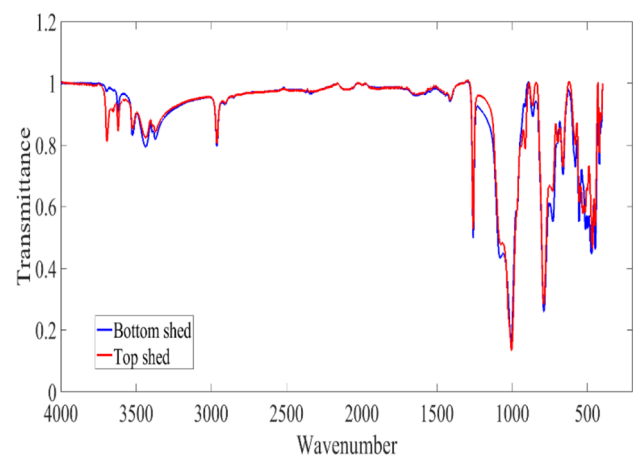
Fig. 13 FTIR of insulator 3 conducted after 1250 h

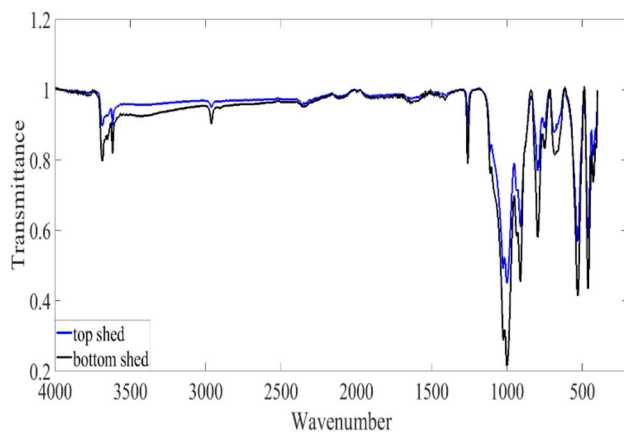
FTIR conducted after 1507 h (end of experiment) is shown in Fig. 14 for insulator 2, and observations remain the same, but rate of degradation is rapidly increased due to the long exposure of top shed to dry-band discharges. Moreover, the peak due to $-OH$ in ATH is almost flat indicating water of crystallization of ATH is evaporated causing the insulation to degrade more on the SIR surface. In addition, the intensity of the main chain peak is considerably low for top shed compared to the bottom shed. This is an indication that most severe degradation takes place at the high-voltage end and intensity decreases toward the ground end.

Fig. 14 FTIR of insulator 2 conducted after 1507 h

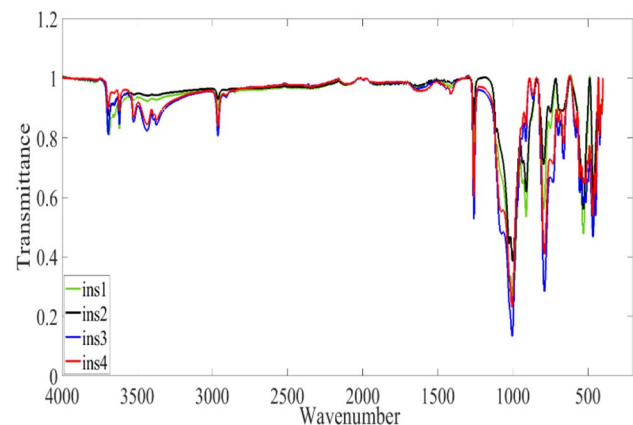
Figures 15 and 16 show the FTIR spectrum for four insulators. For the bottom sheds, the $-OH$ band in 3200 cm^{-1} to 3500 cm^{-1} is attributed to the water of crystallization present in ATH shows more intense peak for non-polluted insulators but not present in the polluted insulators. The effect of heating due to dry-band discharges can be seen in the polluted insulators. The heat from the dry-band discharges is enough to cause the water to evaporate.

Another important observation from Figs. 15 and 16 is that $-OH$ interacts and is present in the form of silanol producing more intense peaks for bottom sheds of polluted insulators compared to the non-polluted insulators. On the contrary, for top sheds for polluted insulators the effect of silanol shown is almost removed. This effect is due to the oxidation of methyl group attached to the main chain, and silicone produces silanol which under dry-band arcing forms silica.

Fig. 15 FTIR of all insulators' top sheds conducted after 1250 h

As observed from the FTIR plots (Figs. 15, 16, 17, 18), the main chain siloxane is converging at the vicinity of 1000 cm^{-1} and this is due to main chain breaking and generation of low molecular weight species of PDMS. As observed in literature [2, 5], the LMW species help in recovery of the lost hydrophobicity. During wettability experimentation, it was seen that the polluted insulators fall into WC-5 while the non-polluted insulators belong to WC-2. The reasons could be the following: Firstly, formation of silica on the polluted silicone rubber insulators hinders the movement of LMW chains to the surface. Secondly, the boiling points of LMW chains are low and so they have vaporized from the surface and thus the hydrophobicity could not be restored. This is because dry-band discharges have occurred after application of the pollution. It was seen in the leakage current analysis that rms values of the leakage current did not change considerably over the period. Moreover, under thermal degradation the LMW chains have moved to the surface and the hydrophobicity could have been restored. The dry-band arcing of polluted insulators under cold and dry conditions may cause severe material damage as seen from the FTIR analysis. The dry-band arcing after application of pollution till the time of the evaporation during this interval degradation has been severe, and hence, the changes in the FTIR plots are observed.

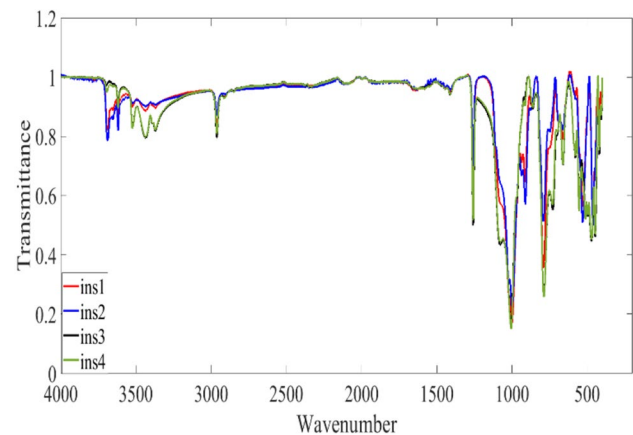
Fig. 16 FTIR of all insulators' bottom shed conducted after 1250 h

Figure 17 shows the FTIR plot conducted on the bottom sheds; comparing this with Fig. 16 the following facts are observed. The two peaks due to the $-\text{Si}-\text{O}-\text{Si}-$ do exist in

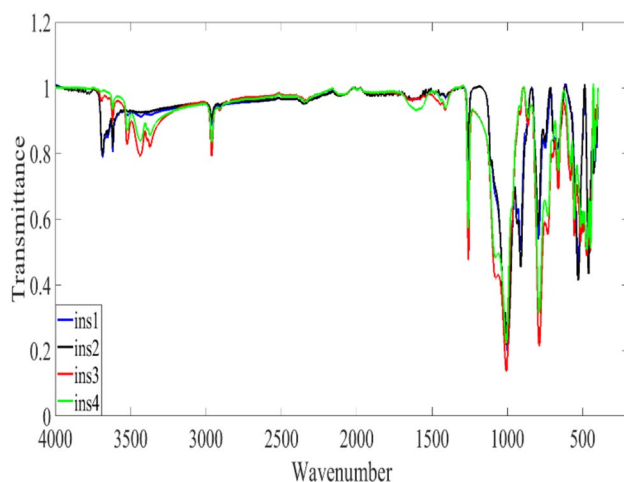
the polluted insulators after 350 h of polluting or 1250 h of experimentation (pollution was applied after 950 h of the experiment); at the end of experiment, the peaks almost converge to a single peak at approximately 1000 cm^{-1} . Thus, with time the degradation with respect to main chain breaking increases.

Fig. 17 FTIR of all insulators' bottom shed conducted after 1507 h

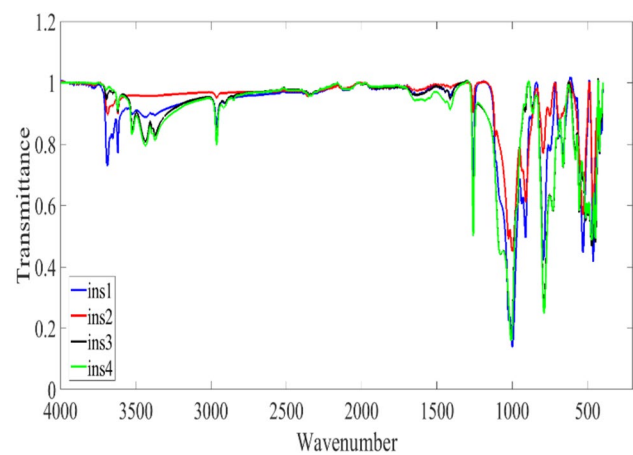
From Fig. 18 it is observed that the insulator 2 is heavily degraded after the end of experiment. The relevant peaks for $-\text{Si}-\text{CH}_3$ and main chain ($-\text{Si}-\text{O}-\text{Si}-$) have shown a significant decrease in the intensity.

Fig. 18 FTIR of all insulators' top shed conducted after 1507 h

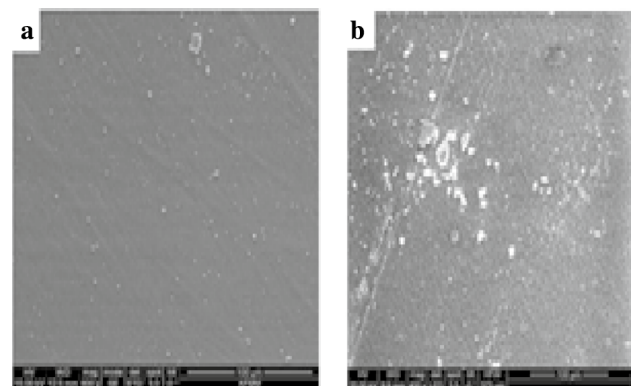
The SEM image shown in Fig. 19 is for 0° at low humidity (35%); it is observed from the figure that after 1000 h some minor degradation is noticed on the sample. Figures 20, 21, 22, 23 show the images of SEM after the experimentation at -20°C . The smoother the surface appears, the lesser the breaking of main chain is. Appearance of ATH on the surface due to the dry-band arcing, partial silanol formation and cross-linking forming silica renders the surface as seen from the SEM results. The SEM results are compared for insulator 1 (which is polluted) and insulator 4 (the unpolluted one). The SEM has been conducted on the insulator 1 for the top shed (near the HV end) and the bottom shed near the ground end. The top shed and the bottom shed are exposed to different levels of electric field, and hence, the degradation level

Fig. 19 SEM of the insulators **a** fresh sample **b** treated sample after 1000 h at 0°C

The oxidation could have resulted in the appearance of white spots on the material surface as seen in the SEM images (Fig. 19). Aluminum level has also increased; this may be due to the ATH filler which may have come to the surface due to occurrence of thermal phenomenon. The sample for the EDAX and SEM is taken from the top shed which is near the triple junction. The observations from SEM to EDAX show not much of degradation on the material surface due to the cold climate and low humidity. Further investigations have been extended to $-20\text{ }^{\circ}\text{C}$ to understand the performance wherein some parts of the country witness this temperature during winter with low humidity levels.

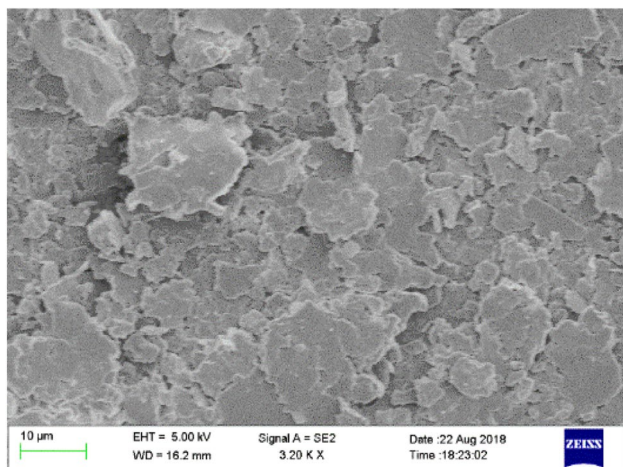
Fig. 20 SEM picture of the bottom shed of insulator 1 after 1507 h of experimentation under sub-zero conditions

Figure 20 shows the SEM image of the bottom side of insulator 1, the SEM image shows several cracked portions, and this appearance is due to the dry-band arcing which occurred after the application of the pollution layer.

appearance. It is seen that the appearance of rough surface is not severe as in case of insulator 1 (Figs. 20 and 21). Therefore, the following observations are made from the SEM study: the effect of pollution on the insulators has shown more degradation and application of pollution enhances the dry-band activity which has triggered severe surface degradation on the polymeric surface.

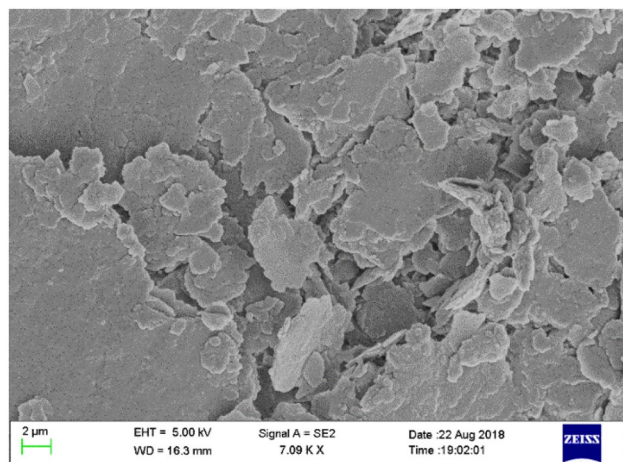
Fig. 21 SEM picture of the top shed of insulator 1 after 1507 h of the experimentation under sub-zero conditions

Figure 21 shows the SEM results of the same insulator for the top shed portion. More degradation is observed; this may be due to the discharges arising from triple point contributing in the higher degradation of the shed, as it happens to be near the high-voltage electrode.

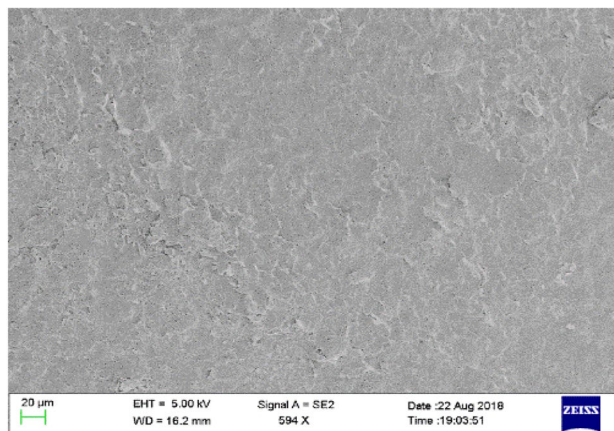
SEM image in Fig. 22 and 23 is shown for non-polluted insulator 4. The bottom shed which is nearer to the ground end shows almost a smooth surface but the top shed which is very close to the high-voltage electrode gives a chalky

Fig. 22 SEM picture of the bottom shed of insulator 4 after 1507 h of experimentation under sub-zero conditions

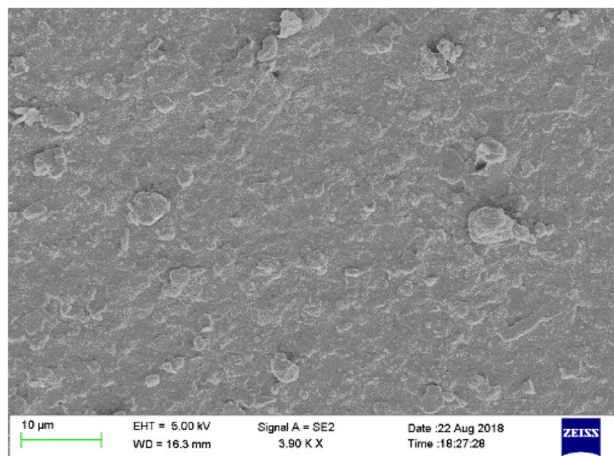
Fig. 23 SEM picture of the top shed of insulator 4 after 1507 h of the experimentation under sub-zero conditions

The dry-band arcing on the polluted insulators has started after application of pollutant in the wet stage, and the dry conditions are restored and less severe activity like triple-point emissions started taking place later. The second observation is the effect of triple-point arcing near the high-voltage electrode which has caused the surface even in unpolluted case to develop a chalky appearance (Fig. 23). The chalky appearance on the top shed of insulator 4 is due to the formation of silica due to the

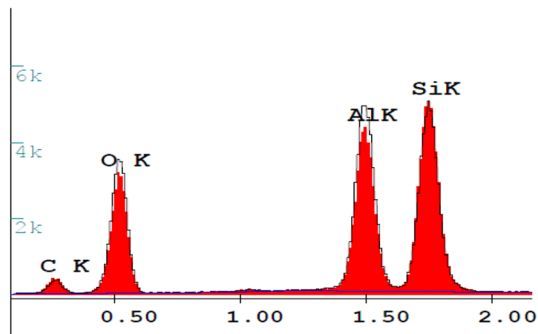
Fig. 24 EDAX of the sample after 1000 h (in black) and fresh sample (in red) (x-axis in keV and y-axis in Counts)

The EDAX analysis on the samples was conducted for Zero and $-20\text{ }^{\circ}\text{C}$. Figure 24 shows the elemental composition on the surface of insulators after 1000 h of experimentation at 0° . The analysis of fresh sample is shown by the red peaks, while the treated sample is shown by the black peaks. From the figure it is seen that for the treated sample the oxygen level has increased marginally. This may be due to the oxidation which has taken place along the surface of the insulators.

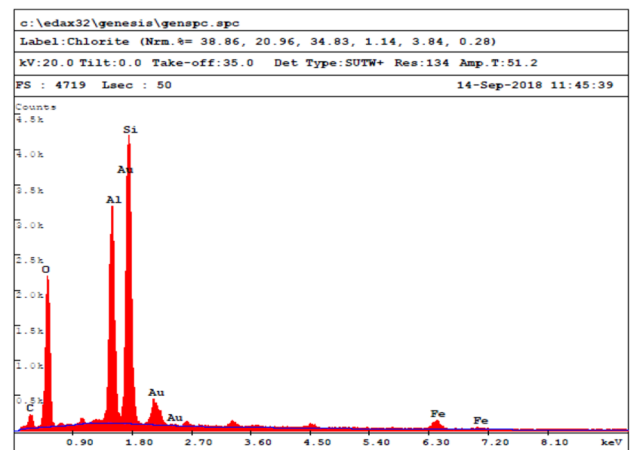
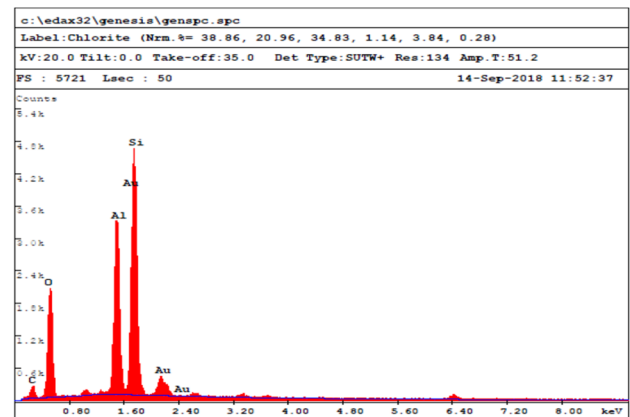
Fig. 25 a EDAX of the bottom shed of insulator 1 and **b** EDAX of the top shed of insulator 1 (x-axis in keV and y-axis in Counts)

As seen from Figs. 25 and 26, the surface degradation of the insulator 2 is comparatively higher than that of insulator 1. The higher silicone level in insulator 2 is indicative of the higher presence of silica. This silica is formed due to cross-linking of the silanol compounds. Moreover, the amount of elemental aluminum is more in the insulator 2 surface (top shed) compared to that of insulator 1 (top shed).

etc.). The severity of discharges at the triple point near insulator 2 high-voltage electrode can be justified by comparing Fig. 25a, b. Figure 25 shows the insulator 1 top shed and bottom shed are shown. The relative amounts of the elements (silicone, aluminum, oxygen) are almost same.

This confirms that the severity of the discharges in case of insulator 1 are weak to cause significant damage to the top shed compared to the bottom shed. Comparing Fig. 26a, b the intensity of the discharges near the high-voltage electrode is significant enough to cause considerable changes on the surface. The amount of aluminum is higher on the top shed of insulator 2 less on the bottom shed; moreover, the amount of silicone is also more.

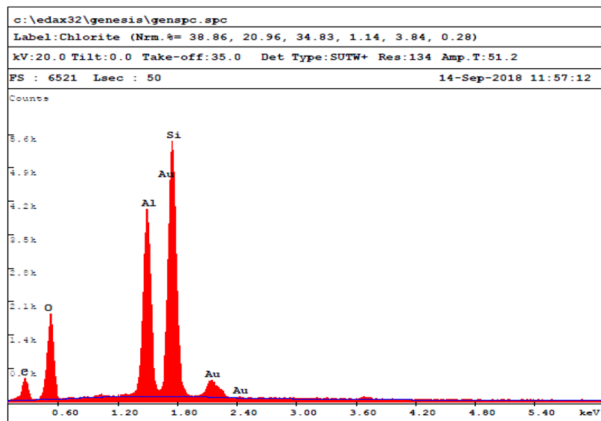
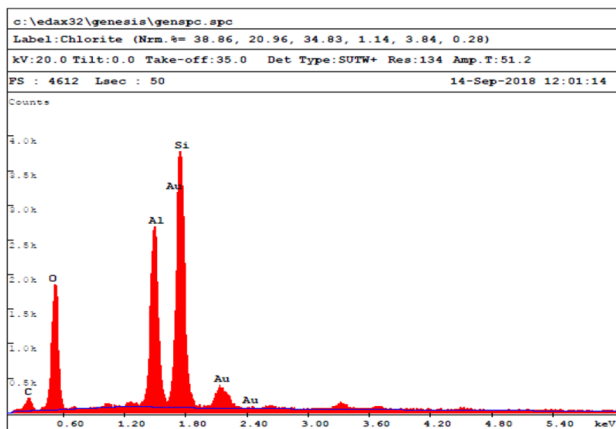
Fig. 26 a EDAX of bottom shed of insulator 2 b EDAX of Top shed of insulator 2 (x-axis in keV and y-axis in Counts)

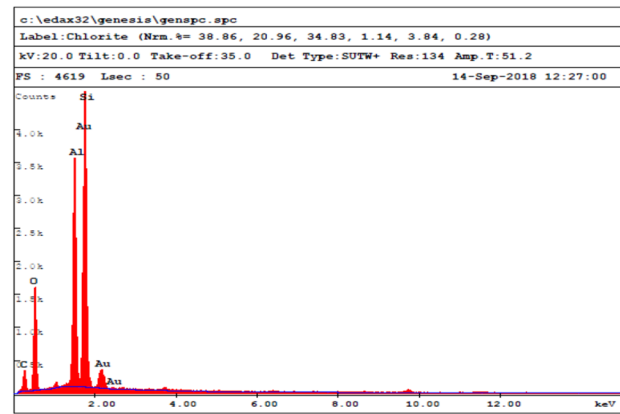
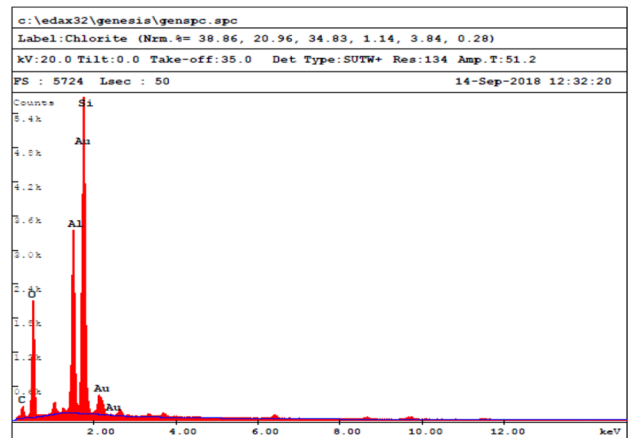
Fig. 27 a EDAX of bottom shed of insulator 3 b EDAX of top shed of Insulator 4. (x-axis in keV and y-axis in Counts)

The quantity of aluminum in both insulator 3 and 4 are almost same as indicated in Fig. 27; however, the amount of silicone and oxygen is more in case of insulator 3. In Insulator 3 the amount of carbon is less compared to insulator 4. This explains that the intensity of discharges near the high-voltage electrode is much more severe in case of insulator 3 compared to insulator 4. The formation of silica by
