Factory site analysis of respirable fibers generated during the process of cutting and grinding of carbon fibers-reinforced plastics

Abstract

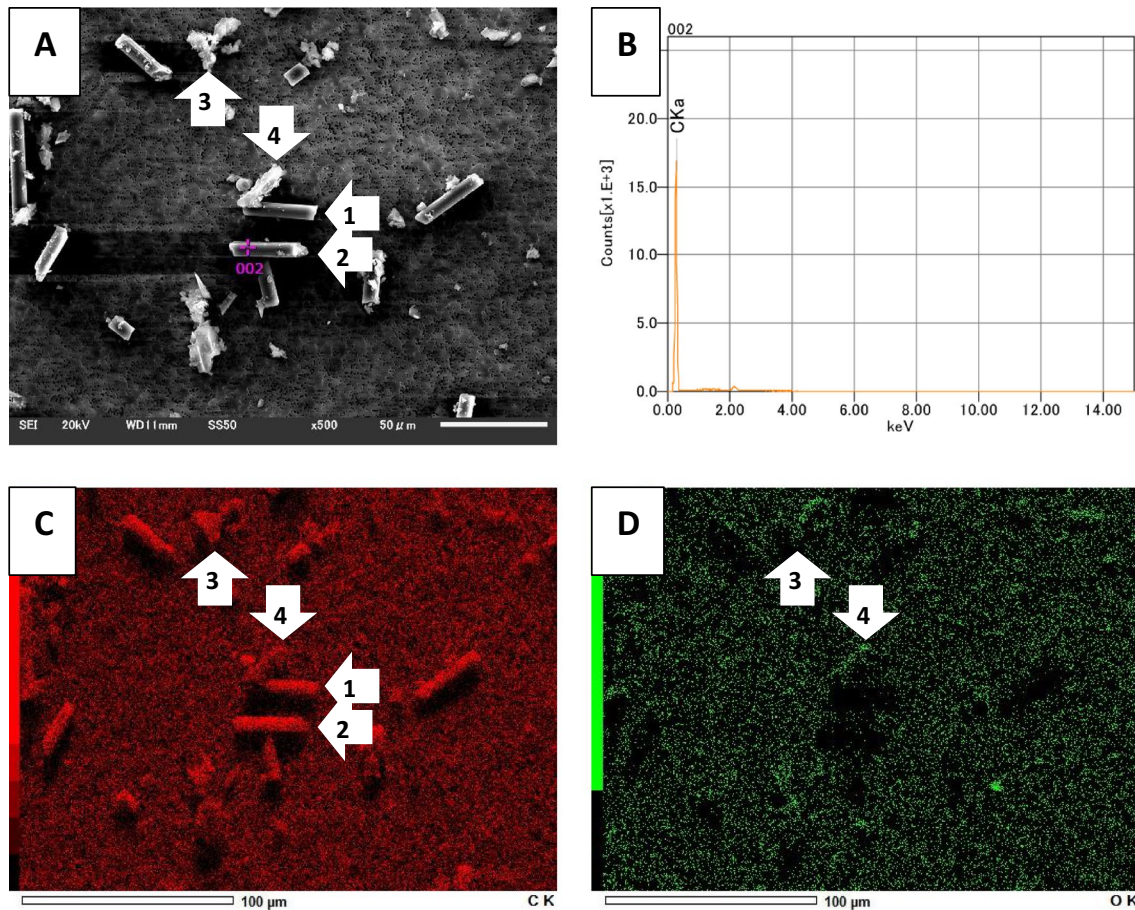
Fig. 2 Analysis of CFRP debris generated by cutting CFRP pipes with grindstone cutter. The released CFRP debris were analyzed by SEM with EDS at magnification $\times 500$. **A** Secondary electron image;

B Spectrum of EDS point analysis (+: focal point in A); **C** Carbon element map; **D** Oxygen element map. Arrows 1 and 2: Cylindrical fibers from CFRP; 3 and 4: Collapsed object from CFRP

SEM (Fig. 2). Many of the observed debris were cylindrical in shape with a diameter of about $7 \mu\text{m}$, which was comparable to the diameter of the original carbon fibers, suggesting transverse break against the longitudinal direction of the fiber (Fig. 2A). The spectrum of energy dispersive spectroscopy (EDS) point analysis of the cylindrical fiber showed that it was made of carbon (Fig. 2B), indicating that the cylindrical fibers were CFRP carbon fibers.

Next, we examined the carbon and oxygen element maps of CFRP debris. The CFRP cylindrical fibers were found in the carbon element map (Fig. 2C, arrows 1 and 2), but not in the oxygen element map (Fig. 2D), probably because it is composed of pure carbon. However, other irregularly shaped objects were faintly colored in the carbon element map (Fig. 2C, arrows 3 and 4) whereas they were vaguely evident in the oxygen element map (Fig. 2D, arrows 3 and 4). These objects are probably breakdown elements of the epoxy thermoset polymer (resin) in CFRP.
