# Degradation of structural adhesive bonding joints on ship exposure decks

## Abstract

The degradation process of adhesive bonding layers on ship exposure decks was examined via an exposure test using adhesive bonding joint specimens under tensile shear load. The degradation was evaluated by the delamination and the deformation of the adhesive layer. The degradation initiated in summer, which was more significant for the specimens located at exposed areas of the ship than those in the engine room (i.e. not exposed area). Environmental measurements revealed that, in summer, the daily highest surface temperature was greatly raised at the exposed areas that, however, exhibited equal or lower average values compared to the engine room. The degradation of an adhesive bonding joint would initiate relatively rapidly in a high-temperature environment. This indicates the highest temperature is a more important factor for adhesive bonding durability than the average temperature. The tensile test conducted after the exposure test showed that the degradation progressed from the adhesive layer edge. The surface temperature on an ocean-going ship was also measured to examine the temperature co

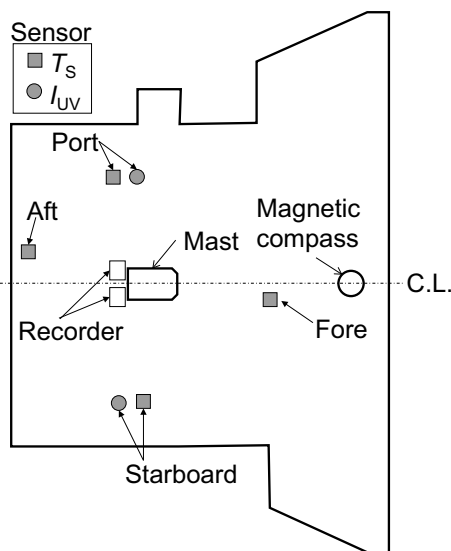
Figure 3 shows the schematic arrangement of the instruments used; surface thermometers were placed at four

Fig. 3 Horizontal plan for the arrangement of the environmental measurement instruments on the compass deck of an ocean-going ship

locations on the deck (fore, aft, port and starboard side) and solar radiation sensors were installed on the port and starboard side, close to the thermometers. The  $T_S$  and  $I_{UV}$  values were recorded on logging instruments every 15 min, which were the same as those used on the YUGE MARU ship. The measurements were conducted for 166 days, from August 2017 to January 2018.

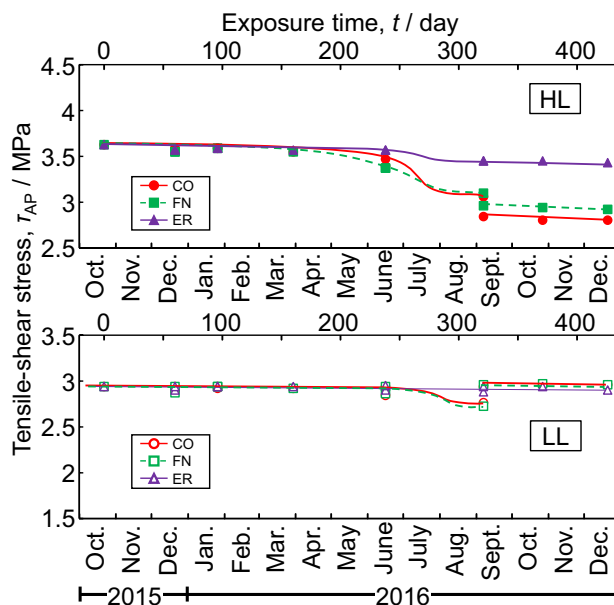
Figure 4 shows the relationship between testing time and specimen  $\tau_{AP}$  in the exposure test. During the first 238 days (from October 2015 to June 2016), only a little  $\tau_{AP}$  decrease was observed for the HL specimens placed at the CO and FN sites, and other specimen's  $\tau_{AP}$  did not decrease in this period, meaning that no significant degradation of the adhesive bonding layer had occurred by the 238th day (June 2016) of exposure, regardless of the stress and environmental conditions.

The tensile shear stress decreased largely during the next 83 days (from June to September 2016) of exposure in the specimens at the CO and FN sites; this decrease, together with the deformation of the adhesive bonding layer, was more evident in the HL specimens than in the LL ones. Due

Fig. 4 Time evolution of the applied tensile shear stress  $\tau_{AP}$  of specimens of two stress conditions (HL and LL) placed on the compass deck (CO), the starboard side of the funnel (FN) and inside the engine room (ER) during the exposure test on the YUGE MARU ship

to the specimen elongation and the length constraint of the jig, the tensile load of the HL specimens in the exposed areas could not return to its initial value after the 321st day of exposure (The small sudden stress decreases of HL specimens on the CO and FN at September 2016 were not caused by the degradation or fracture of the adhesive layer. These would be due to slight unexpected rotation of the jig’s nut at the opposite side.). On the other hand, the adhesive bonding joints of both the HL and LL specimens at the ER site exhibited, respectively, only a little and no stress decrease. After the 321st day, the stress values for all the adhesive bonding joints remained stable (only a little stress decrease was observed) until the end of the exposure test, indicating that their degradation did not largely progress from September to December 2016.

The layer delamination would gradually spread from its edge as described in Sect. 3.1.2. It will be associated with gradual  $\tau_{AP}$  decrease observed from September to December 2016 as shown in Fig. 4. Such gradual degradation had proceeded more slowly than rapid degradation in summer, which might be influenced by water absorption from moisture, rain or sea water, in low temperature environment after September 2016, as drawn in Fig. 9c. There is no additional experiment in this research. However, in general, water absorption causes bonding layer degradation [13]. We previously confirmed the influence of moisture on the SGA adhesion tested in this research by acceleration tests [22]. The delamination-shaped crevice boundaries of the adhesive layer would facilitate this process by interrupting water drying from its boundaries. Preventing water (or other degradation factors if they are important) ingress might be effective to ensure long-term durability of adhesive bonding joints though the quantitative effect of water on long term exposure should be examined by the additional test thoroughly.

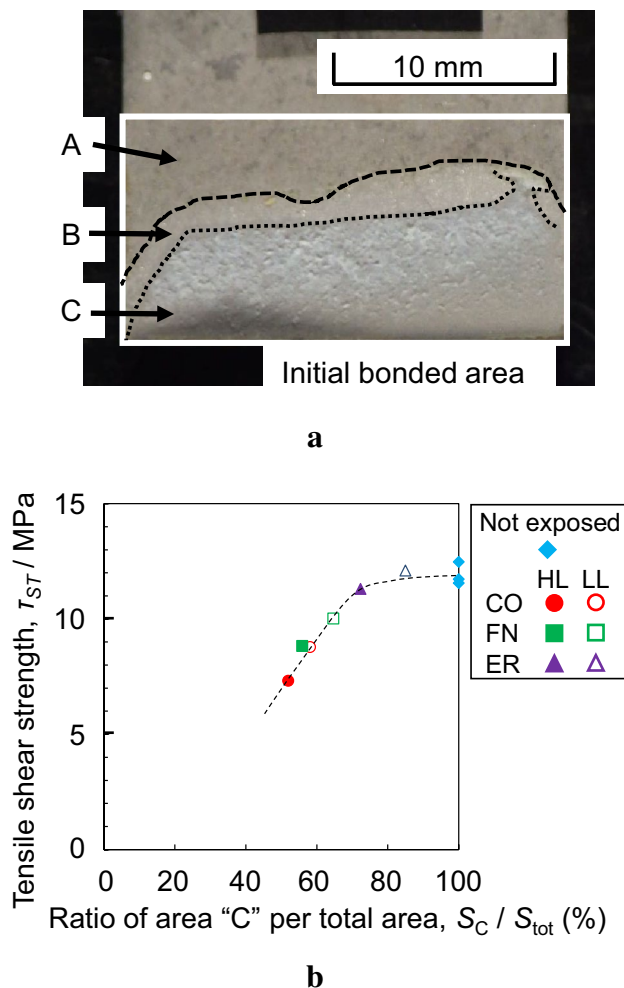
The fracture surface after the tensile test consisted of three distinct areas, as shown in Fig. 6a: A, B and C. Area A was characterized by the formation of aluminium corrosion products, meaning that the adhesive layer was already delaminated in the exposure test. In area B, the adhesive layer was also completely delaminated but no corrosion product was found (the Al plate surface retained its initial state), indicating that the bonding layer already experienced degradation during the exposure and delamination in the tensile test. The residual adhesive medium observed in area C suggested that the adhesive strength value had remained relatively high there. The proportions among these three areas on each specimen were derived from the photographs. Figure 6b shows the relationship between residual strength and ratio of area C to total area ( $S_C/S_{tot}$  as area C divided by initial bonded area), including the results for the not exposed specimens; the relationship observed indicated that the residual strength was clearly correlated with  $S_C/S_{tot}$  regardless of the stress condition and exposure environment. The residual strength could be determined by  $S_C$ , meaning that the adhesive bonding in area C had not been degraded during

**Fig. 6** **a** Classification of the fracture surface for the specimen of HL stress condition exposed at the compass deck (CO) into area A, B and C. **b** Plots of tensile shear strength,  $\tau_{ST}$  of each specimen against ratio of area C to total area,  $S_C/S_{tot}$

more than one year of exposure to temperature changes, solar irradiation, rain and sea salt particles; in other words, the degradation progressed only from the edge of the bonding layer.

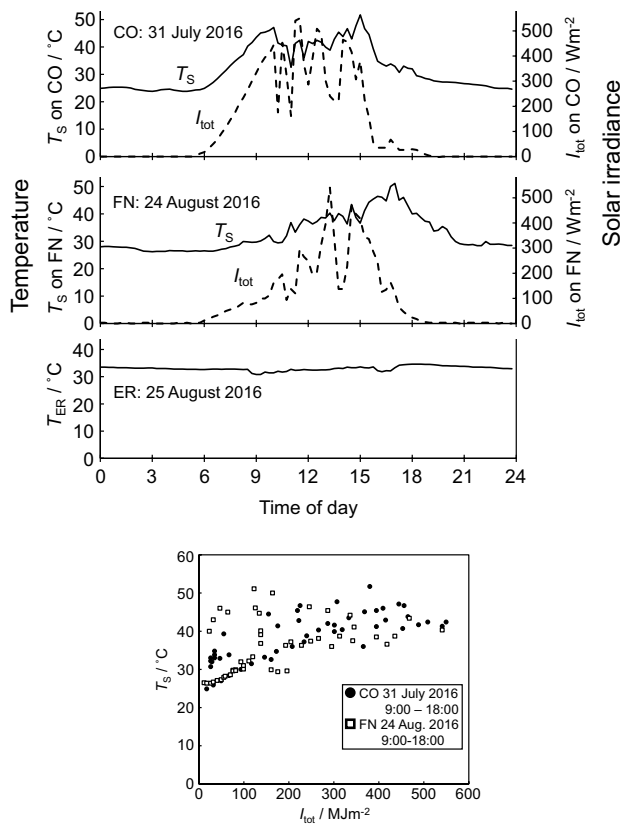
The highest  $T_H$  was 52 °C at CO (31 July 2016), 51 °C at FN (24 August 2016) and 35 °C at ER (25 August 2016); Fig. 8a shows, for these dates, the  $T_S$  values at CO and FN and the  $T_{ER}$  ones at ER, together with  $I_{tot}$ . A clear correlation was observed between  $T_S$  and  $I_{tot}$  at CO. These correlations are presented more clearly in Fig. 8b, showing plots of  $T_S$  against  $I_{tot}$  from 9:00 to 18:00 on 31 July 2016 for CO and 24 August 2016 for FN, respectively.  $T_S$  on CO indicated higher values for large  $I_{tot}$  values (correlation coefficient: 0.76) while  $T_S$  on FN indicated higher value against  $I_{tot} < 200 \text{ MJ}\cdot\text{m}^{-2}$  rather than against larger  $I_{tot}$  (correlation coefficient: 0.42). At FN,  $T_S$  exhibited the highest value at around 5 p.m. while the solar irradiance reached its peak between 2 p.m. and 3 p.m. This time lag could be attributed to the direction of the solar ray; as shown in Fig. 2, the specimens placed at the FN location were attached to the funnel wall, while the solar irradiance sensor faced the vertical direction so that it had poor sensitivity in the transverse direction. Since the YUGE MARU ship was always tied up, the heading direction was 206° and, hence, the specimens at FN faced to 299° direction (close to WSW). Thus, the  $T_S$  increasing around 5 p.m. was probably caused by solar irradiance from the side direction before sunset. The  $T_{ER}$  values did not change largely during the day, but they were higher than  $T_S$  at CO and FN during nighttime. This will result from that the specimens at ER did not receive any solar ray and was placed close to the ship's outer shell, whose temperature was affected by seawater rather than atmosphere. The  $T_S$  values at CO and FN were strongly affected by the solar irradiance, as reported by Ando et al. [14]; at these locations, the high solar irradiance increased  $T_S$  up to approximately 50 °C during the day, from June to September, although the corresponding  $T_{ave}$  and  $T_S$  during nighttime were equal to or less than  $T_{ER}$ .

**Fig. 8** a Surface temperature,  $T_S$  and total solar irradiance  $I_{tot}$  on the compass deck (CO) and the starboard side of the funnel (FN) and temperature inside the engine room (ER,  $T_{ER}$ ), during the day when the highest temperature was recorded at each location. b Plots of  $T_S$  against  $I_{tot}$  from 9:00 to 18:00, on 31 July 2016 for CO and 24 August 2016 for FN

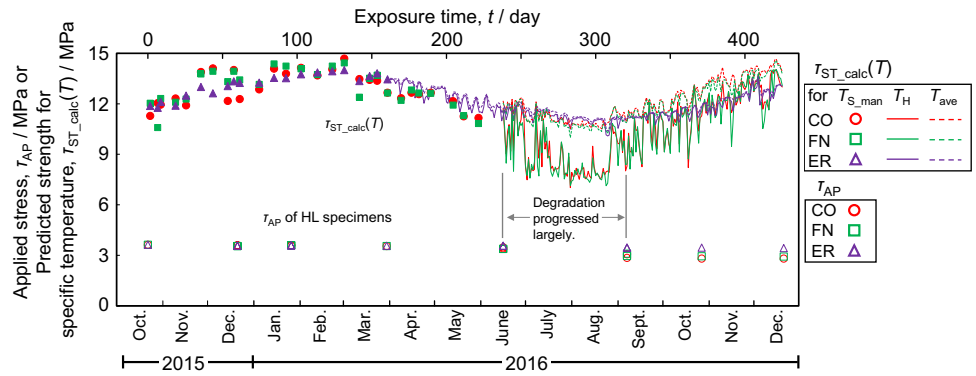
such relation, and these are plotted against the exposure time in Fig. 10 with  $\tau_{AP}$  of HL specimens. Degradations of the specimens significantly progressed on CO and FN in the period when  $\tau_{ST\_calc}(T_H)$  on CO and FN decreased largely, while  $\tau_{ST\_calc}(T_{ave})$  did not drop so much even in summer. The nominal  $\tau_{AP}$  remained higher value than  $\tau_{ST\_calc}(T_H)$ . However, given that higher applied stress is predicted at the edge of bonding layer, stresses on such part would fall under the specific value so that delamination would start there while the residual part would retain enough strength due to the lower local stress applied, even in a high-temperature environment, as illustrated in Fig. 9b.

**Fig. 10** Plots of predicted strength for specific temperature based on catalog data at  $T_{man}$ ,  $T_H$  and  $T_{ave}$ , with  $\tau_{AP}$ , against the exposure time

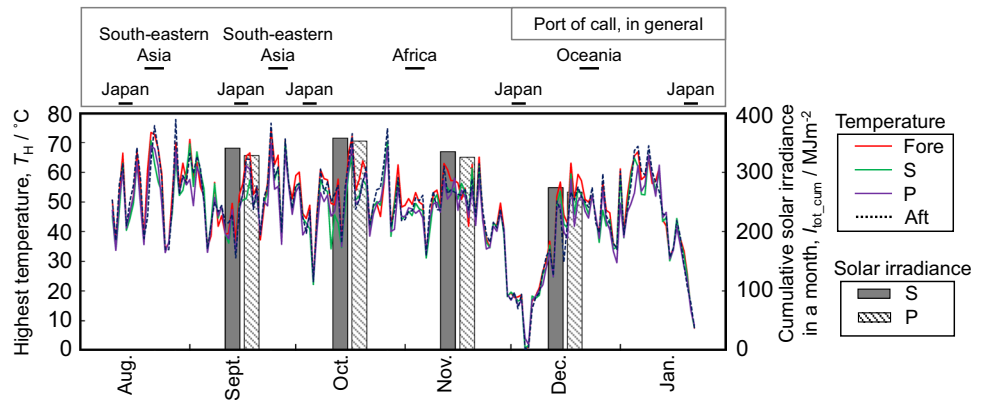
The  $T_H$  values and  $I_{tot\_cum}$  observed on the ocean-going ship are shown in Fig. 11, revealing a wider  $T_H$  range than that observed on the YUGE MARU, probably due to the larger environmental variety where the ocean-going ship was navigated. The highest  $T_H$  was 75 °C on the fore (24 September 2017), 71 °C on the starboard side (21 August 2017), 70 °C on the port side (24 September 2017) and 78 °C on the aft

**Fig. 11** Highest temperature,  $T_H$  and cumulative solar irradiance,  $I_{tot\_cum}$  for each month on the compass deck of an ocean-going ship

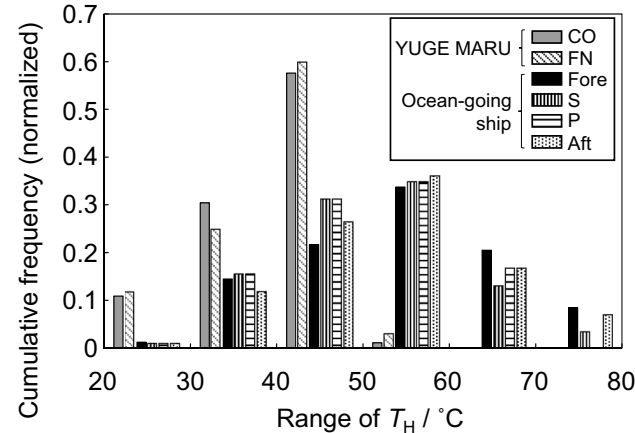
**Fig. 12** Cumulative frequency of the highest temperature,  $T_H$  on the YUGE MARU (from July to September 2016) and an ocean-going ship (from August to October 2017)

(28 August 2017); these values were slightly higher than those reported in literature [15–17]. In addition,  $I_{tot\_cum}$  was always larger compared to the YUGE MARU case. Figure 12 compares the  $T_H$  values measured on the YUGE MARU (from July to September 2016) and on the ocean-going ship (from August to October 2017), clearly indicated that the temperature on the latter was much severe than on
