# Land subsidence and earth fissures in south-central and southern Arizona, USA

**Abstract** Land subsidence due to groundwater overdraft has been an ongoing problem in south-central and southern Arizona (USA) since the 1940s. The first earth fissure attributed to excessive groundwater withdrawal was discovered in the early 1950s near Picacho. In some areas of the state, groundwater-level declines of more than 150 m have resulted in extensive land subsidence and earth fissuring. Land subsidence in excess of 5.7 m has been documented in both western metropolitan Phoenix and Eloy. The Arizona Department of Water Resources (ADWR) has been monitoring land subsidence since 2002 using interferometric synthetic aperture radar (InSAR) and since 1998 using a global navigation satellite system (GNSS). The ADWR InSAR program has identified more than 25 individual land subsidence features that cover an area of more than 7,300 km<sup>2</sup>. Using InSAR data in conjunction with groundwater-level datasets, ADWR is able to monitor land subsidence areas as well as identify areas that may require additional monitoring. One area of particular concern is the Willcox groundwater basin in southeaster

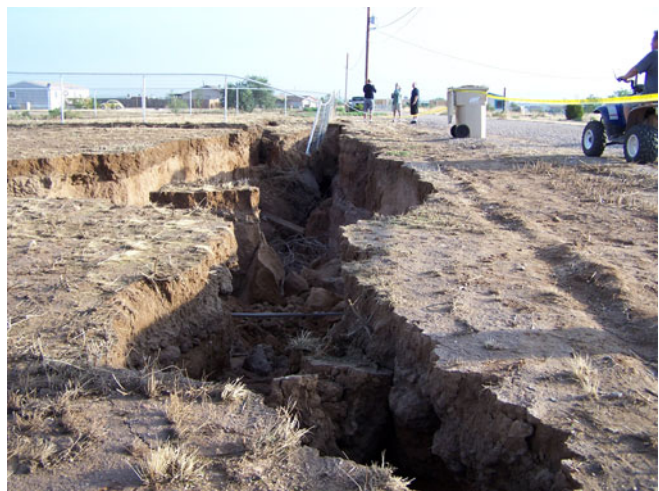
**Fig. 2** Earth fissure in Queen Creek, Arizona, which reopened after a large rain event in August 2005
