# Coring damage mechanism of the Yan-tang group marble: combined effect of stress redistribution and rock structure

**Keywords** Coring damage mechanism · Rock structure · Tensile cracks · Shear cracks · Jin-ping II Hydropower Station

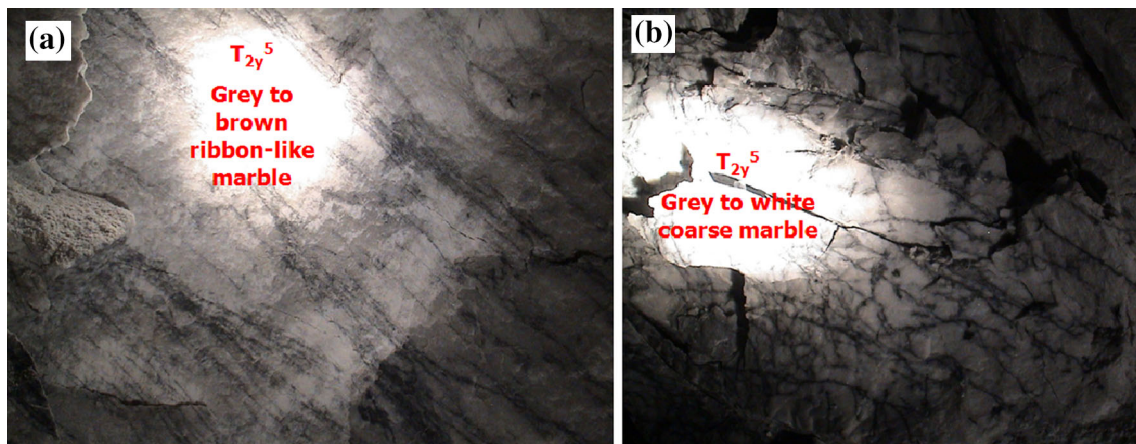
**Fig. 1** Different rock structures of the  $T_{2y}^5$  marble (the 5th layer of the Yan-tang group marble of the Middle Triassic), **a** grey to brown ribbon-like marble, **b** grey to white coarse marble

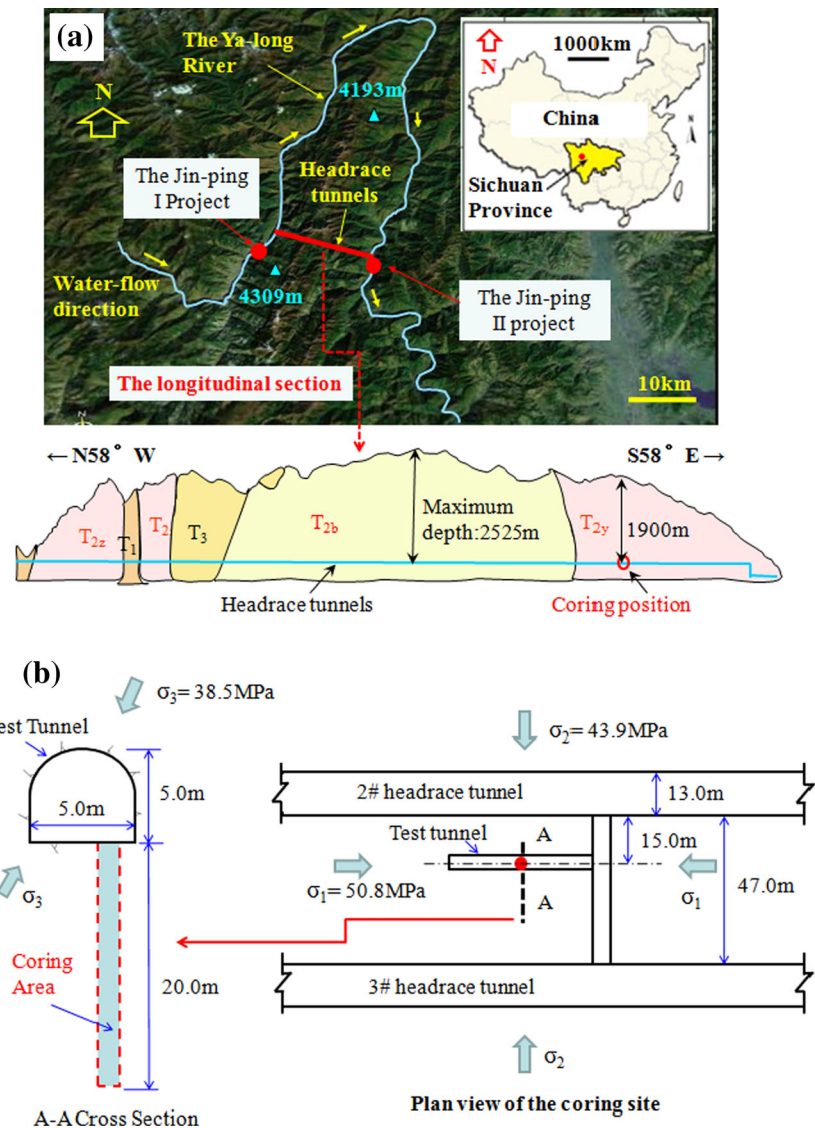
**Fig. 2** General geological conditions, **a** location of coring site and sampling arrangement,  $T_1$  means gray-green epidote and chlorite schist;  $T_{2y}$ ,  $T_{2b}$  and  $T_{2z}$  represent the Yan-tang group marble, Bai-shan group marble and Za-gu-nao group marble, respectively;  $T_3$  means sandstone and slate. The Yan-tang group ( $T_{2y}$ ) includes three sub-groups: the 4th–6th layer ( $T_{2y}^4$ – $T_{2y}^6$ ); **b** situation of the sampling position and in situ stress

The coring sites are located in the test tunnel excavated between the #2 and #3 headrace tunnel of the JPII project, as shown in Fig. 2. The lithology formation along the tunnel axis mainly includes: the Lower Triassic system ( $T_1$ ), the Middle Triassic system ( $T_2$ ) and the Upper Triassic system ( $T_3$ ). The Middle Triassic system ( $T_2$ ) is composed of carbonate rocks containing the Yan-tang group marble ( $T_{2y}$ ), Bai-shan group marble ( $T_{2b}$ ), Za-gu-nao group marble ( $T_{2z}$ ), and, further in, the  $T_{2y}$  marble includes several sub-groups, the 4th–6th layers ( $T_{2y}^4$ – $T_{2y}^6$ ) (Gong et al. 2012).

The buried depth of the sampling position is approximately 1900 m (as shown in Fig. 2), and the monitored in situ stress tensor is:  $\sigma_1 = 50.8$  MPa,  $\sigma_2 = 43.9$  MPa,  $\sigma_3 = 38.5$  MPa. The azimuth angle of the maximum principal stress ( $\sigma_1$ ) is primarily within the range of 120–160° (nearly parallel to the tunnel axis), and the maximum and intermediate ( $\sigma_2$ ) principal stresses are both nearly horizontal with very small dip angles (both within 5–10°), while the orientation of the minimum principal stress ( $\sigma_3$ ) is generally vertical with a dip angle of 77° (Chu et al. 2010). The rocks surrounding the test tunnel are Yan-tang group marble ( $T_{2y}^5$ ) of class III, whose geological

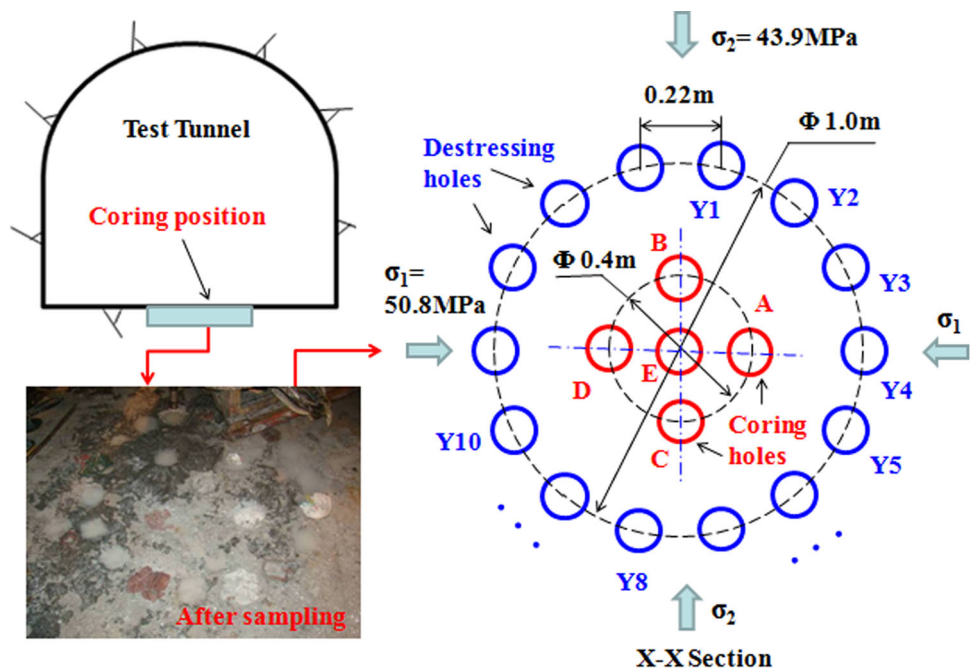
**Fig. 3** Sampling scheme for obtaining cores under different stress levels at the same position

A series of equally spaced de-stressing holes were drilled at a circular boundary to reduce the stress level in the central region gradually, and sampling holes are located in the circle area to collect low-stress cores. This arrangement was designed to obtain rock samples under different stress levels at the same position (Shan et al. 2010), as shown in Fig. 3.

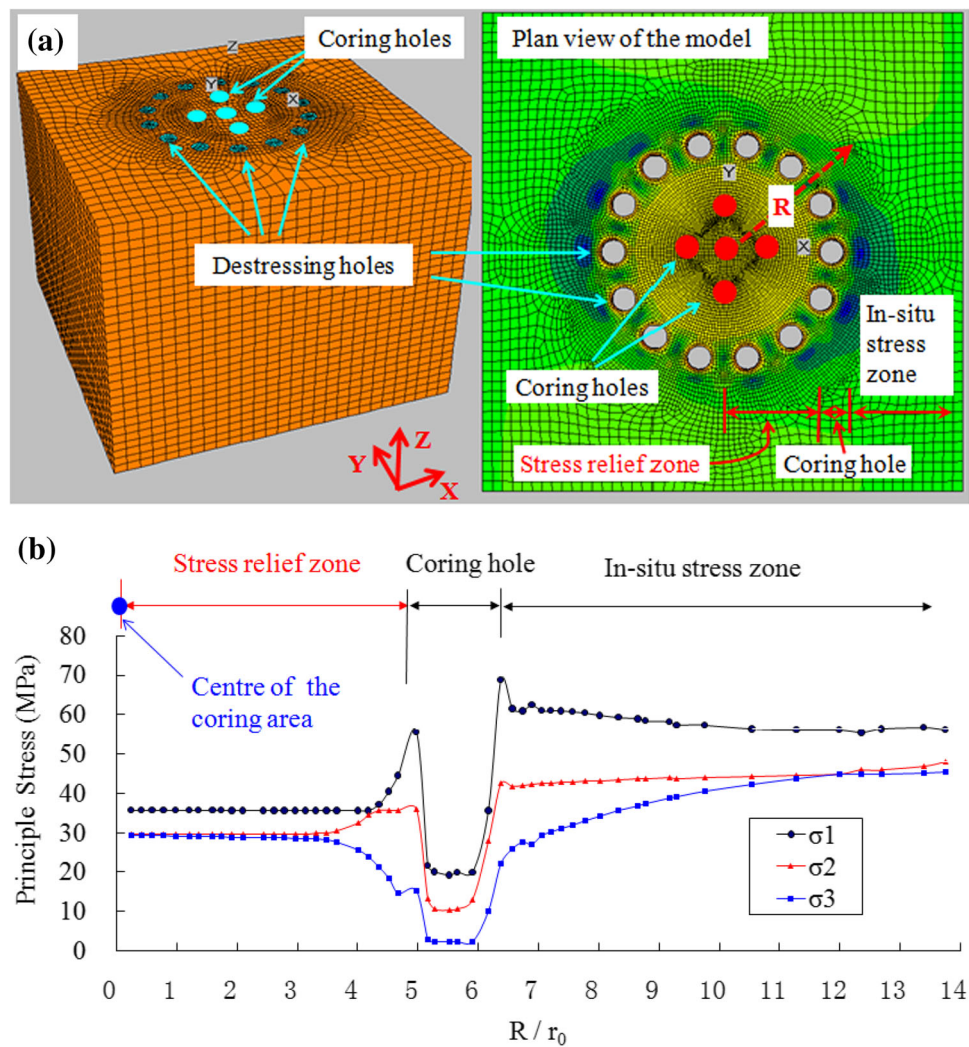
**Fig. 4** Simulation investigation of the damage-relief coring scheme, **a** numerical model; **b** simulated principal stresses on a cross-section,  $R$  is the distance from the centre of the coring area, and  $r_0$  is the diameter of the coring hole

A numerical model has been built to investigate the stress relief effect of the proposed sampling scheme before being implemented. The size of this model is  $3 \times 3 \times 5$  m ( $x \times y \times z$ ). The model was discrete by about 200,000 elements with a maximum size of 0.125 m. The bottom surface of the model was fixed during excavation. The stress sensor used in the simulation is the same as that mentioned above:  $\sigma_x = \sigma_1 = 50.8$  MPa,  $\sigma_y = \sigma_2 = 43.9$  MPa,  $\sigma_z = \sigma_3 = 38.5$  MPa. The principle stresses along the diameter R from the centre to the upper-right corner of the model after drilling all 14 de-stressing holes are also shown in Fig. 4.

It can be observed that in the middle region of the sampling area, the principal stresses were reduced from 40 to 50 MPa (average  $\sim 45$  MPa) to 30–38 MPa (average  $\sim 33$  MPa) after completely drilling all the de-stressing holes, and the deviatoric stress (difference between the maximum and minimum principal stresses) was reduced from 20 MPa to approximately 8 MPa. The deviatoric stress was reduced substantially, by 50 % or more, but the average principle stress was only decreased by 26.7 %. According to Holt et al. (2000), the ideal method to reduce core damage is to perform the coring operation under a low deviatoric stress condition. So, the stress relief effect of the designed sampling scheme is quite promising.

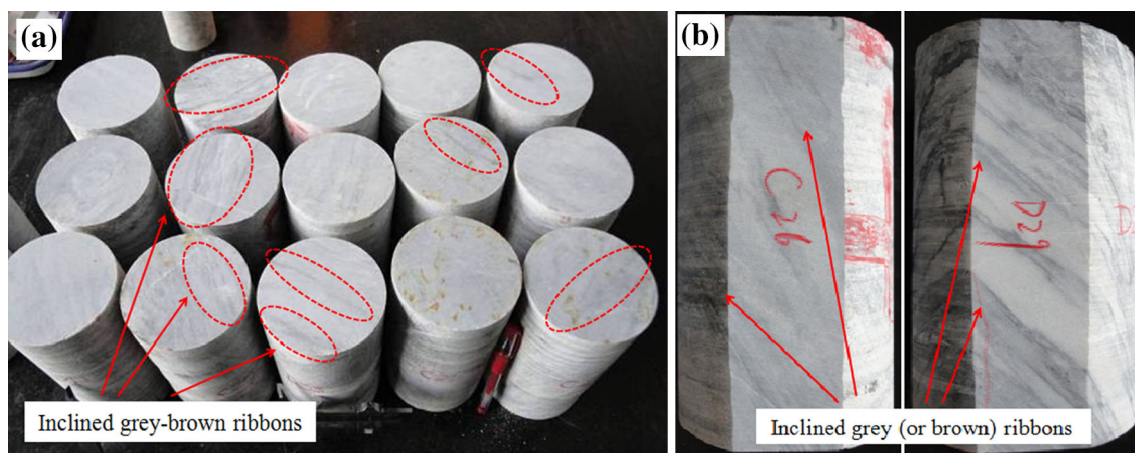
**Fig. 5** Examples of manufactured rock samples and the *brown ribbons*, **a** top review; **b** front review (after manufacturing)

It can be seen from Fig. 5 that no distinct cracks could be found on the two kinds of rock cores, excepting some grey lines of marble rock, which indicates that the coring-induced cracks or damage cannot be observed with the naked eye. More importantly, the coring direction was designed to intersect the strike plane of the grey-to-brown ribbon in the coring site with a large angle, so the inclined grey-to-brown ribbons can be detected almost in every sample. This situation may indicate that the anisotropy of these rock samples may be outstanding.

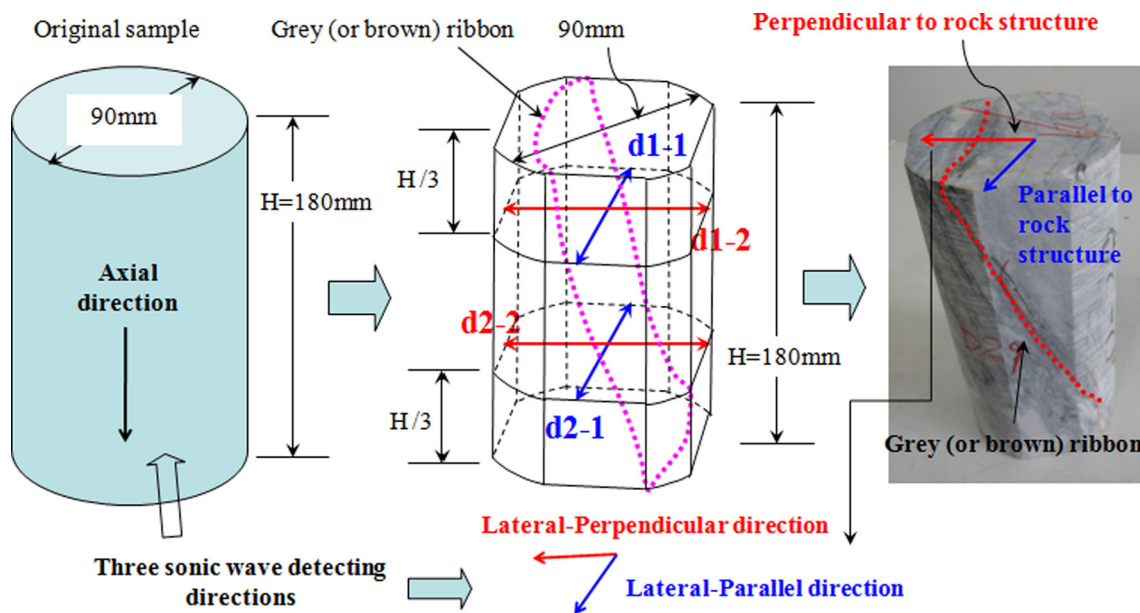
**Fig. 6** Rock sample manufacturing and P-wave detection scheme. In order to increase the contact condition between the flat sonic probe and rock sample, 4 small flats were produced at the ends of two pairs of orthographic diameters. The d1-1 & d2-1 (blue) and d1-2 & d2-2

(red) are parallel and perpendicular to the main strike plane of grey (or brown) ribbons, respectively. The two special directions are referred as lateral-parallel and lateral-perpendicular in the following literature

In order to increase the contact condition (or coupling condition) between the flat sonic probe and rock sample, four small flats were produced at the ends of two orthographic diameters (the subsequent AE monitoring test also requires these flats), as shown in Fig. 6. The two pairs of orthographic diameters (marked by d1-1 & d1-2, d2-1 & d2-2, respectively), located at the H/3 from the top and bottom, respectively, were selected to test the sonic wave velocity. And d1-1 & d2-1 (blue color) and d1-2 & d2-2 (red color) are presupposed to be parallel and perpendicular to the main strike plane of grey (or brown) ribbons in every sample, as shown in Fig. 6a. The two special directions are referred to as lateral-parallel and lateral-perpendicular in the following literature.

Firstly, the axial sonic wave (P-wave) velocity was obtained by detecting it three times and calculating the average value. Then, the lateral P-wave velocities were detected three times along each of the four diameters (shown in Fig. 6), and then their average values were calculated to obtain two meaningful velocities in lateral-parallel and lateral-perpendicular directions, respectively. In addition, the P-wave velocities of the de-stressing hole wall and coring hole wall were also detected with the same sonic detecting equipment and an ordinary single-hole sonic probe.

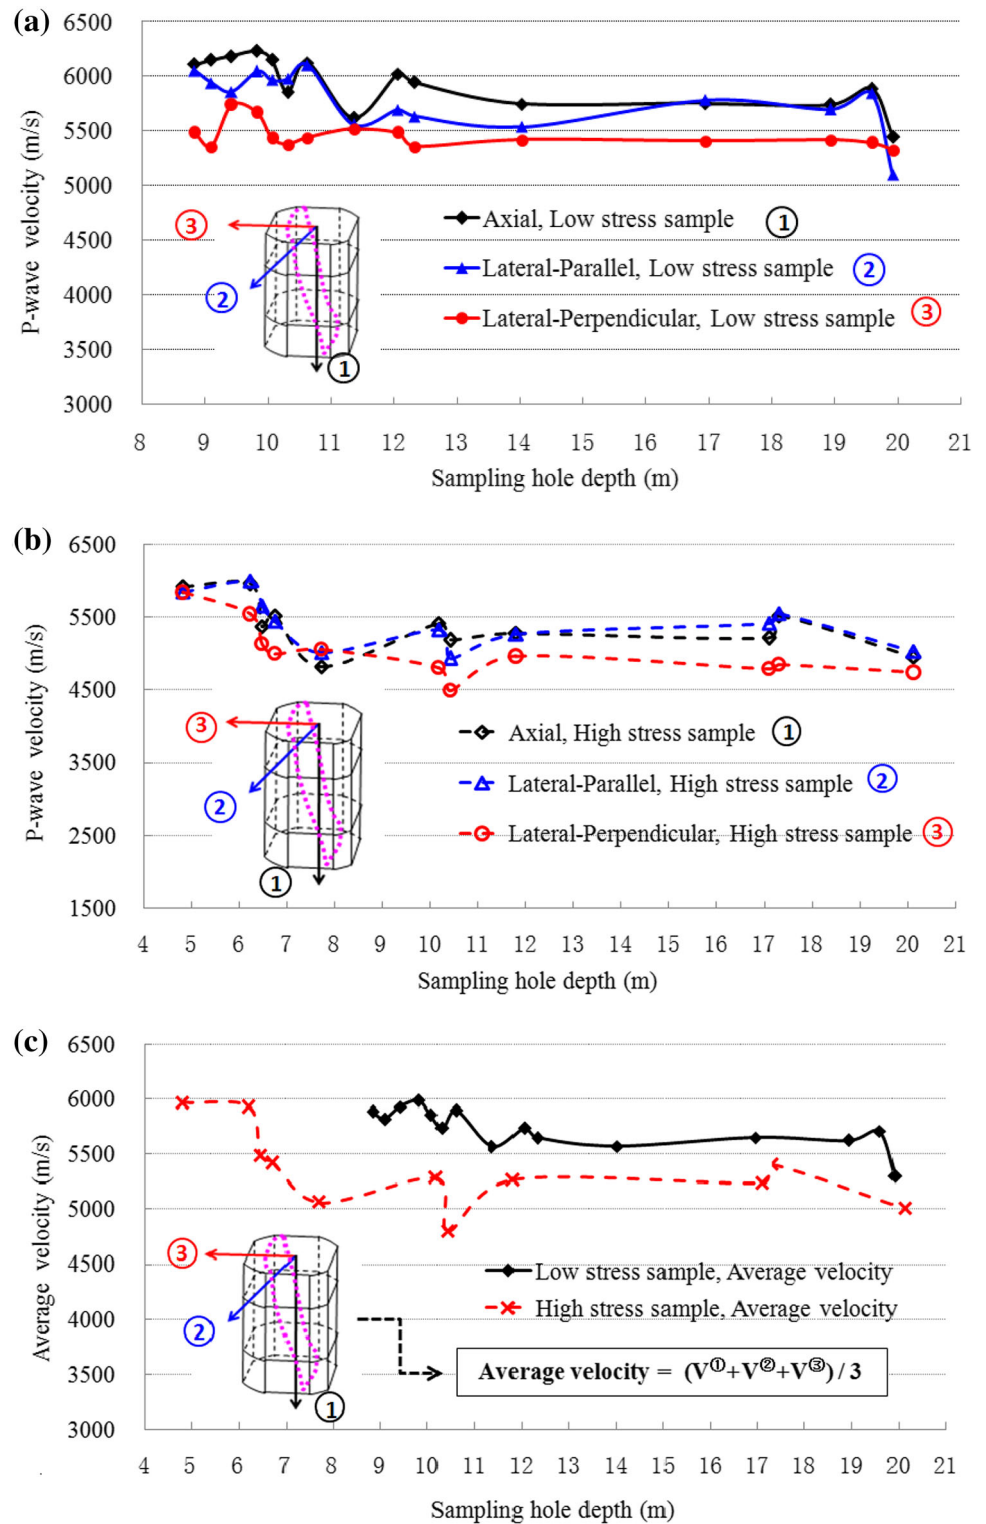
**Fig. 7** Results of the sonic wave velocity detection, **a, b** P-wave velocities of low-stress and high-stress samples in the three detection directions, respectively; **c** average P-wave velocity of high-stress and low-stress samples

Figure 7 presents the results of detected P-wave velocities between the two kinds of samples in all the three directions (including axial, lateral-parallel and lateral-perpendicular directions), and the axial P-wave velocity of the sampling hole wall versus hole depth is also given.

It can be seen from Fig. 7a-c that the P-wave velocities of low-stress samples at all the three detecting directions are evidently larger than that of high-stress samples at same hole-depths, which indicates that the samples retrieved from a high-stress condition (obtained from de-stressing holes with in situ stress of 40–50 MPa) are more severely damaged to that collected from a low-stress condition (obtained from coring holes with in situ stress of 30–38 MPa).

Figure 7a, b presents the comparison of P-wave velocities among the three detecting directions of low-stress and high-stress samples. It can be observed that, for the two kinds of rock samples, the differences between the axial

and lateral-parallel are very small, but both of them are obviously larger than that in a lateral-perpendicular direction at most sampling depths, which indicates that the vertical or sub-vertical micro-cracks are mainly distributed parallel to the strike plane of grey (or brown) ribbons.

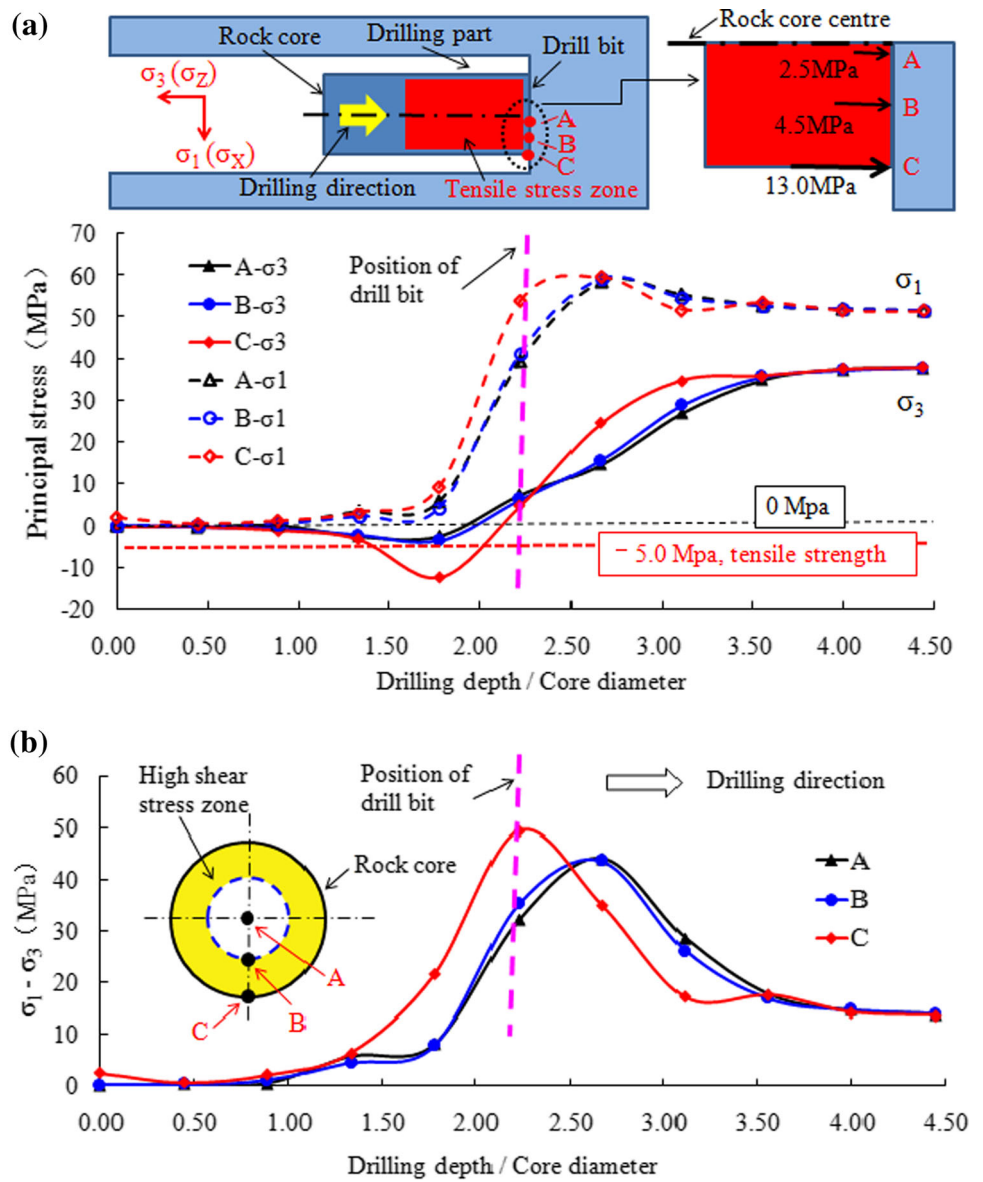
**Fig. 12** Numerical simulation results, **a** estimated principle stresses versus drilling depth; **b** estimated deviatoric stresses versus drilling depth

Three points, A, B and C, located at the core centre, the middle point of core radius and the radius end on core edge, respectively, were selected to monitor the stress path experienced by the rock core, as shown in Fig. 12.

It can be seen from Fig. 12a that the compressive stress concentration is generated immediately below the drill bit, and no tensile stress is produced at the front of the drill bit. Once the core passes the drill bit, the compressive axial stress ( $\sigma_3$ ) turns into tensile stress, and the lateral stress ( $\sigma_1$ ) remains compressive. The maximum tensile stress occurs at the core edge (point C), and its value is about 13.0 MPa. At the middle point of the core radius (point B) and the core centre (point A), the maximum tensile stresses are 4.5 and 2.5 MPa, respectively.

The measured tensile strength of Yan-tang group marble at the JPII project is 4.0–6.0 MPa (Chu et al. 2010), and a medium value of 5.0 MPa is given in Fig. 12a. So, the tensile stress in the external part of the core is larger than the rock tensile strength, and the tensile cracks are expected to generate from the core boundary to the core centre. Furthermore, due to tensile stress ( $\sigma_3$ ) in the direction parallel to the core axis (z-axis) and the compressive stress perpendicular to the axis, the horizontal microcracks will preferentially occur in the core and expand to the core's center, then form a horizontal fracture. This coincides with the core dinking fracture

In addition, Fig. 12b illustrates the principal stress difference in the core at different coring depths. It can be seen that the principal stress difference (deviatoric stress) is about 15 MPa in its original state, and it will increase to 40–50 MPa in a certain area below the drill bit, which is consistent with the results of Holt et al. (2000). The large deviatoric stress may lead to yielding and shear failures in the rock, and the Mohr–Coulomb shear failure criterion can give the best fit to this phenomenon. Considering the rock structure of Jin-ping Yan-tang marble ( $T_{2y}^5$ ), the vertical or sub-vertical cracks are generated along the grey-brown ribbons in the rock core, and are prior to cracks occurring in the external zone of the rock core due to the larger deviatoric stress around the core's edge.
