Resource recovery as a sustainable perspective for the remediation of mining wastes: rehabilitation of the CMC mining waste site in Northern Cyprus

Abstract This paper highlights resource recovery and stabilization as the novel approach adopted in the rehabilitation strategy of the abandoned copper mine site (CMC mine) located in Northern Cyprus, recognized as a source of chronic pollution problems. The site holds 9.5 million tons of tailings stored in poorly equipped ponds. The waste contains pyrite and chalcopyrite undergoing slow oxidation; this way, sulfide has been partly converted to sulfuric acid causing severe acid mine drainage problems. The rehabilitation strategy adopted the EU's key principle of resource recovery, where all tailings would be processed for copper recovery and stabilized to further prevent the chemical mobility of heavy metals before final landfilling. A leaching-cementation process, with no chemical usage,

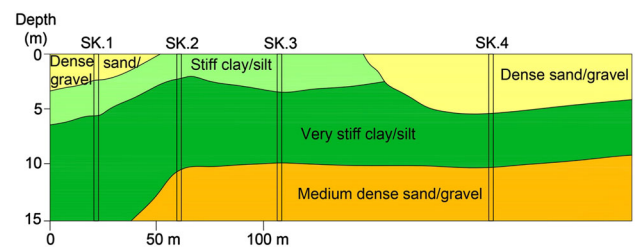
**Fig. 2** Geological cross-section drawn using SK exploration boreholes

Examination of existing borehole logs shows that the aquifer is mainly Bostancı Conglomerate and alluvium (Geology and Mining Department of North Cyprus-GMD 2009). The 40 m deep PSK 14 borehole (pond borehole) encountered sandy silty clay, sand-gravel and sandy clay between 0 and 13 m and only clay between 13–40.5 m (Geosurvey 2015). These data reveal that the land is more clayey around the waste ponds (Fig. 2). Pumping tests, lab and field measurements of permeability for this investigation, and the previous tests in and around the investigation area yielded that transmissibility and permeability of the aquifer were quite heterogeneous (Table 4). The locations of the wells are given in Fig. 3. The earlier pumping tests done by GMD yielded transmissivities of 850 m²/day for CMG1 and 20 m²/day for CMG2; other wells CMG3

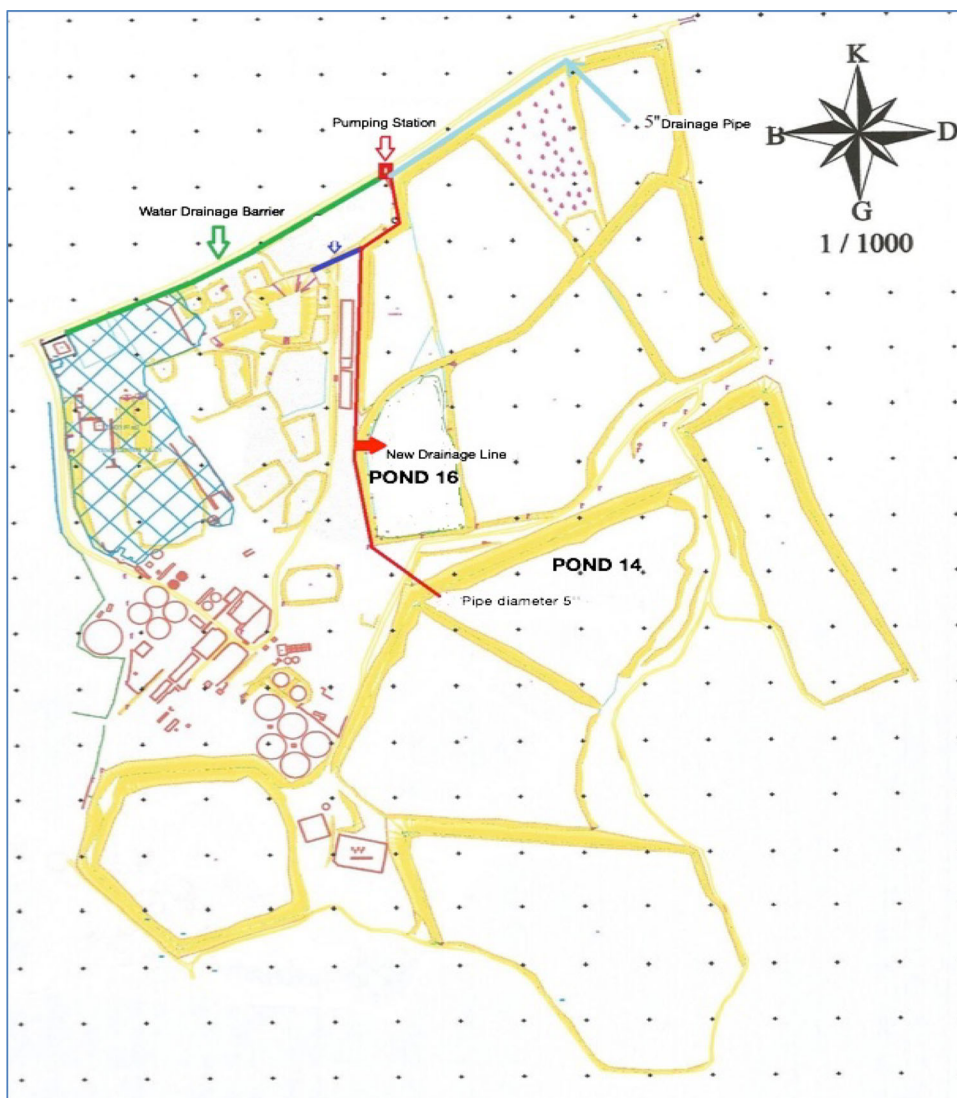
Fig. 5 Storage of storm water drainage and temporary waste protection and storage ponds in the area

tailing ponds. For this purpose, all storm water of the site was captured in a collector system constructed along the shoreline border of the site and pumped into pond no. 16 assigned for this purpose (Fig. 5). This pond has approximately a surface area of 33,000 m² and a clearance volume of around 55,000–60,000 m³ on the surface for storage, evaporation and subsequent reuse of the rainwater. This capacity is quite sufficient to store around 30,000–35,000 m³/year of storm water drainage generated in the area based on practical assessments in the last few years. This system will ensure a zero-waste concept for surface waters.
