The influence of materials on the breaching process of natural dams

Abstract In this study, a series of natural dam overtopping laboratory tests are reported. In these tests, the effect of seven different sediment mixtures on the breaching process was investigated. According to the test results, three stages of the breaching process of natural dams made of different materials were observed. Backward erosion was the primary cause for the incising slopes. The effects of backward erosion became stronger with the larger fines contents of the materials. With an increase in the median diameter (d_{50}) of particles, the breaching time became longer. However, the peak discharge became smaller. With an increase in the fines contents (p), the median diameter of the particles and the void ratio were changed, which resulted in a decrease in the breaching time and an increase in the peak discharge. The breaching time and peak discharge were more sensitive to the median diameter than to the fines contents. The relation between breach width and depth was found to follow a logistic function $W = \frac{\zeta}{1 + e^{[-k(D - D_0)]}}$. The parameters ζ , k , and D_0 are defined by a linear relation

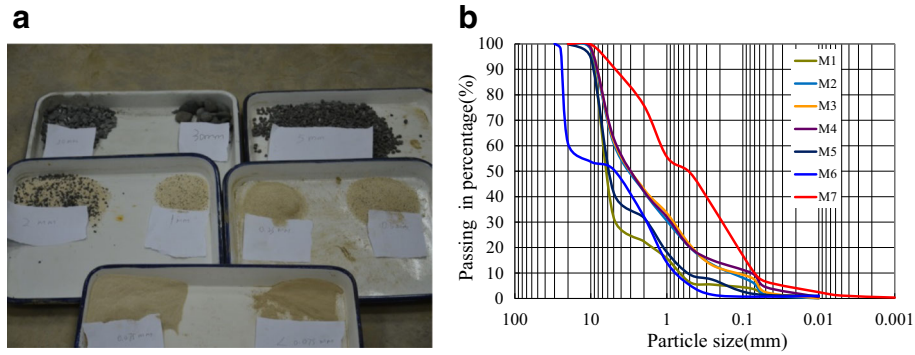
Fig. 1 Experimental materials. **a** Photographs of particles. **b** Gradation curves of dam materials

such that the motion of the different particles in the experimental process could be observed. We sieved the clay, sand, and gravel into nine different ranges of particle size: 2–3, 1–2, 0.5–1, 0.2–0.5, 0.1–0.2, 0.05–0.1, 0.025–0.05, 0.0075–0.025, and < 0.0075 cm (Fig. 1a). The seven mixtures used in the tests were designated M1, M2, M3, M4, M5, M6, and M7. The grain size distribution curves of the seven mixed soils are shown in Fig. 1b. The fines contents, p (i.e., particles less than 0.075 mm), of the seven mixtures were 0.38, 3.84, 6.4, 7.9, 1.872, 0.7, and 11.2%, respectively. The median diameters, d_{50} , of the mixtures were 6.2, 3.3, 3.2, 3, 5.8, 5, and 0.52 mm, respectively.

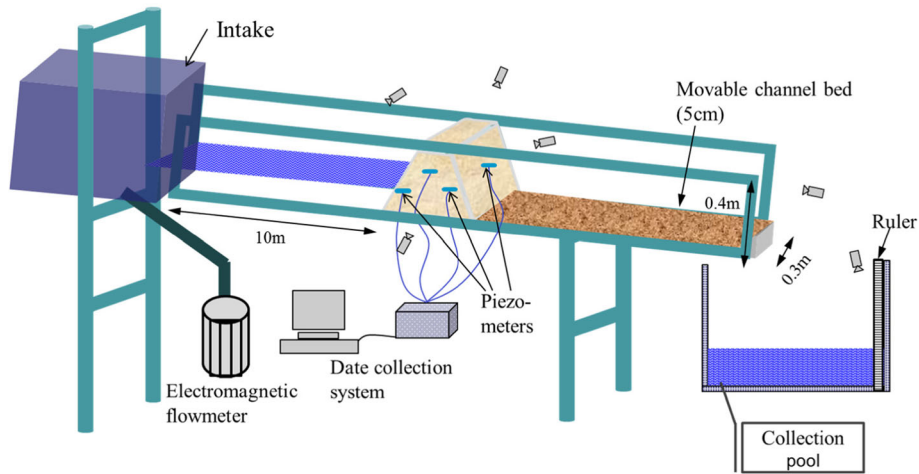
Fig. 2 A sketch of the flume and its hydrological equipment

The tests were conducted in a flume measuring 15-m long, 0.3-m wide, and 0.6-m deep. The flume was made of glass with a variable bottom slope, and the Manning roughness was approximately 0.01. Figure 2 shows the experimental set-up. The inflow discharge could be accurately controlled with an electromagnetic flowmeter. The dam was located 10 m away from the intake. The tests involved the use of a movable riverbed. The movable riverbed was composed of the same materials as the dam and had a thickness of 5 cm. When the downstream area was a rigid bed, the seepage of the dam bottom that makes contact with the flume was severe. Thus, the seepage flow from the piping easily eroded the dam toe and the dam breach progressively (piping mode). The movable bed could reduce the seepage of dam bottom and prevent piping, which ensured that the dam failure mode was overtopping. At the end of the flume, a 5-cm-high plate was set as the boundary condition. A collection pool was used to collect the sediments and water from the riverbed. A 1-m ruler was pasted to

the wall of the reservoir to measure the height of the fluid contained within. As shown in Fig. 2, six digital video cameras were installed above, on the side of the dam, and above the riverbed and reservoir to record the entire process. Piezometers were installed both upstream of and in the dam as shown in Fig. 2. The piezometers were capable of automatically recording 10 data per second. The piezometers were set in two vertical rows and three horizontal columns. The detailed locations of the piezometers in the dam are shown in Fig. 3. After the first layer of the dam was built from bottom to top and compacted, three piezometers were placed on the layer. The fourth piezometer was placed when the top layer was built and compacted. The sensing wires were fixed to the sidewall of the flume.

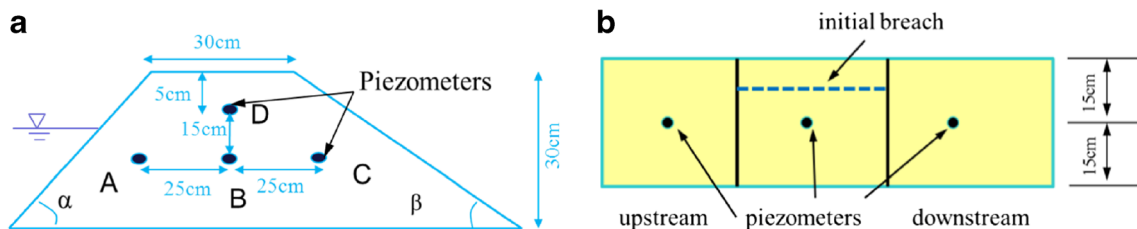
Fig. 3 The locations of piezometers in the dam. a Longitudinal location of the piezometers. b Horizontal location of the piezometers

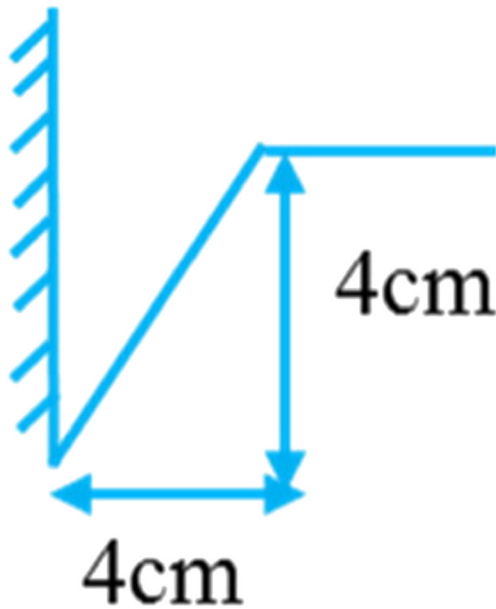
Fig. 4 Dimension of initial breach

A dam with a trapezoidal profile was simulated in the flume tests. The initial upstream and downstream slopes (α , β) of the dams were 20° and 15° , respectively. All of the dams had a common height and width of 0.3 m and a crest width of 0.3 m. A triangular initial breach was set at the side of the dam, of which the depth and top width were 4 cm, and the side slope was fixed at 1:1 (Fig. 4). The inflow discharges used in the experiments were 1 L/s. In total, the experimental designs are summarized in Table 1.

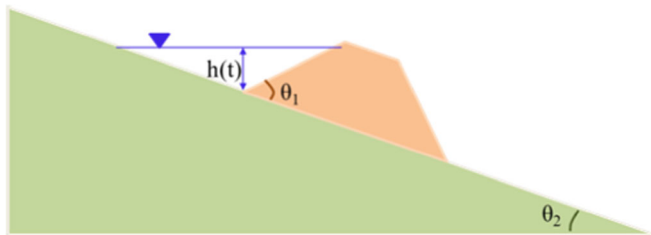
Fig. 5 Sketch of the natural dam and channel

pressure principle, the water depth could be determined by the water pressure. The error range of measured pore pressure water was 0.0001 kPa. The outflow discharge during the breaching process was calculated from the water depth upstream of the dam. Figure 5 shows a sketch of the natural dam. The angle of the upstream slope of the dam was θ_1 , and the angle of the channel was θ_2 . After the lake water had overtopped at time t , the water depth in front of the dam was $h(t)$, and the volume of the lake was

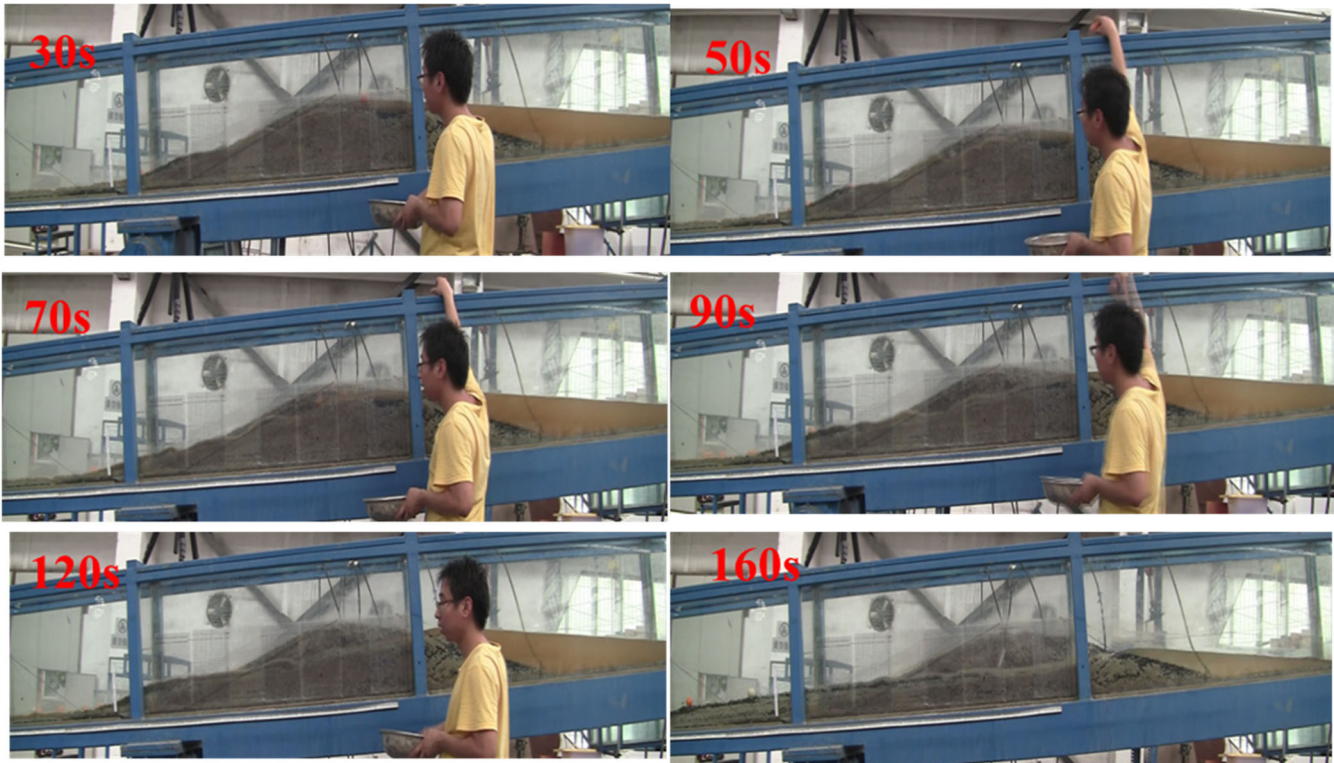
Fig. 6 Images of the dam at different times for T-5, which shows the gully deepening by overtopping erosion and the characteristic breach phases

The natural dams made of the seven test materials all failed by overtopping. Figure 6 shows a sequence of images of the dam breaching at different times for the T-5 case. From the experimental results, the dam breaching began with the initial breach, and then the outflow eroded the downstream surface of the dam. Thus, an erosion gully was formed. The gully was continuously eroded and became deeper. During the gully deepening process, its lateral slopes became steeper, and a mass lateral collapse of the gully occurred, which led to the widening of the gully. During this phase of the breaching process, the outflow increased and then decreased with the increase of the breaching time. Moreover, the water-sand mixture flowed muddied and then became clearer with the development of the breaching. At the end of the tests,

The breaching process images illustrated in Fig. 6 were divided into three distinct phases. In the first phase, the breach developed slowly. While the outflow was overtopping the initial channel, its discharge and the velocity was small, and the depth was shallow. Consequently, the erosion ability of the outflow was weak, which slowly decreased the dam height. In this process, the suspended sediment motion was the only form of sediment movement. The breach slope collapsed intermittently, and the volume was small. The breach shape approached that of a rectangle. These observations are consistent with those of Rozov (2003). In the second phase, the breach developed more quickly in the breaching process. With the development of the breach, the outflow eroded more sediment due to larger outflow discharge and the higher flow velocity. The sediments were washed downstream, and the breach developed laterally and vertically simultaneously. In this phase, the shape of the breach channel was similar to an “hourglass,” and the shape of the breach was nearly trapezoidal. The breach slope frequently collapsed, and the volume was larger than in the first phase. The third phase was the water and sediment rebalance stage. In this phase, the outflow discharge became small; the flow could erode only fine sand and resulted in the formation of an armoring layer on the surface. This armoring layer protected the sediment that could not be washed away, and the dam height remained constant.

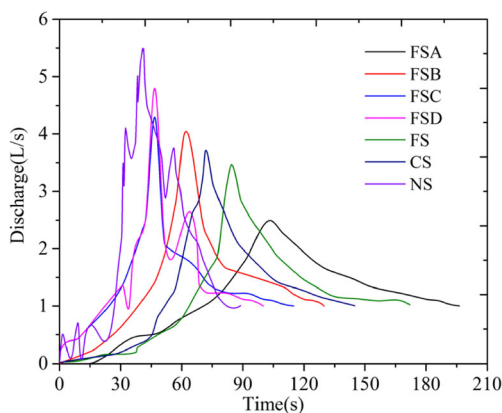
Fig. 7 Breach discharge hydrographs for the seven materials

During the breaching process, the water depth upstream of the dam was recorded by a piezometer, and the discharge was calculated with Eq. (4). Figure 7 shows the discharge hydrographs for the natural dams composed of the seven materials. This figure shows that the discharge first increased and then decreased. With the dams composed of M5, M6, M1, M2, and M3, the hydrograph present a typical unimodal sort. However, the hydrographs for dams composed of M4 and M7 have multiple peaks. The primary reason for this discrepancy is that the breach of dams composed of M4 and M7 broadened more slowly than the incised dams, and when the failed breach side of the slope could block the breach, the outflow stopped. When the blockage was scattered and pushed away, the water continued to outflow and later reached another peak discharge. Figure 7 also indicates that the hydrographs were shaped into a high, thin type when there were high fines contents in the materials.

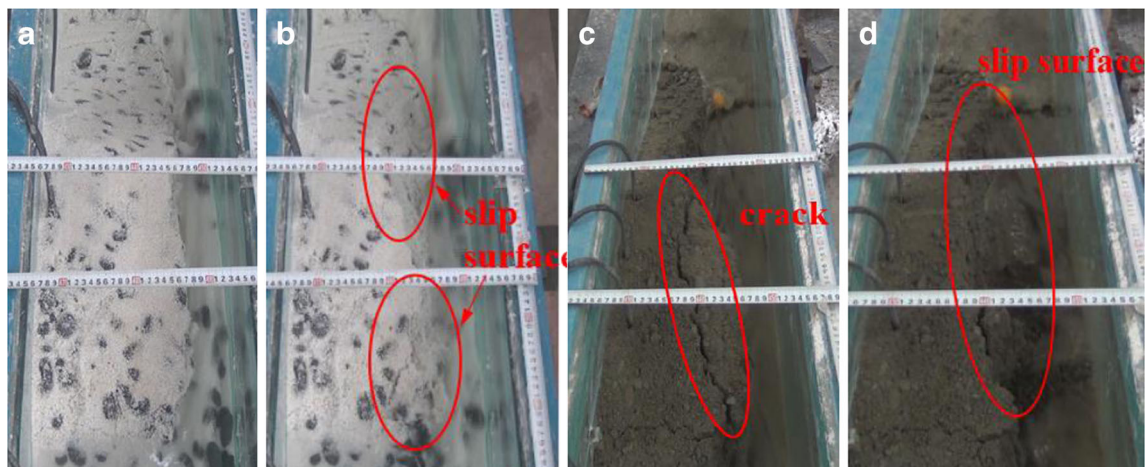
Fig. 13 Images of two failure modes for pre-failure and post-failure. a The dam made of M6 materials before shear failure. b The characteristics of the dam made of M6 materials after shear failure. c The dam made of M7 materials before tensile failure. At this time, a microcrack occurred at the top of the dam. d The characteristics of the dam made of M7 materials after tensile failure. The crack became wider and then fell into the breach

failure occurs earlier than when the water had eroded to the locations of the piezometers. The evolutions of the pore pressure at different locations for the different materials are distinct. For M5 and M6, which contained fewer fines than M7 and M4, the pore pressures at location D first increased and then decreased at the failure time. However, the opposite was true for M7 and M4, i.e., the pore pressures first decreased and then increased. This reversal indicates that shear failures occurred at location D for M6 and M5. No cracks occurred at the top of the dam, and the failure process was very short. After shear failure, an inclined surface appeared (Fig. 13a, b). The tensile failure occurred at

location D for M7 and M4. Before the tensile failure, a microcrack could be seen at the top of the dam. Moreover, the crack became increasingly wide as time progressed. Then, the breach slope failed at the rotated bottom (Fig. 13c, d). However, shear failure occurred at the other locations (A, B, C) of the four materials. The failure modes were related to the materials. First, the M6 material had few fines so the tensile strength of this material type was very small, and the shear strength was primarily resistant strength. The M4 material had many fines, which led to a larger tensile strength that could resist pulling forces. Second, the M6 material had a larger mean diameter than did M4, which resulted in a lower

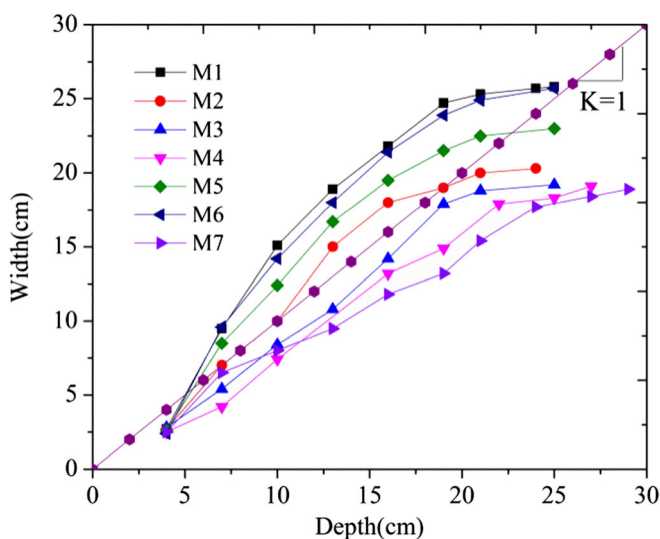
Fig. 14 The relationship between the breach width and depth for different materials

Figure 14 shows the relation between the breach width and depth. All the curves in the figure are nonlinear. The curves of M7, M4, and M3, which contained many fines, are almost all below the straight line with a slope of 1. However; the curves of M1 and M6, which contained few fines, are almost entirely above the straight line with a slope of 1. Finally, the curves of M2 and M5 are below the straight line at both ends with the other part of their curves being above the straight line. Overall, the values in the curves decrease as the fines content of the material increased. The overall outcome is that the vertical erosion

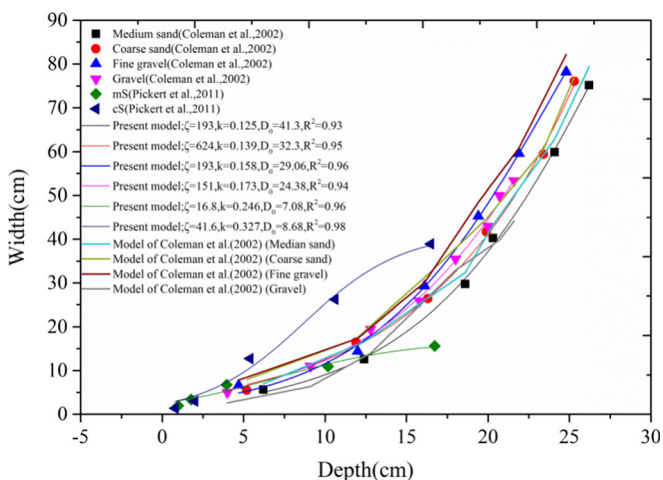
Fig. 17 The relationships between breach width and depth for different materials. The scatter points are measured data by Coleman et al. (2002) and Pickert et al. (2011). Present model is proposed in this paper, i.e., (6). Model of Coleman et al. (2002) is proposed by Coleman et al. (2002)

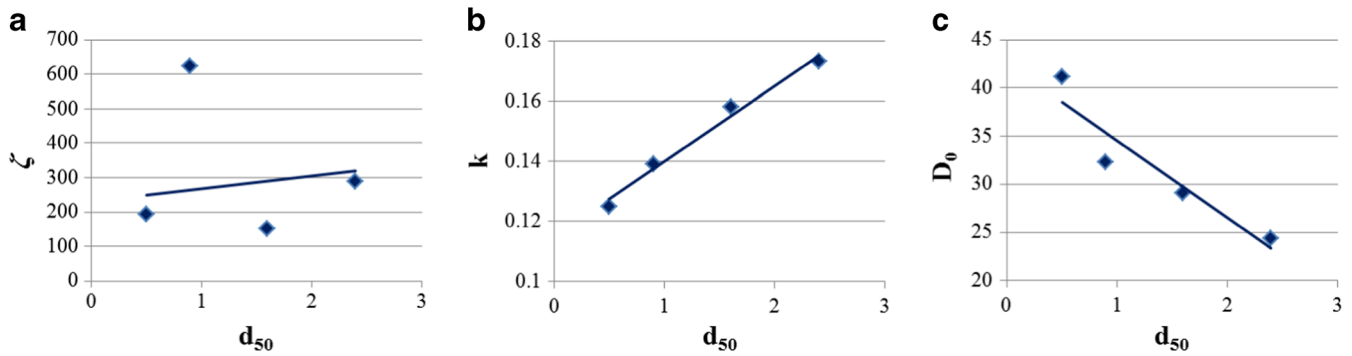
Fig. 18 The influence of d_{50} on the parameters ζ , k , and D_0 . The data in this figure are from Coleman et al. (2002) in Fig. 17. **a** The relationship between ζ and d_{50} . **b** The relationship between k and d_{50} . **c** The relationship between D_0 and d_{50}
