A Comparison of Laser Shearography and C-Scan for Assessing a Glass/Epoxy Laminate Impact Damage

Martin Kadlec · Roman Růžek

Abstract Impact damage is a serious damage mechanism in composite materials, which limits their performance and reliability. Impact damage can occur during in-service applications or as a result of handling during manufacturing. Methods used currently for damage detection are based on different principles, and for that reason, they give a range of results no matter what the real damage is. Therefore, a comparison of the internal real damage with the flaw indications of a glass fibre–reinforced polymer (GFRP) laminate made with two non-destructive technique (NDT) methods has been investigated. Laser shearography measurements and C-scan ultrasonic detection were compared. Metallographic examination and surface indentation measurements provided information about the character of the real damage. Such a comparison has not yet been published because laser shearography is considered a qualitative technique. Each NDT method was able to visualise a different type of damage. The knowledge of the applicability of these methods is the key to taking advantage of both m

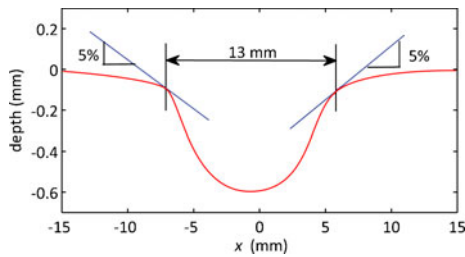
Fig. 2 Evaluation of an indentation diameter from a dent profile curve

Residual impressions can barely be detected in practice by a classic visual inspection, especially when the damage can be classified as BVID. It is generally assumed that indentations with depths less than 1 mm belong to this group. The surfaces of the indentations were scanned with an indicator gauge with a resolution of 0.01 mm. These contact measurements of the *z* axis (depth) were recorded over the line going through the middle of the dents. In addition, some specimens were measured in more detail over the whole area around the dent with a grid size of approximately 1 mm. The dent profile size was evaluated by applying 5% gradient lines to the edges of the dent. An indentation diameter was determined from the distance of the two intersection points defined by the supporting lines and the dent profile (Fig. 2).

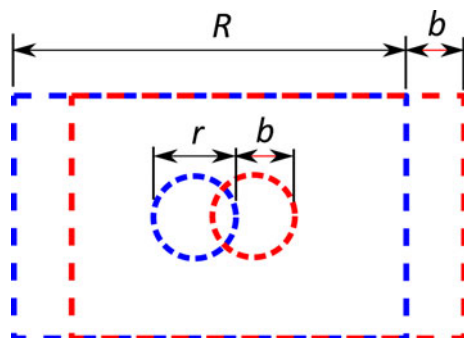
Fig. 4 Recalculation of a flaw indication size ($r + b$) by subtracting shear b

The recorded interferograms of any of the recorded states can be compared and doing so produces fringe patterns. It turned out to be essential for maintaining the low noise level to use the last interferogram from the measurement series as the reference image. The pattern can be recalculated into a deformation gradient. Around a thermally loaded flaw, this gradient is indicated by a typical “butterfly pattern”. The shear base distance should be subtracted from the indicated flaw size measured on the butterfly pattern (Fig. 4).

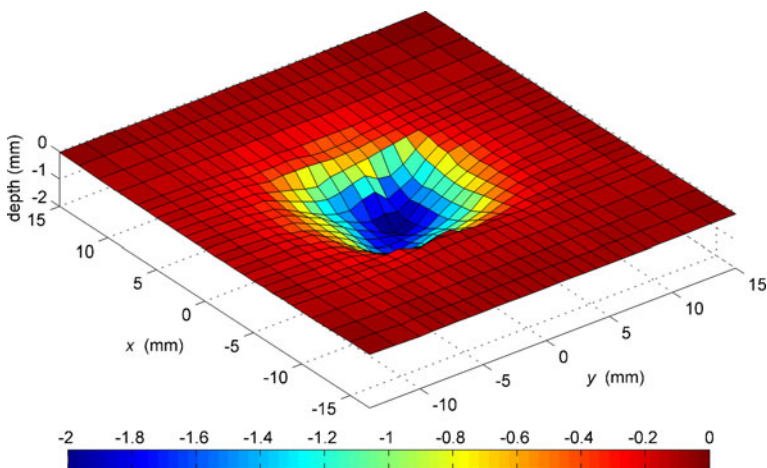
Fig. 5 Residual impression of a 35 J dent

The residual impressions after impact were measured. Figure 5 shows the typical surface shape of the 35 J dent, which was approximately 2 mm deep. The rest of the dents were measured in a line parallel to one of the specimen's edges. The dent profiles for different impact energies are demonstrated in Fig. 6. The diameter of the indentation area is determined on the basis of these profiles with the 5% gradient edge. The indentation depth was measured as the minimum value of a dent profile. Dent depths show a general rising trend with increasing of peak energy. The depth values vary from 3.4 mm for the 40 J dent to less than 0.1 mm for 5 J dents. The 35 and 40 J dents were substantially deeper than the rest of the dents formed with lower damage energies. This occurred because the laminate was 3.5 mm in thickness, and there was not enough supporting material for the damage to be absorbed. These values are summarised in the first part of Table 1. The deformation profiles also include the diameters of the indentation areas measured using the 5% gradient supporting lines. The maximum damage diameters vary from 6 to 19 mm as a function of the impact energy. These values are shown in the same table.

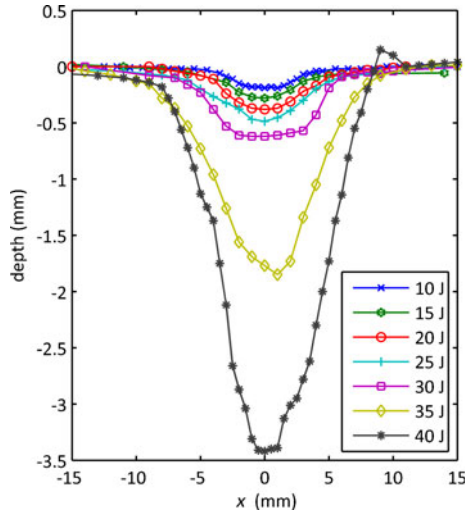
Fig. 6 Dent profiles of laminates impacted by various energies. The laminate was 3.5 mm thick

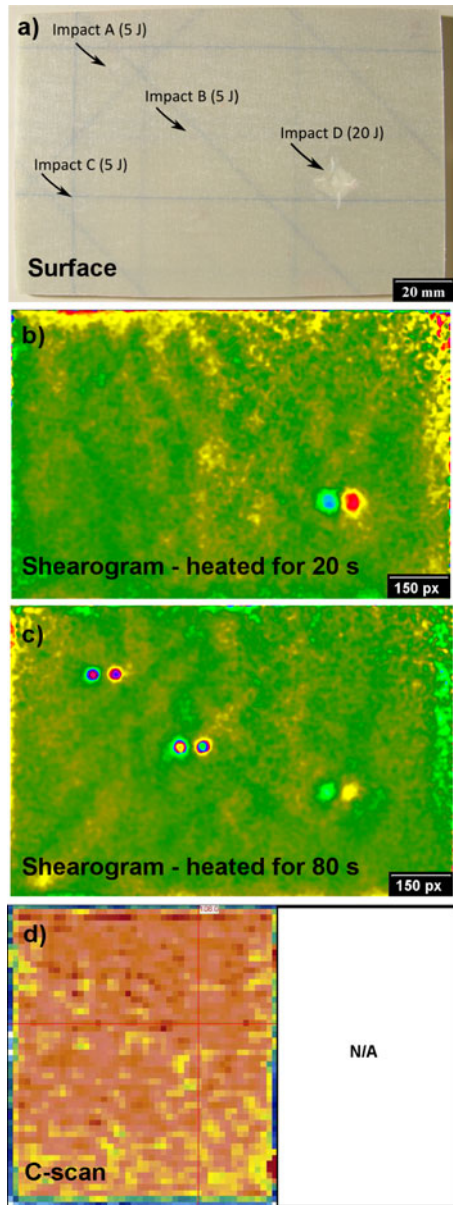
Fig. 7 **a** Impacted specimen surface with 4 dents where 5 J damage is not visible, **b** phase image of this specimen heated for 20 s, **c** another phase image of this specimen heated for 80 s where even some 0.1 mm deep dents can be detected, **d** ultrasonic C-scan of the corresponding area in amplitude visualisation

The shearography evaluation of the indentations can be influenced by heating time, which causes different rates of deformation. Figure 7a presents a specimen damaged by three 5 J impacts and one 20 J impact. Additional interferograms under different loading

conditions were obtained for this specimen. The first measurement was performed after 20 s of heating (Fig. 7b). In this case, only the 20 J impact was indicated. Then, 40 s of heating was performed with the same result. Finally, 80 s of heating was applied to increase the deformation gradient even more. This intensive loading indicated two of the three 5 J dents, which were less than 0.1 mm deep (Fig. 7c). This image was recorded several seconds after heating when the temperature decrease was sufficiently fast. However, the measurement of the intensive deformation gradient reduced the visibility of the 20 J damage pattern.

Some of the specimens were measured with an ultrasonic C-scan, which provides a topological image of the laminate. The discussed four-dent specimen was used. Because other kinds of specimen evaluations were also done, only the left part of the specimen with 5 J dents was measured (Fig. 7d). The C-scan did not detect any of these 5 J indentations for the used parameters.

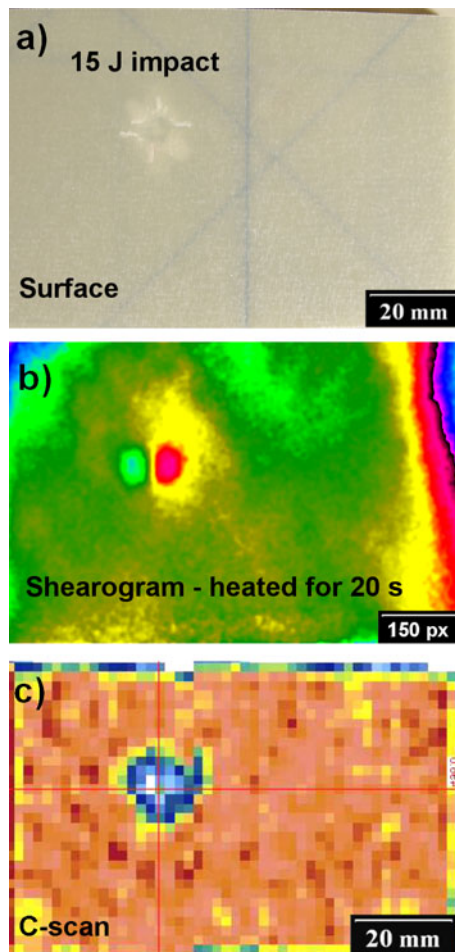
Fig. 8 **a** Impacted specimen surface with a 15 J dent, **b** phase image of this specimen heated for 20 s, **c** ultrasonic C-scan of the corresponding area in amplitude visualisation

The second examined specimen was damaged by a 15 J impact (Fig. 8a). The phase image of the shearogram indicated a dent with the typical pattern (Fig. 8b). An ultrasonic C-scan provided a topological image that revealed the delamination of the 15 J damage (Fig. 8c).

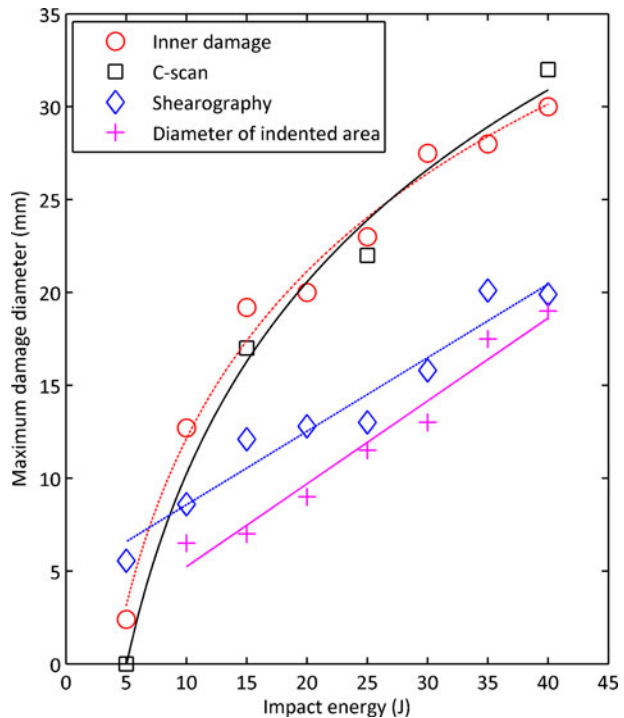
Fig. 10 Comparison of the maximum diameter of the inner damage, the indented surface area and the detected flaw indications with two NDT techniques—the ultrasonic C-scan and laser shearography

Figure 10 summarises the results of the damage indications compared with the real damage state and the indentation area diameter. Circular points correspond to the inner metallographic results, dagger-shaped points correspond to the indentation area diameter and the remaining points represent the C-Scan and shearography results. The inner damage diameter plotted against impact energy can be fit by a logarithmic curve. The same can be done for the C-Scan values. The curves have very similar parameters. It can be stated that the ultrasonic C-Scan method evaluated the real damage effectively. The shearography indications and the diameter of the indented surface can be fit by a linear relation. It can be concluded that shearography is the most suitable method to detect surface residual indentations. Moreover, the measurements are very rapid, and the technique is capable of detecting even the smallest damage from a 5 J impact.
