Comparison of X-ray Computed Tomography and Ultrasonic C-Scan Techniques and Numerical Modelling of Impact Damage in a CFRP Composite Laminate

Two different experimental techniques are employed to visualize the impact damage generated by a low-velocity impact on a carbon-fibre reinforced-polymer (CFRP) composite laminate. At the relatively low impact-velocity of 1.69 m.s^{-1} , and a corresponding impact energy of 7.5 J , used in the present work the damage induced in the CFRP panel is barely visible to the naked eye but the techniques of ultrasonic C-scan and X-ray computed tomography (CT) can detect the damage that has occurred. This damage is mostly inter-laminar damage, i.e. delaminations, between the plies due to a change in modulus from one ply to the next in the laminate. This interlaminar damage is usually accompanied by intralaminar damage, e.g. matrix cracking, in the ply itself. The type and extent of damage detected from using these two techniques is discussed and the relative merits of these techniques are compared. In general, the CT gave the better resolved picture of damage but the lateral extent of the damage was underestimated relative to C-scan which was more se

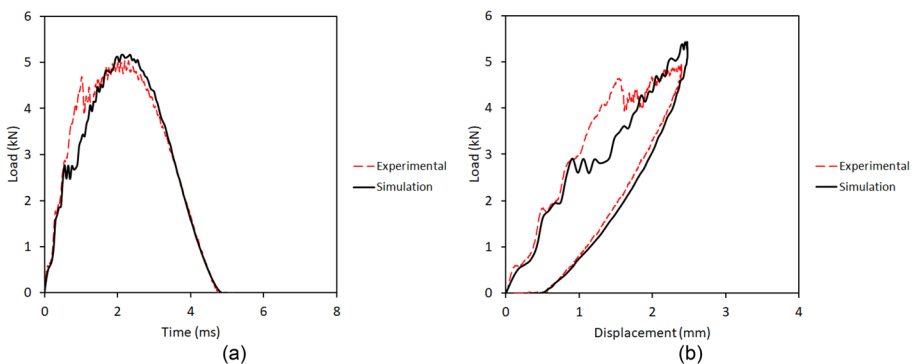
Fig. 2 The experimental and predicted load versus time and load versus displacement curves for the impacted CFRP panels. The red dashed line is a typical experimental test. A duplicate test showed similar behaviour. The black solid line shows the simulation prediction for load versus time and load versus displacement

The load versus time and load versus displacement responses for the rectangular composite panel, subject to the drop-weight impact test, are shown in Fig. 2. Relatively small amplitude, sinusoidal oscillations can be seen on the rising part of the load versus time, and the load versus displacement, experimental curves. These sinusoidal oscillations have previously been discussed in detail [9] and are indicative of mass-spring oscillations. On the experimental load versus time curve (red dashed line), there is a distinct load drop at a load of approximately 4.7 kN at a time of 1 ms, followed by oscillations indicative on the onset of damage initiation. This is also apparent on the load versus displacement curve. A duplicate test showed very similar behaviour. The predictions from the simulation numerical modelling (black solid line), see [9] and as discussed below, also show these effects; albeit the load at which damage initiation occurs in the model is somewhat lower. However, the overall response of the experimental load versus time and load versus displacement curves are very similar to those predicted from the modelling simulations. For example, for both the experimental and modelling results, the maximum load achieved is approximately 5 kN, the duration of impact event is approximately 4.6 ms and the overall displacement is approximately 2.5 mm.

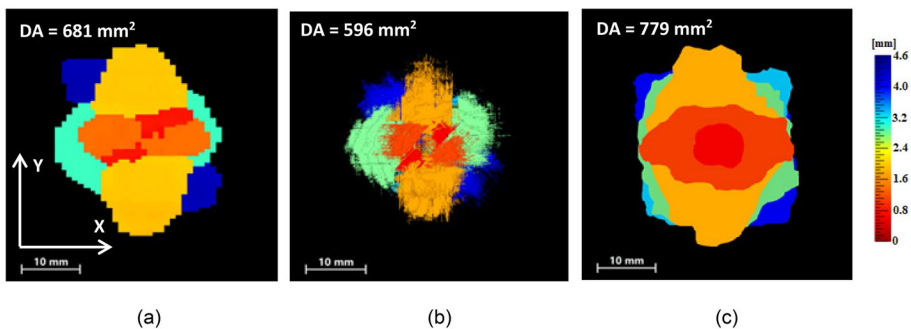
Fig. 6 Typical damage maps in the X–Y plane from **a** the experimental ultrasonic C-scan inspection technique, **b** the experimental X-ray CT technique and **c** the numerical modelling predictions. The impact was on the top surface and the layers are colour-coded from the top (red) surface to the bottom (black) as indicated by the damage depth colour bar

The damage maps from the C-scan and X-ray computed tomography (CT) experimental techniques, and from the numerical simulation predictions, for the delamination footprint, with the associated damage area (labelled ‘DA’), are presented in Fig. 6. The rear surface was selected to be black so that delaminations at different depths through the thickness of the specimen would be more clearly visible. The 0° fibre direction is along the X-direction, i.e. the longest edge of the rectangular 150 × 100 mm specimen. The areal footprint of the damage, i.e. the damage area (labelled ‘DA’), is given at the top left in each case and this

The C-scan damage map in Fig. 6(a) is based on ultrasonic wave reflection with a transducer and detector on the upper surface. This process can detect very accurately any separation, i.e. delamination, between the ply interfaces. However, the C-scan spatial resolution is about 1 pixel per mm² and this is evident in the pixelated nature of the C-scan image.

Now, the given damage area was determined for interlaminar damage, i.e. delaminations, in the CFRP panel resulting from the impact event, as shown in Fig. 6. Delaminations initiate and grow at interfaces where the fibre direction is different in the plies below and above the interface. The propagation of the delamination is dominated by the fibre direction of the ply furthest from the impact surface. Localised deformation drives the initiation of matrix cracking and subsequent delamination. Due to the changes in stiffness across the interface between composite plies in different directions, the interfacial shear stresses can drive the crack growth mainly in Mode II (or shear loading) to form a larger delamination area. As the composite specimen has a symmetric layup of $[45_2/-45_2/0_2/90_2]_s$, the interfaces at each change of fibre orientation initiate delaminations which grow in the direction of the fibre on the lower ply, and this gives the characteristic delamination rosette, seen in Fig. 6(a).

Nevertheless, the orientation and relative size of the delaminations, at the respective interfaces, of the composite laminate are very similar from both techniques, see Fig. 6(a) and (b) which have similar colour coding to show the depth of the delamination through the thickness of the composite specimen. In Fig. 6(b) the results from the X-ray CT scan reveal that the striations and other features indicate very clearly that the delaminations are growing in the direction of the plies beneath each ply interface. Figure 6(a) for the C-scan image identifies the delaminations in the same locations through the depth of the composite as the results from the X-ray CT scan and also confirms that the delaminations are growing in the direction of the plies beneath each ply interface. Figure 6(a) for the C-scan and Fig. 6(b) for the X-ray CT scan both show a similar characteristic rosette indicative of the delaminations, observed at the ply interfaces, for the fibre layup of $[45_2/-45_2/0_2/90_2]_s$. Thus, the overall shape and locations of the delaminations are very similar as determined from both the X-ray CT and the ultrasonic C-scan inspection techniques. However, the detail and resolution of the X-ray CT image are much sharper than for the C-scan image, as would be expected.

Figure 6(c) shows the results from the numerical modelling simulations for the delamination damage and a delamination rosette is predicted from these studies with all the features observed from the experimental ultrasonic C-scan and X-ray CT techniques, see Fig. 6(a) and (b) respectively. This is with delaminations occurring at the interfaces between plies and growing in the fibre direction below the ply interface. The overall delamination damage area (DA) appears to be slightly overestimated in Fig. 6(c) but when considering the complexity of the damage processes involved, and the fact that all the main processes of the impact event and damage are captured in the model without any fitting factors, it is considered that the predictions are in very reasonable agreement with the experimental results.

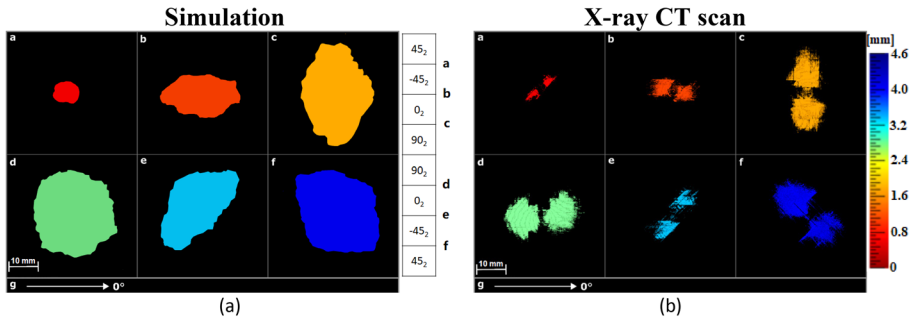
Fig. 10 Interlaminar damage between blocking plies, comparing the results from **a** the numerical modelling with those from **b** the experimental X-ray CT scan

Figure 10 shows the damage numerically predicted and experimentally recorded for the X-ray CT scan for delamination at each of the interfaces between differently oriented plies through the thickness of the composite panel for the present CFRP layup of 45₂, -45₂, 0₂, 90₂, 90₂, 0₂, 45₂, 45₂. The numerical prediction, in Fig. 10(a), shows that delaminations tend to grow in the fibre direction that is present below the interface. For comparison, the experimental X-ray CT scan delamination map is shown in Fig. 10(b) and there is good agreement with the simulation results with respect to the shape and location of such interlaminar damage, although again the experimental X-ray CT technique does appear to underestimate the areal extent of the delaminations.
