# Understanding post-earthquake decisions on multi-storey concrete buildings in Christchurch, New Zealand

Frédéric Marquis<sup>1</sup> · Jenna Jihyun Kim<sup>1</sup> · Kenneth J. Elwood<sup>2</sup> ·  
Stephanie E. Chang<sup>3</sup>

**Keywords** Multi-storey concrete buildings · Insurance · Residual capacity · Damage · Decision-making · Canterbury earthquakes

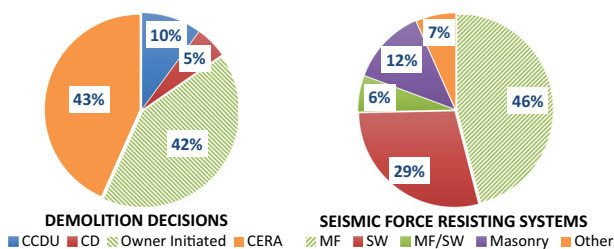
**Fig. 2** Summary—significant building demolitions (out of 150 demolitions). *CCDU* Christchurch Central Development Unit, *CD* Civil Defence, *CERA* Canterbury Earthquake Recovery Authority, *MF* Moment Frame, *SW* Shear Wall, *MF/SW* mixed system with both moment frames and shear walls
