Fire Hazard Analysis of Modern Vehicles in Parking Facilities

Abstract. Vehicle fires in parking structures developing into large conflagrations are rare but can result in severe economic losses. It is important to understand the hazard posed by modern vehicle fires to determine whether current fire codes for parking garages are mandating adequate fire protection requirements. There has been an increase in the fire hazard from changes in vehicle design and increased use of plastics and other combustible materials in vehicle construction, along with denser parking of vehicles in parking structures. This manifests as faster flame spread within the vehicle, easier ignition and more rapid fire spread to neighboring vehicles. Based on the findings, test data from vehicles older than 2000–2005 model years should not be used as basis for development of codes and regulations. Open parking structures emerge as the main area of concern regarding fires in modern vehicles. The lack of any requirements for active protection systems in the fire codes, and trends in vehicle and garage design suggest that large, devastating fires in these structures could become increasingly common. The spread of

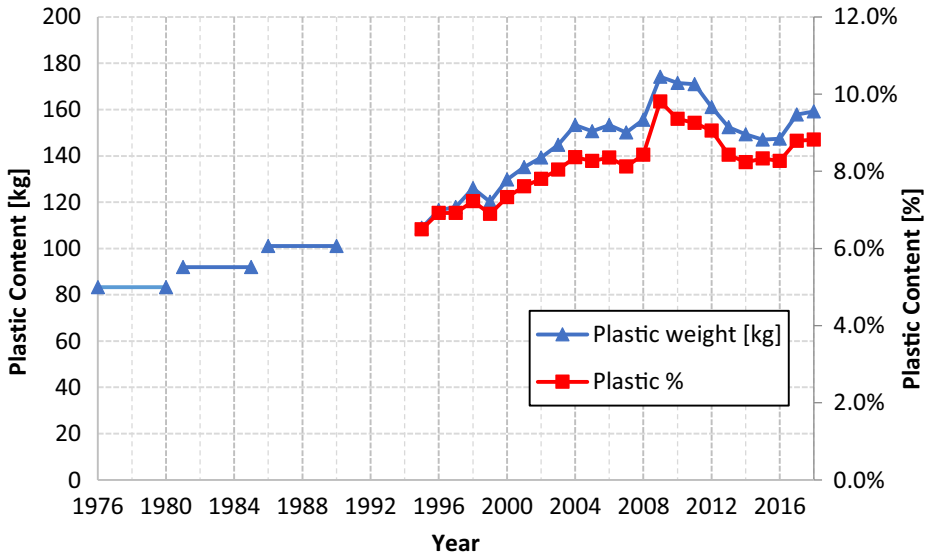
Figure 1. Amount of plastic in average US light vehicles in weight (kg), and as percentage of vehicle curb weight.

The Economics and Statistics Department of the American Chemistry Council released a report “Plastics and Polymer Composites in Light Vehicles” [22] analyzing the material composition of light vehicles assembled in the NAFTA countries (USA, Mexico, and Canada), representing 16.8 million vehicles produced in 2018. Annual plastic content by weight is provided for 2008 to 2018. A report by Argonne National Lab [28] similarly analyzed the US light vehicle fleet providing annual data for 1995 to 2014. A government steel industry report from 1991 gives some 5-year average data for material content of US vehicles for the years 1976–1990 [30]. Combining these data sources, the weight of plastics in the average US/NAFTA vehicles from 1976 to 2018 are plotted in Fig. 1, in kilograms and as percentage of average vehicle weight.

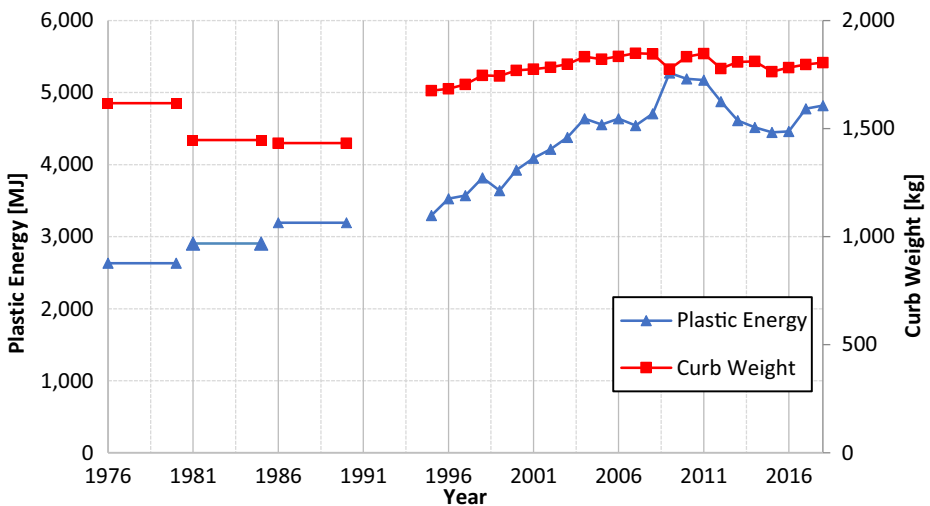
Figure 2. Curb weight and plastic content potential fire energy from average North American vehicles from 1975 to 2018.

from plastic content increased by an annual average between 47 and 52 MJ per year. Noting that there is a data-gap from 1991 to 95, the increase in plastic energy content from 1995 onwards was an average of 65.5 MJ/year. The total increase in energy content from plastics in the average vehicle (in the USA/NAFTA) from 1976 to 2018 was 2298 MJ, a total increase of 91%. The increase in vehicle curb weight and plastic fire energy is plotted in Fig. 2.

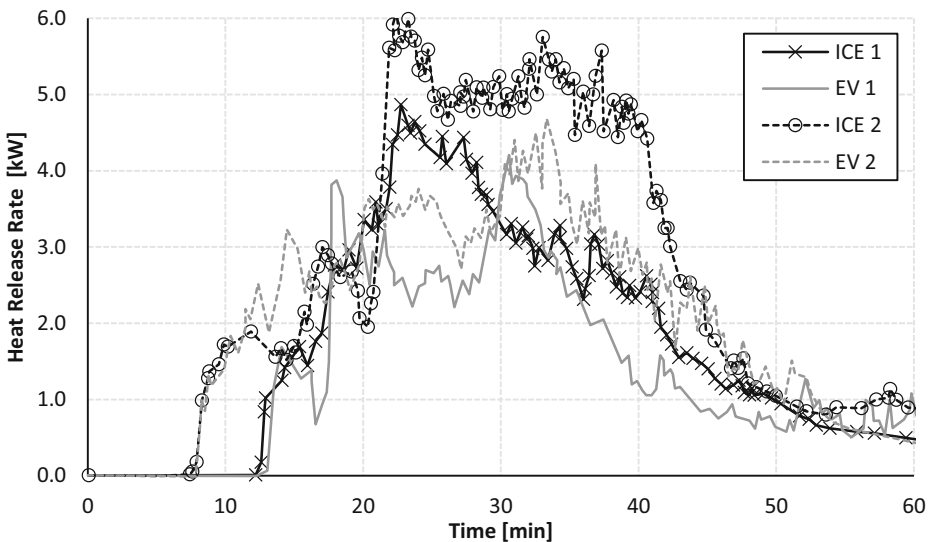
Figure 3. Heat release rate for two pairs of similar ICE and EV vehicles for tests conducted by Lecoq [62].

5.2.1. Battery Energy Release Two pairs of similar EV and ICE vehicle models from two manufacturers were tested by Lecocq [62]. The first pair were smaller vehicles, both around 1100 kg, while the second pair were larger at 1400 and 1500 kg for the ICE and EV model respectively. The vehicles were ignited by a gas burner placed in the front seat, with the window open. The peak heat release rate results were similar for the first pair at 4.2 MW and 4.8 MW, with the ICE vehicle being higher. For the second, larger pair, the EV had a peak of 4.7 MW, while the ICE vehicle had a peak HRR of 6.1 MW. The HRR plots for all four tests are shown in Fig. 3. The ICE vehicles are represented by solid lines, while dotted lines are used for the EVs.

5.2.2. EV Fire Extinguishment As shown in Fig. 3, this test performed on two pairs of similar ICE vehicles and EVs find that peak HRR is lower for the EV in each case, and largely similar in growth rate and fire development time. Despite similarities in fire characteristics, there are some fundamental differences in burning behavior between ICE vehicles and EVs. For ICE vehicles in a fire, the fuel tank will eventually rupture or melt, and depending on the nature and orientation of the surface underneath, free-flowing gasoline can disperse from the burning vehicle and spread the fire to neighboring items. A lithium-ion battery pack will remain in place, generally underneath the passenger compartment making up the floor of the vehicle. As the fire penetrates the layers of the battery, high-temperature jet flames can occur which can extend some distance from the vehicle. This flame may or may not extend further than running gasoline would, as that depends on the slope where the vehicle is parked, and the nature of the battery rupture. In a narrow parking spot this flame could ignite another vehicle parked immediately next to the EV. The recommendations to firefighters to deal with EVs is to apply very large amounts of water directly to the outside of the battery, potentially for several hours [38]. These issues are important for firefighters to keep in mind and are a concern for extinguishment tactics, water supply and containment of the fire.

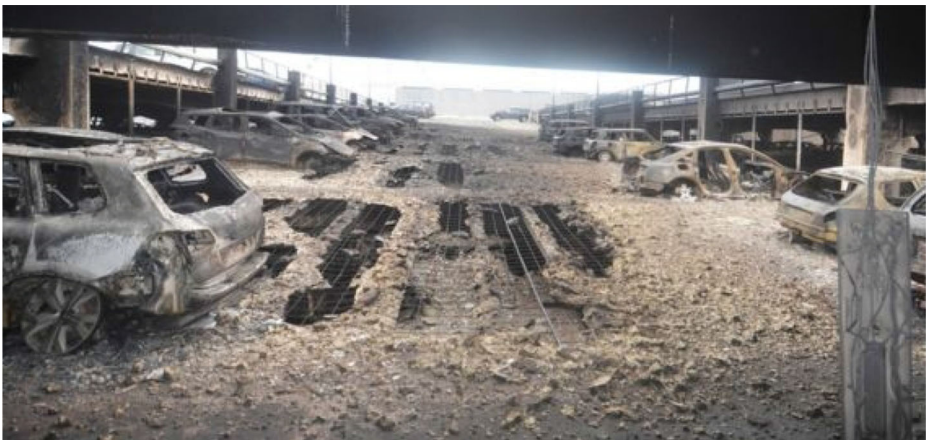
Figure 4. Concrete spalling in Liverpool, England 2017 fire [3].

5.4.1. Spalling of Concrete Concrete spalling is reliant on high temperatures over a long period of time, potentially several hours, and is a complex phenomenon that is difficult to predict [71]. But generally, internal concrete temperatures are required to reach at least 374°C, the critical point of steam. Any constant exposure above this level can eventually lead to spalling, and the higher the concrete temperature the quicker it occurs. Significant spalling was observed in both the Liverpool, England 2017 fire (see Fig. 4) and the Stavanger, Norway 2020 parking garage fire (Fig. 5), and is an active area of research [72]. The spalling created large penetrations between the different garage levels and undoubtedly contributed to vertical fire spread. It is important to note that spalling typically occurs after several hours, once the fire has grown to a substantial size [71]. The spalling phenomenon is unlikely to have any effect on the early phases of the fire. It is not unique to vehicle fires and has the potential to occur in any building with uncontrolled fire spread through a large fuel load.

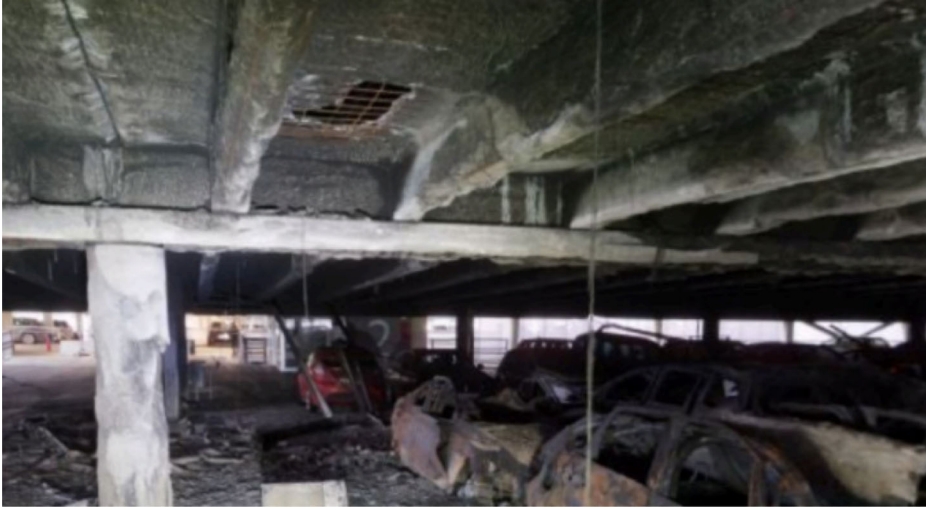
Figure 5. Concrete spalling in Stavanger, Norway 2020 fire [74].
