The Application of the Laws of the Indies in the Pacific: the Excavation of Two Old Stone-Based Houses in San Juan, Batangas, Philippines

Abstract During the Spanish Occupation of the Philippines from the sixteenth to the nineteenth centuries, the Laws of the Indies and ordinances determined where settlements should be established and how structures should be built. These laws radically changed indigeneous settlement patterns and created a hierarchy of space. In this paper, two stone ruins located in the old town of San Juan, Batangas, are investigated to trace the development of the town using the Laws of the Indies and ordinances as framework. The methods of study include integrating excavation results, interviews with local residents, and archival research. This research shows that the ruins were domestic units dating to the late 1800s. The architectural style of the houses and the artifacts recovered indicate that these structures belonged to local elites. These stone-based houses were the first to be archaeologically investigated in the Philippines. The results of the investigation show that the old town of San Juan was most likely a forced resettlement by the Spanish colonis

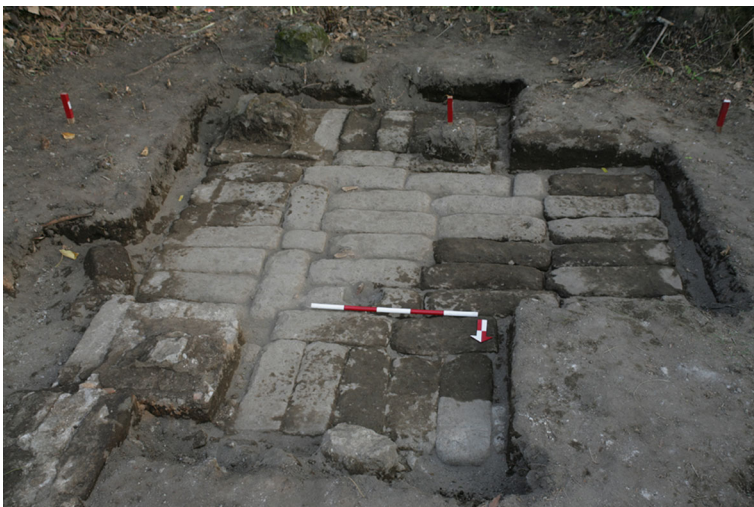
Fig. 3 The tuff block floor of the *kamalig* (granary)

The kitchen on the second floor was above the *koloong*. East of the *koloong* we found a floor of tuff blocks that may have functioned as a *kamalig*. The floor of the *kamalig* was fully exposed in 2011 after its initial excavation in 2009 (Pineda et al. 2011, pp. 122–123). Mortar was found on the edges of the tuff blocks forming the boundary of the *kamalig* (Fig. 3). It appears that something was attached to these blocks with lime mortar. The width of the objects placed on top of the tuff floor on the south side was 16–23 cm, while the width of the object on top of the tuff blocks on the north side was 28–33 cm. A 26-cm diameter posthole appeared in the middle of the floor.

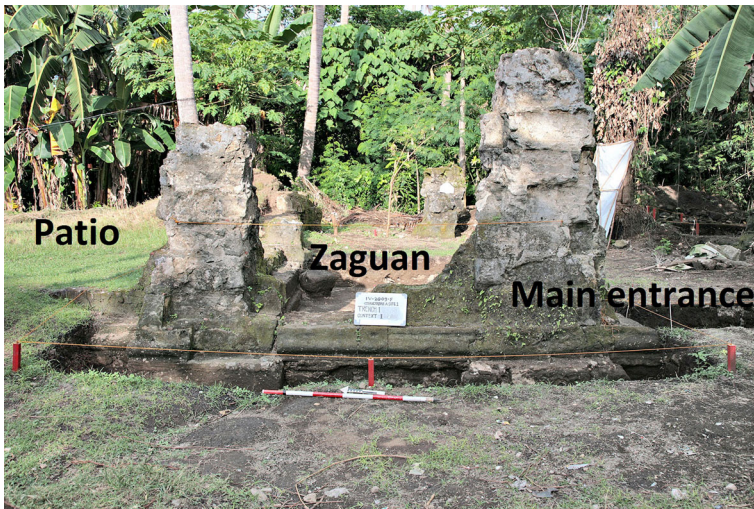
Fig. 4 Southwest side of Structure A showing the location of the main entrance which leads to the zaguan (passage way from the entrance to the patio) and the patio on the north

Adjoining the *zaguán* is the patio, a room with clay floor tiles (Fig. 4). To the north and east of the patio were dirt floors interpreted as *bodegas*. Old stone-based houses often had two *bodegas* (Zialcita and Tinio 1980, p. 251). Two passageways, both measuring 1.4 m wide were identified in the patio, one leading to one of the *bodegas* and the other leading to the *zaguán* (Figs. 5 and 6). Comparison with two existing stone-based houses in the greater Manila area display flooring similar to the tiled floor and the adjoining compact dirt floor (Fig. 7). We also found the base of the stairs (Fig. 8) (Pineda et al. 2011, pp. 120–122).

A 2 m- wide entrance appeared along the west side of the house leading into the *zaguán* (Fig. 10, see also Fig. 4). It is comparable in terms of size to the oblique main

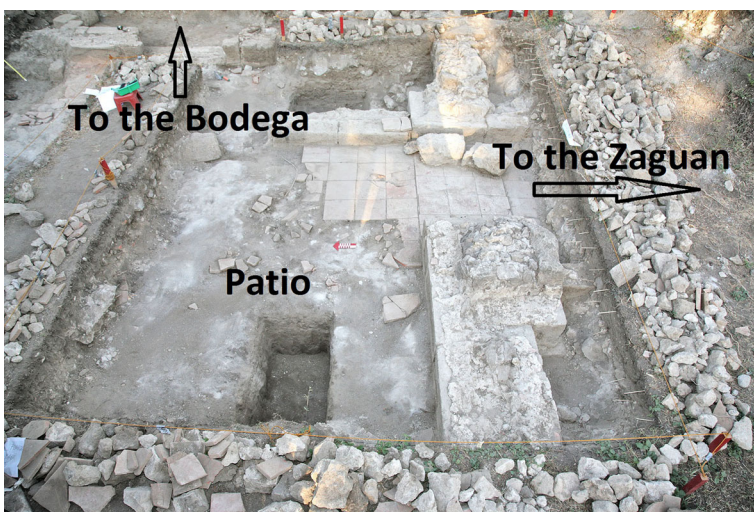
Fig. 5 The tiled patio showing two entry ways, one leading to the zaguan and the other to the bodega (store room)

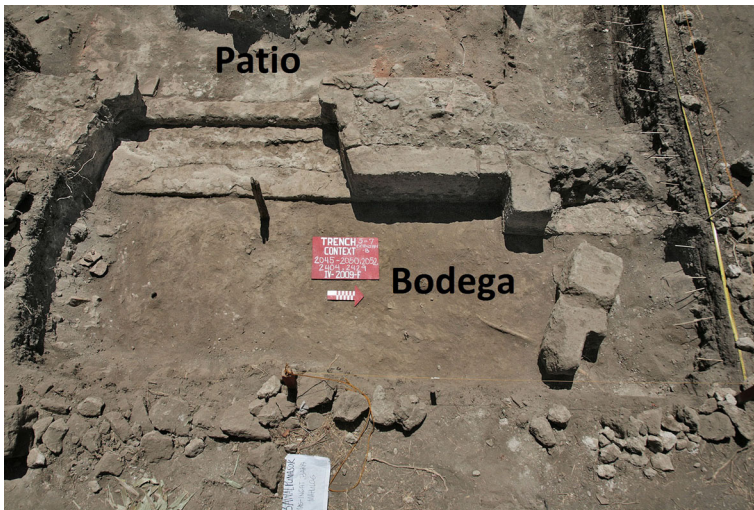
Fig. 6 A close-up of the entryway between the patio and the bodega

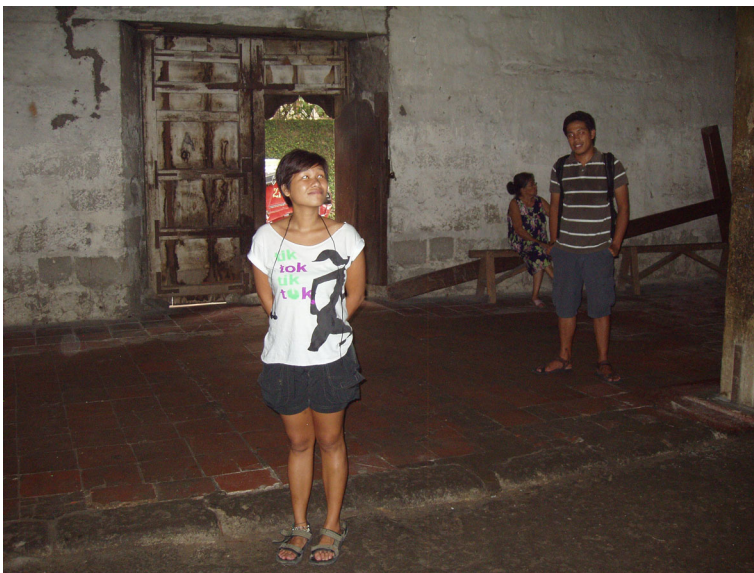
Fig. 7 The *Bahay na Tisa* in Pasig City showing the main entrance, the tiled floor, and the adjacent dirt floor. The floors are similar to those recorded in Structure A

entrance of the Bahay na Tisa in Pasig City that also measures 2 m at its narrowest and 2.53 m at its widest (see Fig. 7). The entrance to another stone house we surveyed in Makati City is 2.18 m wide. Calculation of an entrance width based on a colonial house plan was also 2 m (Zialcita and Tinio 1980, p. 251). The excavated entryway faces the main road. According to UP Architecture Professor, Emilio Ozaeta (pers. comm.), “Main entrances or *puertas* would have simply faced the street for easy manoeuvring of the *carroza* (carriage). It may face either a main street around a plaza or a side street. There really is no definitive article in the Laws of the Indies mandating the positions of the

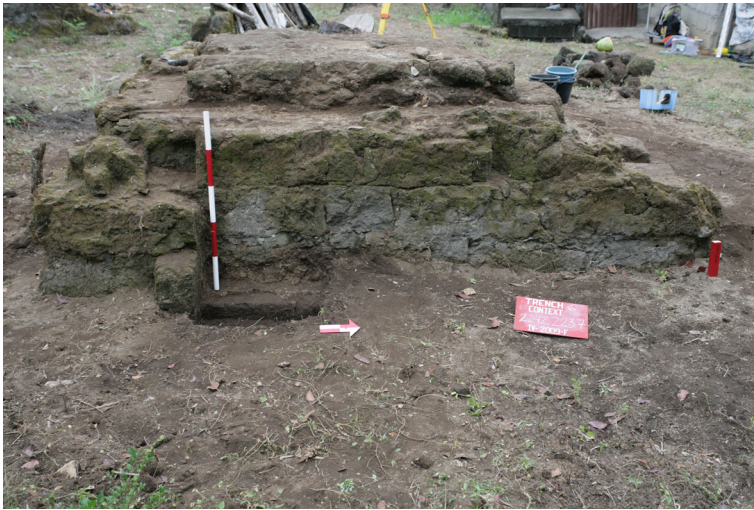
Fig. 8 The stair base in Structure A

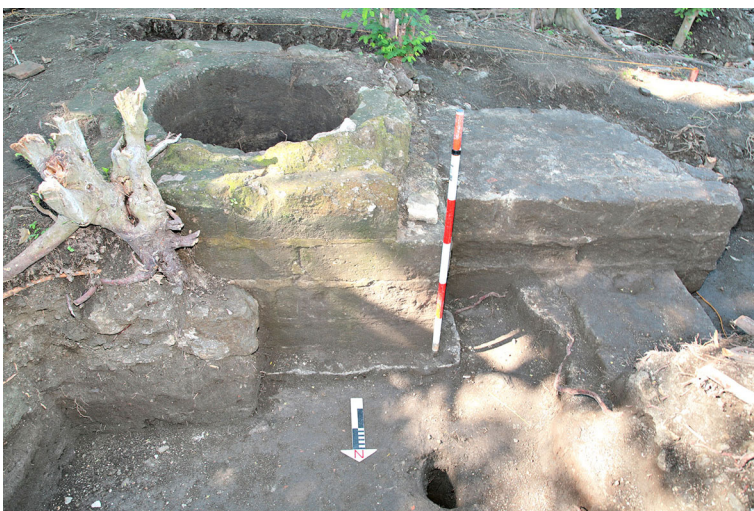
Fig. 9 The *koloong* (water well) with a border as its base resting on a mortar floor and the platform immediately to its west

The round *koloong* is bordered by tuff stones. The border of the well measures 1.54×0.63 m. The maximum diameter of the *koloong* is 131 cm. The excavated height of the well is 73 cm. A mortar border appears at the base of the well. West of the *koloong* is a mortared platform, measuring 94 cm wide and 170 cm long. Stone voids appear on the platform. Local accounts indicate that the well reached the second floor of the house, and evidence suggests that this platform was the remains of a wall supporting the *koloong*. According to Cesar Chavez (65 years old in 2009), as a 12-year-old boy he climbed the stones to go to the top of the *koloong*, hence, the original height of the well was higher than what we had recorded (Fig. 9). Two existing water wells surveyed in Pinagbayanan are almost 2 m high and access is from the second floor of the house and can be used as an analogy.

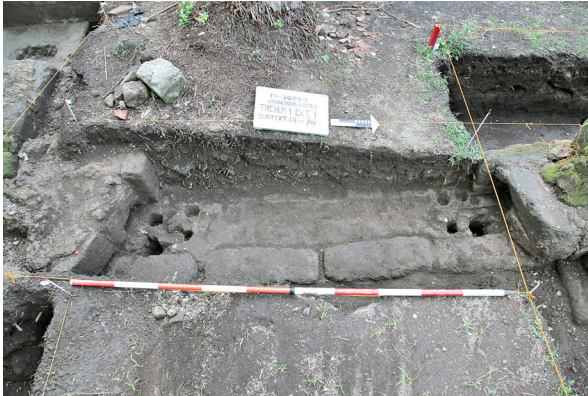
Fig. 10 Main entrance of Structure A showing postholes for door posts

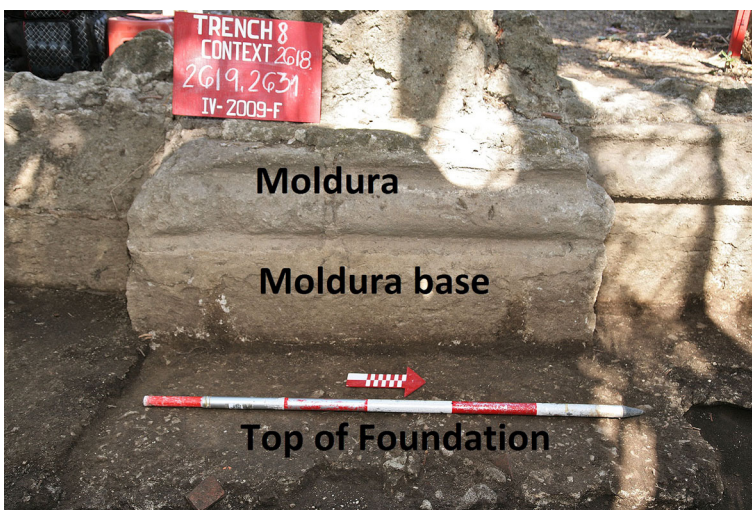
Fig. 11 *Moldura* (moulding) on the exterior east wall of Structure A. Just below the *moldura* base is the top of the foundation

In Structure A, beneath the unearthed *moldura* or moldings base on the exterior walls, the top portions of the foundations are visible (Fig. 11). The moldings range from 47 to 81 cm in length and average 28 cm wide. The matrix of the foundation was relatively absent of rubble and was compact compared to sediments above it. The original occupation surface appear as sediment below the moldings found on top of the foundations and floors. The

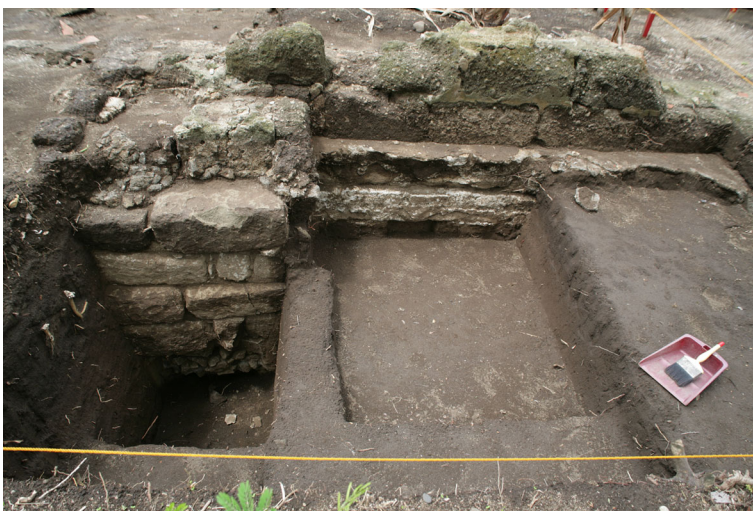
Fig. 13 The column base foundation along the western portion of the north wall of Structure B measuring 140 cm thick compared to the foundation of the wall which is 50–58 cm thick

Tuff and conglomerate blocks were the main components of the stone walls. Structure B’s foundation were made of tuff blocks and the binding agent was a combination of lime mortar and cement mixed with aggregates. The column bases foundation in the west portion of the north wall had no binding agent, indicating that dry laying was the method of construction (Figs. 13 and 14).

The foundations of the walls were shallower compared to the foundations of the column bases and stone pillars (see Fig. 13). The foundations of double walls range 50–74 cm thick while the foundation of single walls was 25 cm thick. The column bases foundations were 92 and 140 cm thick. The stone pillar foundation forming the southwest corner of Structure B is 116 cm thick (see Fig. 14). The foundations of the stone pillars found inside the house averaged about 60 cm thick.

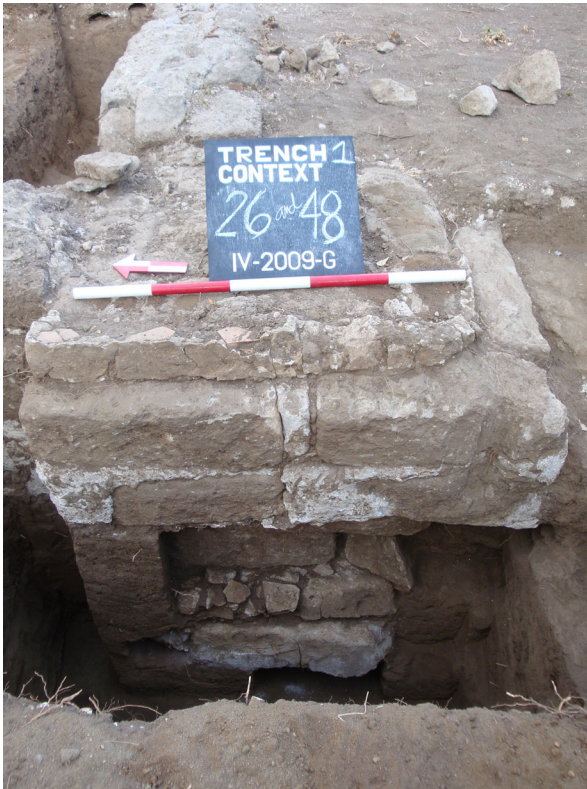
Fig. 14 The foundation of the southwest corner of Structure B

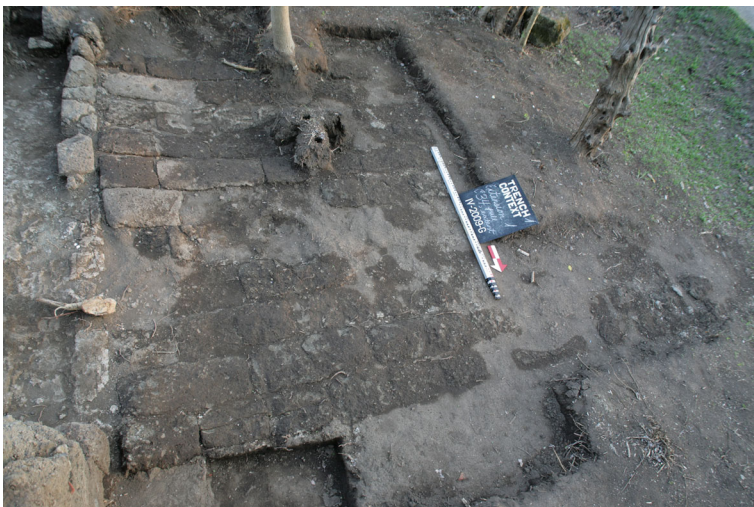
Fig. 15 The pavers at the main entrance of Structure B at the northwest side

The main entrance to Structure B was in the northwestern section of the house and, like Structure A, it faces the main road. A stone pavement composed of 11 rows of aligned conglomerate blocks oriented in an east–west direction leads to the main entrance (Fig. 15).

The blocks were laid in a Flemish bond pattern. The center section of this pavement was worn and depressed, perhaps indicating foot traffic or the travel of single horse-drawn carriages. Immediately east of the pavement is a lime mortar bed with stone block impressions. This lime mortar bed does not extend further east, meaning that it was part of the entrance. This stone pavement measures 2.48 m wide and 4 m long and corresponds to the width of the entrances mentioned above. More evidence supporting the idea that the stone pavers led to the main entrance in the northwestern section of the house appears in the northwest corner of this feature. It probably formed one side of the entrance because of its smooth finished and tilting in a northeast-southwest direction, where the minimum width of the entryway was at the exterior and the maximum width in the interior. The same feature was noted in the main entrance of Structure A. Another entrance was found in the northeast section of Structure B directly opposite the main entrance (Fig. 16). It was composed of four rows of parallel stone blocks measuring 140x110 cm. The stone pavement associated with the northeast entrance is inclined where the stone blocks near the entrance are elevated compared to the pavers further

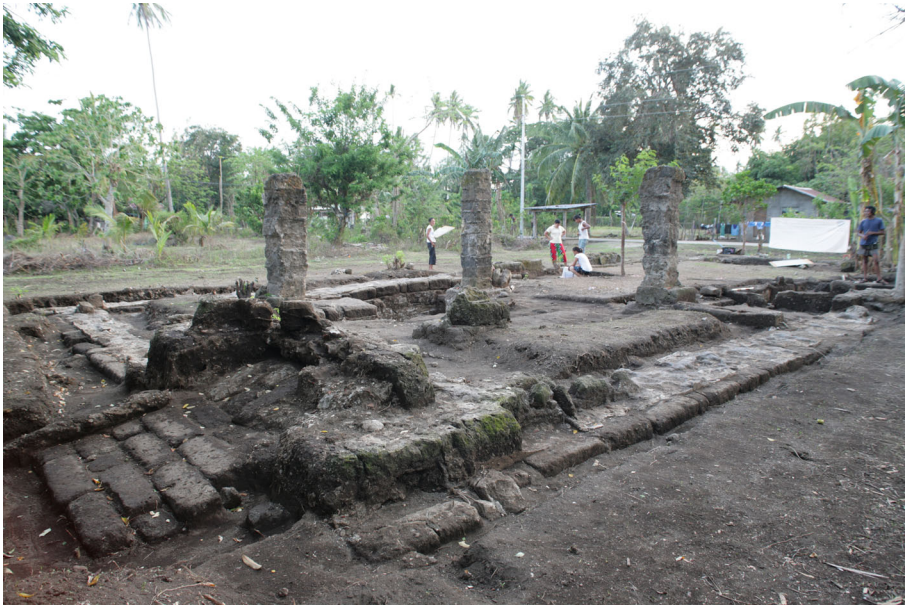
Fig. 16 The pavers at the northeast entrance of Structure B

east. The northeast entrance was blocked off at a later time perhaps because of the local superstition that entrances directly opposite one another bring misfortune to the residents of the house.

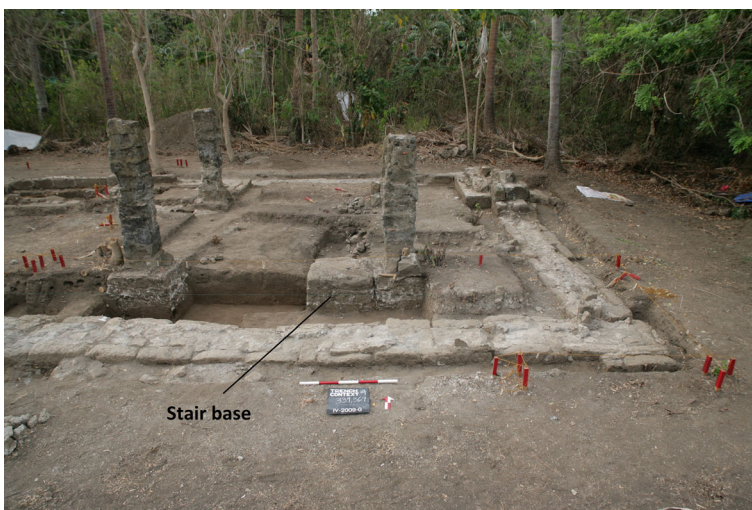
Fig. 17 The east portion of Structure B which is the back part of the house showing the four stone pillars, the stair base, and the southeast corner

A square, lime mortar feature, which can only be accessed from inside the house, was found directly west of the southeast stone pillar in the east section of Structure B (Fig. 17).

All four corners of Structure B were investigated. Both the northeast and northwest corners showed evidence of being entrances. The southeast and southwest corners were constructed differently (Figs. 17 and 18). The point where the east and south walls of Structure B intersect forms the southeast corner. Additional stone blocks were added on the south side to make it appear that the corner juts out. The southwest corner was formed separately from the west and south walls of Structure B, and was constructed similar to the stone pillars, such that stone blocks were used as molds with the center filled with lime mortar.

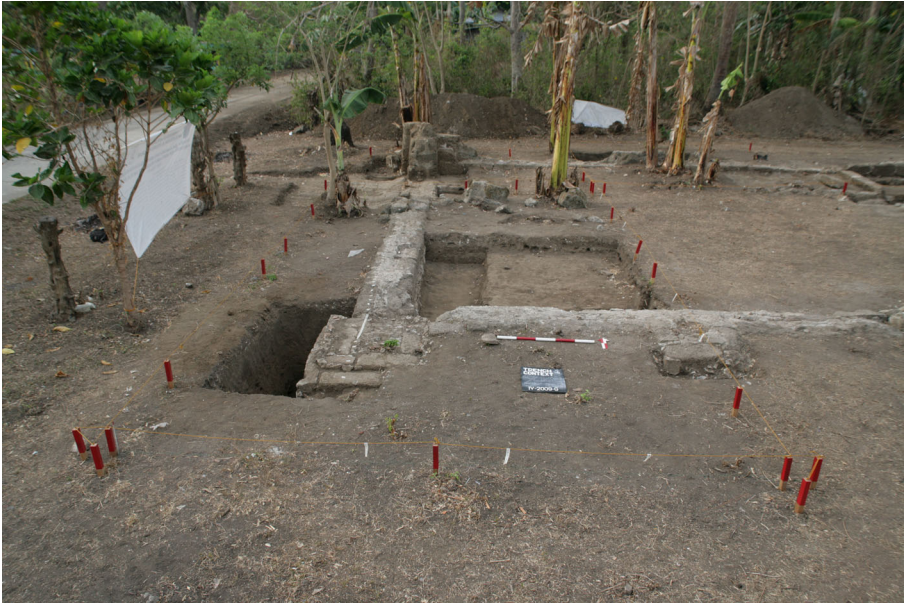
Fig. 18 The southwest corner of Structure B constructed differently from the southeast corner

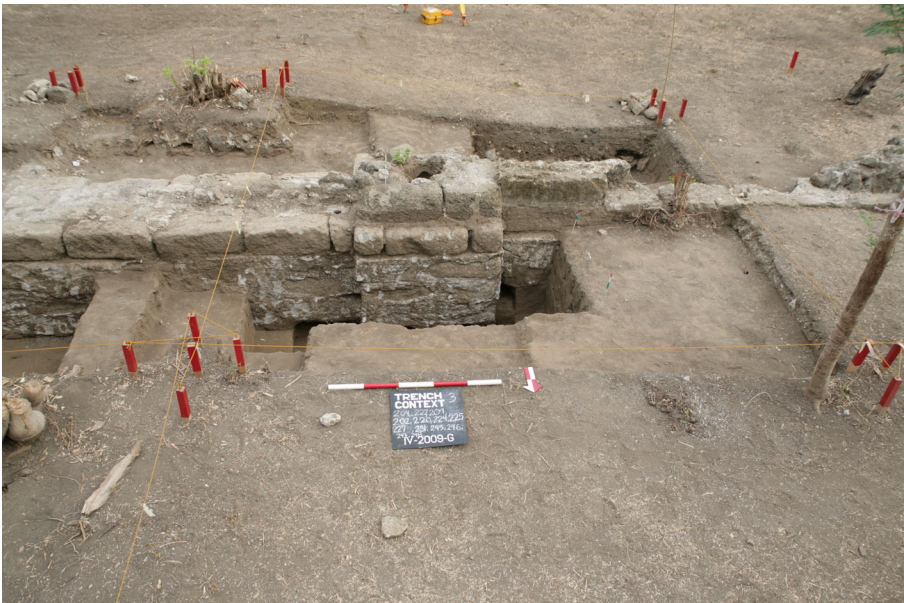
Fig. 19 The south wall of Structure B showing the difference in wall thickness, materials used, and foundation depths of the west side and east side

The wall west of the column base in the southern wall of Structure B is thinner compared to the wall found on the east of the same column base (Fig. 19). The west side is 32–55 cm thick while the east side is 93 cm thick. In addition, the foundation of the west side is shallower compared to both the east side and the column. The west side contained conglomerate blocks and the east side tuff blocks. The difference may be evidence for the later construction of the west

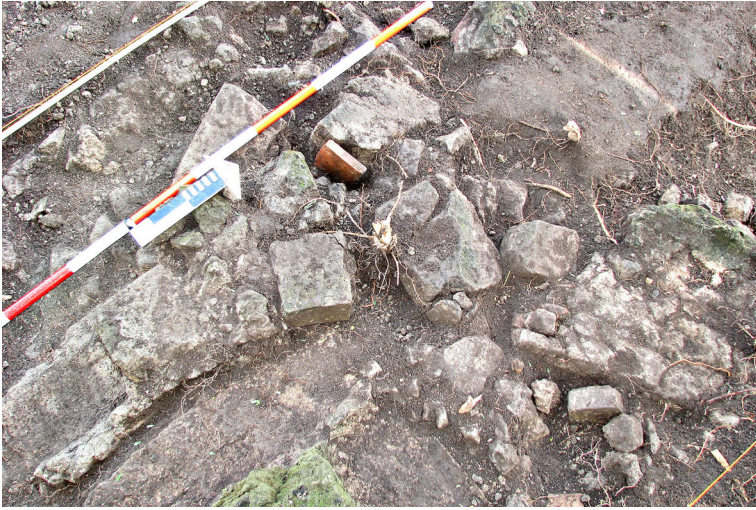
Fig. 20 The remains of an arch found in the *koloong* area in Structure A

The major reason for the abandonment of the old town of San Juan was attributed to the great flood in 1883 (Pineda 1992, p. 18). However, interviews with local residents supported by archaeological data demonstrate that both structures were still intact in the 1920s and until the 1950s. Structure A even functioned as a school prior to the establishment of the Pinagbayanan Elementary School in its current location in 1957 (Manjares 2015, p. 1). Investigation of the stone walls reveals many clean voids on the current wall surfaces, suggesting that the stone blocks were deliberately taken. The destruction of both stone-based houses was due to the owner's order to collect the stone blocks to be recycled for the construction of fish ponds in the 1950s. The stone blocks were also collected by the locals to be used either as a *tungko* (stove), bench stand, for gardening, and other domestic purposes. During the town's centennial celebration of its transfer in the 1990s, the remaining standing walls and arches of Structure A were leveled to make room for the procession. The remains of an arch in Structure A was found on the topsoil suggesting that it collapsed recently while another arch rested on the tiled floor (Figs. 20 and 21).

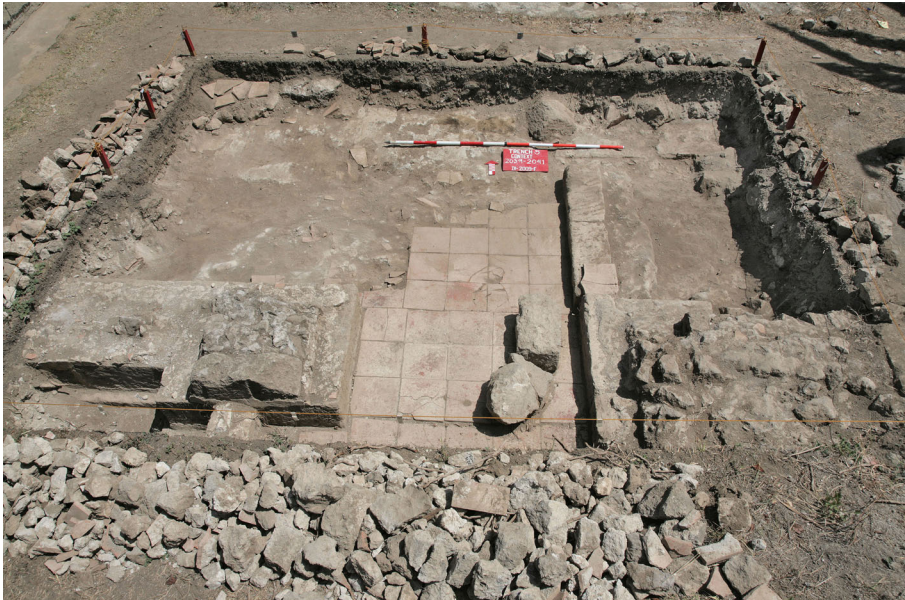
Fig. 21 The remains of an arch found on the tiled patio in Structure A associated with a different destruction phase. It collapsed between a passageway indicating that the arch could be part of an entryway

The contexts on which the two arches were found indicate more than one destruction phase of the structure. The northern section, where the arch on the tiled floor was recorded, appears to have been demolished first, thus corresponding to the initial phase of destruction.
