Amidships Assembly of the Sixteenth-Century Emanuel Point II Shipwreck

The Emanuel Point II (EP II) shipwreck was part of a 1559 Spanish colonizing expedition along the coast of Florida, under Tristán de Luna y Arellano. Initially discovered by University of West Florida archaeologists in 2006, over the last decade EP II has provided several generations of undergraduates and graduate students a platform for learning practical underwater techniques. Recent funding has allowed year-around work that included uncovering articulated hull structure in the amidships area. Archaeologists recorded the mainmast step and its associated pump well construction. Results from this analysis suggest that EP II was a relatively new ship with unique features, when compared to other known sixteenth-century vessels.

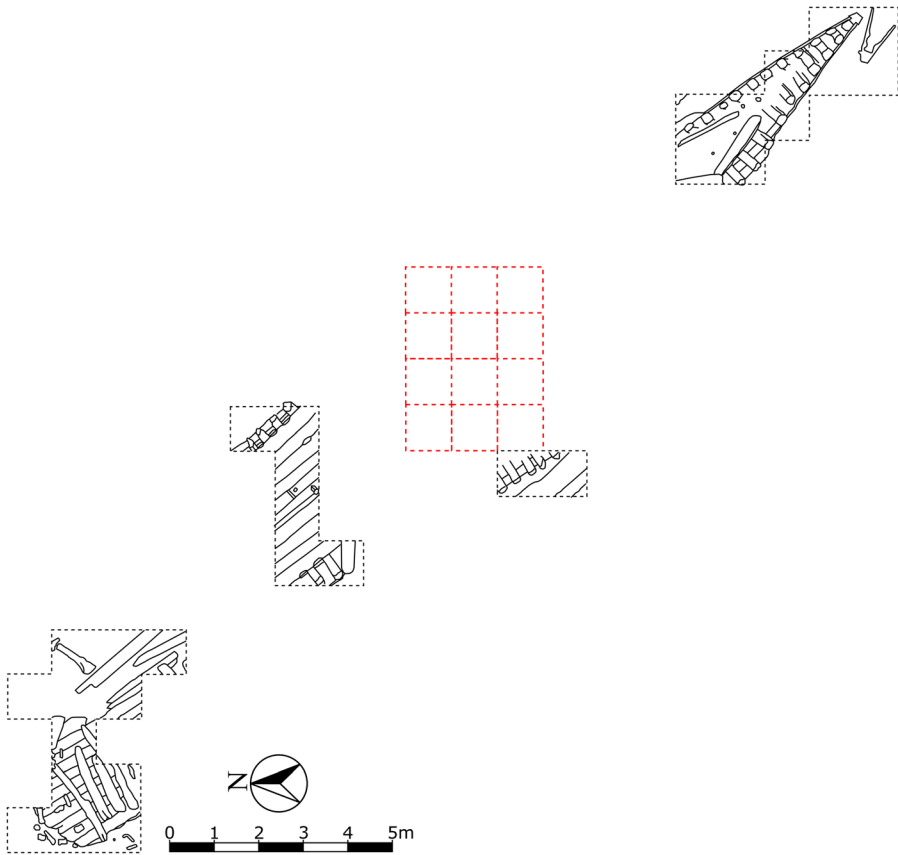
Fig. 2 Emanuel Point II site plan prior to 2014 excavations. Note: recent excavation area highlighted in red. (after Cook, 2009:92)

Over the course of the later excavation on EP I, UWF developed a working relationship with FBAR to build a robust research program in maritime archaeology. Each year undergraduates and graduate students operated along Pensacola's surrounding waterways conducting remote sensing surveys, recording, and excavation of historic shipwrecks. Toward the end of a 2006 maritime field school, students and faculty were investigating magnetic anomalies near Emanuel Point. One such anomaly, magnetic target 17, turned out to be another ballast mound approximately 400 yards [366 m] from the location of EP I (Cook, 2009:93). Preliminary excavations in the fall of 2006 uncovered articulated hull structure and associated Spanish olive jar, tin-glazed pottery, and Columbian plain majolica. The new find, designated Emanuel Point II, or EP II (8ES3345), was tentatively identified as another ship from the Luna expedition. Almost every summer since its discovery, EP II has been used by principal investigators, Drs. John Bratten and Gregory Cook, as a teaching platform for students to learn practical underwater field techniques in a low visibility environment. For the first several field seasons, UWF archaeologists focused on finding the outline of the ship by locating the bow, stern, and digging a trench across the hull forward of amidships (Fig. 2).

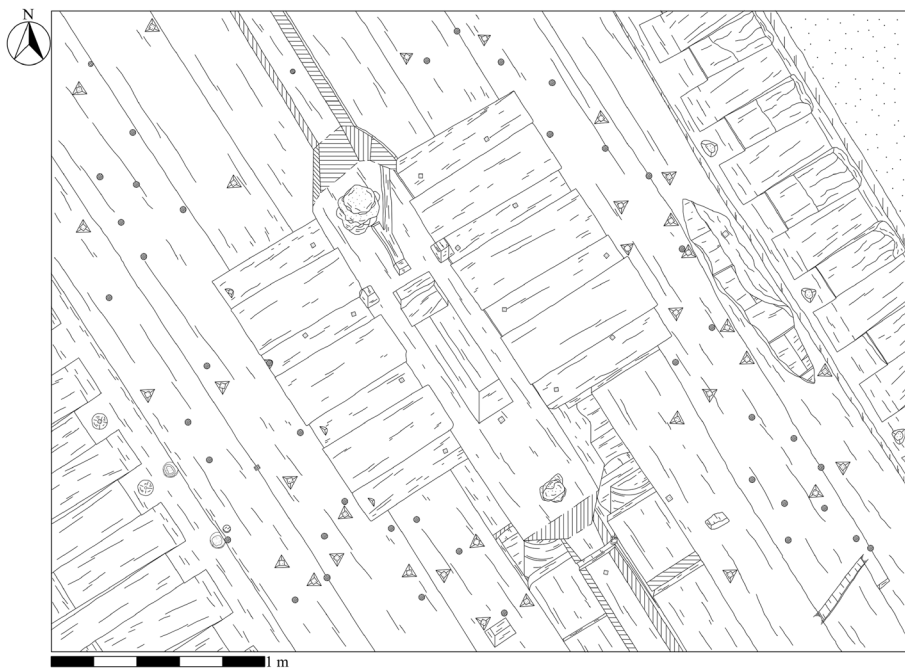
Fig. 4 Site plan of the mainmast step from the Emanuel Point II shipwreck. (Drawing by Author)

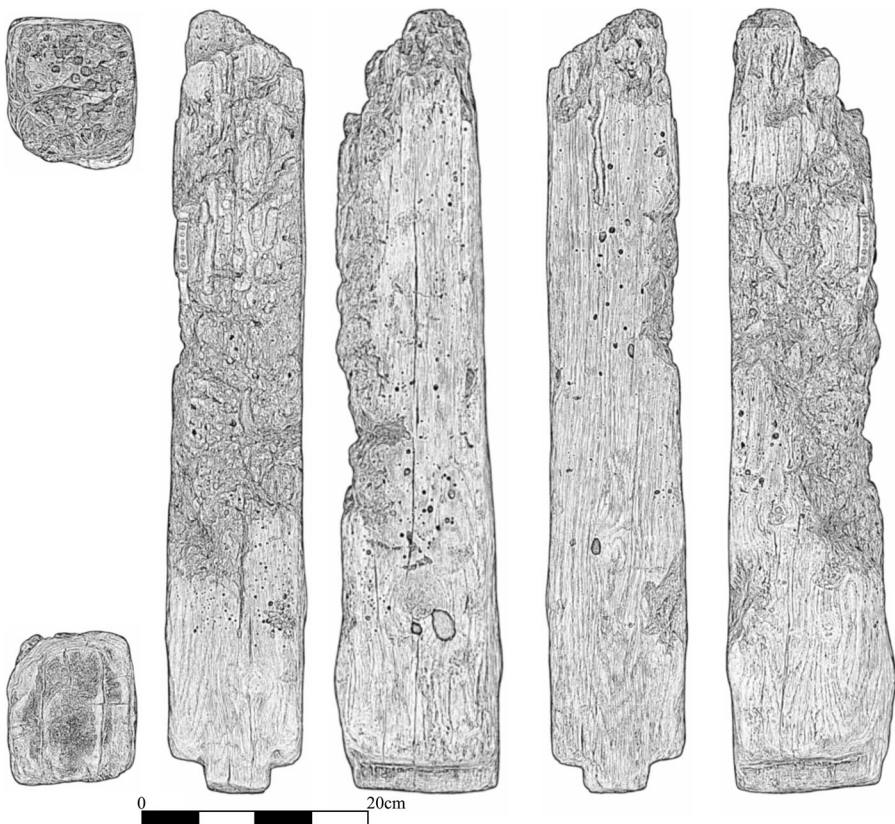
Fig. 7 Deck stanchion originally located forward of the mainmast step. (Drawing by Author)

There is an additional channel cut with similar dimensions connected to the mortise at a 65° angle toward starboard that terminates at the edge of the beveled forward face of buttress BS.S.1. Originally, the channel was perceived as part of the wrecking event, however, the surviving deck stanchion (62 cm long and 10.3 x 13 cm) was found in situ with a 11.3 x 5 cm tenon (Fig. 7). Rather than impact damage, it appears the channel was a modification by the shipwrights, due to the positioning of the pump well. When the pump well was installed, the forward wall was blocked by the deck stanchion, requiring the craftsmen to cut a channel and reposition the stanchion further forward. Two robust mallet handles (described below) were found in the vicinity with broken tenons, suggesting that the upper deck may have already been installed requiring the stanchion to be knocked out with manual force. It should also be noted that the deck stanchion tenon is still too thick for the shallow mortise and no wedge was found to keep it from unstepping.

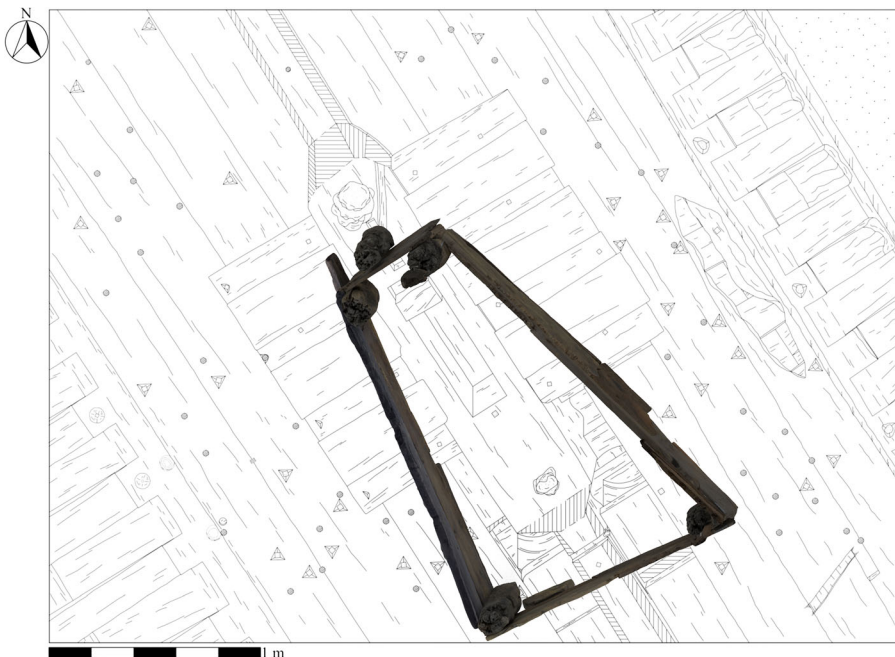
Fig. 12 The reassembled pump well angled over the site plan. (Image by Author)

When considering the placement of the mainmast and pump tubes, very little space was available to move and service the pump sumps (Fig. 12). If the mainmast was 40 cm in diameter, it would only leave 16 cm on either side to move past and reach the pumps. The portside pump tube allowed 25 x 19 cm of clearance and the starboard is 22 x 25.5 cm. These compact spaces required either the pumps to be pulled out for service or a small individual, perhaps a cabin boy, to be sent down to clean the pump sumps. The trapezoidal shape of the pump well also covered part of the bilge boards

and would have made it very difficult for a sailor of any stature to clean the bilge in this area properly.
