# A protocol for patients with cardiovascular implantable devices undergoing magnetic resonance imaging (MRI): should defibrillation threshold testing be performed post-(MRI)

## Abstract

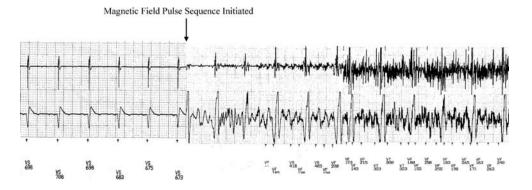
Fig. 2 Electromagnetic interference noise from the MRI scan is interpreted by the ICD device as ventricular tachycardia and ventricular fibrillation. The activation of the MRI magnet is indicated by the *arrow. VS* ventricular sense, *VT* ventricular tachycardia, *VF* ventricular fibrillation

original intent. All MRI scans were categorized as diagnostic studies by independent readers and were free of image quality limiting artifact attributed to the CIED. No patient experienced spontaneous or device induced arrhythmias. In PMD patients, there was no evidence of pacermaker malfunction including inappropriate inhibition of pacing. There were no observed pauses noted or changes in rate settings during the MRI scanning. In addition, no patients reported pain, burning sensation or tugging during or immediately after MRI scanning. Artifacts due to electromagnetic interference (EMI) were seen in the majority of patients with ICD/CRT-Ds. In nine out of 14 (64%) patients, the EMI was interpreted by the device as fast ventricular tachycardia or ventricular fibrillation (VF; Fig. 2).

Oversensing of EMI as VF was observed in the majority of ICD/CRT-D patients (64%). Although there exists the potential for delivering therapy for inappropriate VF sensing, it seems unlikely that ICDs can deliver an inappropriate shock within the MRI environment even when high voltage therapy is inadvertently left on [21]. The interaction between the static magnetic field and the device's capacitor results in saturation of the transformer resulting in a short circuit with ineffective voltage transformation and the inability to charge the capacitor [21]. However, other issues may develop that are associated with EMI oversensing by ICDs and may lead to battery depletion from unintended attempts to charge the capacitor [21].

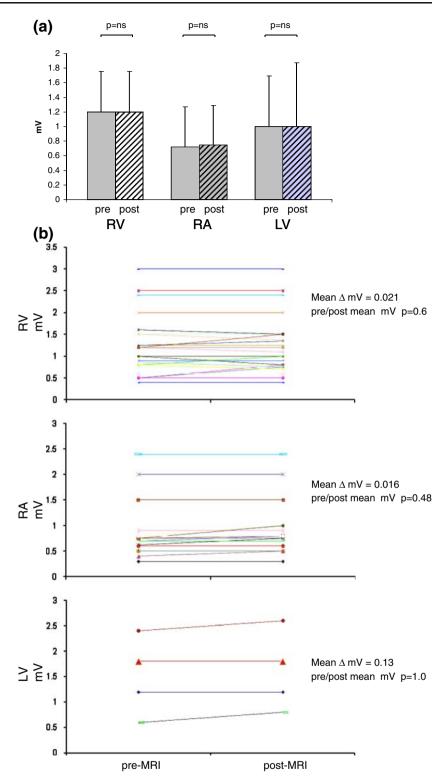
Fig. 3 Changes in the pacing thresholds pre- and post-MRI in PM patients. Compared with pre-MRI scan settings, there was no significant change in pacing thresholds (shown) and all other measured device parameters

Post-MRI device interrogation proceeded without difficulty, and there was no evidence of device circuitry damage. All pre-MRI settings remained unchanged. Compared with pre-MRI scan settings, there was no significant change in battery voltage, lead impedance or pacing and sensing thresholds (Fig. 3). There were no ICDs that delivered inappropriate therapy and no CIEDs experienced an electrical reset. These findings remained consistent without significant difference among patients irrespective of the number of same-day scans, repeat scans, or particular body part scanned. At 3 months follow-up, there were no significant changes in device parameters compared with immediate post-scan interrogation.

Maximum RF-induced heating occurs at the electrodetissue boundary and may lead to deterioration of pacing thresholds [21]. Therefore, the lack of post-MRI changes in thresholds and impedance confirms no clinically relevant damage at the endocardial interface from excessive heating. Heating from RF has been shown to correlate with: higher SAR, the position of the electrode in relation to the scanner, lead configuration (looping), and likely correlates to the implantation depth and viability of the tissue [22–24]. The MRI scans in our study were performed without MRI sequence modification or alteration of MRI hardware and or software that may potentially affect the overall image quality of the scan.
