Safety of magnetic resonance imaging in patients with permanent pacemakers: a collaborative clinical approach

Barry Anthony Boilson · Anita Wokhlu · Nancy G. Acker · Joel P. Felmlee · Robert E. Watson Jr · Paul R. Julsrud · Paul A. Friedman · Yong-Mei Cha · Robert F. Rea · David L. Hayes · Win-Kuang Shen

Objective This study aimed to characterize the interactions of pacemakers with magnetic resonance imaging (MRI) and to identify device characteristics that could predict adverse interactions.

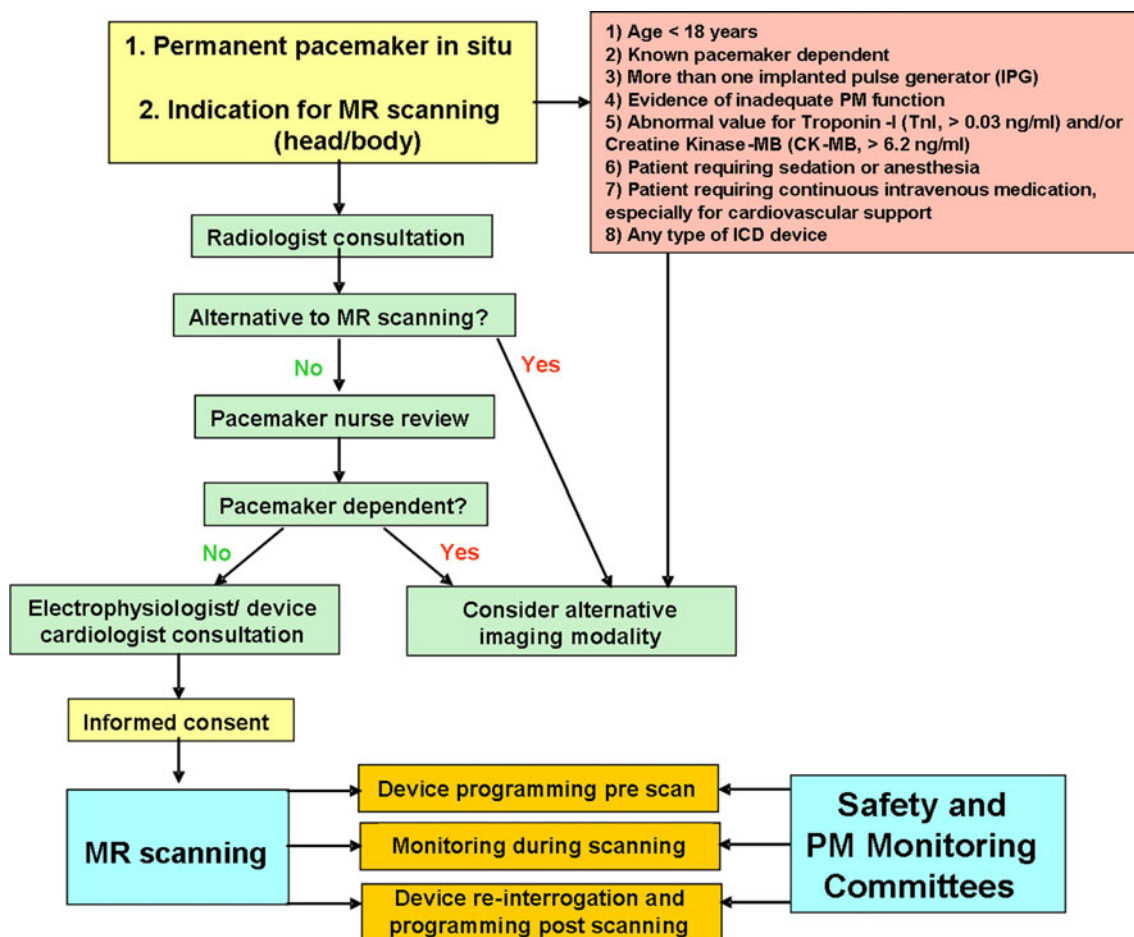
Fig. 1 Algorithm for magnetic resonance scanning in patients with permanent pacemaker devices *in situ*. ICD implantable cardioverter defibrillator, PM pacemaker

Mayo Clinic recently developed a pilot clinical protocol for body and head MRI in patients with cardiac devices (Fig. 1). This protocol incorporated common elements from
