The origin of fatigue fracture in single-crystal silicon

H. Izumi¹, T. Kita^{1,2}, S. Arai³, K. Sasaki^{3,4}, and Shoji Kamiya^{1,*}

¹Nagoya Institute of Technology, Gokiso-cho, Showa-ku, Nagoya 466-8555, Japan

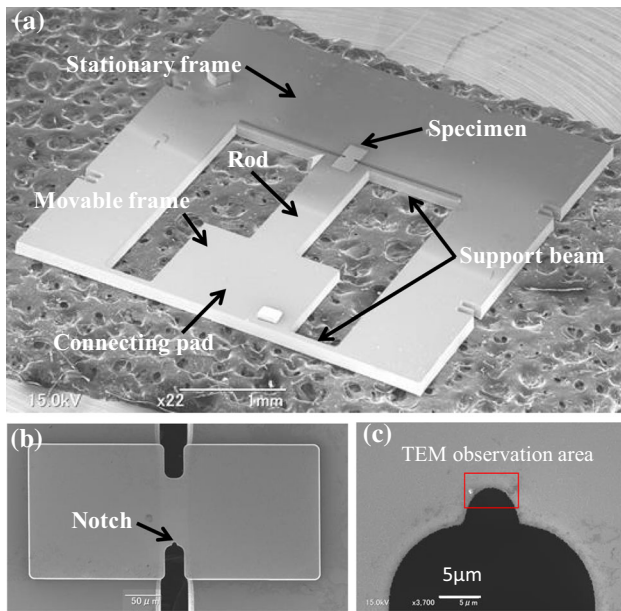
Figure 1 Scanning electron microscopy (SEM) images of micro-test structure and specimen fabricated by silicon on insulator (SOI) technology. **a**, The micro-test structure comprised a stationary frame and a movable frame. The thin film silicon specimen was integrally fabricated on the micro-test structure. **b**, Silicon thin film specimen (2 μm thick, 100 μm long, 26 μm wide). **c**, Oval notch on specimen for a stress concentration factor of 3.55; the area indicated by the red rectangle was investigated by high-voltage transmission electron microscopy (HVTEM).

A $2\text{-}\mu\text{m}$ -thick specimen was designed and fabricated into the configuration shown in Fig. 1a, as being integrated onto the loading structure. To confine the area of observation, the specimen was designed with notches for local stress concentration, as shown in Fig. 1b. It also had a small notch on one side with a radius of curvature of $5\text{ }\mu\text{m}$ for further stress concentration, as indicated in Fig. 1c. Actual fabrication was carried out using silicon on insulator (SOI) wafers manufactured by Semiconductor Wafer, Inc., Taiwan, which consisted of a $2\text{ }\mu\text{m} \pm 0.5\text{-}\mu\text{m}$ -thick device layer, a $0.8\text{ }\mu\text{m} \pm 0.5\%$ -thick buried oxide (BOX) layer, and a $200\text{ }\mu\text{m} \pm 10\text{-}\mu\text{m}$ -thick handle layer. The front and back surfaces comprised {100} oriented p-type single-crystal silicon and were mirror-polished. The electrical resistivity of the device layer and handle layer was $10\text{--}20\text{ }\Omega\text{cm}$. The specimen and the loading structure were made out of the

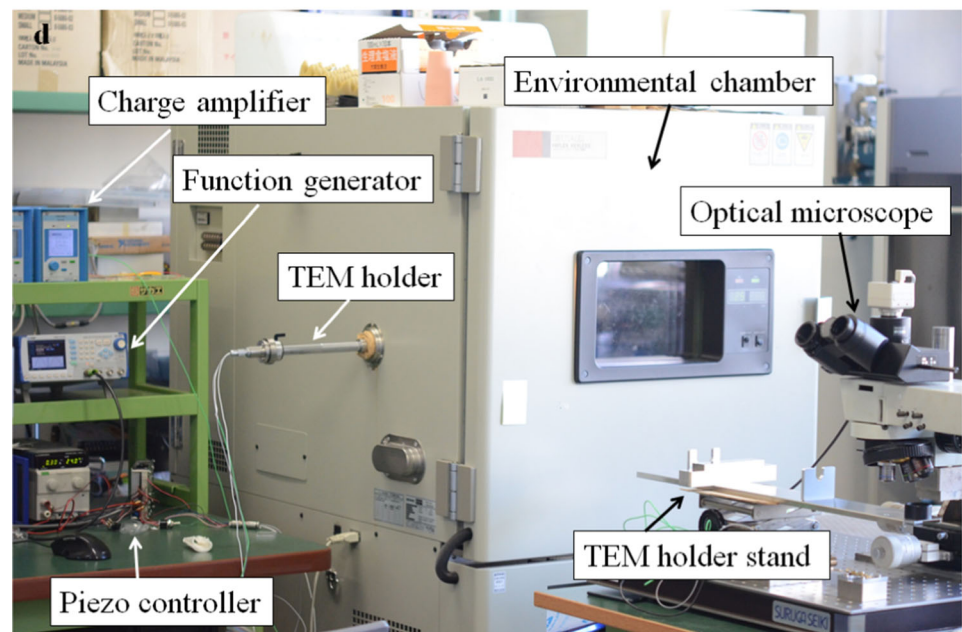
Figure 2 Experimental setup for loading specimen on the high-voltage transmission electron microscopy (HVTEM) sample holder. **a** Load cell and piezoelectric (PZT) actuator inside holder body for applying force to specimen. **b** Overview of transmission electron microscopy (TEM) holder body. **c** Close-up view of sample stage and mounted micro-test structure. **d** Environmental chamber assembled with the HVTEM holder for static and fatigue tests.

The load was applied to the specimen through the loading structure while being installed on a holder for HVTEM observation. This was to facilitate the transfer between experiment and observation anticipating subsequent in situ experiments. The loading structure was 4.4 mm \times 4.4 mm square and consisted of a stationary outer frame and a movable inner frame, as shown in Fig. 1a. One end of the specimen was anchored with the remaining BOX layer to the stationary frame, and the other end was anchored to the movable frame, so that the load was transferred to the specimen when the movable frame was shifted by the external actuator. For the purpose of connecting the loading structure to an external actuator, the movable frame had a pad that was soldered to the silicon rod, which was then screwed onto the end of the loading train. The loading train, which coupled a piezoactuator (model P-841.20, travel 30 μm , resolution 0.6 nm, PI, Germany) and a

silicon rod with a load cell (model 9215, resolution 1 mN, stiffness 140 N/ μm , Kistler, Switzerland) in between, was assembled inside the HVTEM sample holder, as shown in Fig. 2a–c. Each experiment was carried out on the HVTEM sample holder, which was inserted in an environmental chamber (model TH441HA, accuracy ± 0.1 $^{\circ}\text{C}$ and $\pm 1\%$, ETAC, Japan) at 25 $^{\circ}\text{C}$ and 80% relative humidity (RH), as shown in Fig. 2d.

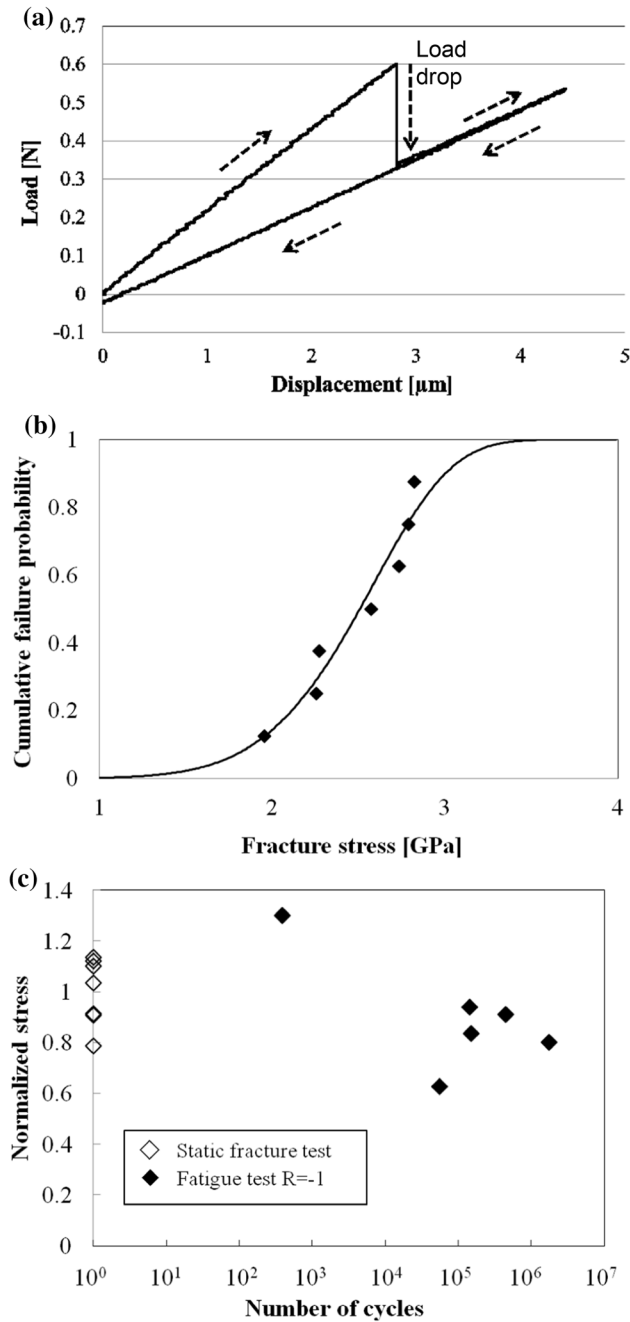
Figure 3 Results of static and fatigue tests at 25 °C and 80% relative humidity (RH). **a** Example of load (ordinate) versus displacement (abscissa) plot obtained from the static test. **b** Fracture stress plotted using the mean rank method; the fitting curve represents the Weibull distribution. **c** Fatigue lifetime data with the stress ratio $R = -1$.

As the first step, the stress amplitude level of the fatigue test was determined. This was accomplished by subjecting some of the specimens to static tensile tests to determine their strengths by applying a monotonically increasing load, and subjecting the remaining specimens to fatigue tests. Figure 3a shows an example of the load–displacement curve associated with the static tensile test. A sudden drop appears in the load, which corresponds to the load applied to the specimen immediately before fracture. The strength of each specimen, i.e., the stress applied at the notch tip when the specimen broke, was obtained using the commercial finite element analysis software ABAQUS on the basis of this drop in load [21], with the notch tip stress concentration and the thickness of the individual specimen taken into account. Figure 3b presents the distribution of strength, where the cumulative fracture probability was obtained by the mean rank method [22] and plotted along the ordinate with the applied stress along the abscissa. The average strength of the specimens was 2.53 GPa. The fitting curve represents the Weibull distribution [22], which is widely used to estimate the strength of brittle material and was optimized to the experimental data. The shape parameter m and the scale parameter σ_0 were

As the second step, a tension–compression fatigue test with a stress ratio $R = -1$ was carried out [24]. The stress amplitude level was set to within 80%–130% of the average strength. The frequency of the cyclic load in the fatigue test was set at 40 Hz. Figure 3c is a plot of the fatigue lifetime of the specimens, in which the stress amplitude normalized with

the average strength is plotted on the ordinate and the number of cycles to fracture is plotted on the abscissa. The fatigue lifetimes of the specimens were distributed within the range 10^5 – 10^7 cycles under a stress amplitude level of 80%–130% of the average strength, and once again they are in agreement with other common experimental data [25].

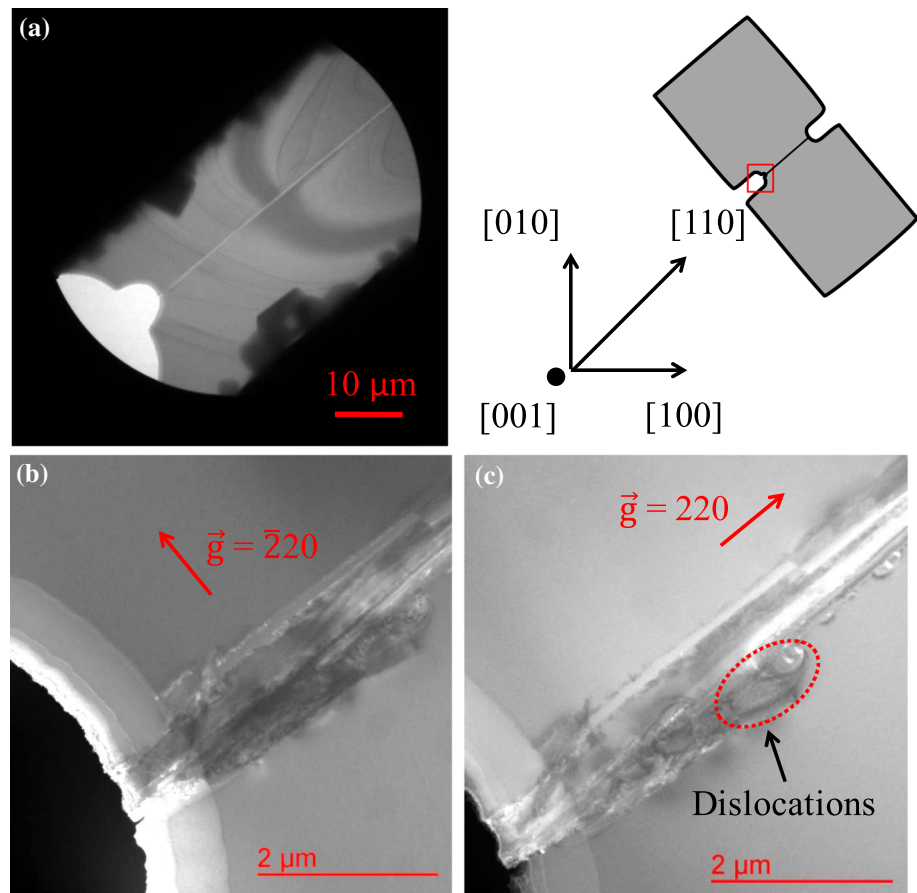
Figure 4 Dark-field high-voltage transmission electron microscopy (HVTEM) images of the notch tip on the specimen after the static test. **a** Low magnification HVTEM image of the broken specimen (left), and illustration of specimen showing crystallographic orientations (right). **b** and **c** HVTEM images of notch tip under various diffraction conditions. Dislocation originating from an extending crack was observed around the fracture surface.

Figure 4 shows dark-field HVTEM images of the notch tip obtained from a specimen broken by a monotonically increased load. The images are intended for comparison with those of a fatigue fracture, which are shown later. Figure 4a shows a low-magnification HVTEM image of a broken specimen on the left side and an illustration of the entire specimen on the right side. The illustration shows the crystallographic orientations, and the red square indicates the region from which the magnified HVTEM images in Fig. 4b and c were obtained. They were obtained using weak-beam dark-field image contrast experiment [26] with diffraction vectors $\bar{2}20$ and 220 , as indicated over the images. The bright arc areas in the lower-left sides of the images are due to the partially thinned notch edge with scallops that formed during the etching process [27]. The bright, solid straight patterns running diagonally to the upper right corners of the figures, which did not alter with the diffraction vectors, probably correspond to a crack that emanated from a point along the notch tip and extended unstably to break the specimen in a brittle manner. Because the bright straight pattern has a certain width, and plural cracks hardly ever extend simultaneously from a mechanical perspective, it should be a single crack extending along $(1\bar{1}\bar{1})$ inclined to the specimen surface (001) . It is widely known that silicon has its slip planes along $\{111\}$ [28], and cleavage planes along $\{111\}$ and $\{110\}$, whose surface energies are close to each other (1.23 J m^{-2} and 1.51 J m^{-2} , respectively) [29]. In contrast, the ambiguous dark and hazy cloud-like patterns in Fig. 4b and c probably correspond to dislocations, judging from the fact that dislocations are invisible to TEM when the diffraction vector is perpendicular to the Burgers vector, and that parts of them appear and disappear depending on the diffraction vector. We speculate that dislocations were emitted from the crack as its extension was being accelerated unstably by the excess elastic energy.

and 8. These accumulated defects appear completely different from those in Fig. 4, which were induced by sudden unstable crack extension with excess strain energy in a static fracture test.

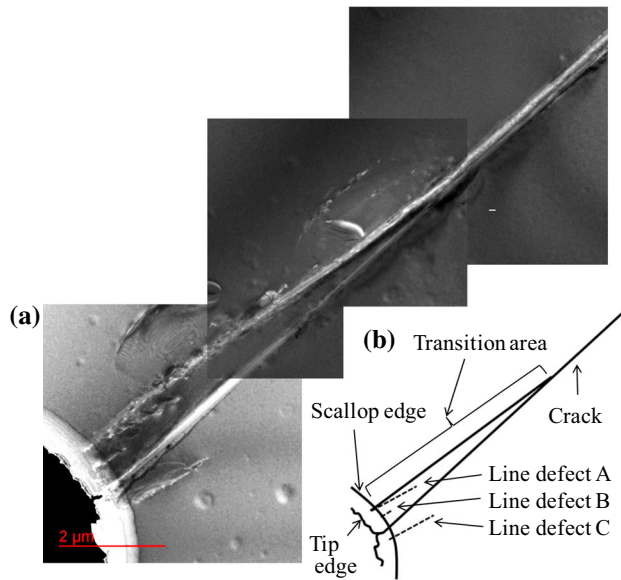
Figure 5 Bright-field high-voltage transmission electron microscopy (HVTEM) images of fractured specimen after fatigue test with $R = -1$. **a** Magnified view of the notch tip showing the crack extension and linear defects accumulated by mechanical loading. **b** Schematic representation of the notch tip on the fractured specimen.

Figure 5 shows bright-field HVTEM images of the notch tip obtained from a specimen broken by 4.49×10^5 cycles of fatigue loading at a stress level of 91.1% of the strength. As shown in Fig. 5a, an unstable crack appears to be extended in the same way as in Fig. 4, originating along the $(1\bar{1}\bar{1})$ plane and gradually shifting to extend along $(1\bar{1}0)$ in a long run,

as schematically illustrated in Fig. 5b. As mentioned in the previous paragraph, in this case silicon slipped along $(1\bar{1}\bar{1})$ or $(1\bar{1}1)$ where the largest shear stress was applied, $(1\bar{1}0)$ was another potential cleavage plane. Therefore, in this situation the unstable crack extension may have started with slip deformation along $\{111\}$ and may subsequently have gradually shifted to the $\{110\}$ cleavage plane with just a little larger surface energy and a much larger tensile stress. A similar scenario may also hold for cases of fracture under monotonically increasing load, as shown in Fig. 4. In such cases, it is commonly recognized that initial defects induced by etching [30] determine the strength of the silicon structure, while possibly triggering unstable slip deformation to initiate crack extension along $\{111\}$. However, a number of shorter bright lines are also clearly visible in Fig. 5a that are not present in Fig. 4; they extended from different points along the notch edge, as illustrated in Fig. 5b. Furthermore, the lines are probably line defects emanating from points not on the extending crack but from directly along the notch edge apart from the

crack, because their appearance is significantly different from that of the vaguely cloud-like lines in Fig. 4. Therefore, the lines in Fig. 5a accumulated before the crack started its unstable extension.

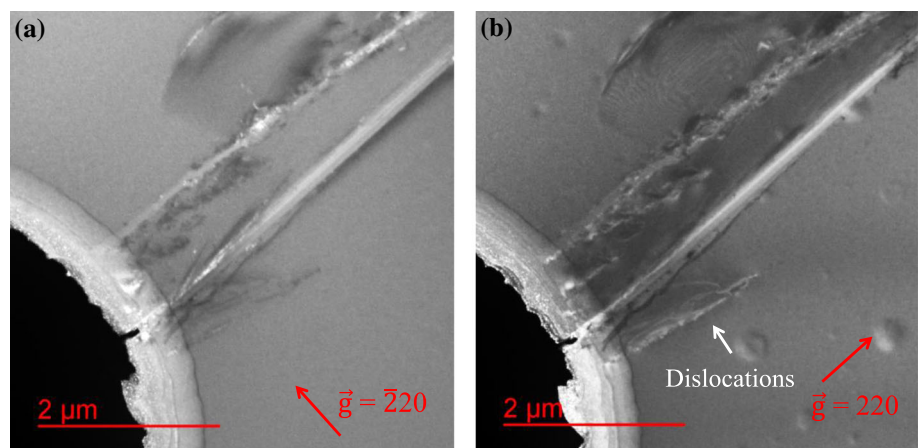
Figure 6 Dark-field high-voltage transmission electron microscopy (HVTEM) images showing edge dislocation near fatigue crack origins in specimens. Figures **a** and **b** show the same specimen shown in Fig. 4.

Figure 6a and b shows dark-field images showing the weak-beam dark-field image contrast experiment, obtained from the same specimen shown in Fig. 5. Once again, because some corresponding parts of the line defects appear and disappear depending on the diffraction vectors, they must be edge dislocations. In comparison with the case of fracture under a monotonically increasing load shown in Fig. 4, these dislocations appear in more clearly defined triangular patterns, as indicated in Fig. 6b. The crystallographic orientations of the slip system and the expected direction of the dislocation line in silicon are illustrated in Fig. 7a. In comparison with the HVTEM image in Fig. 7b, which is a repeat of Fig. 5a, and the projection of the slip system illustrated in parallel in Fig. 7c, the triangles obviously spread along the $\{111\}$ slip plane confined within the two $\langle 110 \rangle$ slip directions. In particular, line defect C indicated in

Fig. 5b, which is also indicated in Fig. 6b by the white arrow, is located completely apart from the other defects in the image and does not intersect with the crack. Therefore, the lines appear to have been emitted and accumulated in a more stable manner, probably in advance of the activity of the unstable crack extension in the event of fatigue fracture to release the strain energy at a certain cycle of loading.

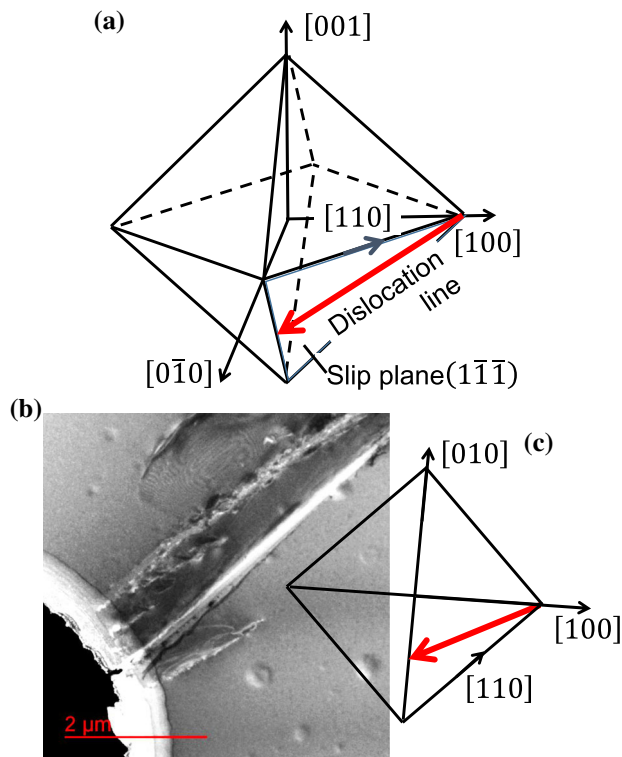
Figure 7 Crystallographic orientation and slip system of each specimen. **a** One of the slip planes with the largest resolved shear stress and the expected direction of the dislocation line. Part of Fig. 5 is presented here as **b** next to the slip system **c** projected onto the specimen surface [001].

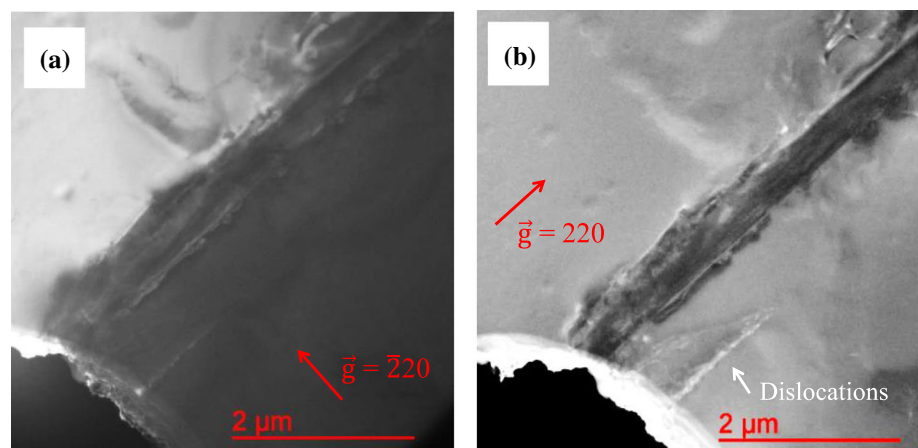
Figure 8 Another case of similar defect accumulation observed in a different specimen from that in Fig. 6.

Another case of such a situation is shown in Fig. 8a and b, which are similar dark-field images obtained from a different specimen fatigue-fractured at a stress

amplitude level of 62.9% after 5.47×10^5 cycles. Again, a trace of subcritical dislocation accumulation is clearly visible in the triangles apart from the crack that broke the specimen. These multiple observations indicate an essential scenario for fatigue fracture in silicon, as follows. Dislocations such as those shown in Figs. 5, 6, and 8 accumulate along the {111} slip planes, starting from the initial defects induced by etching [30], and progress in a number of small local areas along the region of stress concentration under cyclic fatigue loading. Such defect accumulation induces further local stress concentration, thereby reducing the remaining strength of the material. After a certain number of fatigue cycles, an unstable crack extension starts from the most severely stressed and weakened area along the same {111} plane. The evidence for this scenario is discussed in the next section.
