Correlation of Acoustic Emission with Fractography in Bending of Glass–Epoxy Composites

Abstract

Keywords Micro-crack initiation · Debonding · Acoustic emission · Historic index · Step-load

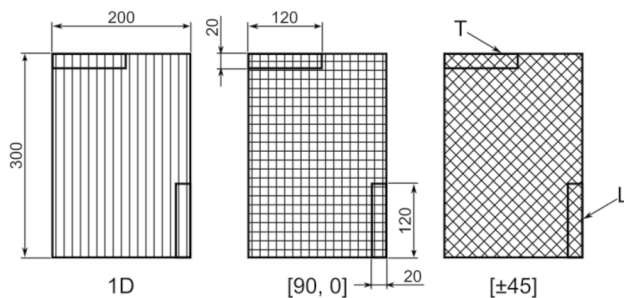
Fig. 2 Fiber lay-up in the examined GFRP composites and the scheme of sample cutting for mechanical testing

The GFRP plates were prepared in three basic fiber configurations: quasi-unidirectional $[0^\circ]_n$, cross-ply $[90^\circ, 0^\circ]_n$ and angle-ply $[\pm 45^\circ]_n$. The number of glass fabric layers and the amount of epoxy resin were purposely varied to give composites with different fiber volume contents (according to manufacturer): low $\sim 30\%$, medium $\sim 40\%$ and higher $\sim 50\%$, respectively, for each fiber lay-up. The uneven number of glass fiber fabric plies ensured identical fiber lay-up on both bottom and top surface of each composite plate. To control closely the crack initiation [19] in quasi cross-ply composites $[90, 0]$, the warp yarns in bottom surfaces were always laid along shorter sides of composite plates.

The E-glass-fiber fabric layers were embedded in mixture of epoxy resin with hardener³ and composite plates were cured in room temperature (RT) for 24 h, covered with aluminium plates to obtain surface smoothness. The value of bending strength of hardened epoxy resin is given by manufacturer as 90 MPa. Rectangular samples of the size 120 mm \times 20 mm \times 2 mm were cut with diamond saw parallel (L) and perpendicular (T) to longer side of composite plates, as shown in Fig. 2.

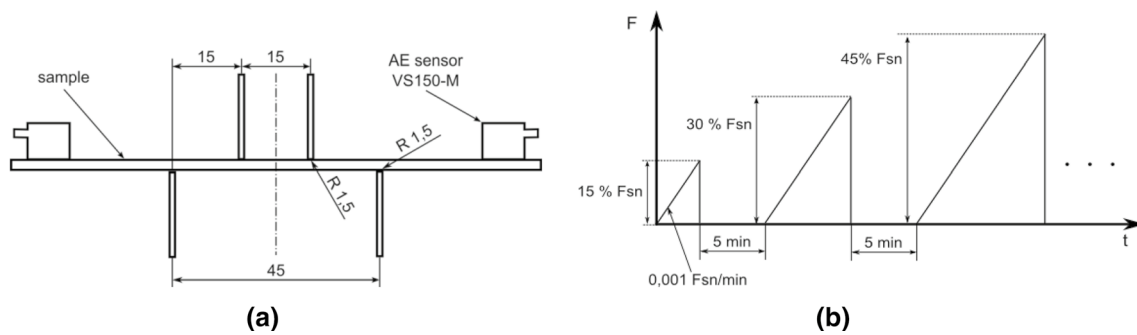
Fig. 3 **a** Experimental set-up for 4-point bending tests of GFRP with positioning of AE sensors, **b** loading schedule during flexural step-load tests

The bending strength of GFRP composites was determined in monotonic 4-point bending tests using universal testing machine Instron (model 33R4467), with simultaneous monitoring of AE response of materials. The cross-head speed was 2 mm/min and the inner/outer span of load points were 15 mm and 45 mm, respectively (Fig. 3a). Five samples were examined in each of three types of composites (quasi 1D, cross-ply, angle ply), for each fiber volume content (low, medium, high) and cutting direction (L, T). All together 90 GFRP composite samples were tested in monotonic 4-point bending at room temperature (23 °C) and humidity of 55%. Based on fracture load levels measured in monotonic tests, the load increments were defined accordingly for each material examined in step-load tests.

Step-loading was applied in a saw-tooth mode (Fig. 3b), with a sequence of loading and unloading [20]. Load increment was of the order of 15% of ultimate bending strength (F_{sn}) measured earlier in monotonic tests and was increased at average rate of 0.001 F_{sn} per minute. Unloading rate was on average 0.1 F_{sn} per minute, down to the level not exceeding 1% of fracture stress, to prevent machine's instability. After each unload the hold period of 5 min was applied. This sequence was repeated till final failure of the sample, or until interruption of the test.

For increasing load tests in 4-point bending, three samples were selected in each GFRP composite type, fiber volume, and cutting orientation. One sample in each lot had its tensile surface (opposite to inner load points—Fig. 3a) pre-polished for microscopic (SEM) observations. Flexural step-load experiments were performed with similar inner/outer spans as in monotonic tests, using the servo-hydraulic MTS 810 machine, equipped with force sensor MTS 661 19F-01 and FlexTest software, version 3.5B 1787.

software for parametric and transient data acquisition and analysis. The AE signals were collected by Vallen resonant sensors V150-M placed on GFRP samples' ends (Fig. 3a), with surfaces covered with silicone grease and secured with scotch tape. The V150-M sensors embrace the frequency range from 100 to 450 kHz, the most important for capturing signals from AE events typical of micro-crack initiation in GFRP composites. The AE sensors were coupled through Vallen AEP3 preamplifiers to AE system with the signal threshold set to 40.7 dB and preamplifiers gain of 34 dB. The AE duration discrimination time was set to 0.25 ms, rearm time 0.41 ms and TR sample rate 5 MHz. Damage initiation processes during the step-load tests of GFRP samples were monitored with use of Vallen system model AMSY3, with similar V150-M resonant sensors, AEP3 preamplifiers and identical system settings. In both types of mechanical tests with assistance by acoustic emission, the standard AE signal calibration procedure using the Hsu-Nielsen source preceded the actual measurements [21].

Step-load tests of GFRP composites were performed here primarily to control (with use of AE) the process of micro-crack initiation in these materials and the load level at which it occurs, as shown in Fig. 3b. It has been described in earlier works [23] that during the tensile tests of composites the micro-crack initiation may occur in the entire volume of the sample under stress, including large side surfaces. Preparation of surfaces and detailed SEM analyses of large scale samples could be difficult, time consuming and costly. Other known direct NDE techniques like C-scan or X-ray inspection do not have sufficient accuracy (measurable in micrometers) as compared to SEM [9]. During bending tests of materials the damage in form of micro-cracks most likely initiates in the area of maximum stress on the outer surface of bent sample. In most cases of 4-point bending tests damage should become visible within the area between the inner load points. Such a limited area can be easily inspected with sufficient accuracy using the high-resolution SEM.

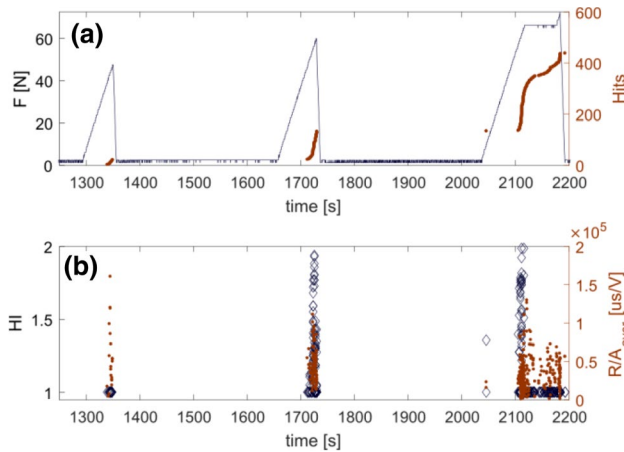
Fig. 6 a Increases of force applied and registered AE hits number with time of step-load test of transversal (T type) sample of 1D GFRP with low fiber volume fraction (30%), b the values of AE HI and R/A parameters during these last three step-load cycles

Figure 6a shows incremental growth of the number of AE hits during last three cycles of step-load test before failure of 1D GFRP transversal sample (T type) with low fiber volume. Figure 6b compares the data of AE HI readings (left axis) for this sample with increases of AE rise time/amplitude ratio (R/A—right axis) occurring at the same time (± 1 s.) as HI maximums in each of these loading cycles.

during loading and processed by floating averaging within 1 s span. In all other (than shown in Fig. 6) step-load tests of transversely cut 1D GFRP composites with varying fiber volume, the increases of AE R/A parameter correlated well with registered HI patterns in a similar way, i.e. within a narrow time window of ± 1 s.

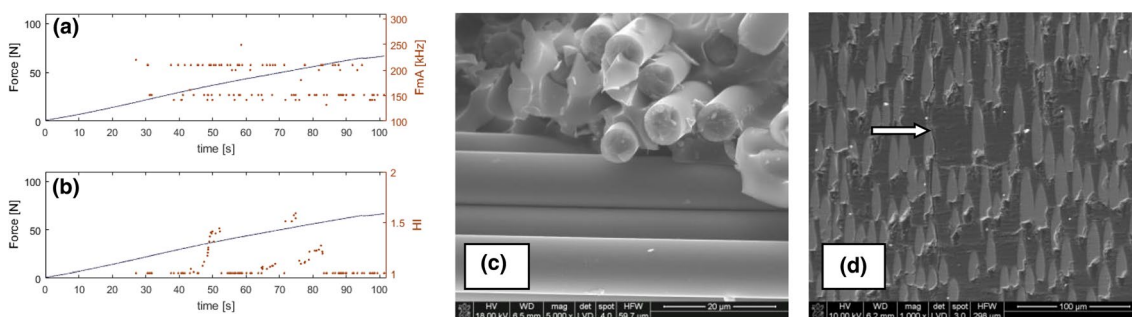
Fig. 8 **a** The AE frequency (FmA), and **b** AE HI of [90,0] GFRP laminate in monotonic bending, **c** SEM of fracture surface of [90,0] GFRP ruptured in monotonic test (average fib. vol. 40%), **d** debonding crack in warp yarn on tensile surface of [90,0] GFRP sample (aver. fib. vol. 40%)

Figure 8 summarizes typical mechanical, acoustic emission and microscopic data obtained for L type samples of

cross-ply [90,0] GFRP composite during monotonic 4-point bending test. The measured values of AE frequency (FmA) shown in Fig. 8a reveal the interphase debonding and also matrix micro-cracking as dominant mechanisms of damage initiation. Increases of AE HI during bending shown in Fig. 8b indicate the timing of damage initiation. The fracture surface observed in SEM after monotonic test (Fig. 8c) informs of the state of the sample after rupture, with no leads concerning the sequence of damage. However, the presence of crack shown in SEM picture of tensile surface of the sample examined after interrupted step-load cycling (Fig. 8d), confirms that fiber debonding contributes to damage initiation in this material, macroscopically still carrying the load.

In both monotonic and step-load tests of composite samples with transversal warp fibers (1D type T and cross-ply L samples), the AE HI increases indicated points of time of damage initiation (Figs. 5b, 8b), while the AE frequencies

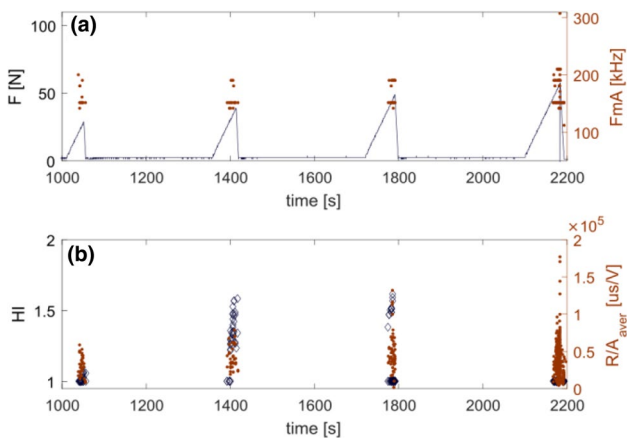
Fig. 9 **a** The AE frequency (FmA) during step-loading sequence of L type GFRP [90,0] sample, **b** the indications of AE R/A and HI parameters during the last four cycles of step-load test

These observations are consistent with AE results obtained during step-load tests. Figure 9a indicates typical for interphase phenomena values of AE frequency (FmA) registered during last 4 cycles of step-load bending test of L type GFRP [90,0] sample, with glass fiber warp yarns perpendicular to tensile stress on the outer surface.

Figure 9b shows the values of AE R/A parameter (right axis) registered in these tests and overlapping the AE HI values (left), which may be indicative of strong contribution of fiber debonding to formation of transverse cracks in the examined GFRP composites.

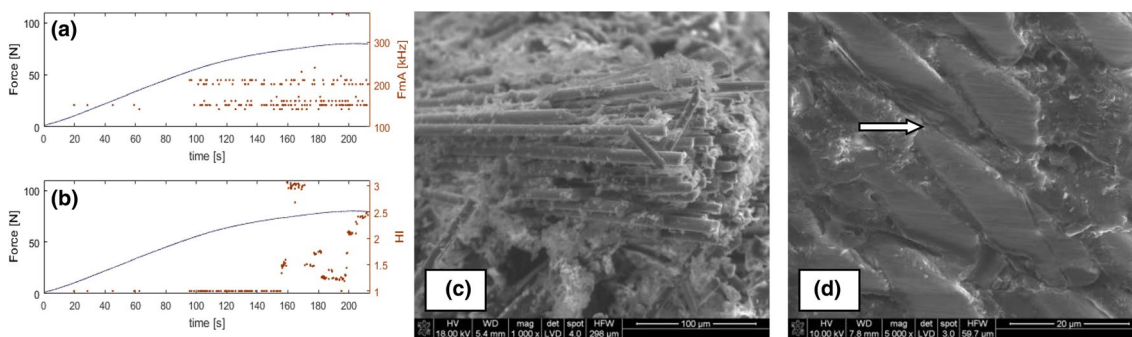
Fig. 10 **a** The AE frequency (FmA) and **b** historic index of angle-ply GFRP laminate of average fiber content (40%) in monotonic bending, **c** SEM of fracture surface of angle-ply GFRP, **d** debonding crack

on side surface of angle-ply GFRP sample with average fiber content (40%) after interrupted step-load

equipment settings used. Figures 10a and 11a confirm that the AE frequencies (FmA) in 4-point bending monotonic and step-load tests were dominated by interphase and matrix damage. The AE HI increase in monotonic tests (Fig. 10b) indicates damage initiation signals near 70% of loading time.

As can be seen in Fig. 11b below, the AE R/A ratio increases (right axis) measured in step-load tests of angle-ply composites also overlap the values of AE HI (left). Both these AE parameters correlate well with microscopic (SEM) observations of side surfaces after interruption of step-loading (Fig. 10d), confirming that debonding cracks contribute substantially to damage initiation in GFRP angle-ply composites.

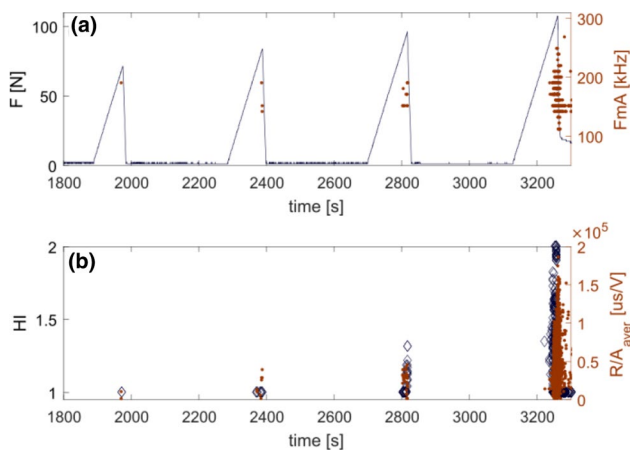
Fig. 11 **a** Step-load curve and AE frequency (FmA) indications observed in angle-ply GFRP, **b** the AE parameters R/A: (right axis) and HI (left) in angle-ply GFRP composite
