COMPARISON OF FRACTURE CHARACTERISTICS OF OPEN-HOLE-NOTCH CARBON-FIBER-REINFORCED COMPOSITES SUBJECTED TO TENSILE AND COMPRESSIVE LOADINGS

Open-hole tension (OHT) and open-hole compression (OHC) tests were carried out on hot-pressed carbon-fiber-reinforced composite samples with a singular open hole. The fracture surfaces of the OHT- and OHC-tested specimens were examined by using scanning electron microscopy (SEM). SEM micrographs showed significant features on the surface of carbon fiber, matrix, and especially in the fiber/ matrix interface. Interpretation of these micrographs revealed the possible failure mechanism of composite samples with an open hole under tensile and compressive loadings. Furthermore, a comparative study of these micrographs also pointed to certain specific differences between the fracture characteristics of open-hole composite samples failed under tension and compression. This information is useful in the post-failure analysis of a composite structure.

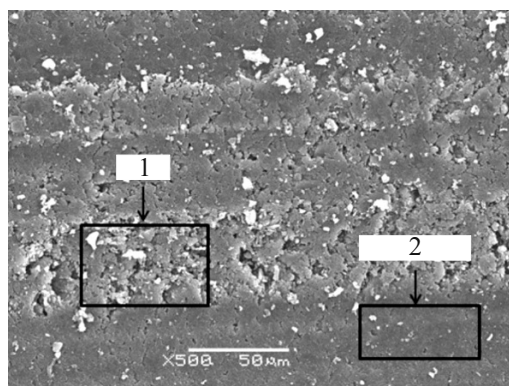
Fig. 1. Photomicrograph of the surface of a hole created by drilling: 1 — resin and 2 — carbon fiber.

Figure 1 presents a photomicrograph of the inner surface of a hole created by drilling in a composite sample. Several microcracks were identified both in the matrix and fiber phases, which were more prominent in the matrix. They were produced by the stresses generated by drilling. These stresses caused greater damage, in the form of micro- and macrocracks, to the resin

Despite the soft and smooth drilling, microcracks were generated at the periphery of holes (Fig. 1), which acted as stress concentration points. Moreover, the region close to an open hole also became lean and weak due to the removal of the composite material. Hence, upon application of a tensile load to an open-hole composite sample, the microcracks at the inner rim of the hole coalesced and formed a macrocrack, which started its propagation and left river pattern marks on the resin adhered to fibers (Fig. 2), showing the direction of crack growth from the center to the edge of sample (perpendicular to the

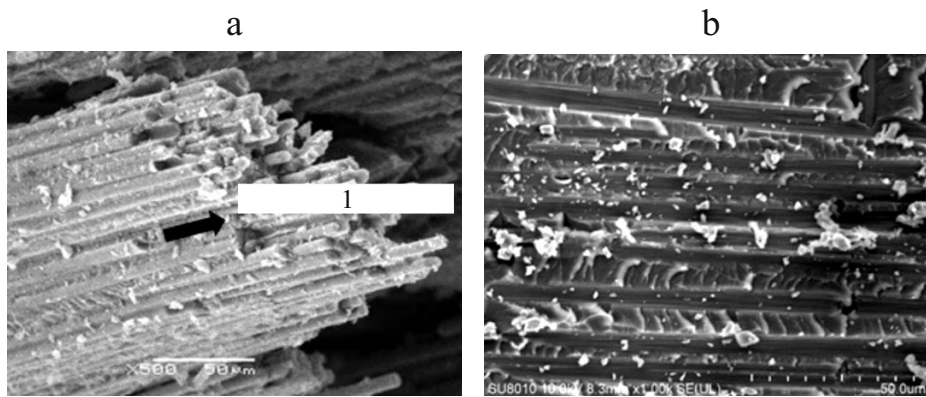
Fig. 2. River marks in the resin among fibers, showing the direction of crack growth (1) in OHT (a) and OHC (b) samples.

In the resin adhered to the fiber surface in the OHT samples, river marks could be seen, as illustrated in Fig. 2a, which pointed to the presence of interlaminar shearing. These marks were formed by the coalescence of numerous small 45° tensile microcracks in the resin between fibers. The size, shape, and morphology of these marks varied over the fracture surface depending on the amount of resin between fibers, fiber orientation, and the percentage of shear. Direction of these marks showed the overall growth direction of crack, which seemed to start from the open hole towards sample edges.

Similar river marks generated by interlaminar shearing between carbon fibers in an OHC sample are shown in Fig. 2b, which are more prominent than those in Fig. 2a. Direction of the marks was arbitrary and signified that the crack growth was also arbitrary along the center line through the open hole.

As the OHT and OHC samples had an open hole at their center, the microdamage in them initiated from the hole boundary upon application of a compressive load. The damage grew along the center line of the open-hole in a random direction perpendicular to the applied load, leaving river pattern marks (Fig. 2b), but the direction of this pattern in the OHC samples was significantly different from that in the OHT (Fig. 2a). The load transfer among layers was very similar to that in the OHT samples, but with much more shear hackle marks (Fig. 3b). As in the OHT samples, with increase in load, the carbon fibers broke across the entire width of samples in the same region, but by microbuckling and crushing (Fig. 5), exposing chop marks (Fig. 7) in spite of fiber radials in the OHT samples. The ultimate failure occurred with a crack passing through the hole in an uneven crack path (Fig. 8a) and with a smaller crack deflection than in the OHT samples.

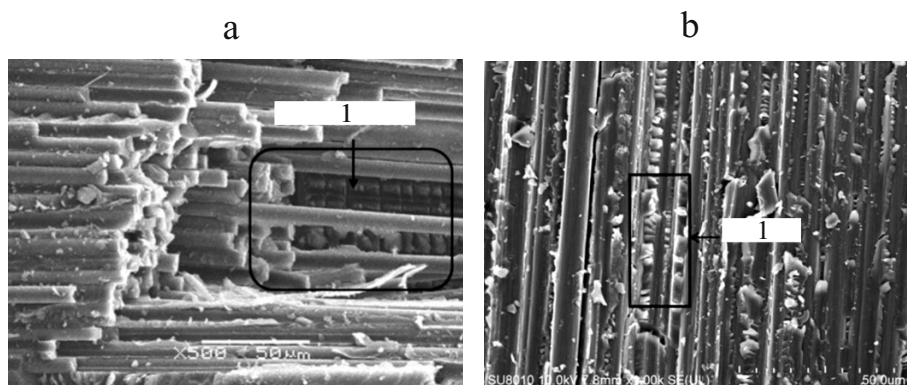
Fig. 3. Shear marks (1) in the resin in OHT (a) and OHC (b) samples.

Meanwhile, with breakage of fibers around the open hole, the load was transferred to the neighboring fibers through the fiber/matrix interface, leaving shear marks both in the OHT and OHC samples. These marks can be seen in Fig. 3. However, it was noticed that they were much less in the OHT samples than in the OHC ones. This indicated that the failure of OHT samples was dominated by the failure of carbon fibers, while in the OHC ones, it was dominated by the failure of both carbon fibers and matrix.

Some of the shear marks originating during the load transfer among carbon fibers in the OHT and OHC samples are presented in Fig. 3. They emerged due to the mismatch between the elastic moduli and strains of carbon fibers and resin. These

marks indicated that the load had been transferred from one layer to another through shearing at the fiber/matrix interface both in the OHT and OHC samples, but their quantity differed. The greater quantity of shear marks in OHC samples pointed to a higher load transfer and higher shear in the OHC samples than in the OHT ones.

applied load). Meanwhile, some part of the load was also transferred to other carbon fiber plies through interlaminar shearing, with the appearance of hackles (shear marks, Fig. 3) in the matrix phase. As the tensile load increased, the fibers in the weak region close to the open hole broke and were pulled out of the matrix (Fig. 4), revealing radial fiber patterns on fiber cross sections (Fig. 6). After reaching the ultimate stress, the samples failed suddenly, exhibiting irregular crack paths with detectable deflections of cracks.

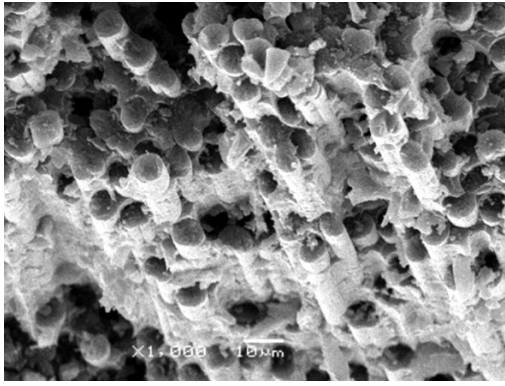
Fig. 4. Fiber pull-outs in an OHT sample.

Significant fiber pull-outs can be observed in the micrograph of an OHT sample shown in Fig. 4. As seen, the carbon fibers are distributed evenly, but the shape, size, and contrast of their cross-sectional images vary over the surface. Some of them are bright and big, signifying that their location was more close to the SEM electron beam, whereas others are dark and small due to their greater distance from the beam. This suggests that fibers broke at different locations (relatively far) due to the pronounced crack bridging and crack deflection mechanisms.

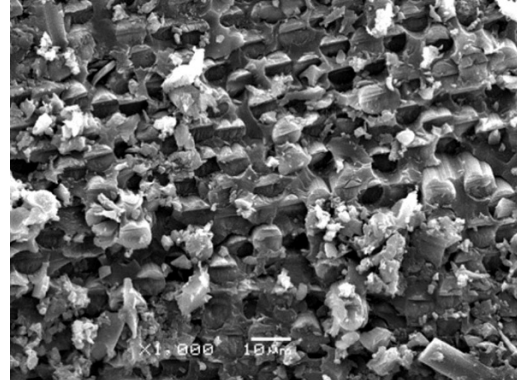
Fig. 5. Microbuckling and crushing of carbon fibers in an OHC sample.

The microbuckled and crushed fibers present in an OHC sample are shown in Fig. 5. As seen, the distribution of carbon fibers in the resin is homogenous, with a similar shape, size, and contrast of their cross-sectional images over the fracture surface. This indicates that the breakage of fibers occurred close to each other, with less pronounced crack bridging and crack deflection mechanisms than in the OHT samples. Significant key features were also observed on a deep and careful examination of the cross-sectional images of carbon fibers (at a higher magnification) in the OHT and OHC samples. These features were different from each other and gave information about the loading conditions of samples which caused their failure, i.e., tensile or compressive. Such information would be of great value in structural failure analyses.

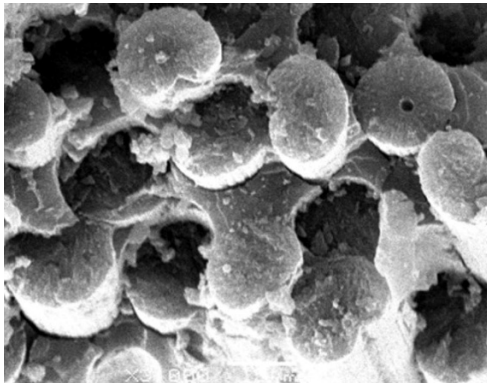
The cross-sectional view of carbon fibers after an OHT test is shown in Fig. 6. The radial patterns of fibers — the key feature of pure tensile fracture of carbon fibers — are seen. These patterns are clearly distinguished on the cross section of individual fibers. They were found in groups and probably had originated at the circumference of fibers under the influence of a combination action of residual stresses in the matrix and the additional stresses arising in the fracture process.

Fig. 6. Radial patterns on the cross section of carbon fibers under tensile loading.

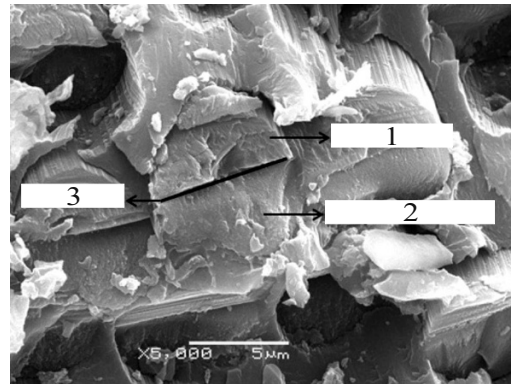
A cross-sectional view of carbon fibers after an OHC test is shown in Fig. 7. A shear crippling due to the microbuckling of fibers caused by the compressive load is observed. The crippling produced the key feature of fracture known as chop marks. Three specific regions of chop marks on fiber ends can also be seen in the Fig. 7. The first is the tensile region, indicated by fiber radials, the second is the compression region, indicated by a flat, often angled, fracture surface, and the third is the neutral axis or line separating the two regions. After reaching the ultimate stress/strength, the OHT and OHC samples both failed spontaneously (in the hole area) without any plastic deformation. The final fracture surfaces and crack paths for the OHT and OHC samples were significantly different.

Fig. 7. Chop marks on the cross section of carbon fibers under compressive loading: 1 — tensile region, 2 — compressive region, and 3 — neutral axis .

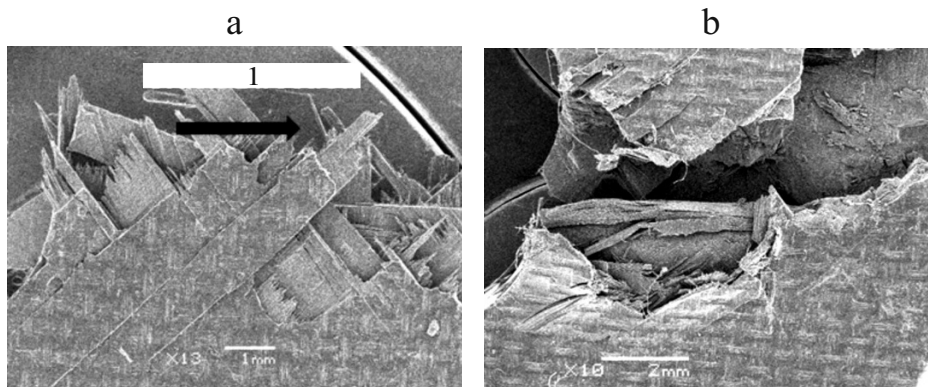
Fig. 8. Photomicrographs of the final fracture and crack path (1) in OHT (a) and OHC (b) samples..

Figure 8 presents a photomicrograph of the final fracture and the crack path for an OHT sample, which was neither smooth (straight) nor heavily splintered. Fibers were broken randomly in an irregular path with cracks deflected along the fiber direction, but only over short distances, pointing to a fairly good interfacial bond between the carbon fibers and epoxy matrix. Some fiber splintering was also noticed.

The final fracture and crack path for an OHC sample is shown in Fig. 8b. The crack paths in the OHC samples were straighter and less jagged than in the OHT ones. Fibers were broken randomly in the form of groups in an irregular path, which was much shorter than that in the OHT samples. Microbucklings due to compression, with almost no individual fiber splinterings, could also be seen.
