ABOUT THE NATURE OF QUASI-CLEAVAGE IN LOW-CARBON STEEL EMBRITTLED WITH HYDROGEN

E. D. Merson,¹ V. A. Poluyanov,¹ D. L. Merson,¹ and A. Yu. Vinogradov²Translated from *Metallovedenie i Termicheskaya Obrabotka Metallov*, No. 3, pp. 53 – 57, March, 2019.

Scanning electron microscopy and confocal laser scanning microscopy are used to study a fracture surface of hydrogen-charged low-carbon steel, which has been deformed in air at room temperature to 12% residual strain and then crushed in liquid nitrogen. It is shown that the quasi-cleavage facets formed during the room-temperature deformation have a strongly curved surface in contrast to the flat cleavage facets formed under the loading in liquid nitrogen. It is inferred that the quasi-cleavage facets in the hydrogen-charged steel do not form by the mechanism of cleavage in the deformed structure.

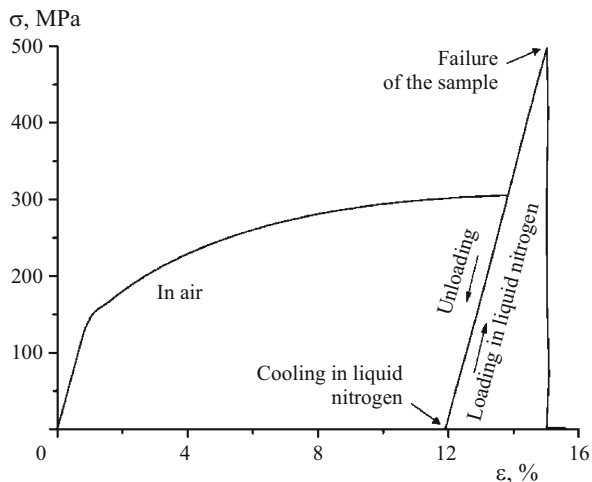
Fig. 1. Diagram of loading of a hydrogen-charged sample by uniaxial tension in air and in liquid nitrogen.

As a result of the mechanical tests by the method described above, we plotted a stress-strain diagram (Fig. 1), from which we may infer that the sample tested in liquid nitrogen has fractured in the range of quasi-elastic deformations without any additional plastic strain. However, when a similar sample was tested in liquid nitrogen without subjecting it to preliminary charging with hydrogen and plastic deformation, the stress-strain diagram exhibited a well manifested yield plateau and a short region of the stage of strain hardening [16].

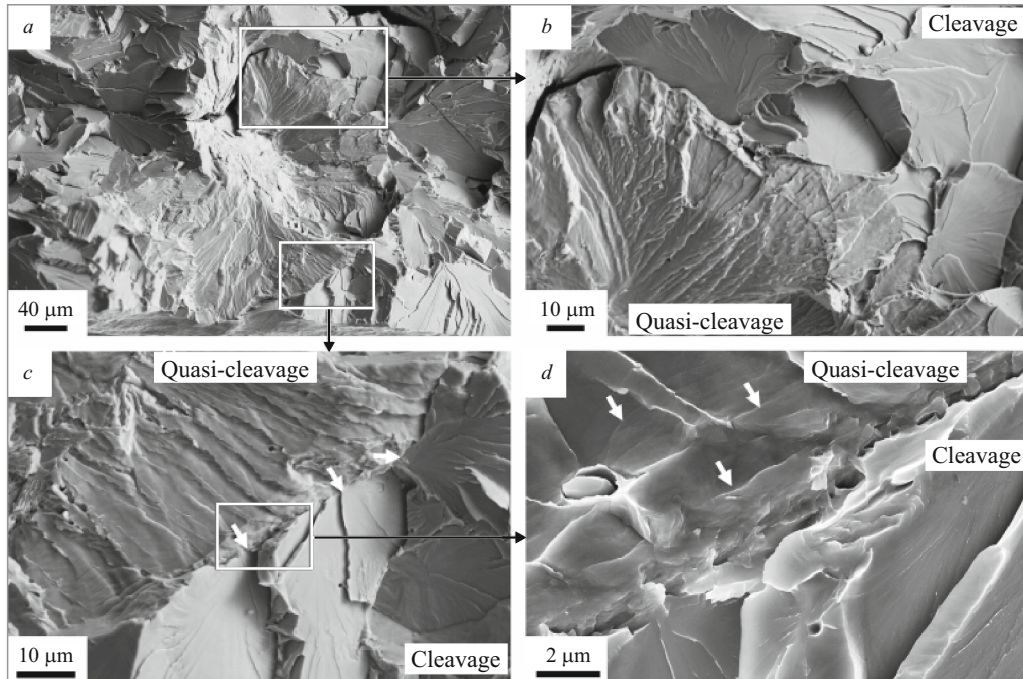
Fig. 2. “Fish eye” flaw with quasi-cleavage morphology surrounded with cleavage facets (SEM): *a*) appearance; *b* – *d*) magnified regions on the cleavage/quasi-cleavage interface; the arrows in Figs. *c* and *d* mark sources of nucleation of cleavage facets and a band perpendicular to the river lines, respectively; *a* – *c*) SE detector; *d*) in lens detector.

Analysis of the fracture surfaces has shown the presence of several “fish eye” flaws in the form of round regions on the fracture surface with faceted quasi-cleavage morphology (Fig. 2a). The orientation of the river lines decorating the surface of the quasi-cleavage facets indicates that the “fish eyes” have formed in a radial direction from the center (Fig. 2a – c). Outside the “fish eyes” the fracture was fully represented by cleavage facets. The images obtained by SEM and CLSM exhibit a well-manifested interface between the “fish eye” flaw and the cleavage surface (Figs. 2 and 3). It can be seen from Figs. 2 and 3 that the quasi-cleavage facets have a different contrast and a much more developed surface relief than the cleavage facets. At the same time, like the cleavage facets, they possess well-manifested boundaries and remind ferrite grains in the microstructure of the steel in the size and in the shape. A distinguishing feature of the morphology of the quasi-cleavage facets is the presence of numerous detachment ridges on their surface and of bands oriented almost perpendicularly to the river lines and resembling fatigue striations (marked with the arrows in Fig. 2d).
