Assessment of hurricane wind performance and potential design modifications for informally constructed housing in Puerto Rico

This study assesses the wind performance of various housing typologies representing informal construction practices in Puerto Rico to suggest modifications to enhance housing resilience in hurricanes. Based on fieldwork and interviews, the study defined four base housing typologies and possible variations in design and construction details. Each house was assessed using performance-based static wind analysis of potentially critical components. The results show that the initial governing failure mode in all base house typologies considered is roof panel loss due to tear-through at the fasteners, with subsequent governing failures being panel loss due to failures at the purlin-to-truss connections and failures of the truss-to-wall connections. In-plane wall failures and masonry uplift failures were both found to occur at much higher wind speeds than roof failures. To improve the hurricane performance, several feasible modifications are suggested, including installing hurricane straps at both the truss-to-wall and the purlin-to-truss connections, as well as im

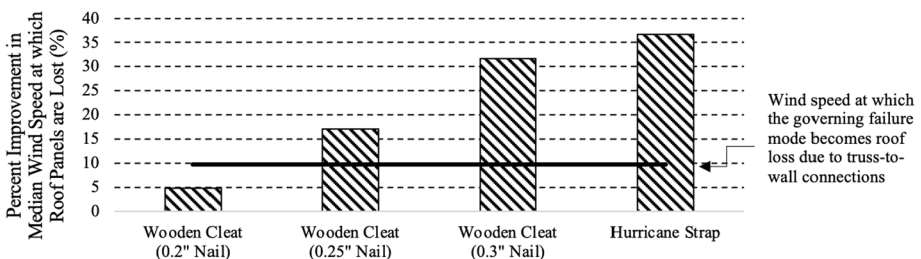
Fig. 5 Changes to median wind speed at which roof covering is lost due to modifications at the purlin-to-truss connection. Note: Percent improvement from the previous case at 92 mph (Base structure: nailed purlin-to-truss connections)

When the panels or the fasteners undergo any one of the changes shown in Fig. 4, panel loss due to the purlin-to-truss connections becomes the governing failure mode. These types of connections were assumed to be nailed in the base typology and can be improved by using a wooden cleat or a hurricane strap at the connection. Cleat performance depends upon the diameter of the nail used in the cleat connections. Figure 5 shows at least a 0.25 inch (6.4 mm) or greater diameter nail in a wooden cleat connection or use of a hurricane strap results in a change in the governing failure mode to the truss-to-wall connection (which occurs at a median wind speed of 101 mph (162 kph)).

Field observations and interviews revealed that some houses with concrete/masonry walls and a wooden roof do not have any truss-to-wall connections at all; the roof just rests atop the walls. In this case, this connection would be the first to fail, and adding a connection, even if it is just a nailed connection, is a top priority for improving the house’s wind performance. Even in houses that do have a nailed connection, these results indicate the improvement of the truss-to-wall connection is a top priority due to the catastrophic nature of this failure that results in the loss of the entire roof structure. Like the purlin-to-truss connection, possible improvements to the truss-to-wall connection include replacing the nailed connection with a wooden cleat connection or a hurricane strap. Relative to a case with a toe-nailed truss-to-wall connection, a wooden cleat performs 36% better, and the hurricane strap performs 62% better.
