Risk evaluation and warning threshold of unstable slope using tilting sensor array

Abstract

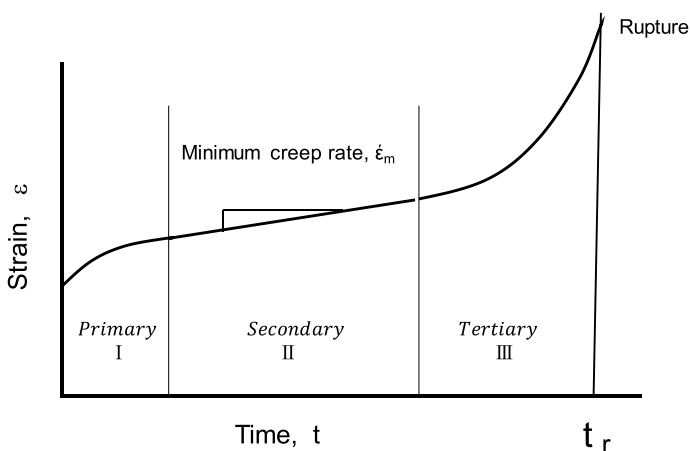
Figures 1 and 2 show the concept of the creep-rupture curve, which exhibits a relationship between the strain caused by creep and time for almost solid material. This diagram classifies the entire process into three stages, which are the primary stage wherein the strain rate decreases with time, the second stage wherein the strain rate is kept constant, and the tertiary phase wherein the creep rate quickly increases until the final failure. The tertiary

Fig. 1 Conceptual sketch of relationship between strain and time remaining until failure

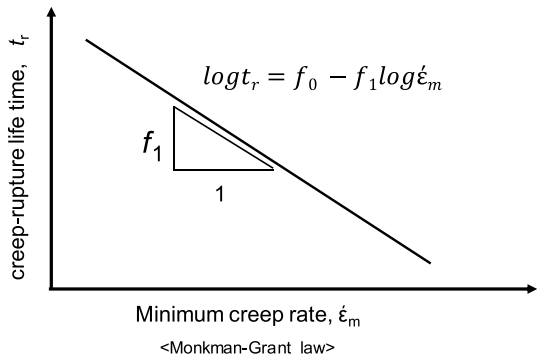
Figure 3 illustrates the idea of this relationship.

Fig. 3 Relationship between creep time remaining until failure and a minimum rate of creep strain based on Monkman–Grant relationship (Monkman–Grant relationship 1956)

phase of this diagram shows that, as time passes, the creep rate increases while the time until failure decreases. The change of the strain rate with time is schematically shown in Fig. 2. The material behavior shown in Fig. 3 is called the Monkman–Grant relationship (1956) and may be useful in predicting the remaining lifetime (time until failure, t_r) from the observed creep deformation rate, $d\epsilon/dt$.

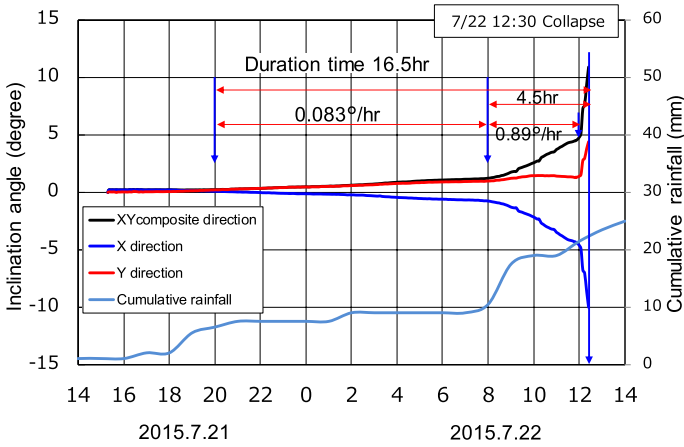
Fig. 8 Time histories of monitored data at Fukuoka site

Figure 8 shows the plot of the tilt angle and the rainfall data on July 21st and 22nd, shortly after the main slope collapse. The slope was considered to be prone to further failures during the restoration works. From 4 to 8 PM on July 21st, that is, immediately after the tilt sensor installation, the tilting rate of $0.083^\circ/\text{hour}$ was recorded and continued until 8 AM on July 22nd. Thereafter, the tilting rate accelerated to $0.89^\circ/\text{hour}$, possibly owing to rainfall amounting to approximately 10 mm from 8 to 9 AM. Furthermore, owing to further rainfall after 11 AM, the tilting rate sharply increased to $12^\circ/\text{hour}$ after 12 PM and the slope finally collapsed at 12:30 PM. Thus, the field monitoring helped control the traffic during the critical period and ensured the safety of human life.

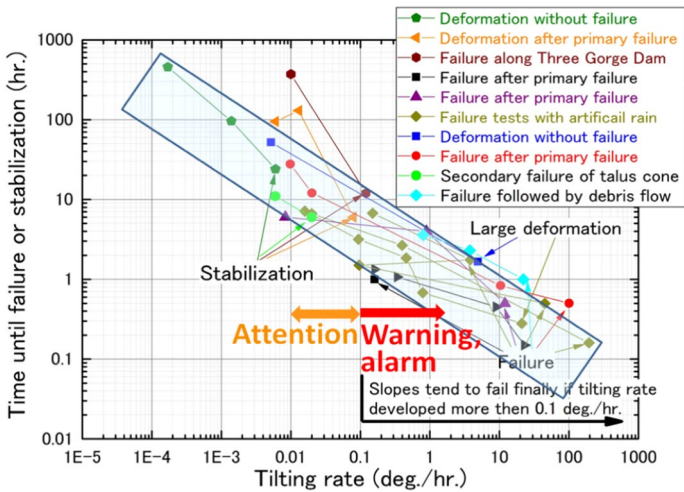
Fig. 9 Tilting rate varies with time until slope failure or time of stabilization (summary of several case histories)

Uchimura et al. (2015) summarized the tilting rates monitored at several natural slopes subjected to heavy rainfall. Figure 9 shows the sets of the tilting rate and time remaining until failure. This data group is placed in the right half of the Fig. under the indication “large deformation” or “failure”. Another group of data was obtained from cases wherein the tilting rate was small and the movement was stabilized without failure (see “stabilization” group). Figure 10 shows the detailed definitions of the tilting rate and time, where T_i is the time until failure or stabilization, and R_i is the tilting rate. When the slope failed, “time” means the time that elapsed from measurement until failure. Conversely, when failure did not occur, “time” means the time between measurement and stabilization.

Based on practical experience at many sites with and without failure, Fig. 9 presents information over a wide tilting rate range from $0.0001^\circ/\text{h}$ to $10^\circ/\text{h}$. Obviously, a higher tilting rate is associated with less time until failure, which suggests that urgent evacuation is required. When the tilting rate exceeds $0.1^\circ/\text{h}$, the time remaining until failure is one hour at minimum. Therefore, the authors (2015) recommend that a warning and evacuation order should be issued at this tilting rate. Moreover, precaution may be issued at a tilting rate of $0.01^\circ/\text{h}$ to ensure safety, because the time left until failure will be several hours or longer.

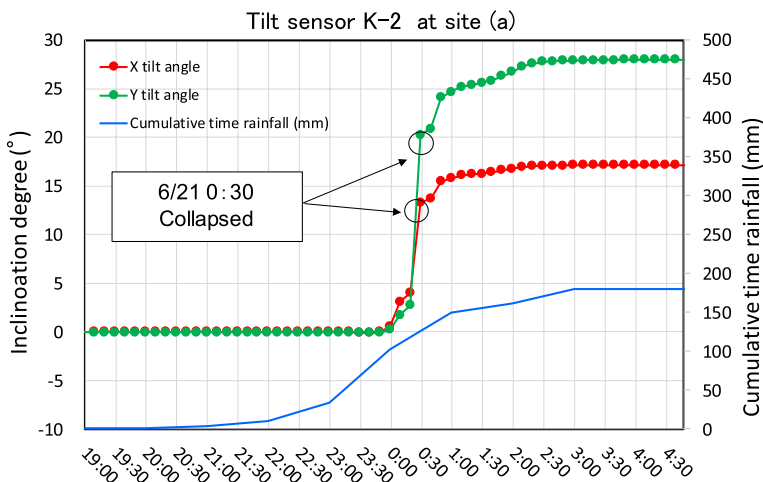
Fig. 14 Tilting and rainfall records at monitoring site (a) in Kumamoto (June 20–21, 2016)

behavior through the wireless sensor (Fig. 14), a caution alert and subsequently a warning alert was automatically issued. Eventually, the slope failed.

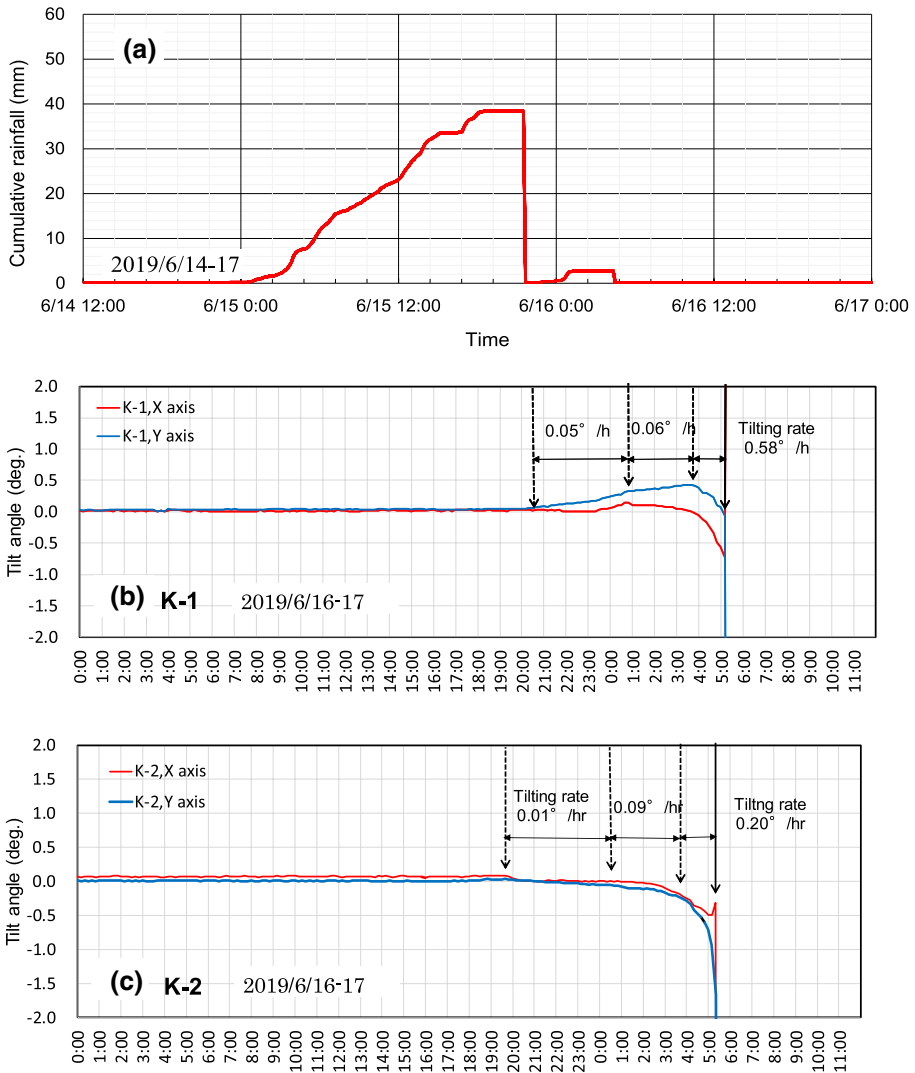
Fig. 17 Recorded cumulative rainfall and tilt angles at sensor K-1 and K-2 at the site shown in Fig. 16 (June 15th and 16th)

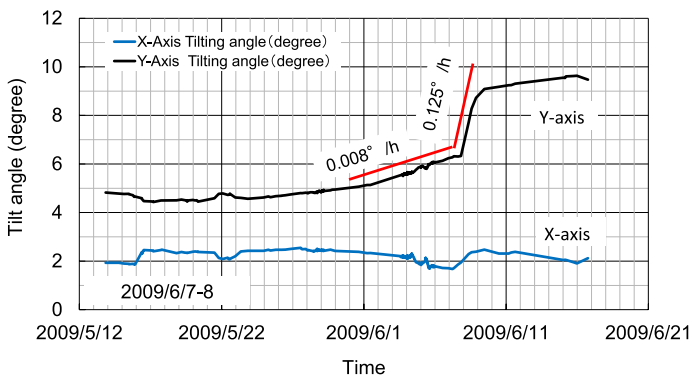
Fig. 21 Time histories of tilting angle obtained by sensor unit 2 at Sai Wan Ba

The slope monitoring resumed in October 2008. Heavy rainfall that occurred on June 7 and 8, 2009, caused significant displacements in the monitored landslide bodies including the position of the sensor unit 2. The time history of the tilting angles of the pole in the X and Y directions is shown in Fig. 21. During rainfall events, the tilting angles gradually increased, and the tilting angle in the Y-axis reached 5° at the beginning of June 2009. The positive values of the tilting angle in the Y direction mean that the pole tilted toward the top of the slope. In contrast, the X component of the tilting angle that was oriented in the lateral direction of the slope had relatively smaller values. During this event, the rate of the Y tilting angle was 0.125°/h, while the rate just before this event was approximately 0.008°/h. This quick behavioral change was induced by the ongoing landslide.

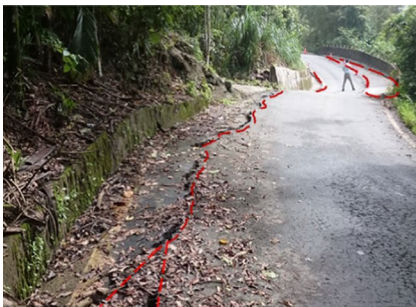
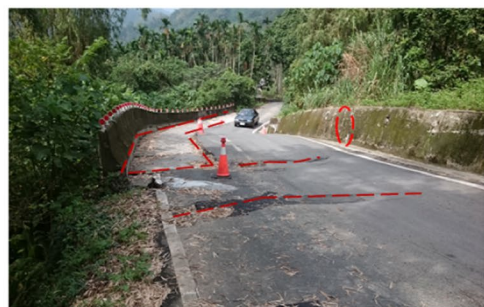
(a) Cracks on road pavement

(b) Lateral translation of retaining wall

Fig. 23 Cracks in the road surface and lateral translation of retaining wall on side of national route No.135–2 in Taiwan

The pavement cracks and translation of the retaining wall along the national route No.135–2 are shown in Fig. 23. The traffic was stopped when these problems were detected. Figure 24 presents the results of the combined XY inclination value and daily rainfall at tilt sensor T9 located at the top of the slope, which is close to the retaining wall where many cracks and lateral displacement were detected. It is still unclear why the tilting angle shown in Fig. 24(a) remarkably increased in the middle of August and September, and after the end of October when the local rainfall was negligible. The possible reason for this is that the underground hydrology delayed the rainfall effects, but this was not confirmed. Notably, Fig. 24 shows that slopes may start to move regardless of the antecedent rainfall.

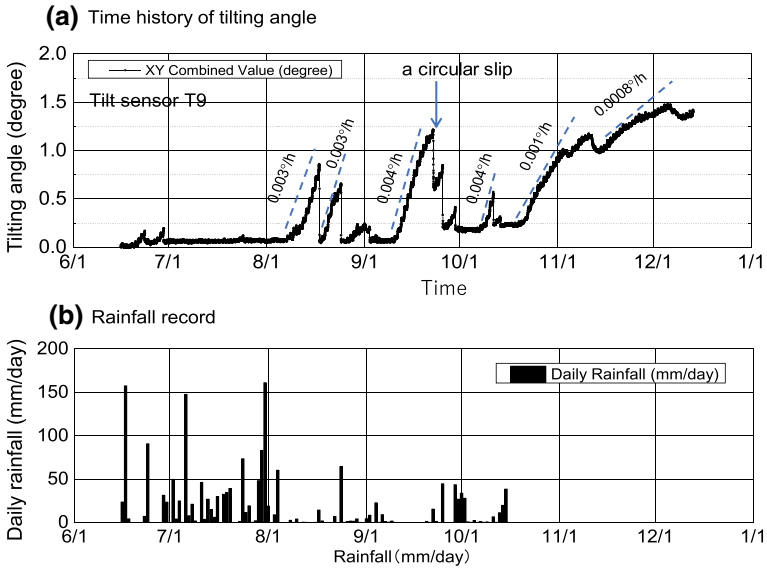
Fig. 24 Inclination value and daily rainfall of tilt sensor T9 on top of Zhongpu slope site close to national route No.135–2 in Taiwan

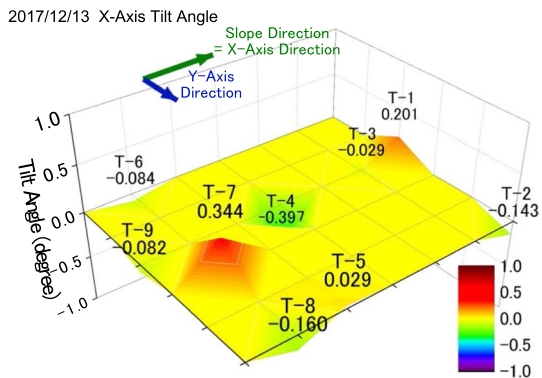
Fig. 25 Distribution of tilt angle at X-axis (slope) direction close to national route No.135–2 in Taiwan **a** Sensor locations at the slope in Queensland, Australia (X denotes downslope direction) **b** Cross-section from GPR profile showing the position of white clay/bedrock reflector (dashed line)

One of the advantages of multi-point monitoring is the three-dimensional view of the slope deformation, which is shown in terms of the distribution of the sensors’ tilt angle in the slope gradient direction (Fig. 25). Throughout the monitoring period of six months, the head (Sensor T-9) and bottom (Sensor T-1) of the slope exhibited a larger inclination toward the bottom of the slope, while substantial tilting was observed in the opposite direction (toward the top of the slope) in the middle part (Sensor T-4). This feature was also observed in other slopes, as will be discussed later, and maybe an interesting feature of slope instability. Hence, it is thought that slope failure was unlikely because the cumulative tilt angles (0.201° at T-2, -0.394° at T-4, and 0.082° at T-9) did not exceed 1° . Moreover, at all sites, the tilting rate did not exceed the $0.01^\circ/h$ threshold for issuing a caution alert. Thus, the failure of this slope was unlikely, but the slope movement did not stop and the monitoring had to continue.

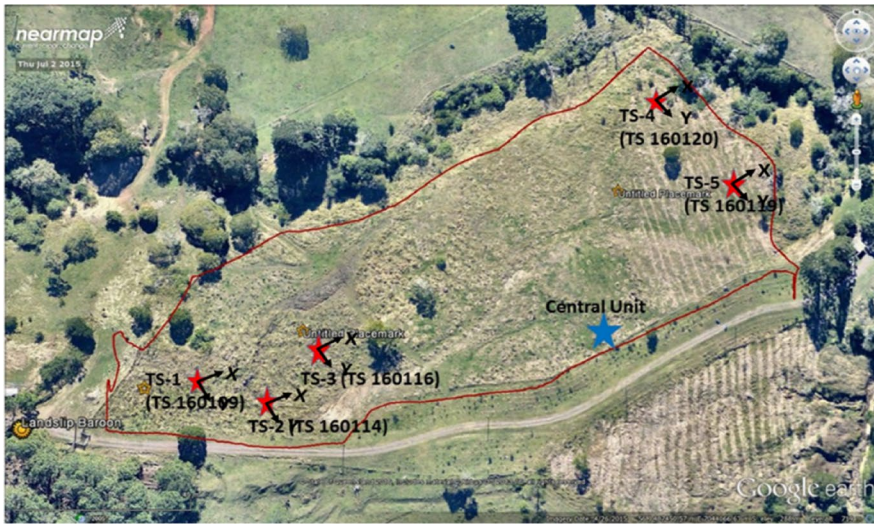
(a) Sensor locations at the slope in Queensland, Australia (X denotes downslope direction)

(b) Cross-section from GPR profile showing the position of white clay/bedrock reflector (dashed line)

Fig. 26 Site of slope monitoring in Queensland, Australia (Abeykoon et al. 2018, 2019)

A real-time monitoring system comprising five sensor units (TS1, TS2, TS3, TS4, and TS5) and a central logging station was installed on the slope as shown in Fig. 26. Each sensor unit comprised its own logging and transmission unit, a MEMS tilt sensor, volumetric soil moisture sensor, and temperature sensor.

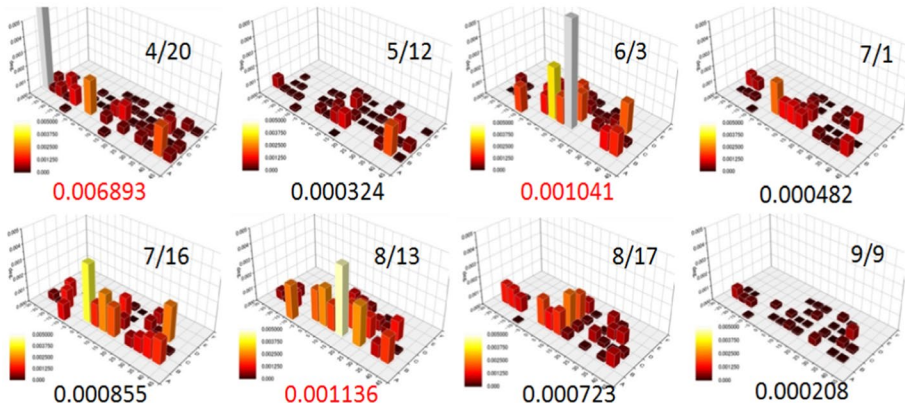
Fig. 33 Distribution of tilting rates during each rainfall day at the Manzawa site

The distribution of the accumulated tilt angle over the monitored area is shown in Fig. 32, and its local variation is obvious. The rate of tilting during the respective precipitation events is shown in Fig. 33. The precipitation events on April 20, 2017, June 3, 2017,

and August 13, 2017, caused relatively higher tilting rate values, but these values did not exceed the precaution threshold of $0.01^\circ/\text{hour}$. Another issue is that a higher tilting rate occurs at different points during different precipitation events, as revealed by comparing the data obtained on April 20 to those obtained on June 3 and August 13. During the two-year field validation, there was no significant change in the tilting angle, and no alert was issued. Thus, the slope was assessed as stable.

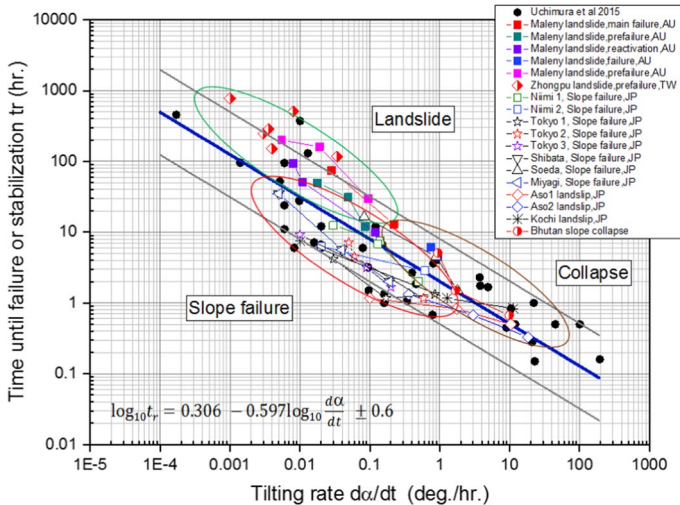
Fig. 34 Relationship between time remaining until failure and tilting rate based on field monitoring

Table 2 and Fig. 34 summarize the results of the authors’ slope monitoring projects since 2004, which have considered landslides, slope failure, collapse, and field experiments (Uchimura et al. 2015). The authors define landslides as events that require months or years until failure, slope failures as events that require days or weeks until failure, and collapses as events that only require hours until failure. Thus, the case of rainfall-induced slope failure is classified as a collapse. As previously mentioned, the brief amount of time until failure makes it difficult to select a relevant monitoring method. While the overall trend of the obtained data in Fig. 34 is similar to the Monkman–Grant model (Fig. 3) and the authors’ previous empirical diagram (Fig. 9), it is further proposed that three different failure times may affect the plotted relationship.

In line with Eq. 1, the authors approximate the data in Fig. 34 using Eq. 3:

where t_r denotes the time remaining until failure (hours) and $d\alpha/dt$ denotes the rate of the tilting angle (degree/hour). The prediction using Eq. 3 is indicated by the solid black line in Fig. 34. To further improve the time prediction, the following measures are considered:

To implement these measures, a more extensive case history is required. At this moment, the different slope displacement rates in Fig. 34 suggest the following:

- i) Landslides have sufficient time until failure, and emergency caution and warning alerts are appropriate measures.
- ii) The failure of surface sediments (slope failure in Fig. 34) has several hours until failure if a warning is issued when the rate is 0.1°/hour.
- iii) Collapse occurs suddenly and practical experience suggests that failure occurs within one hour or less. Hence, evacuation is not feasible and the reinforcement of the slope in advance using rock bolts, and so on, is advisable.
