SURFACE-INTERFACE MICROSTRUCTURES AND FRICTION-WEAR PERFORMANCES OF THERMAL SPRAYED FECRBSI COATINGS OBTAINED BY HIGH-VELOCITY OXYGEN FUEL PROCESS

A layer of FeCrBSi coating was prepared on H13 hot work steel using a high-velocity oxygen fuel spraying (HVOF). The morphologies and distribution of chemical elements and phases in the obtained coatings were analyzed using a field emission scanning electron microscopy (FMSEM), energy dispersive spectrometry (EDS), and X-ray diffraction (XRD), respectively. The friction-wear performance of FeCrBSi coating was examined using a wear test, and the wear mechanism was also discussed. The results show that the coating is primarily composed of Fe, Cr, B, and Si elements, which are uniformly distributed in the coating, enriched in the coating, and poor in the substrate at the coating interface. Among them, the Fe content decreases gradually in the substrate-coating direction, the Fe content of the coating is 40% lower than that of the substrate. The Cr, B, and Si contents in the coating are higher than those in the substrate, which form compounds and diffusion at the interface; as a result, the coating is combined with the substrate in the form

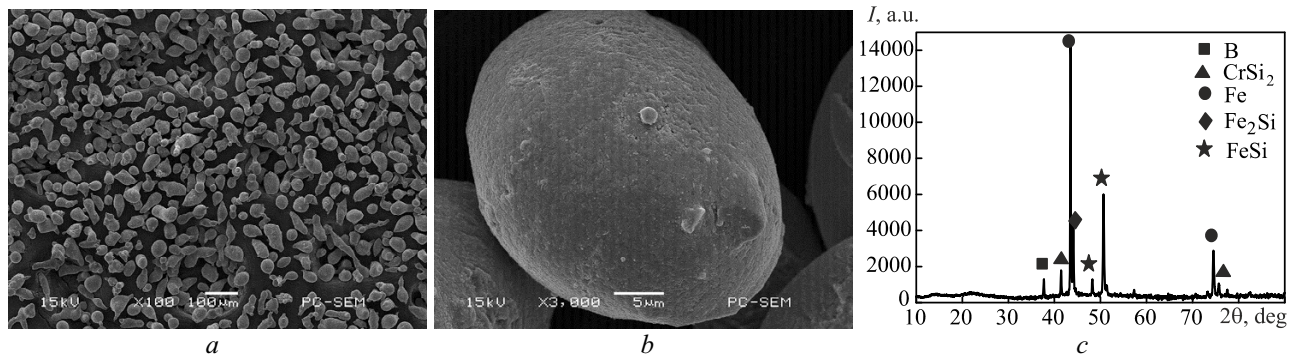
Morphologies and XRD Analysis of Powder. Figure 1a shows that the particle sizes of FeCrBSi powder were consistently and uniformly distributed. In Fig. 1b, the FeCrBSi powder was presented with a nearly ball, the skeleton was CrBSi particles, and Fe was the binder. The particle diameter was 50–95 μm, which was not stick with the spraying equipment or other particles, and the dense particles reduced friction effect and increased the particle flow properties in the spraying process. From Fig. 1c, it can be seen that the main phases of the powder were composed of B, CrSi₂, Fe, Fe₂Si, and FeSi, with no other impurities.

Fig. 1. Morphologies and XRD analysis of FeCrBSi powder: a) low magnification, b) high magnification, and c) XRD analysis

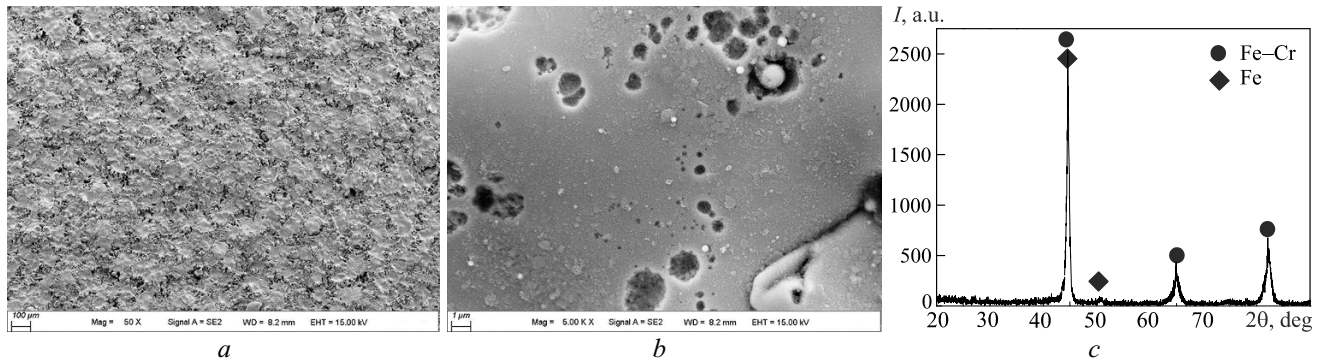
Figure 2a shows that the FeCrBSi coating was relatively flat, the roughness of the obtained coating was 0.8 μm, higher by 0.4 μm than that of the substrate, which had a certain effect on wear performance of the coating. The melting effect of sprayed powders was well; there were no obvious convex peaks and pits. Because the powder feeding was relatively large in the spraying process, the powder particles did not turn into a molten state completely, and some part of the powder particles was directly embedded in the sprayed surface with the original particle state. The small holes were unmelted particles falling off from the coating, which had a few effects on the coating performance, as shown in Fig. 2b. The primary phases of the coating were composed of Fe–Cr and Fe phase;

Fig. 2. Surface morphologies and XRD analysis of FeCrBSi coating: a) low magnification, b) high magnification, c) XRD analysis

as shown in Fig. 2c, the B and Si phases were not detected due to the low contents. The hardness of the obtained coating measured by using a HXD-1000TMC type Vickers microhardness tester was 600 HV, which was higher by 120 HV than that of the substrate.

EDS Plane Scan Analysis of Coating Surface. The FeCrBSi coating surface in Fig. 2a was analyzed using a plane scan, the result is shown in Fig. 3a. The weight contents of chemical elements (wt.%) were as follows: 32.57 C, 11.05 O, 0.85 Si, 10.88 Cr, 45.65 Fe; and atomic contents (at.%): 61.57 C, 15.69 O, 0.68 Si, 475 Cr, 17.38 Fe. The Fe, Cr, Si, O and C elements were evenly distributed, as shown in Fig. 3b–f. There was no atom-rich and atom-poor regions, which was conducive to improving the integrity and wear performance of the coating. The Cr and C contents in the coating were high, resulting in a large number of carbides such as Cr_{23}C_6 and Cr_7C_3 ; among them, the microhardness of Cr_7C_3 reached 1450 HV, which was the primary hard phase of the coating. The coating structure was Fe–Cr solid solution, dispersing the hard phases of Cr_{23}C_6 and Cr_7C_3 with good thermal stability, which protected the substrate from oxidizing.

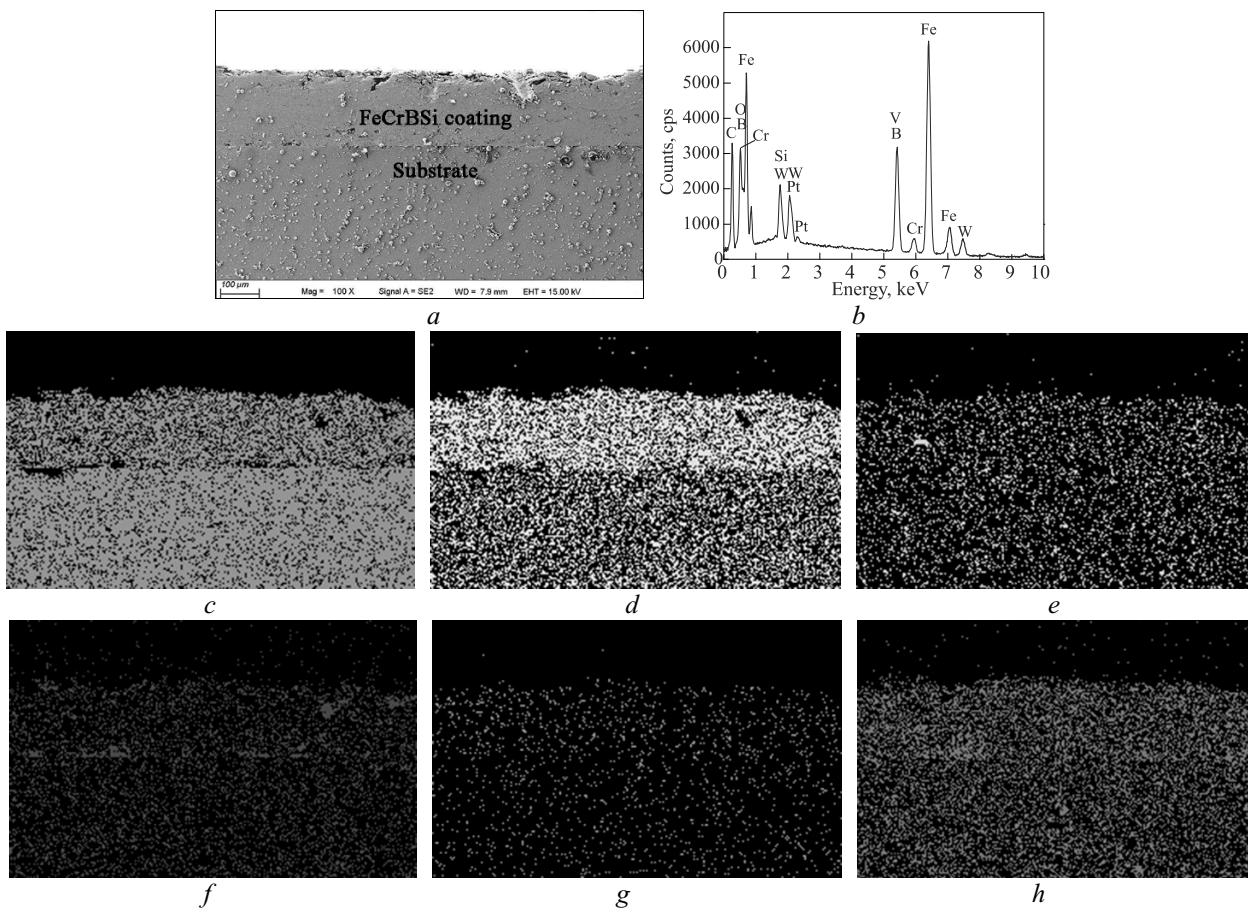
EDS Plane Scan Analysis of Coating Interface. Figure 4a shows the plane scanned position of the coating interface, the coating microstructure was uniform and was bonded closely with the substrate, no obvious cracks. Only a small number of porosities existed, and the layered structure of the coating was not very obvious. The result of plane scan analysis is shown in Fig. 4b; the weight contents of chemical elements were as follows (wt.%): 28.83 C, 6.05 O, 0.28 Al, 0.87 Si, 0.28 S, 0.42 V, 674 Cr, 54.97 Fe, 1.57 W; and atomic contents (at.%): 60.67 C, 955 O, 0.26 Al, 0.79 Si, 0.22 S, 0.21 V, 3.27 Cr, 24.86 Fe, 0.22 W. The peak of Fe element was the highest, and that of C, Cr, B, and Si elements was high, which indicated that the coating interface was primarily composed of Fe, C, Cr, B, and Si elements. The Fe element was uniformly distributed at the interface, which was the same content at different depths, as shown in Fig. 4c. The divided line was not obvious between the coating and the substrate, indicating that the mechanical bonding was good at the interface. The Cr content in the coating was high, as shown

Fig. 4. Plane scan analysis of FeCrBSi coating interface: a) interface morphology, b) result of plane scans, c) Fe content, d) Cr, e) B, f) Si, g) O, and h) C content

in Fig. 4d, playing a role of binder in the thermal spraying process. Figure 4e shows the distribution of B elements: B was also uniformly distributed at different depths, and the coating and the substrate at the interface had a certain content of B. Figure 4f shows the distribution of Si element; during oxidation of the substrate surface, the Si element appeared in the atom-rich region on the substrate surface and generated Fe_2SiO_4 with Fe of the substrate, embedding in grain boundaries of the substrate surface, which improved bonding strength of the coating and the substrate. Figure 4g shows the distribution of O element at the interface; there was no atom-rich phenomenon, showing that the oxidized elements were fewer in the spraying process, and the effects on the interface were small. Figure 4h shows the distribution of C element, the coating and the substrate had a certain content of C.

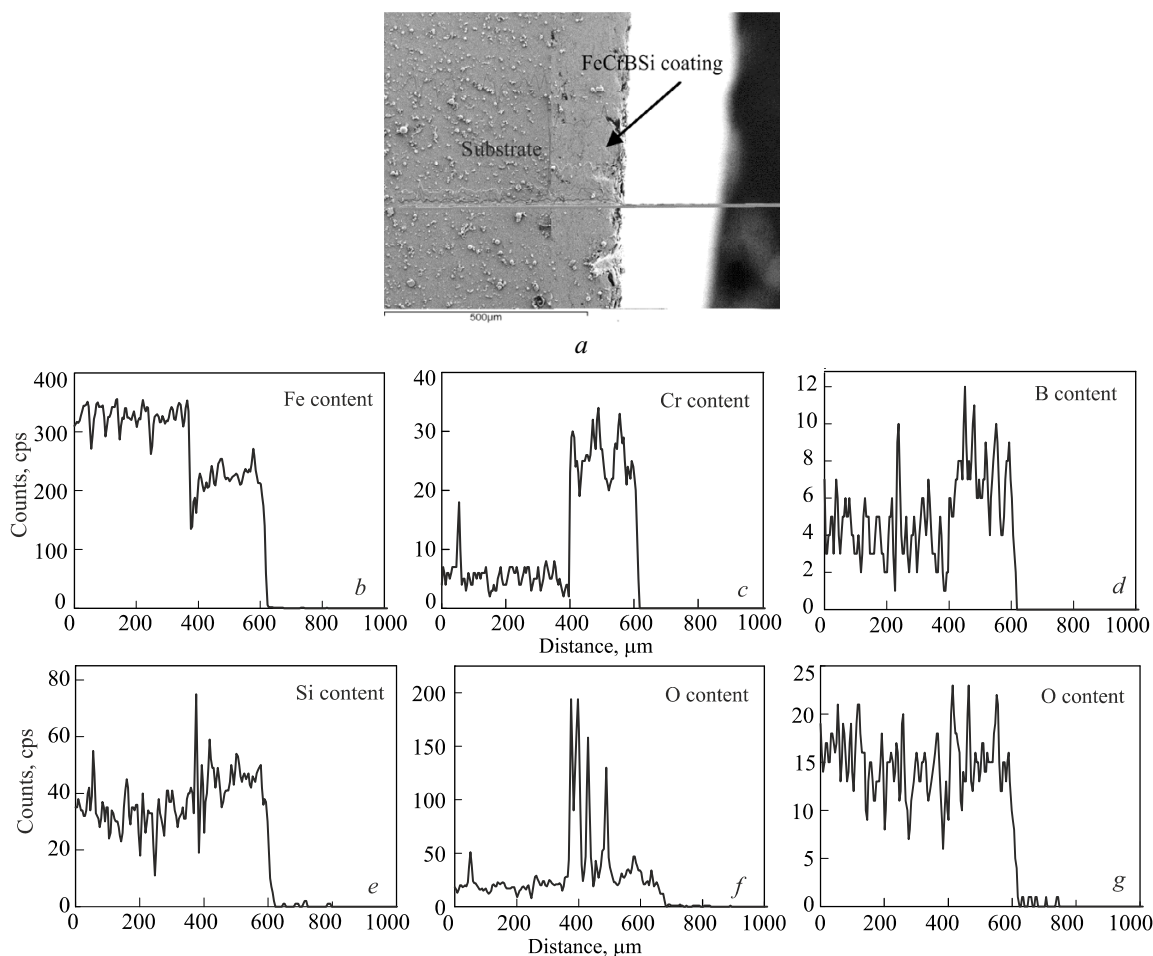
EDS Line Scan Analysis of Coating Interface. Figure 5a shows the line scanned position of the FeCrBSi coating interface. As seen from Fig. 5b, the Fe element showed a decreasing trend in the direction from the substrate to the coating and the Fe element in the substrate did not diffuse into the coating. Figure 5c shows the line scan distribution of Cr element at the interface; the Cr content in the coating was high, and produced the diffusion into the substrate. Figure 5d shows the line scan distribution of B element at the interface; the B content in the coating was high, and that in the substrate was low, there was no diffusion phenomenon. Figure 5e shows the line scan distribution of Si element at the interface; the Si content gradually reduced in the direction from the coating to the substrate. Figure 5f shows the line scan distribution of O element at the interface, the O content in the coating was almost the same as that in the substrate. Figure 5g shows the line scan distribution of C element at the interface; the O element almost existed in the substrate, no C in the coating.

The Cr content at the interface was high; this was because a part of FeCrBSi reacted with O_2 to form oxides in the spraying process, the O content at the interface was significantly higher than that of the coating and the

Fig. 5. Line scan analysis of FeCrBSi coating interface: a) interface morphology, b–g) elements content

substrate. The Cr, Si, and B contents decreased slowly from the coating to the substrate, the descent gradient at the interface was relatively small and no mutant, indicating that there was thermal chemical reaction and element penetration phenomenon at the interface, and Cr, Si and B of the coating appeared to obviously diffuse to the substrate. The Fe content slowly increased from the coating to the substrate, and slow transition occurred at the interface, which indicated that Fe of the substrate had certain diffusion to the coating. From the curves of line scan analysis, the Fe, Si, and B elements had gradually decreased, indicating that these elements diffused into the substrate, which had homogenizing effect on the coating microstructures and improved the bonding state at the interface by forming metallurgical bonding.

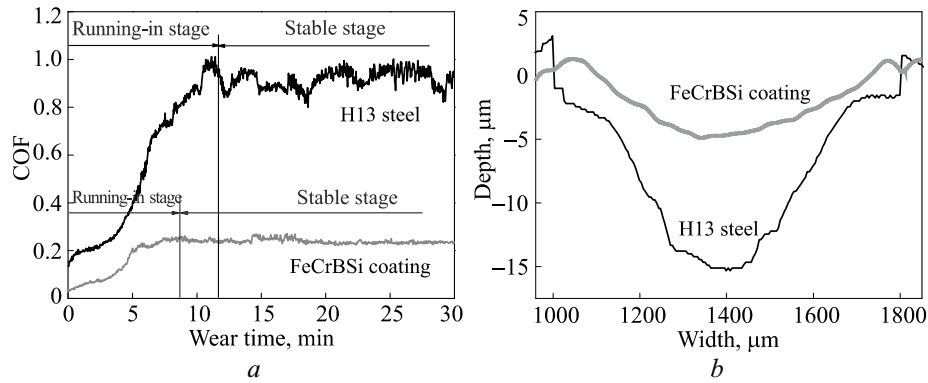
Fig. 6. COFs vs wear time and wear profile: a) COFs vs wear time, b) wear profile

COFs and Wear Profile. The average COF of H13 steel was 0.7692, while that of the coating was only 0.2126, decreased by 72%, as shown in Fig. 6a, which indicated that the FeCrBSi coating had good friction resistance. The wear process of the coating was divided into running-in period and normal wear period.

During the running-in period (0–8 min), the COFs of the coating were small, and the average COF was 0.1391. This was because the contact surface between the micro convex body and the wear debris gradually increased with increasing wear time; therefore, the COFs were also shown as an increasing phenomenon. With

friction continuing, the worn particles migrated to maintain a balance, the friction tended to be stable [13]. After entering normal wear period (8–30 min), the average COF was 0.2394, and the value was small. The wear depth of H13 steel was 15.33 μm , while that of the coating was only 4.89 μm , decreased by 68.1%, as shown in Fig. 6b. The wear rate of H13 steel and coating was $4.7 \cdot 10^{-6} \text{ mm}^3/\text{sec} \cdot \text{N}$ and $1.5 \cdot 10^{-6} \text{ mm}^3/\text{sec} \cdot \text{N}$, respectively, indicating that the wear resistance of FeCrBSi coating was significant.

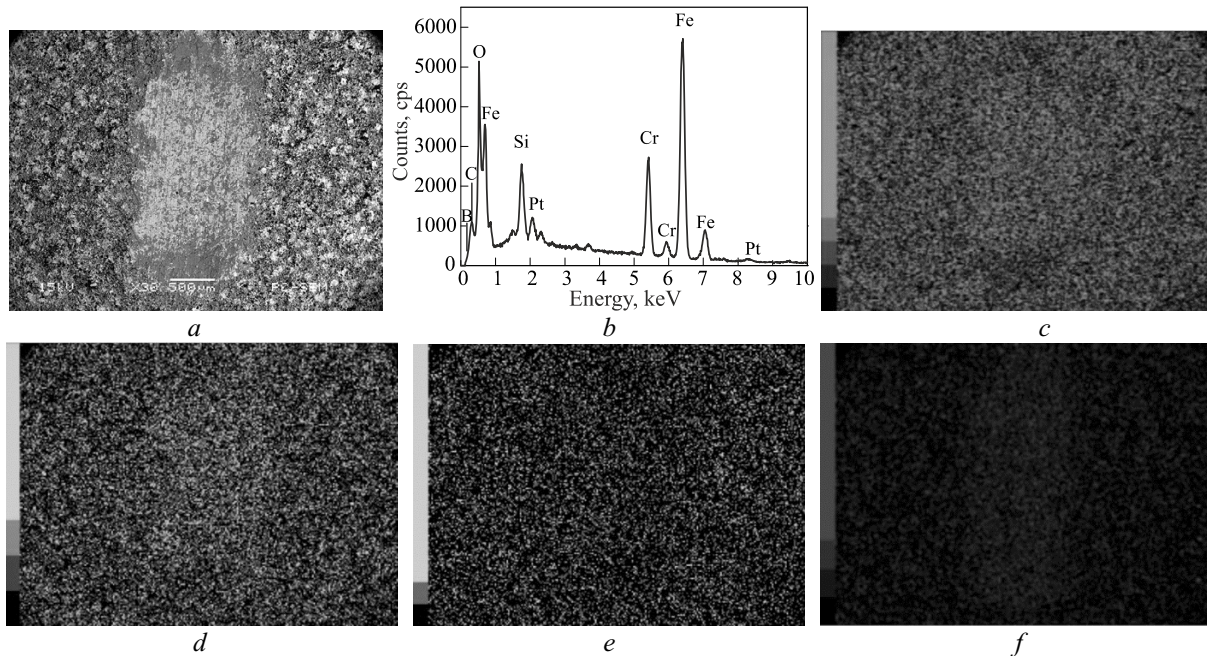
Fig. 7. Plane scan analysis of worn track on FeCrBSi coating: a) position of plane scan analysis, b) result of plane scan analysis, c) Fe content, d) Cr content, e) B content, f) Si content

Worn Morphologies. The plane scanned position of the coating is shown in Fig. 7a, the surface of worn track was relatively flat. The weight contents of chemical elements were shown as follows (wt.%): 74.30 Fe, 16.33 Cr, 0.44 B, 1.88 Si, 0.67 C, 6.39 O; and atomic contents were shown as follows (at.%): 60.90 Fe, 14.45 Cr, 0.64 B, 3.08 Si, 2.55 C, 18.39 O. The Fe, Cr, and B elements on the worn track were uniformly distributed and did not produce the atoms-poor region, as shown in Fig. 7c–e. Compared with the element distribution on the coating surface, the element distribution in the worn track did not change significantly, which indicated that the friction process was stable and consistent with the test results of COFs in Fig. 6a. The Si element on the worn track produced the atom-rich region, as shown in Fig. 7f, which was due to the sticking of Si elements from ceramic balls on the worn track.

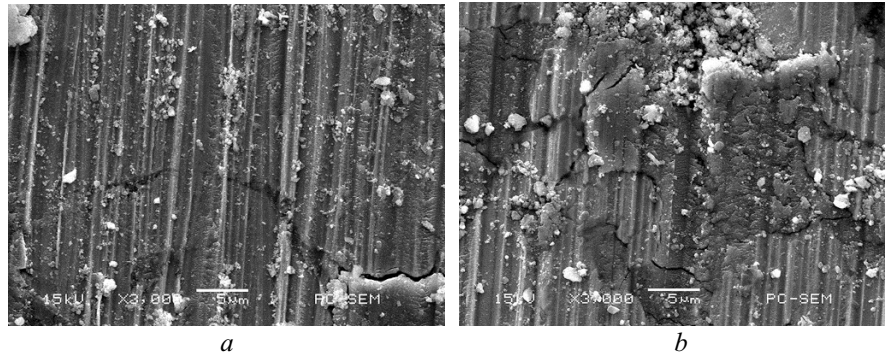
Fig. 8. Worn morphologies of FeCrBSi coating: a) abrasive wear, b) spalling

The wear of the coating was more serious; there was obviously a wide and deep worn track, presenting the mechanism of abrasive wear, as shown in Fig. 8a. At the same time, the coating surface appeared to have serious cracks and peeling phenomenon, as shown in Fig. 8b. This main source was shown as follows [14, 15]: i) the boride hard phase fell off from the coating under the action of frictional load; ii) the residual stresses produced microcracks, resulting in brittle falling off during HVOF spraying; iii) the oxide film generated in the process of wear appeared to show brittle spalling.

Therefore, the wear mechanism of the coating primarily consisted in abrasive wear and spalling.
