# In-situ Investigation of the Onset of Cavitation Damage from Single Bubbles on Technical Alloys

**Keywords** In-situ microscopy · Cavitation erosion · Single-bubble cavitation · Wear testing

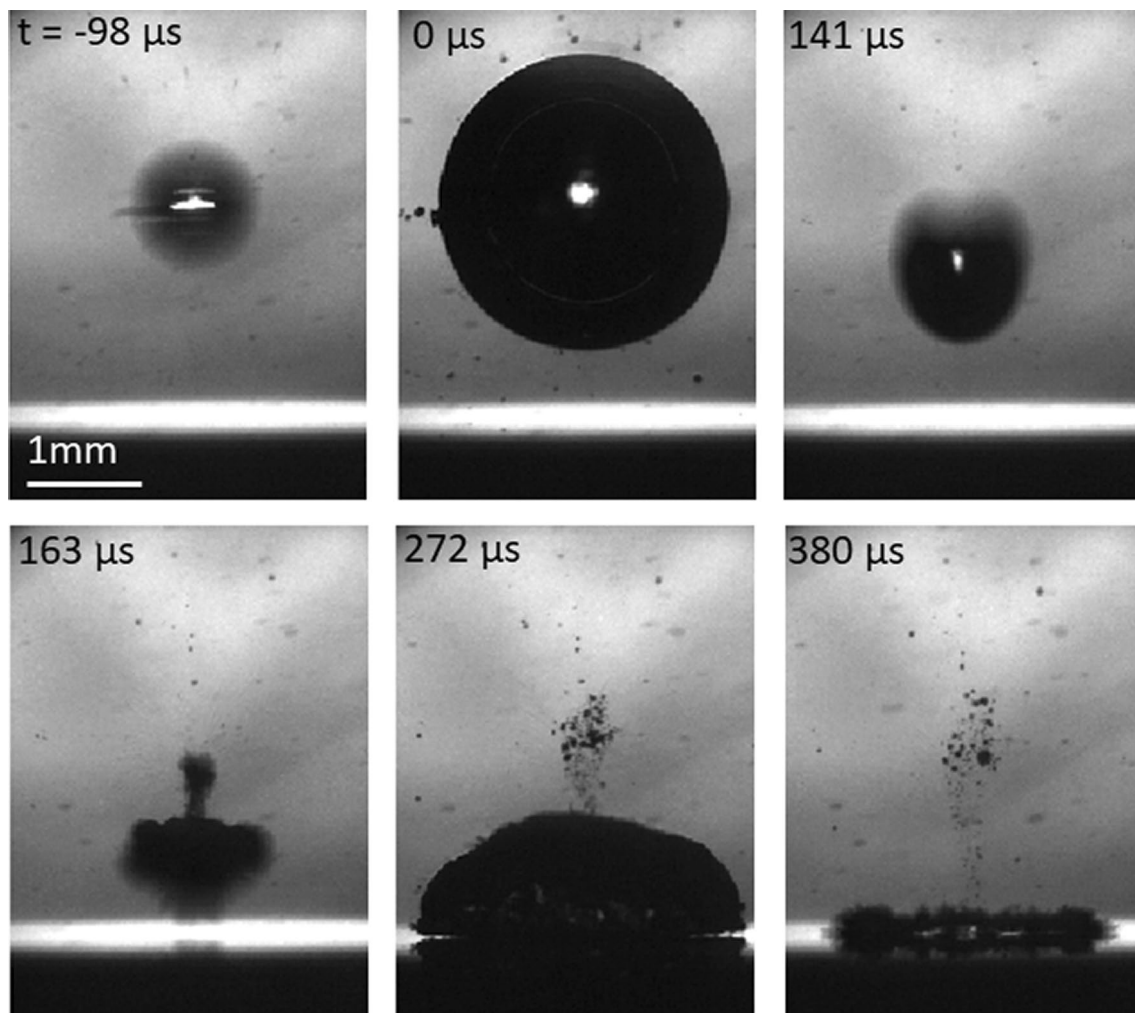
**Fig. 2** Selected frames from an example recording of the dynamics of a 2.5 mm diameter bubble at  $\gamma = 1.4$ . Time zero is defined here as the time of maximum bubble diameter. The laser incident is from the left

It is well-known that the dynamics of a bubble collapsing near a surface are strongly influenced by the stand-off distance  $\gamma$  [27, 28]. Most of the current experiments were performed at  $\gamma = 1.3$  to 1.4, a range for which a relatively complex damage pattern occurs, as will be seen below. An exemplary bubble collapse for  $\gamma = 1.4$  is shown in Fig. 2. As in all images in this paper, the laser is incident from the left. The first frame at  $t = -98 \mu\text{s}$  shows the plasma (whereas the central bright spot at later times is from the LED back-illumination) and the start of the formation of the bubble. After 98  $\mu\text{s}$  the bubble reaches its maximum diameter. It collapses towards the surface and is pierced by a downward liquid jet [28]. The rebound and the second collapse in Fig. 2 at 272  $\mu\text{s}$  and 380  $\mu\text{s}$ , respectively, occur in a toroidal shape very close to the solid surface. Note that the reflection of the bubble shadow on the polished sample surface helps locate the sample surface with respect to the bubble. The small dark spots throughout the image are attributed to bubbles

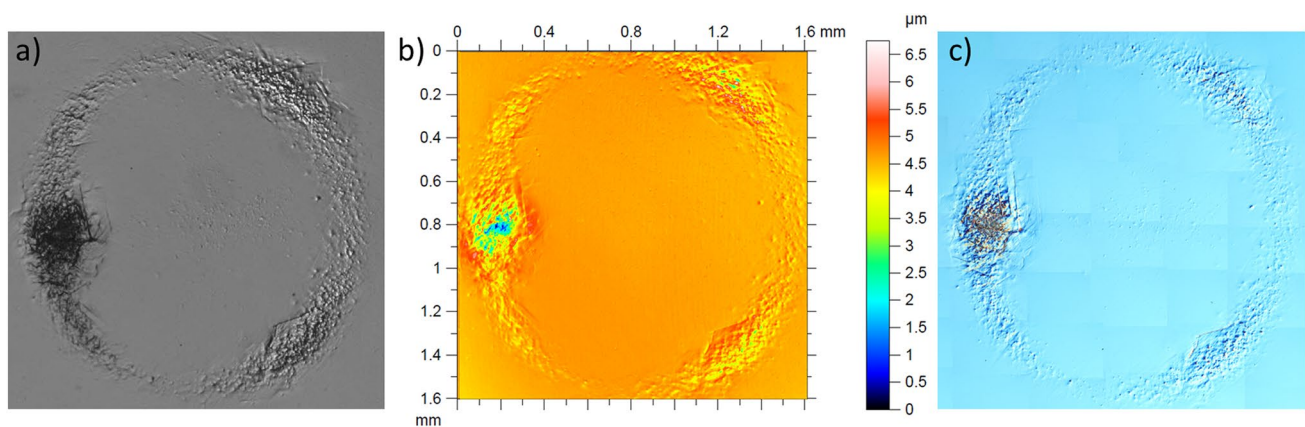
**Fig. 3** Comparison of an in-situ microscope image on 316L after 30 000 individual bubble impacts compared with the ex-situ imaging of the same damage. **a** in-situ image, **b** surface elevation from confocal

scanning, **c** DIC image, assembled from about 60 frames acquired with a 20 $\times$  objective. All images are shown at the same magnification, with the spatial scale given in **(b)**

Figure 3 shows three different microscope images of the cavitation damage on a 316L sample impacted by a series of 30 000 bubbles with a maximum diameter of 2.5 mm at  $\gamma = 1.4$ . The image taken by the in-situ microscope is shown in Fig. 3a. The other two, ex-situ images of the same damage, from confocal scanning microscopy (Fig. 3b) and a commercial light microscope with DIC (Fig. 3c), serve as a reference for the quality and informative value of the in-situ microscope images. The circular shape of the damaged region seen here is consistent with other works [16, 18]. There are both less damaged regions where individual pits can still be discerned, and a more severely damaged region. Thus, the quality of the images can be assessed in both of these damage scenarios, which may also be representative of earlier and later stages of local damage evolution.

Comparing Fig. 3a, c, the effects of aberrations caused by the 20 mm of water above the sample are visible as a slight blur in the in-situ image. But as far as the overview figure allows, all major features that can be seen in ex-situ can also be found in-situ. A more detailed ex-situ analysis can then complement that with quantitative measurements. For example, the confocal image in Fig. 3b shows that the depth of the most damaged region is 4  $\mu\text{m}$  and that of a typical single pit is about 0.25  $\mu\text{m}$ , consistent with our previous work with the same material [23]. This then can be linked to the corresponding contrast in the in-situ image.

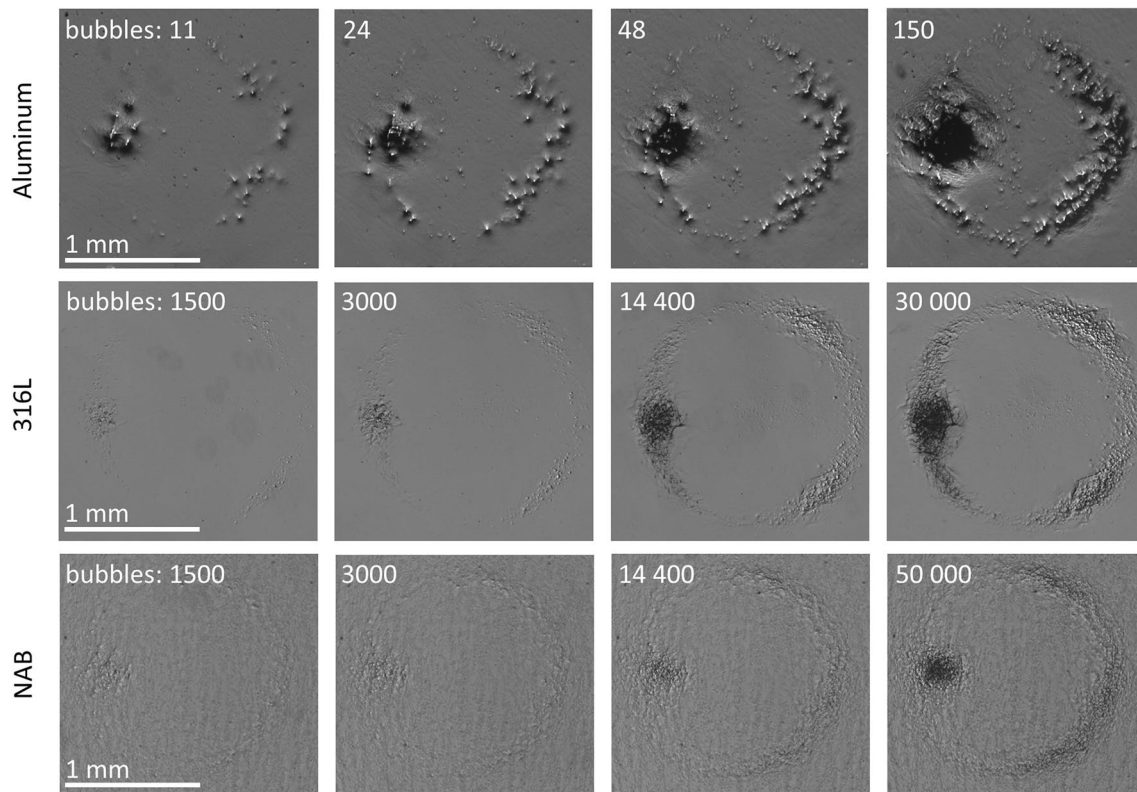
**Fig. 4** Damage evolution on aluminum (top), 316L (middle), and NAB (bottom) at  $\gamma=1.4$  and  $r=2.6$  mm bubble radius

Series of measurements were performed with selected stand-off distances. The in-situ images in Fig. 4 give a first overview of the stages of the damage processes for aluminum, 316L, and NAB. The experiments on aluminum were performed to link to the literature results on soft materials. The samples were successively exposed to 30 000 single cavitation bubbles for 316L and 50 000 for NAB. Images at 1 500, 3 000, and 14 400 bubbles are also shown in Fig. 4. Aluminum was exposed to a number of bubbles that induced similar cavitation damage as on the technical alloys, with images at 11, 24, 48, and 150 bubbles shown here. For all three materials, with an increasing number of bubbles an increase in the damage becomes visible. At all stages, most of the damage is in a ring-shaped area, best seen in the last images, and this is again consistent with the literature [16, 18]. The ring consists of smaller individual

pits. For aluminum, after 11 bubbles already more than 25 individual pits can be detected. This means that one bubble can cause more than two pits on aluminum. The damage evolution on the soft aluminum shows some differences to that on the harder two materials. Besides progressing much faster, the pits are bigger, and the area surrounding each pit appears more deformed.

Our findings are consistent with those of Philipp and Lauterborn [18] and Isslin et al. [16] in that they show an asymmetry in the otherwise ring-shaped damage patterns, with an area of more severe damage towards the direction of incoming laser light. This is most likely due to an asymmetry in the plasma breakdown [18], which is not spherical, but rather elongated and conical [29], as Fig. 2 at  $t=-98$   $\mu\text{s}$  indicates. Among all stand-off distances,  $\gamma=1.4$  creates the laterally most extended damage area, which may make the damage more prone to such asymmetries (see [18] for damage patterns with other stand-off distances). In fact, experiments with this  $\gamma$ -value can be used to detect plasma asymmetries that otherwise are difficult to visualize.

Among the two technical alloys, in good agreement with our previous work, NAB shows greater resistance to cavitation exposure than 316L in that the optically detected damage appears less severe after the same number of cavitation bubbles [23]. Also, the change in surface

damage appearance differs between 316L and NAB. The difference increases with the number of bubbles. For 316L, after 30 000 bubbles almost the full circumference of the ring-shaped damage displays pits. The damage concentration towards the incident beam appears very dark, indicative of its great depth. On the opposite half of the ring, two regions with less pronounced damage accumulation are recognizable (at approximately 1 and 5 o'clock). On NAB all these features appear less pronounced, and regions adjacent to the most damaged region on the side of the incident beam display almost no damage in these images. Furthermore, the surface of the NAB sample in general appears less smooth, showing small-scale grey variations in brightness in the image. This is caused by the complex microstructure in NAB, which contains both areas of high density of hard intermetallic phases, and others consisting mainly of softer Cu-rich solid-solution phase. A small difference in surface height between these different regions after polishing the sample surface causes the diffuse grey shading of the surface. The hard phases improve NAB's resistance to cavitation exposure by hindering plastic deformation and limiting pit dimensions. 316L on the other hand is a single-phase material, in which only grain boundaries and strain hardening limit pit formation by plastic deformation, which may act in NAB as well.

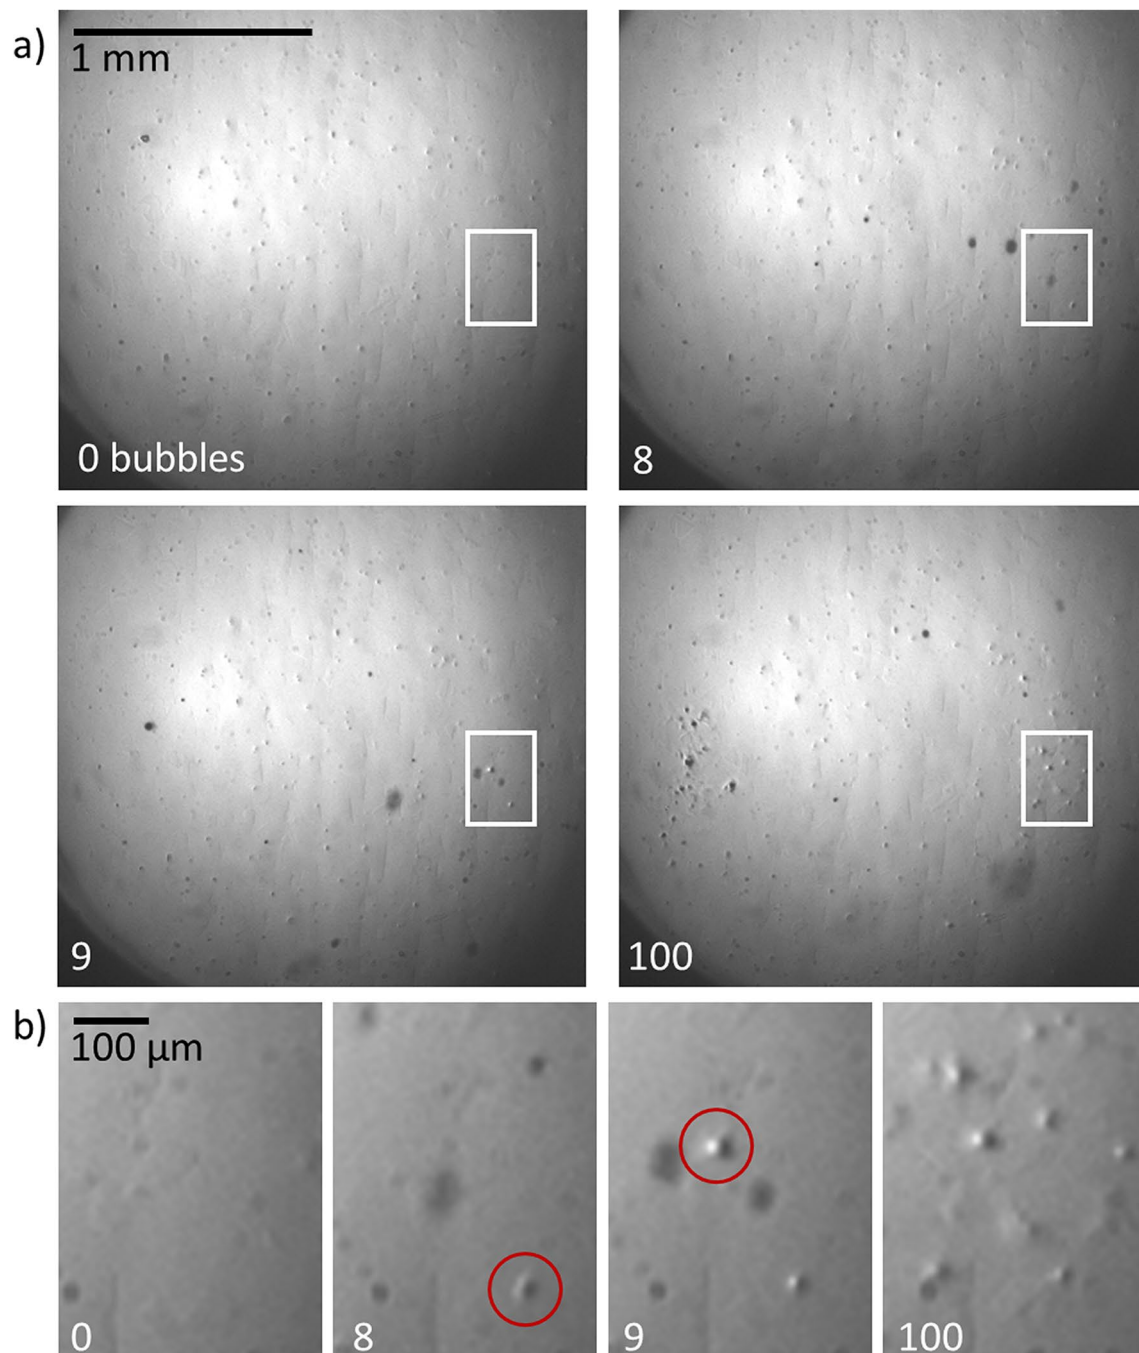
**Fig. 5** Damage formation on 316L at  $\gamma=1.4$  and 1.25 mm bubble radius. **a** full field of view, **b** magnified region corresponding to the white rectangle in (a). The red circles mark features discussed in the text

Figure 5 shows four microscope images from a 316L sample, taken after 0, 8, 9, and 100 bubble collapses, as well as a magnified region within each of these images. As discussed with Fig. 3, the dark, more or less diffuse spots that change position between images are shadows of small bubbles remaining after the preceding bubble collapse.

After the 8th bubble, the first pit appears, as marked in Fig. 5b. The next pit occurs already with the next (the 9th) bubble. This pit is then due to exactly the single preceding bubble. After 100 bubble collapses these two pits can still be identified. Note that the visual appearance of a given pit may change slightly between images. This is due to the fact that the water surface through which the images are taken is not perfectly still. The small pits that are the result of the bubble collapses later accumulate to form the larger ring structure as discussed above. As for the individual pits that now can be assigned to specific bubbles, we have not yet identified any feature in those particular bubble collapses that produce the pit in that particular spot. Nevertheless, the small size of the pit indicates that this damage might not have been caused by the first bubble collapse (for example, by the jet [8, 22]) but a smaller-scale event in the second toroidal-shaped collapse, as already suggested by other works [8, 22, 32].

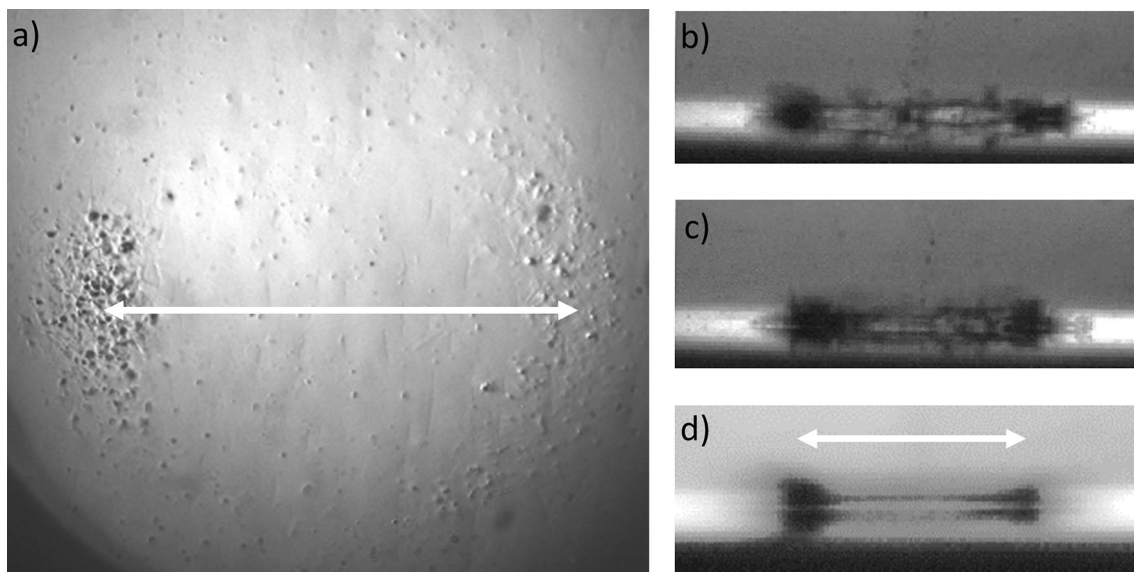
**Fig. 6** Relation of **a** the damaged region as seen by the in-situ microscope after 1000 bubbles and **b–c** the second collapse visualized with the high-speed camera. **b, c** are single shots of the second collapse

in selected bubbles, while **d** shows the mean of 200 collapses. The arrows in both images correspond to 1.55 mm. The images are from the same sample as those in Fig. 5

Indeed, Fig. 6. shows that the damage ring is located under the second, toroidal bubble collapse. Still, it remains unclear what exactly caused a pit in a given spot. It may have been a particular, local feature of the bubble. An asymmetry in the torus of the second collapse can clearly be seen in Fig. 6 a–c. Regions on the ring displaying damage accumulation as described above (see Fig. 4) appear darker in the high-speed camera images, indicating the presence of more and possibly larger bubble structures. The shockwave emitted from the initial bubble might be a central part of the bubble dynamics as it has the potential to grow cavitation nuclei in the vicinity of the solid boundary [22, 32].

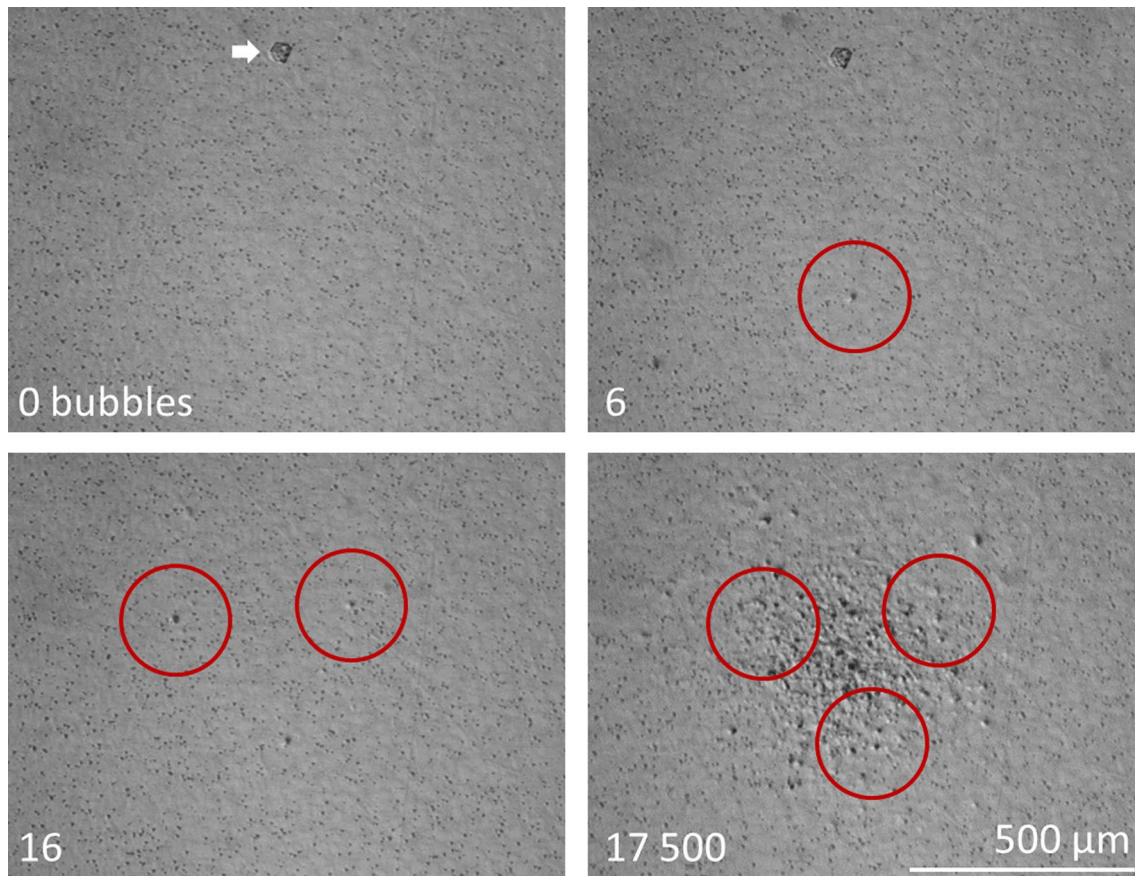
**Fig. 7** Early damage formation after 6 and 16 bubbles, and accumulated damage after 17 500 bubbles on NAB with  $\gamma=1.7$ . The circles mark features discussed in the text. The white arrow in image 0 marks

a feature that is an adhering particle of dirt that detached from the sample surface between the 6th and the 16th bubble

In Fig. 7 the damage progression is shown for  $\gamma = 1.7$  on NAB. For this stand-off distance less damage was observed than for  $\gamma = 1.4$ , as can be seen by comparison with Fig. 4 (NAB 14 400 bubbles). The first pit appeared after the 6th bubble, and two pits were caused by the 16th bubble collapse. Thus, even on technical materials, it is possible for one bubble collapse to create more than one pit. For  $\gamma = 1.7$  the damage pattern after many bubbles is not a ring but a smaller, central area that is again formed by smaller pits. The damage shape is consistent with measurements with this  $\gamma$  by Philipp and Lauterborn on a soft sample [18]. The last image in Fig. 7 shows that the first three pits are not clearly recognizable anymore at a count of 17 500 bubbles, because they are covered by further pits.

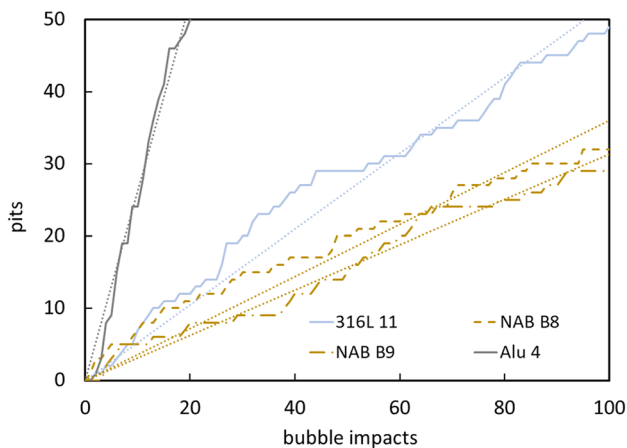
**Fig. 8** Pit count per bubble and linear fit of the pit count. For NAB, two samples were considered, as indicated in the legend after the material designation

To obtain a quantitative measure of early damage progression, we counted the pits after each bubble within a series. Pit counting was done by visual inspection, and the size and shape of the pit was disregarded. Figure 8 shows the result for series of 100 successive bubbles for the three materials, with two samples for NAB. Between zero and six additional pits are found after a single collapse. The slope of this pit count graph, approximated here as a

linear fit through the origin to each data series, is then the series-mean pitting rate. The parameters of these experiments and the pitting rate are listed in Table 1. About 50 pits could be counted on a single sample before it became hard to distinguish overlapping pits. Beginning pit overlap may also be the reason why the slope of all traces decreases towards higher pit counts. The pitting rates have the same order among the materials as the corresponding material hardness, as does the maximum number of pits after a single-bubble collapse. After one collapse, 0–2 pits occurred on NAB, 0–3 on 316L, and 0–6 on aluminum. It is also remarkable that on one hand, even a soft material like aluminum did not show damage after every collapsing bubble. On the other hand, sample B8 from the hard NAB had a pit after the very first bubble. The two NAB samples differ slightly in their bubble parameters and in the pit count progression, but in this initial demonstration it is not clear if the difference is significant.
